REPORT OF INVESTIGATIONS No. 53

EFFECTS OF LARGE STRUCTURES
on the
OHIO SHORE OF LAKE ERIE

By
Robert P. Hartley

COLUMBUS
1964

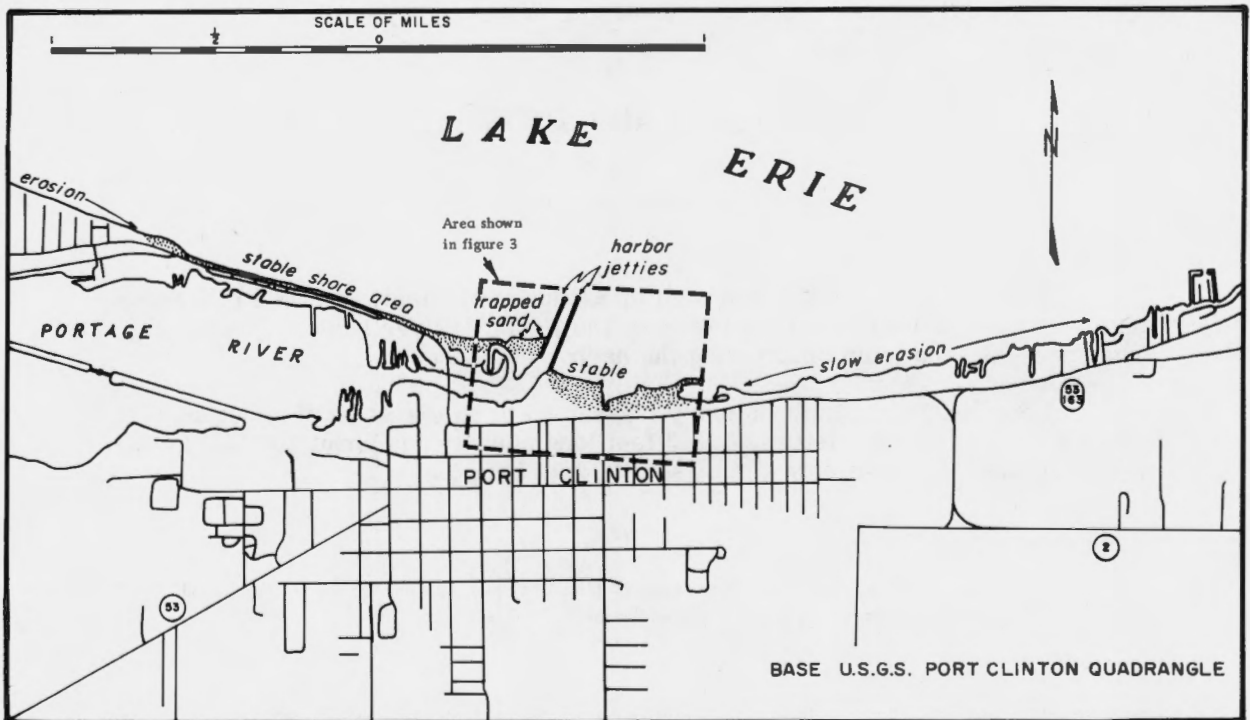
Figure 2.- Port Clinton, Ohio, harbor jetties and beach area.

The beaches both east and west of the jetties are not affected by the jetties as much as might be expected. There is an accumulation of sand just west of the west jetty (fig. 3), but this accumulation does not extend far to the west, even though the jetties have been in existence for 80 years. The beach to the east is not building and the shore is gradually retreating. A fair supply of sand lies just offshore throughout the area but it does not contribute to beach-building. The area appears to be virtually static. The very slow retreat to the east is probably caused by subsidence of the shore and not by a loss of sand.

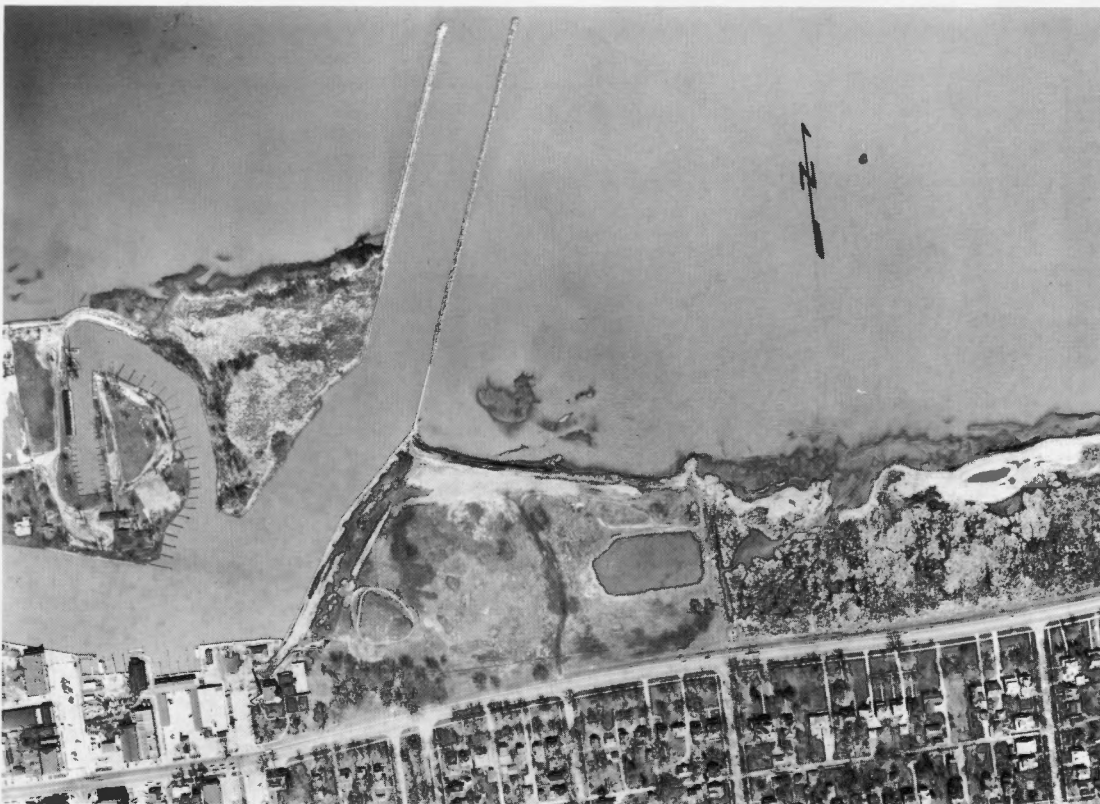
Figure 3.- Port Clinton harbor entrance and adjacent shores. Dark patches along shore are sand bars. Note position of water line on west side of jetties relative to that on east side, indicating eastward drift. Photo taken 4/15/57. Water level 573.0.

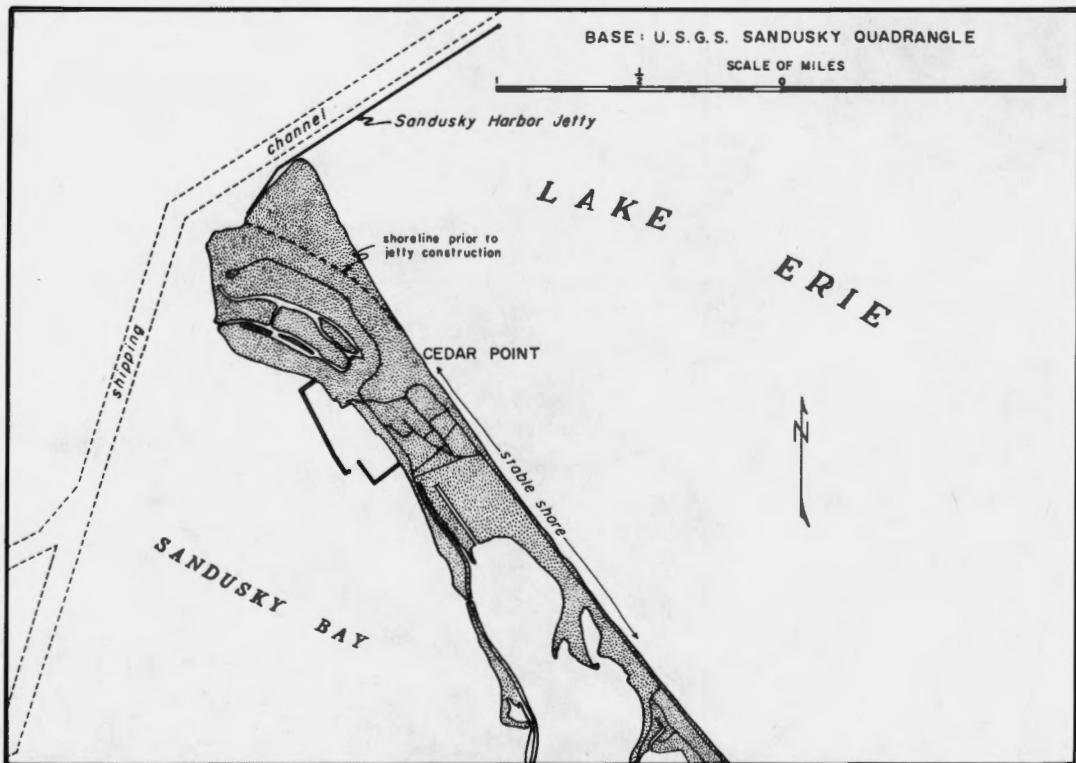
Figure 4.- Sandusky, Ohio, Cedar Point spit and harbor jetty.

The Sandusky harbor jetty has trapped a great amount of sand on its southeast side, to the advantage of the amusement park and residents along the spit to the southeast. The mouth of Sandusky Bay is northwest of the jetty and there have been no detrimental effects. This is the only large structure along the Ohio shore

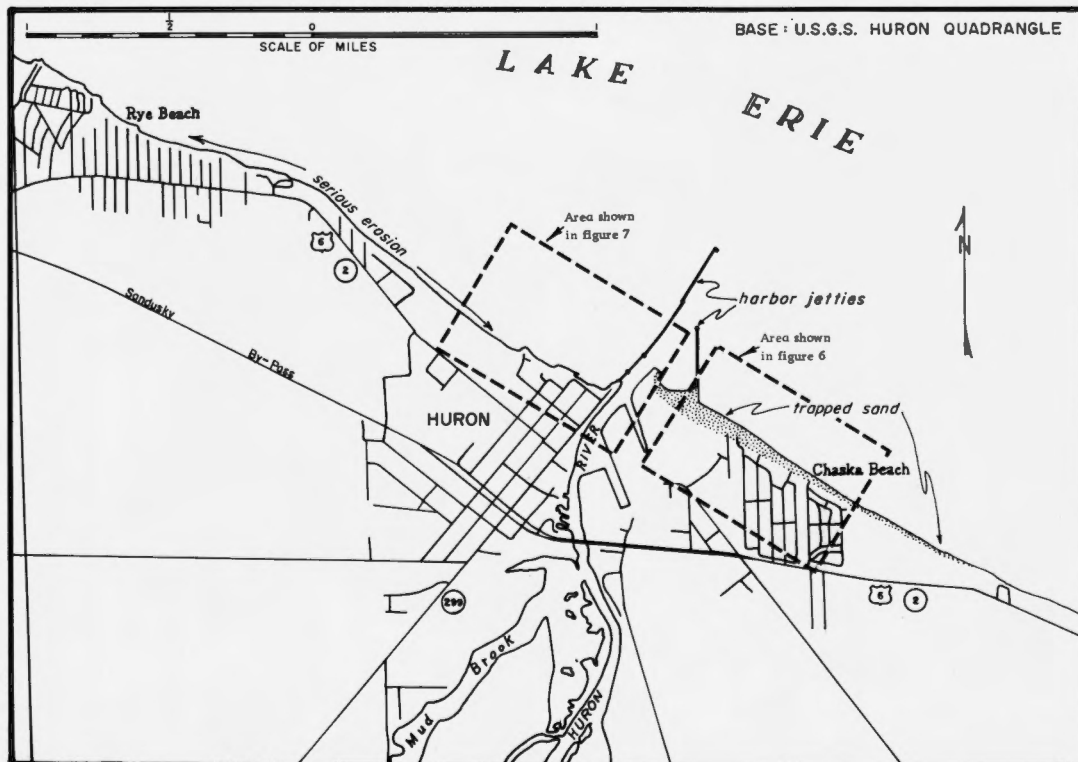
Figure 5.- Huron, Ohio, harbor jetties and shore conditions.

The jetties at Huron, in summary, have caused a good, mile-long beach to be built to the east, while adversely affecting, by sand starvation, about five miles of shore to the west. East of the beach, beyond the jetties, the effect has been slight.

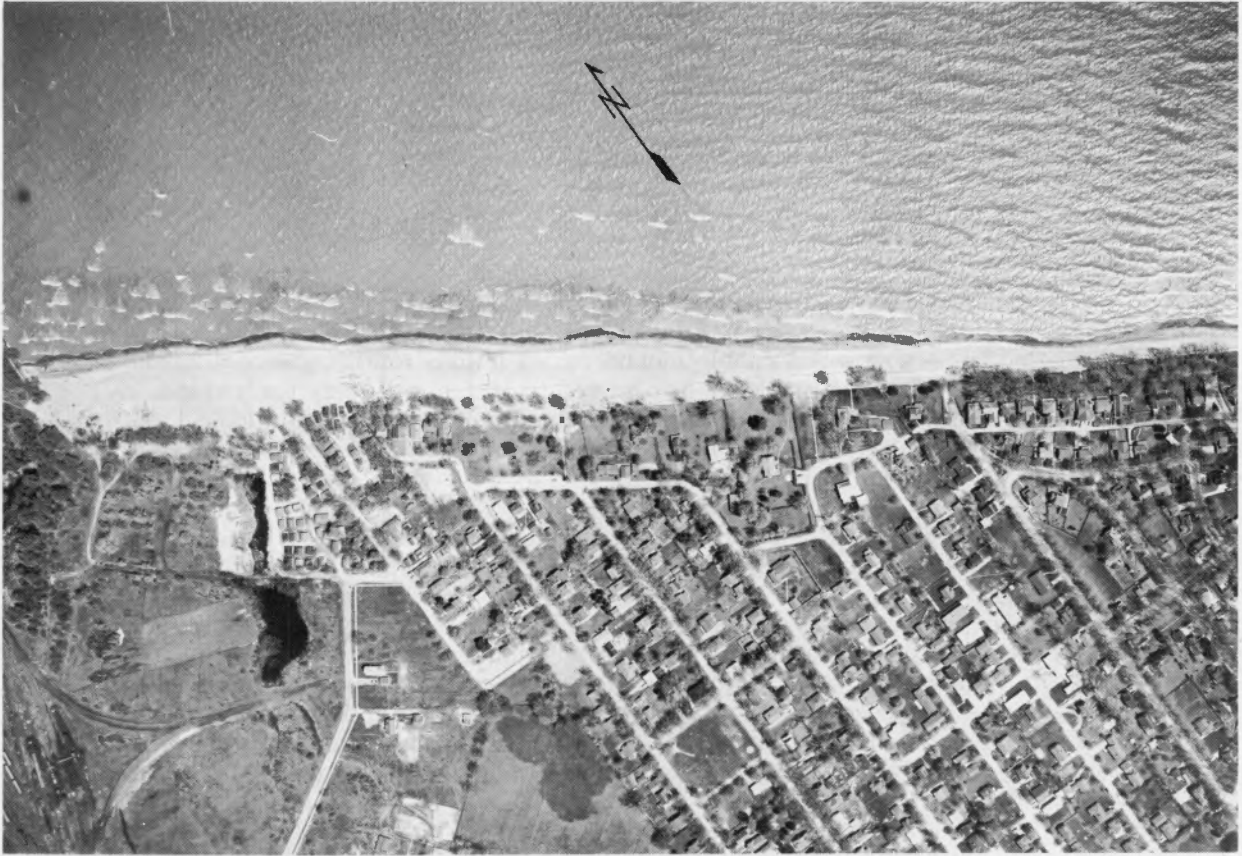
The east jetty has trapped and maintained a wide beach which extends eastward about one mile (fig. 6). Thus this section has been stabilized by a permanent beach derived from erosion of the shore and nearshore bottom to the east.

→ Figure 6. - Beach east of Huron River mouth at Huron, Ohio. Base of east harbor breakwater at extreme left of photograph. Note length and width of beach. Photo taken 5/7/56. Water level 573.2.

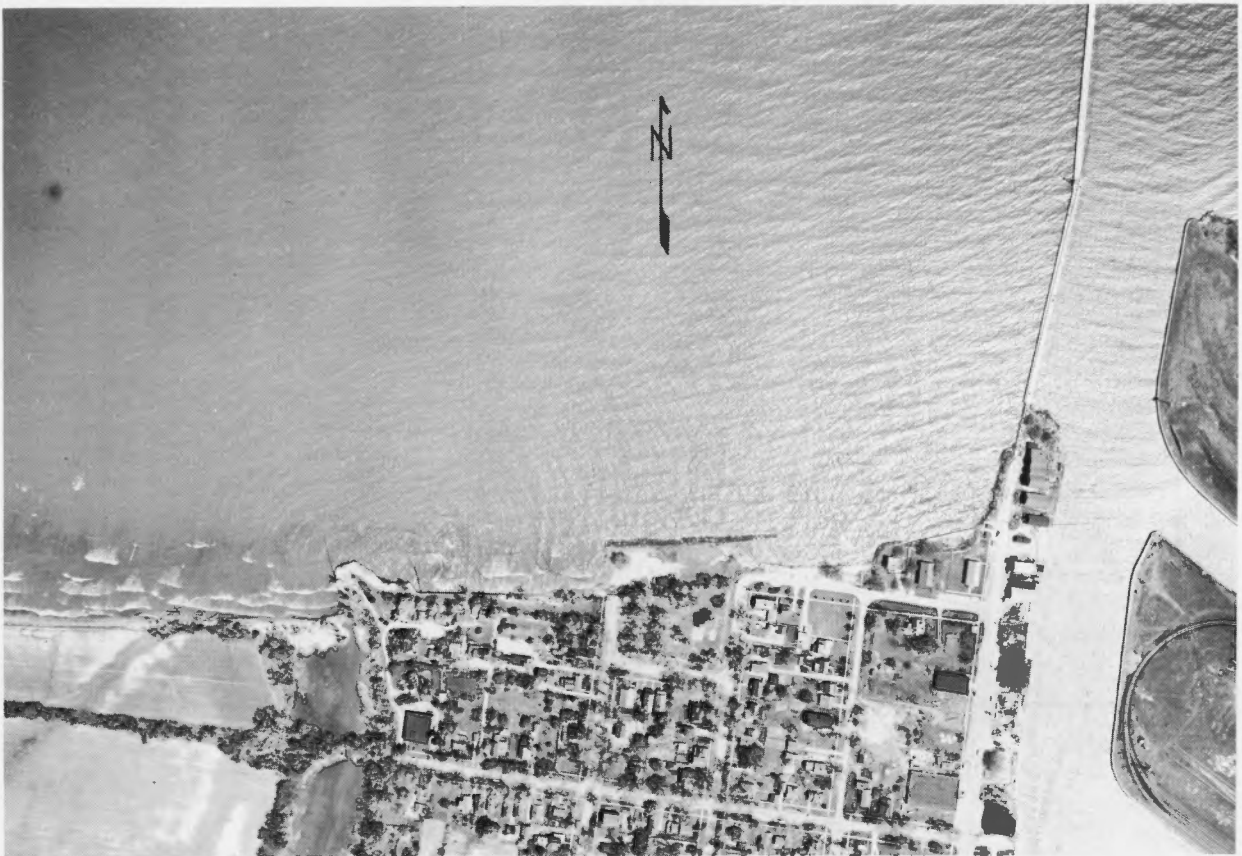
The predominant littoral drift in the Huron area is toward the west. Because the jetties effectively stop the movement of beach materials in the drift, the shore west of the jetties is starved of sand. Beaches are scarce or absent along the shore for $2\frac{1}{2}$ miles west of the jetties (fig. 7). The scarcity of protective beaches has necessitated the construction of bank protection. Protected banks add to the problem by eliminating the only important source of beach supply, for the nearshore bottom

→ Figure 7. - Shore west of Huron River mouth at Huron, Ohio. Compare condition of shore with that of fig. 6. Shore in eroding condition. West harbor breakwater at right side of photograph. Photo taken 5/7/56. Water level 573.2.

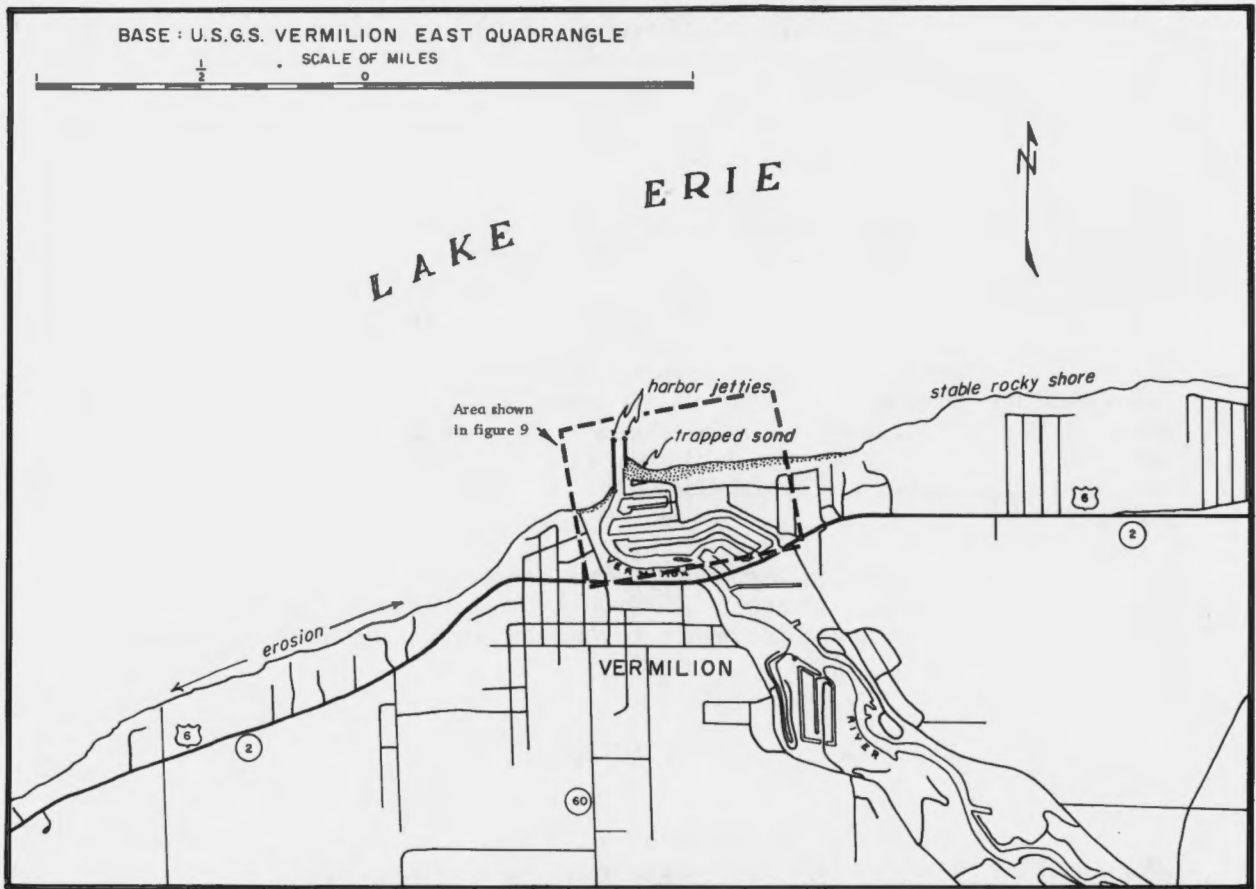
→ Figure 8.- Vermilion, Ohio, harbor jetties and shore conditions.

The jetties at Vermilion do not greatly affect the shore to the west because of the slight supply of sand and relatively short lengths of the jetties. However, they have kept the sand on the beach to the east out of the littoral supply, with the result that shore conditions on the two sides are not in balance.

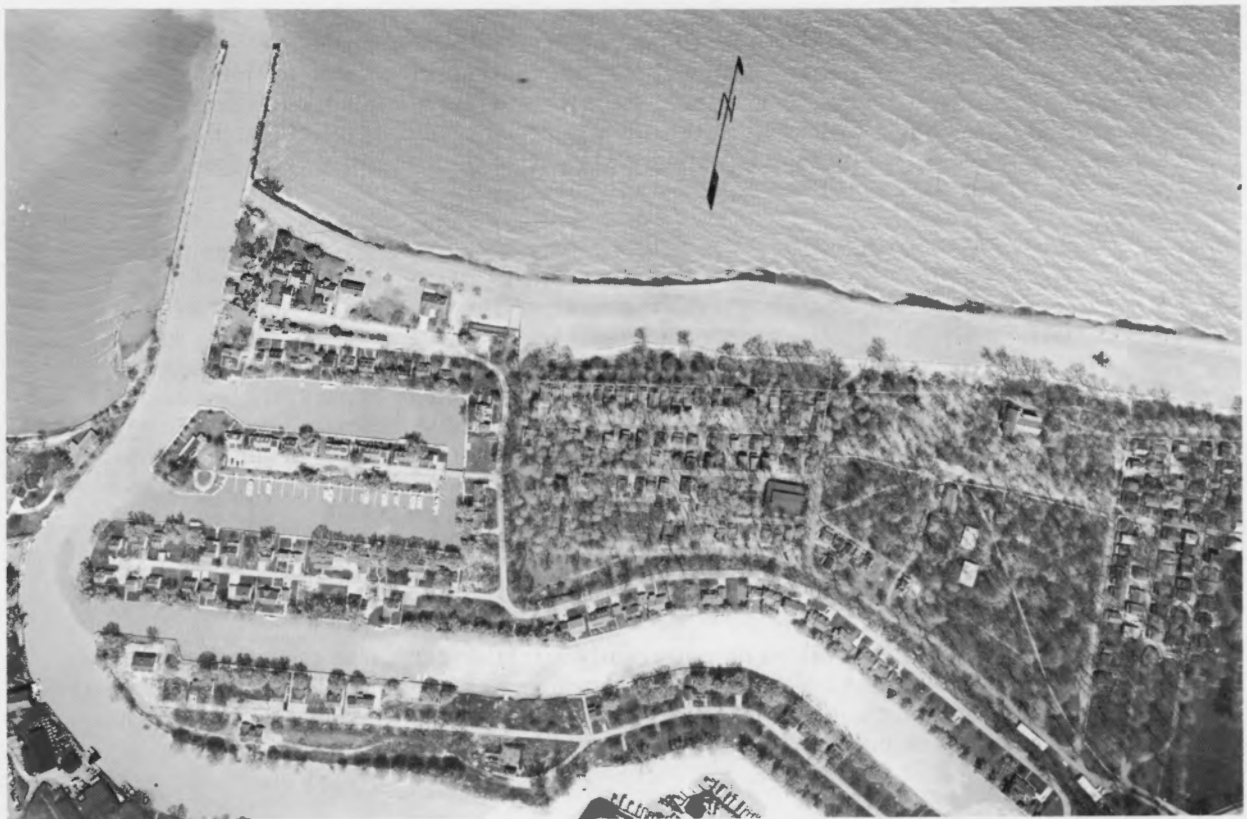
A beach more than 3,000 feet long has been trapped east of the jetties (fig. 9). The beach exceeds 150 feet in width and offers excellent protection to the landward residential and park areas. The beach is stable and has not changed materially in many years. Apparently the east jetty has trapped its limit of beach sand. Some sand is being added to form small dunes along the back of the beach. East of the beach the jetties have no effect on shore processes.

→ Figure 9.- Vermilion, Ohio. Vermilion harbor jetties at upper left. Beach east of jetties trapped by east jetty. Note position of shore west of jetties compared to that east of the jetties. Photo taken 5/7/56. Water level 573.2.

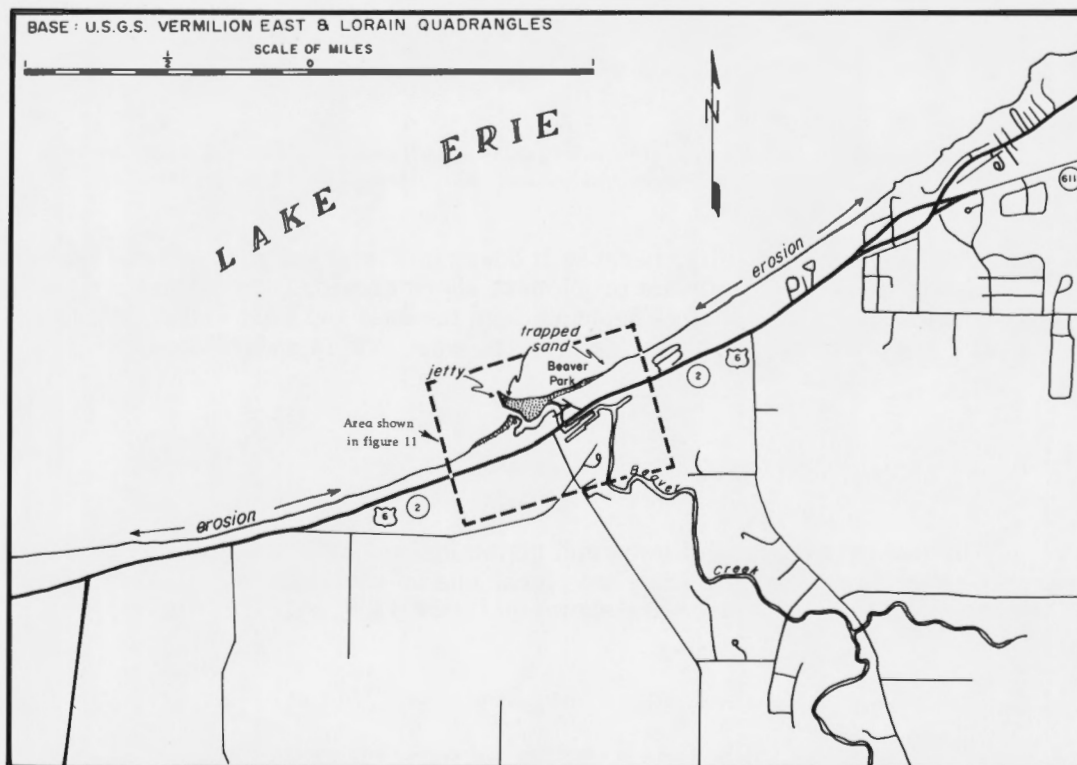
Figure 10.- Mouth of Beaver Creek, jetties and shore conditions.

The jetty along the east side of the mouth of Beaver Creek has been built to prevent sand from damming the mouth (fig. 10). It is 400 feet long and built of dumped rip-rap. The jetty is impermeable to sand and on its eastern side has trapped a good beach more than 2,000 feet long.

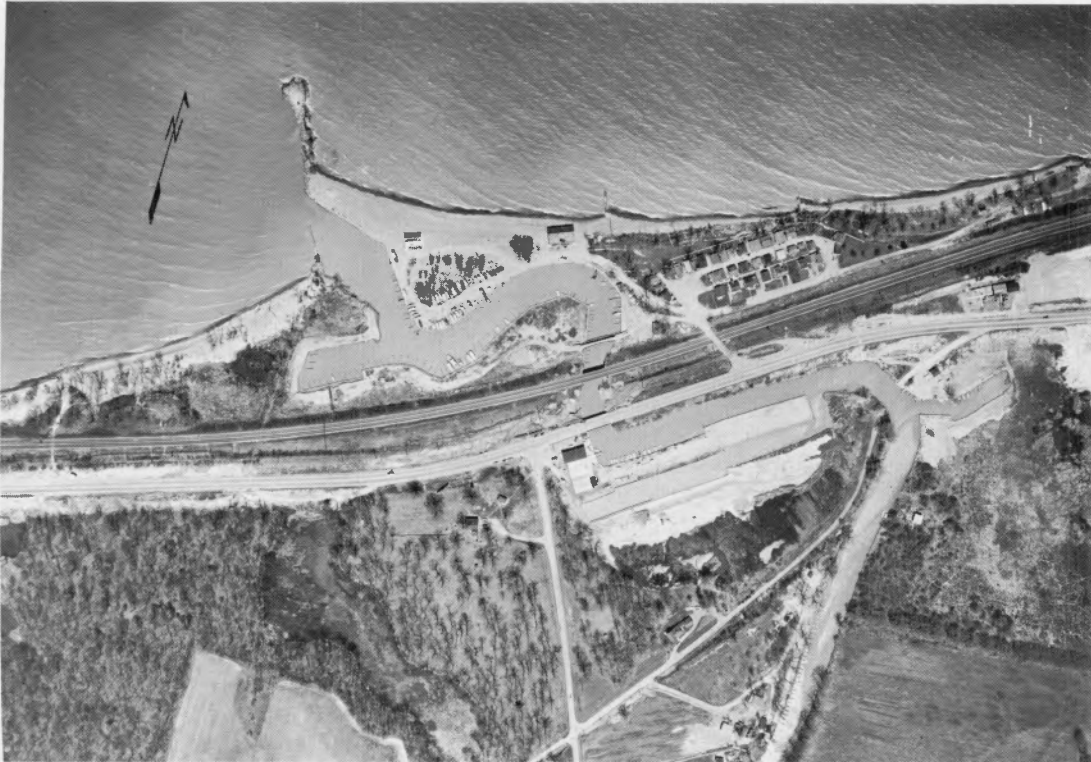
The longshore drift in the Beaver Creek area is toward the west, which accounts for the beach build-up to the east (fig. 11). The jetty has apparently trapped as much beach as it can be expected to hold, and sand now passes to the west around the end of the jetty. A beach about 1,500 feet long west of Beaver Creek appears to be maintained by the flow of sand past the jetty. A quantity of sand lies in the near-shore zone off the western beach. A comparable area of sand does not exist off the beach east of the jetty, and the bottom is subject to scour.

Figure 11.- Beaver Creek, four miles east of Vermilion, Ohio. Beaches east and west of creek mouth jetty are relatively stable. Jetty retains beach to east. Photo taken 5/7/56. Water level 573.2.

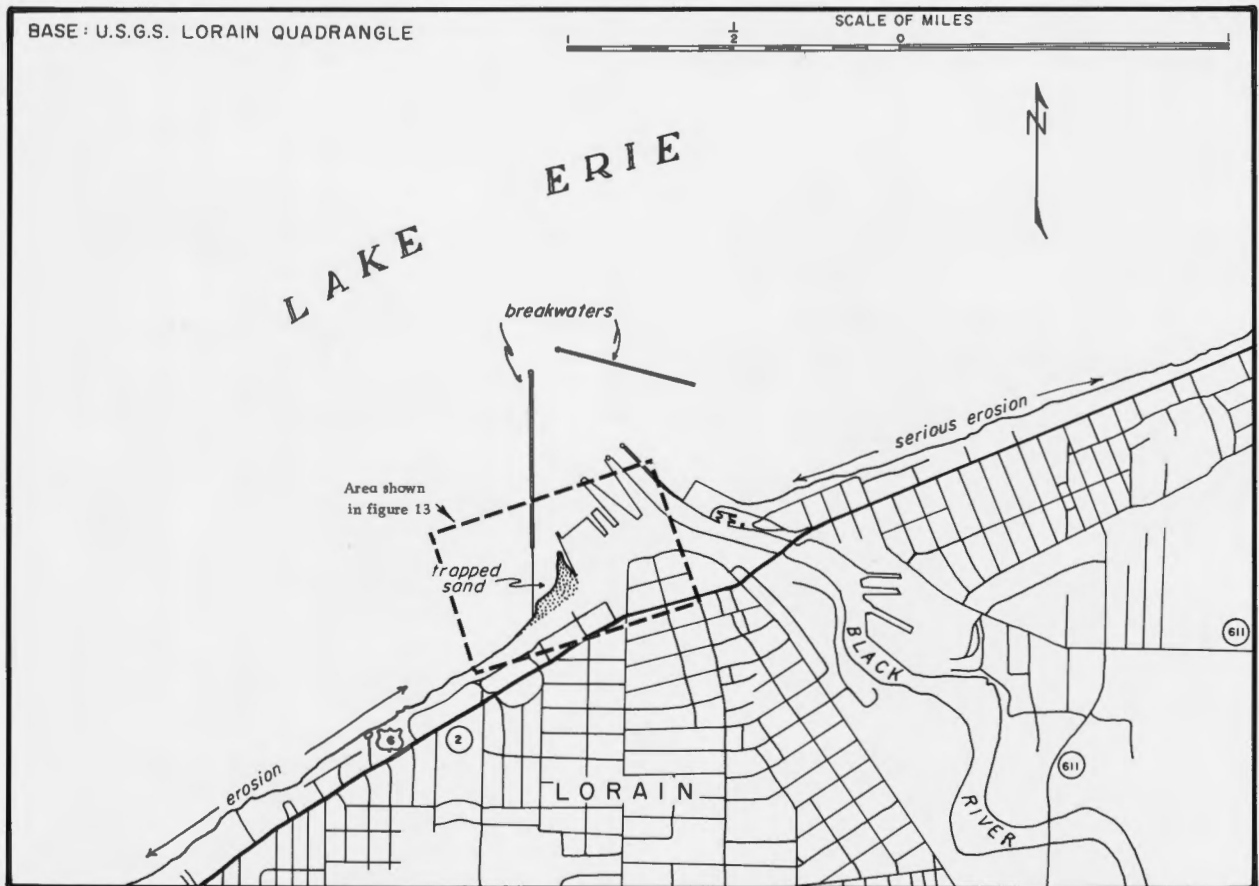
Figure 12.- Lorain, Ohio, harbor breakwaters and shore conditions. ➔

The condition of the shore along the city of Lorain indicates that the structures may have a more or less adverse effect on both the east and west sides. Erosion is very active to the east. A small pebble beach has been built at the base of the east pier. This beach contains little sand and appears to be static in growth. Its composition indicates that it is comprised, in part, of materials dumped over the banks to the east. The orientation of the east pier, at an obtuse angle to the east shore, apparently allows beach material in westerly movement to pass by and into the outer harbor area. This is an offshore movement protected from deflection by the east breakwater.

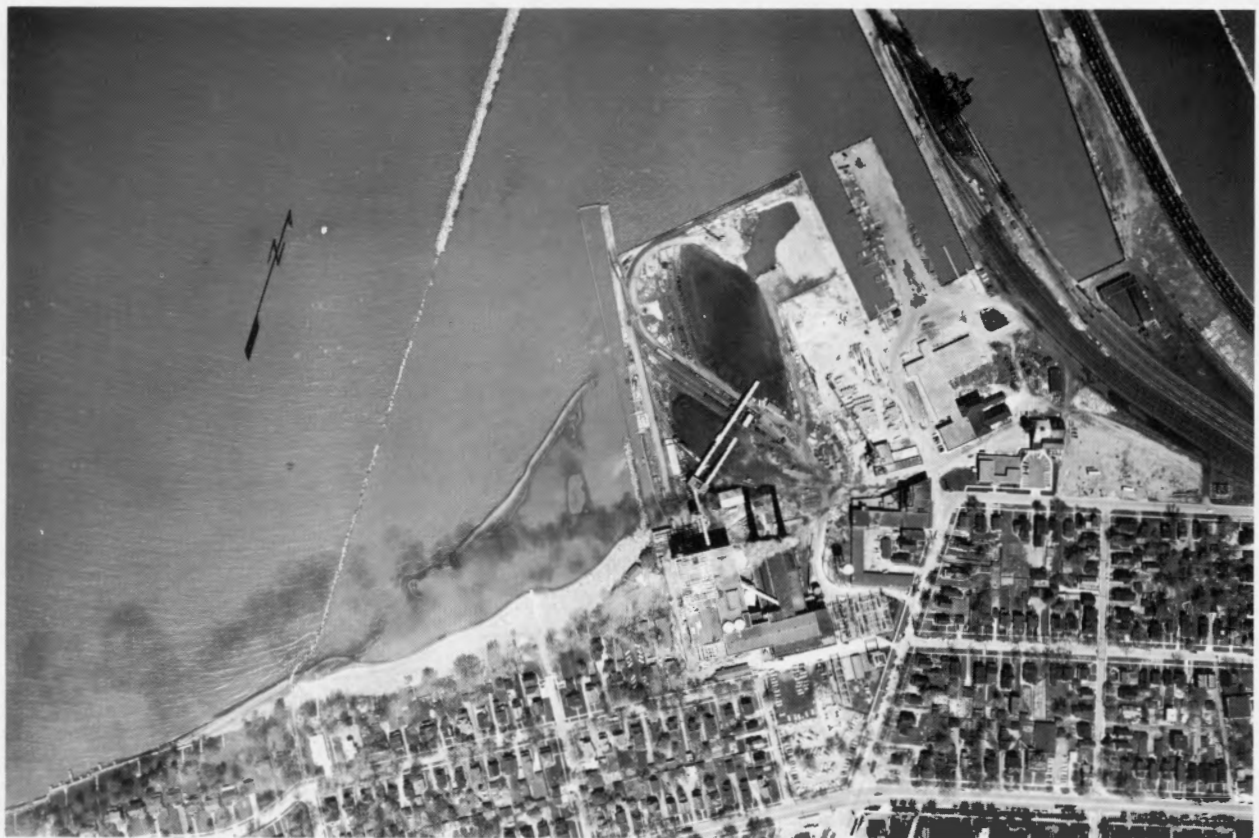
Figure 13.- Shore of Lorain, Ohio in vicinity of west harbor breakwater. Breakwater at left center of photograph. Note accumulation of sand inside breakwater with a relative scarcity of sand west of breakwater. Photo taken 5/7/56. Water level 573.2. ➔

At first glance the build-up of sand at the base of the west breakwater indicates a predominant eastward drift in the area. However this conclusion is not necessarily true. Instead, indications are strong that the area west of the breakwater, in the city park and farther westward, is being starved of sand. Accretion patterns indicate a predominant westward movement.

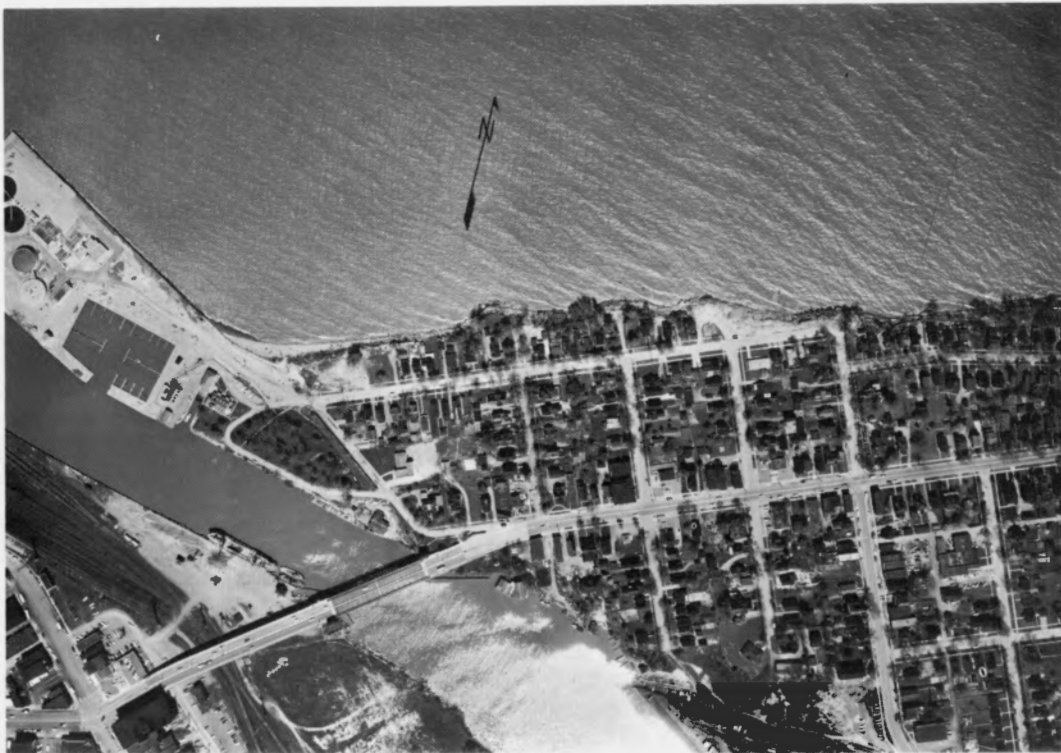
Figure 14.- Shore just east of Black River mouth at Lorain, Ohio. A potentially serious erosion problem exists here. Note lack of beaches. Orientation of sea wall at left end of photo allows unimpeded flow of material toward northwest. Photo taken 5/7/56. Water level 573.2.

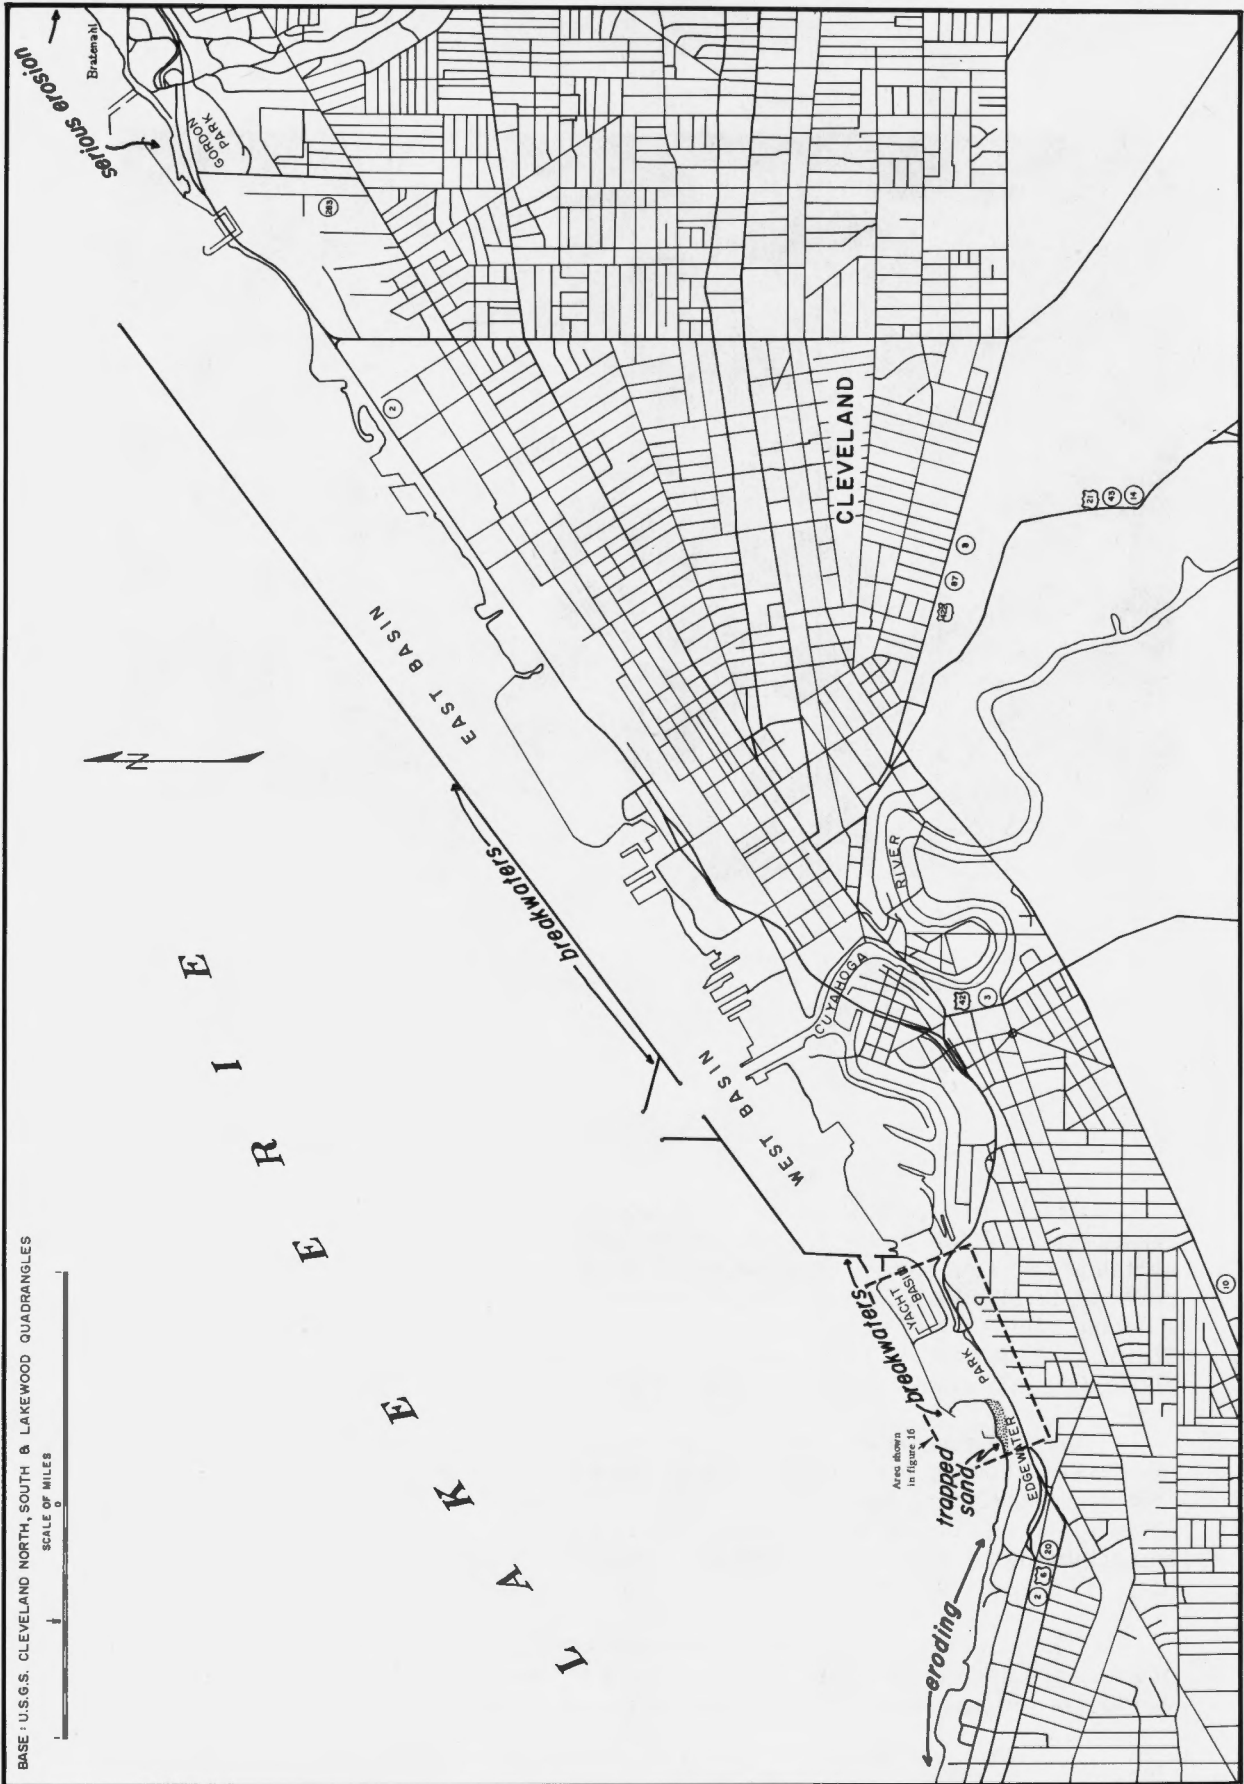
← Figure 15.- Cleveland, Ohio; harbor structures and shore conditions.

The breakwaters have had no adverse effects on the shore throughout their length. However, the shore east of the breakwaters is eroding seriously (fig. 17). The banks are high and comprised of clay and silt. They are easily broken down by wave attack because there are no protective beaches of any consequence for several miles. The breakwaters impede the west-to-east littoral drift which would otherwise be available to the area. Materials which could be useful in beach-building probably move eastward along the lake side of the breakwaters, but they are so far offshore that they cannot be brought ashore after reaching the eastern end. In this way the breakwaters tend to starve the shore to the east for more than two miles.

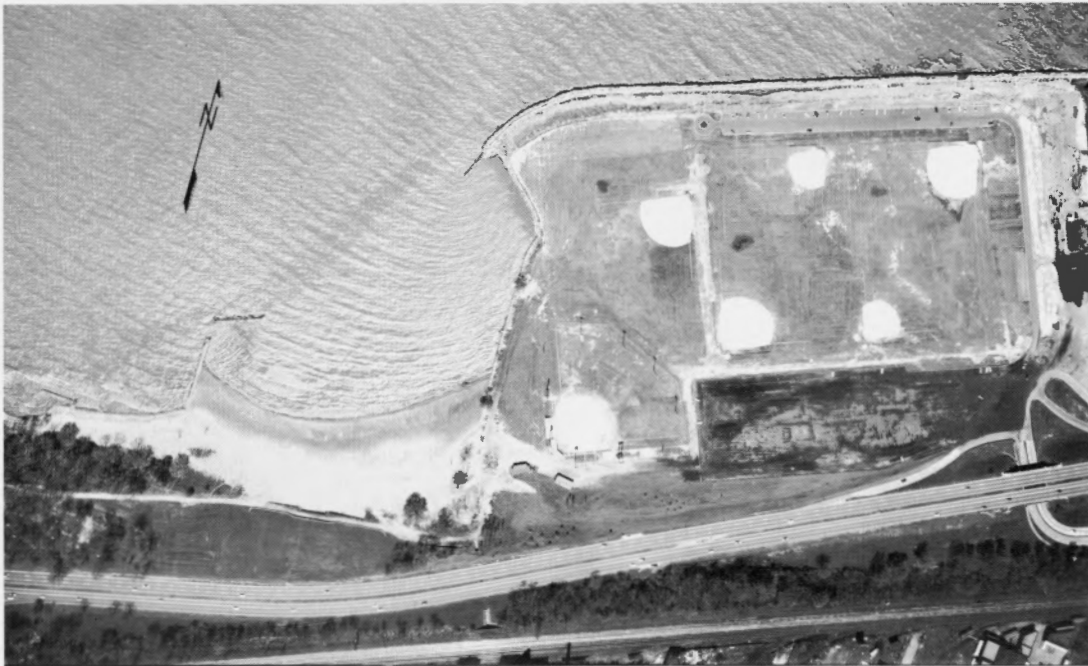
Figure 16.- Edgewater Park and Beach on west side of Cleveland harbor structures. Wide beach shown in west half of photograph trapped by sea wall to east. Most of area between sea wall and freeway in east half is artificial fill. Photo taken 5/7/56. Water level 573.2.

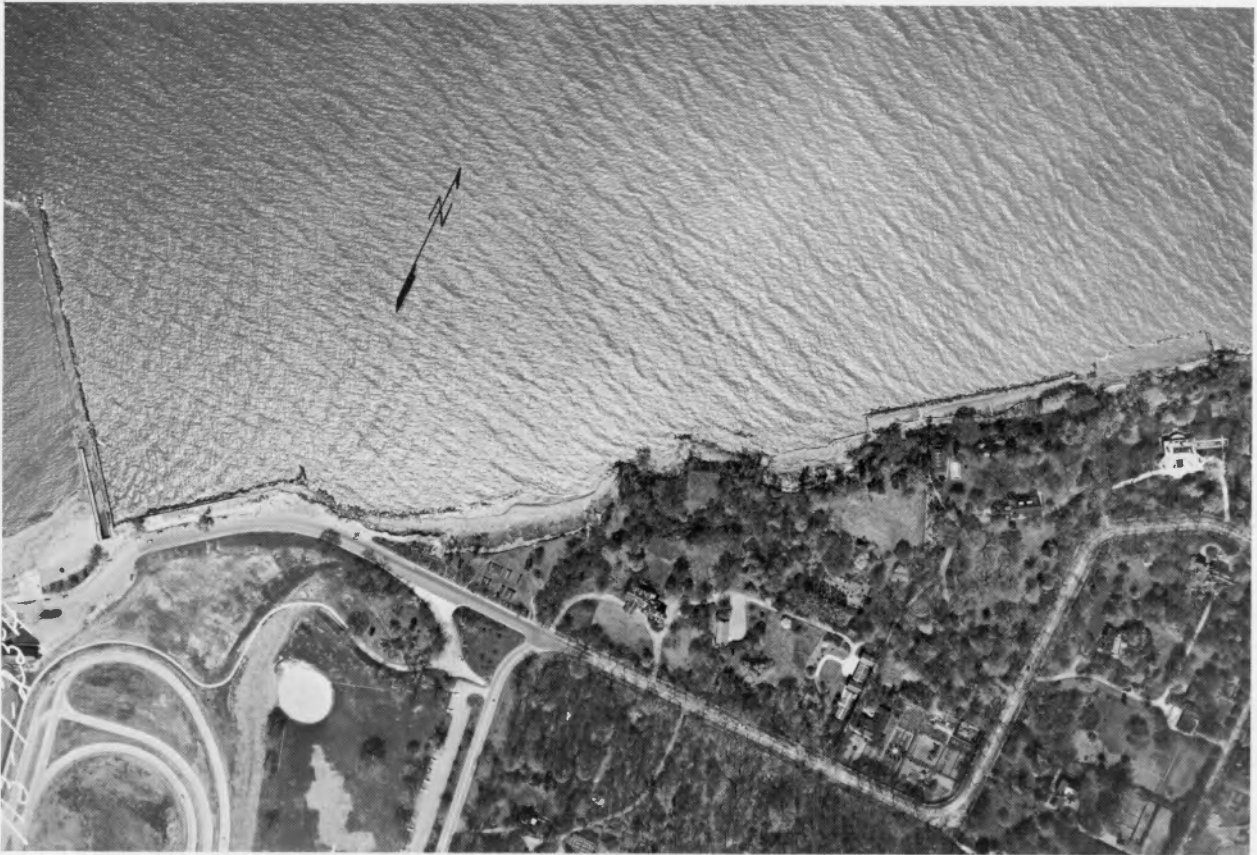
← Figure 17.- Gordon Park and vicinity in east Cleveland. East end of harbor breakwater about one half mile offshore at west end of photograph. Note serious erosion and lack of beaches. Photo taken 5/7/56. Water level 573.2.

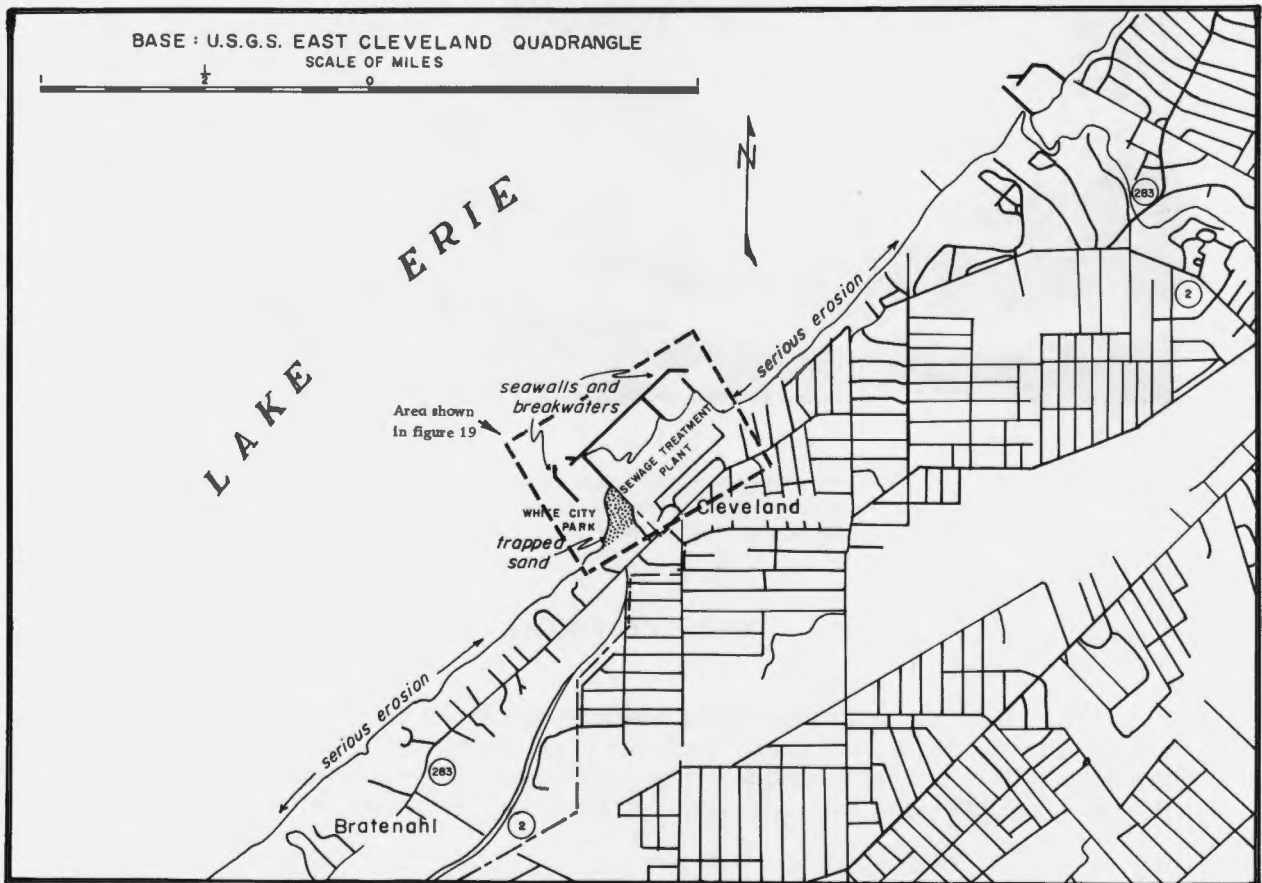
← Figure 18.- Cleveland, Ohio, White City Park, structures and shore conditions.

The structures tend to hold a small beach at the eastern shore intersection, but they have caused or accentuated the starvation of beaches for the next 3,000 feet, resulting in very serious bank erosion. Farther east the groins at Euclid Beach Park have maintained a long stable beach for many years.

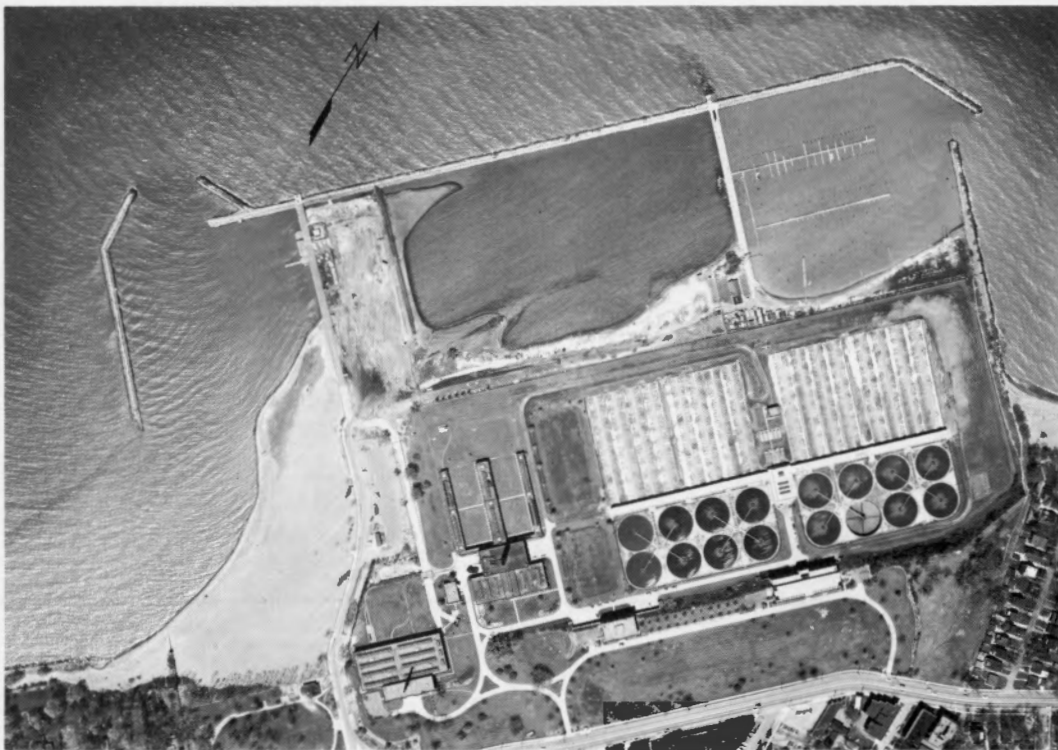
The park is just west of the sewage treatment plant. Here the westernmost structures have caused a beach of remarkable proportions to be formed along a stretch of shore characteristically lacking in beaches (fig. 19). Accretion is still taking place rapidly, creating the highly unusual condition of too much sand. Dunes form on the back part of the beach and tend to encroach upon the bordering entrance road. A boat anchorage formed by the walls and the offshore breakwater is filling with sand. Much of this area was dredged in 1961 and thousands of cubic yards of sand were removed to be used for inland construction.

Figure 19.- White City Park and sewage disposal plant, Cleveland, Ohio, just east of eastern village limit of Bratenahl. Sand accumulation here has been very rapid. Note unusual shape of beach, probably due to offshore breakwater in left center of photograph. Erosion serious east and west of this area. Photo taken 5/7/56. Water level 573.2.

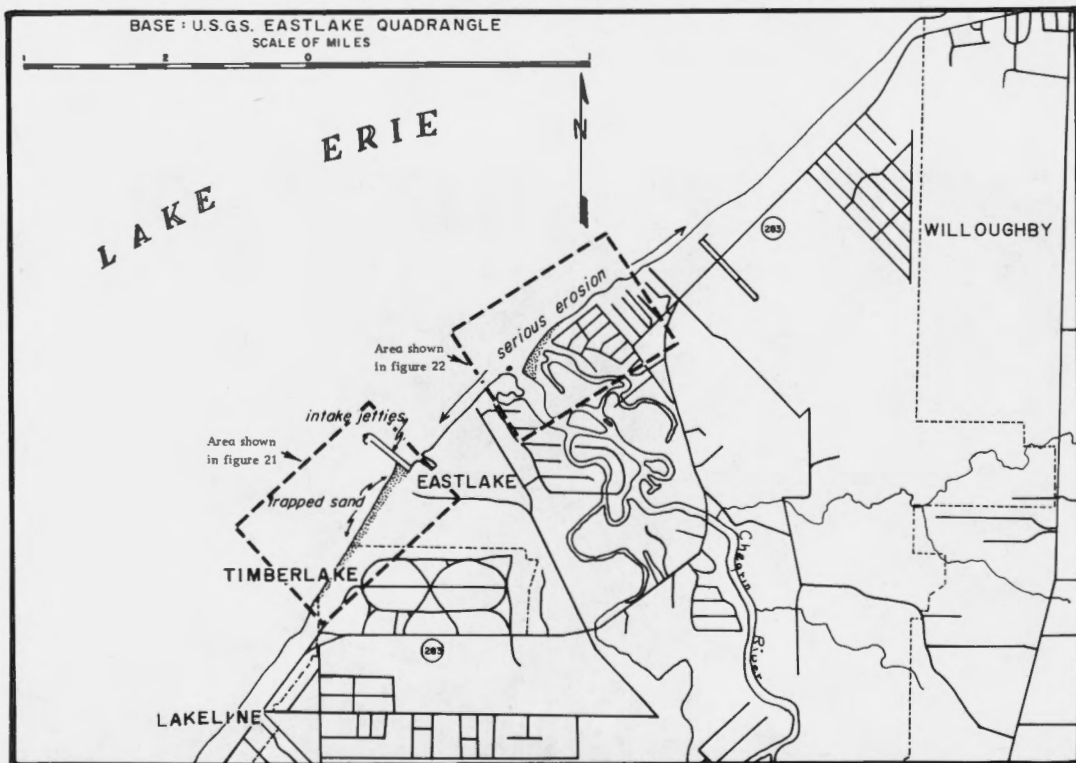
Figure 20.- Eastlake, Ohio, water intake jetties and shore conditions.

The long piers have probably had more far-reaching and significant effects on shore processes during their short existence than any other structures of comparable size along the Ohio shore. While quickly providing a protective beach to the southwest, they have had an extremely serious effect on the shore to the northeast. Formerly a wide beach some 3,000 feet long fronted the valley of the Chagrin River (fig. 22). This beach is rapidly being lost because of sand starvation. The loss is accelerated by the annual dredging in the mouth of the river. The effect is not as serious farther to the east of the Chagrin valley, but the sand starvation is apparent for at least two miles. Deepening of the nearshore bottom is occurring, and, with higher lake levels, the entire area may become one of very rapid erosion.

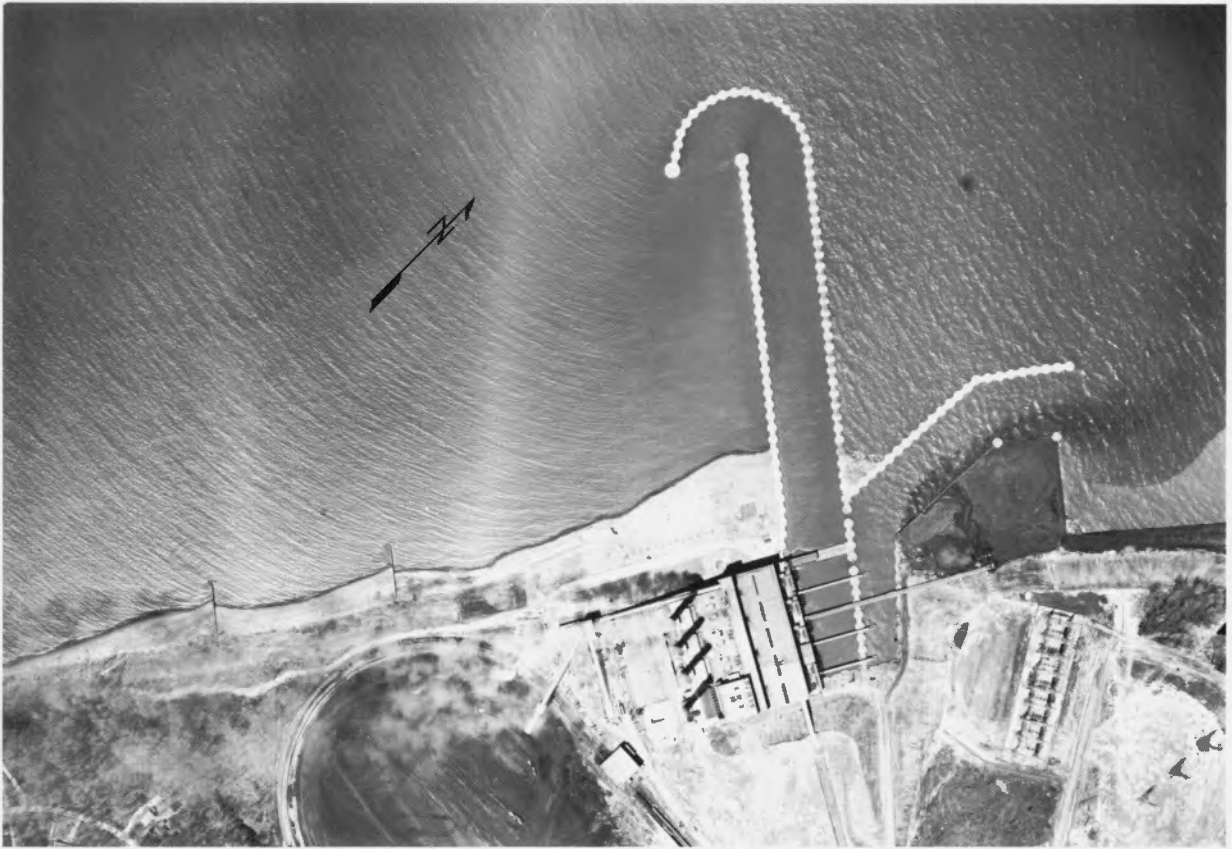
Figure 21.- Electric power company at Eastlake, Ohio. Long, wide beach shown west of jetties had accumulated in only four years. Erosion active east of jetties necessitating sea wall construction. Photo taken 5/7/56. Water level 573.2. →

Since their construction in 1952 they have virtually stopped the longshore movement of sand from the southwest and have quickly built a wide beach on the southwest side which now exceeds half a mile in length (fig. 21).
