REPORT OF INVESTIGATIONS No. 53

EFFECTS OF LARGE STRUCTURES
on the
OHIO SHORE OF LAKE ERIE

By
Robert P. Hartley

COLUMBUS
1964

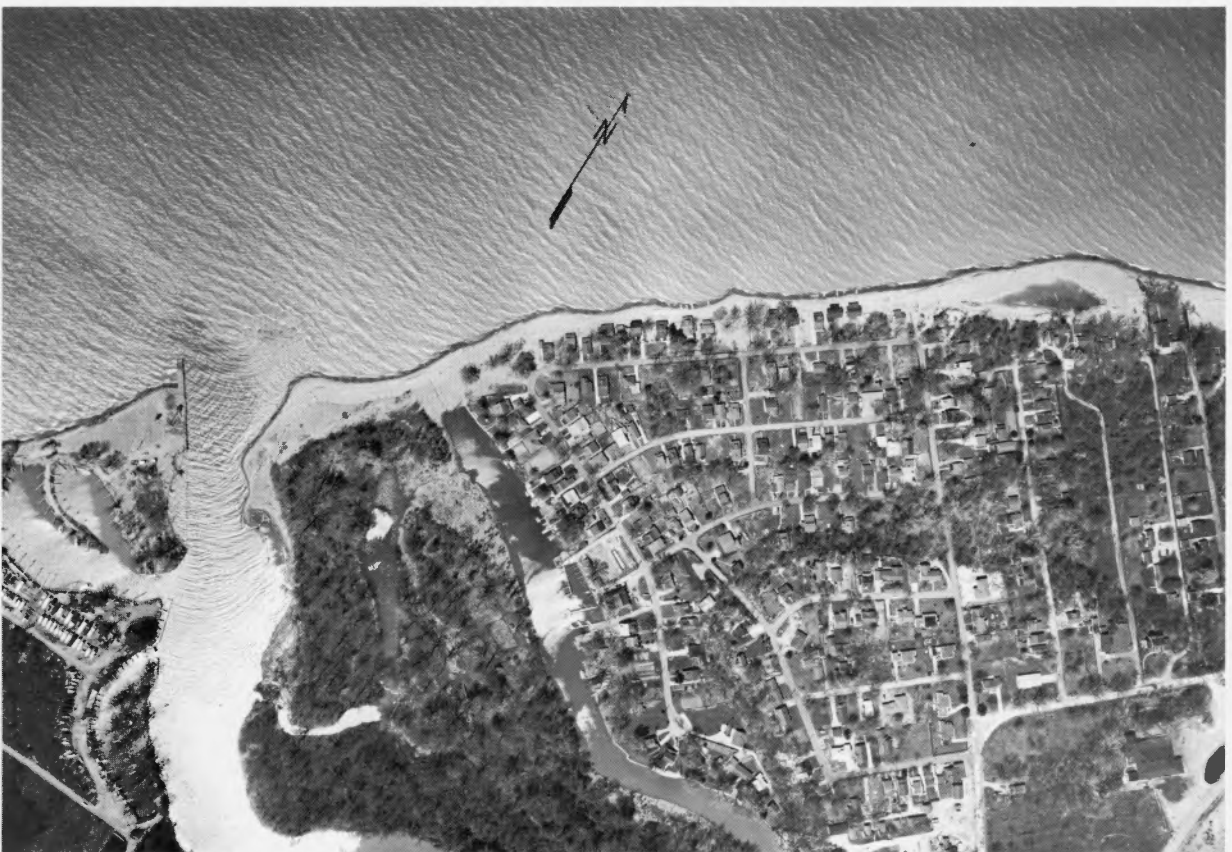
Figure 22.- Chagrin Harbor Beach allotment, Eastlake, Ohio. One half to one mile east of area in fig. 20. Beach eroding, now averaging 50 to 75 feet narrower than at time photograph was taken. Photo taken 5/7/56. Water level 573.2. →

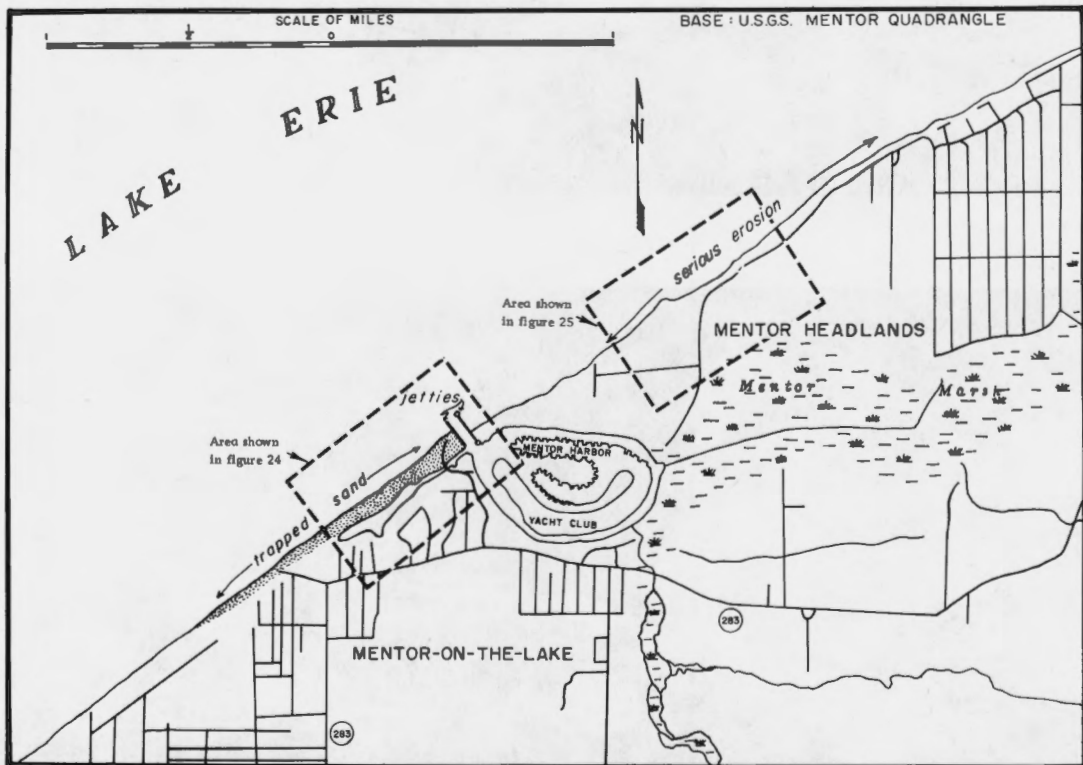
Figure 23.- Mentor-on-the-Lake, Ohio, harbor jetties and shore conditions.

Parallel jetties were built at the entrance to Mentor Harbor in 1931 in an attempt to prevent damming of the entrance by sand in littoral transport (fig. 23). The jetties are about 400 feet long, about 8 feet above datum, and are of cellular steel sheet pile construction filled with sand.

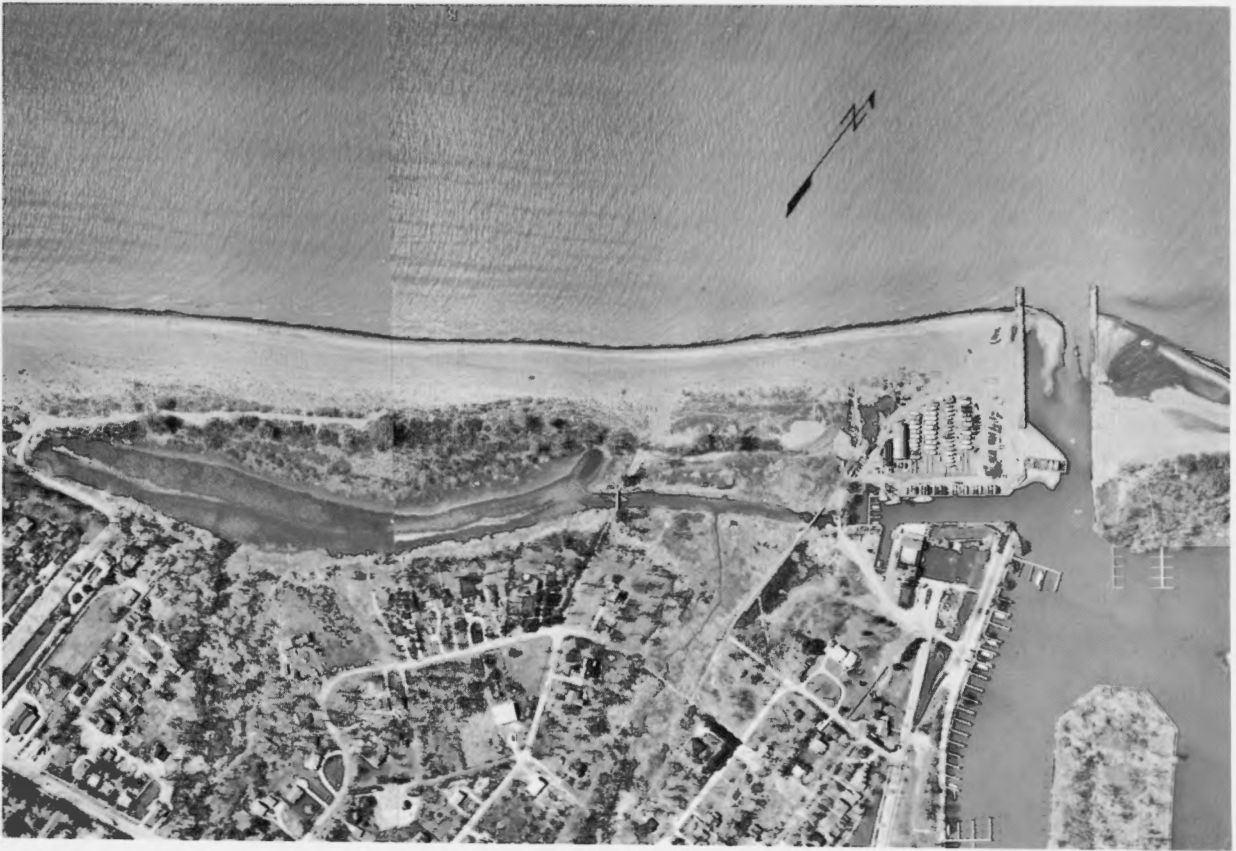
Figure 24.- Shore just west of Mentor Harbor inlet. Entrance jetties at right side of photograph. Note unusual length and width of beach compared to length of jetties. Note sand bars in channel and east jetty, indicating beach drift is not now stopped by jetties. Photo taken 5/1/58. Water level 571.5. ←

The Mentor Harbor jetties caused an exceptionally large build-up of beach to the west (fig. 24). The beach is more than 200 feet wide and about 6,000 feet long, and is unique along the Ohio shore in that it is retained by structures of such short length. It is probable that the jetties alone are not responsible for the build-up. They may have caused a build-up which, in itself, interrupted the longshore drift of materials, thereby resulting in natural accretion. The supply for this beach probably is mainly the nearshore bottom, which, for some distance lakeward, is characterized by sand and gravel in the form of massive bars. The nearshore deposits may have originated as stream-carried sediments at the former outlet of the Grand River. Much of the beach is backed by the former stream channel, which is now a lagoonal marsh.

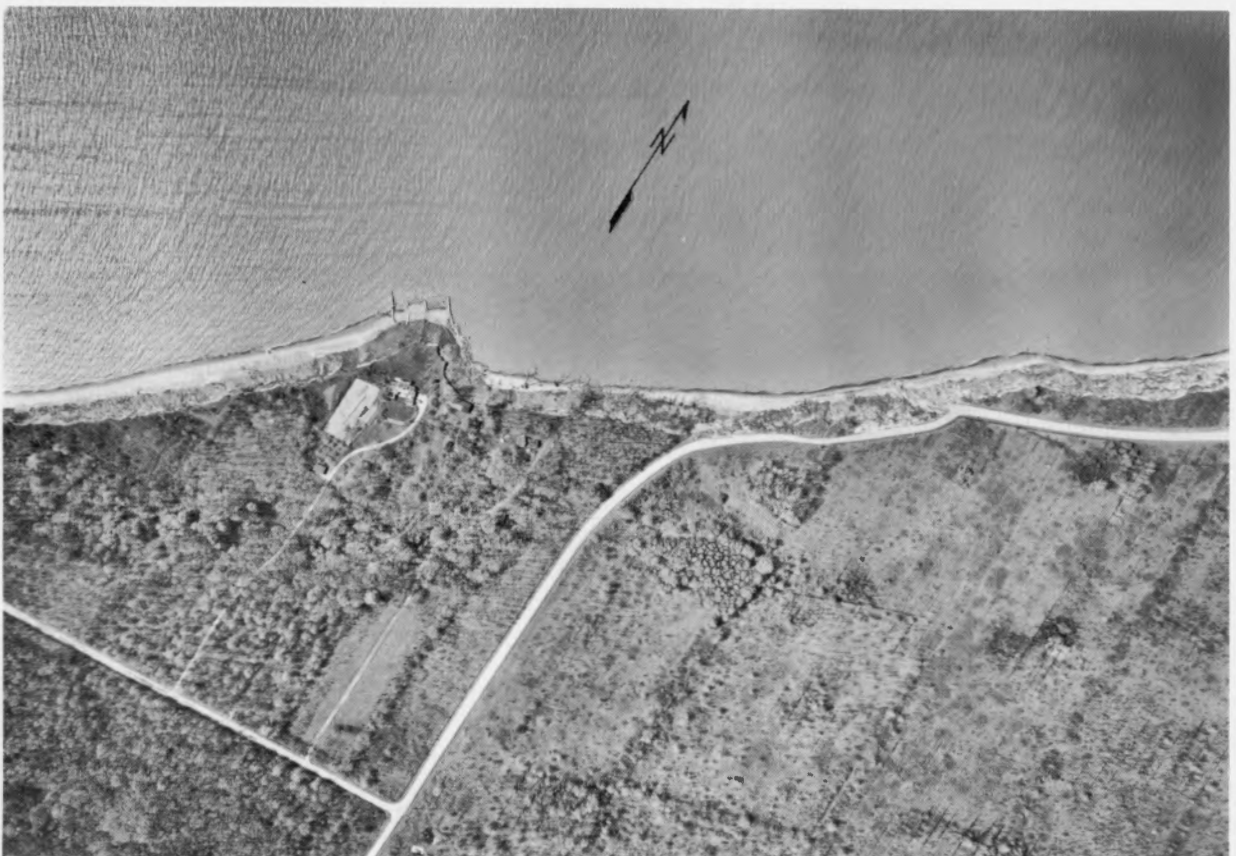
Figure 25.- Mentor Headlands area one mile east of Mentor Harbor. Compare shore with that shown in fig. 24. Erosion of 70-foot banks is serious and rapid. Note effectiveness of groins in maintaining promontory even though beach is relatively narrow. Photo taken 5/1/58. Water level 571.5. ←

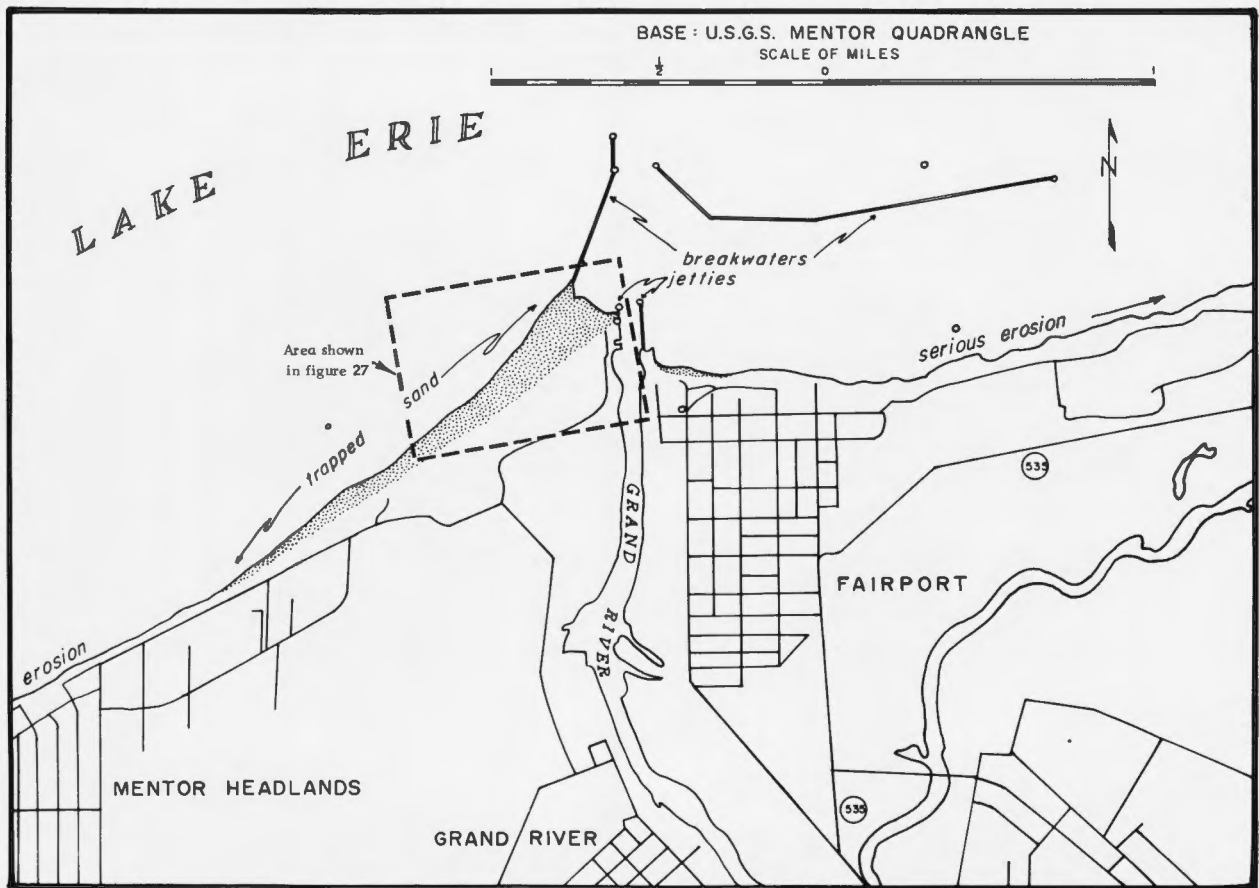
Figure 26.- Fairport, Ohio, harbor breakwaters and shore conditions. →

The shore along the village of Fairport, just east of the Grand River, has been more or less protected by both the east and west breakwaters. The predominant easterly longshore currents are deflected lakeward by the west breakwater and are ineffective along the village shore. Southwest, west, and northwest storms are also prevented by both breakwaters from attacking the shore. Northeast storm waves reach the shore, and they bring in materials which cannot be removed. This has resulted in the building of a good beach fronting Fairport. The beach is about 1,600 feet long with a maximum width of about 200 feet. The beach is fairly stable, apparently because there is not a good source of beach supply to the east where rock is near lake level.

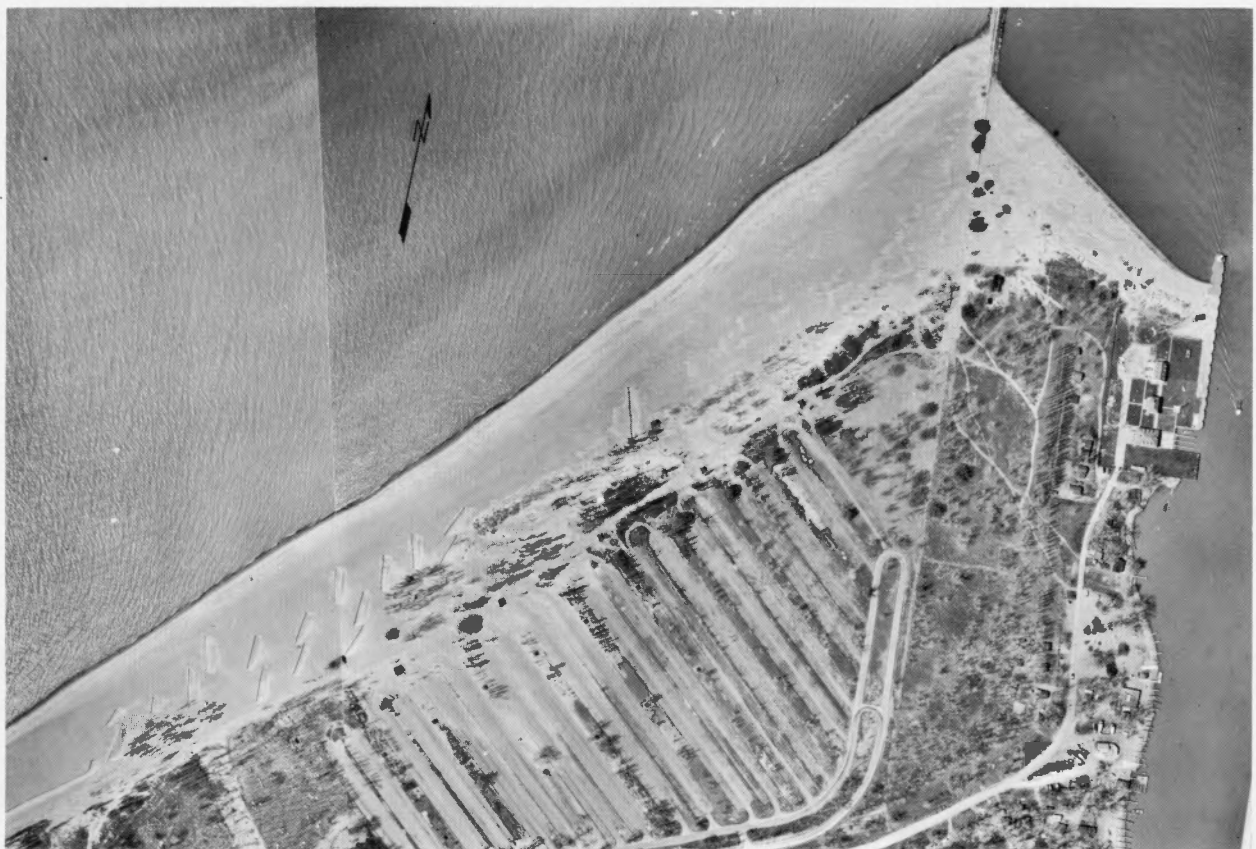
Figure 27.- Fairport State Park beach west of Fairport, Ohio. Grand River at extreme right of photo. Fairport west harbor breakwater shown at top right. Nearly all of land area in this photo is beach sand trapped by structure. Photo taken 5/1/58. Water level 571.5. →

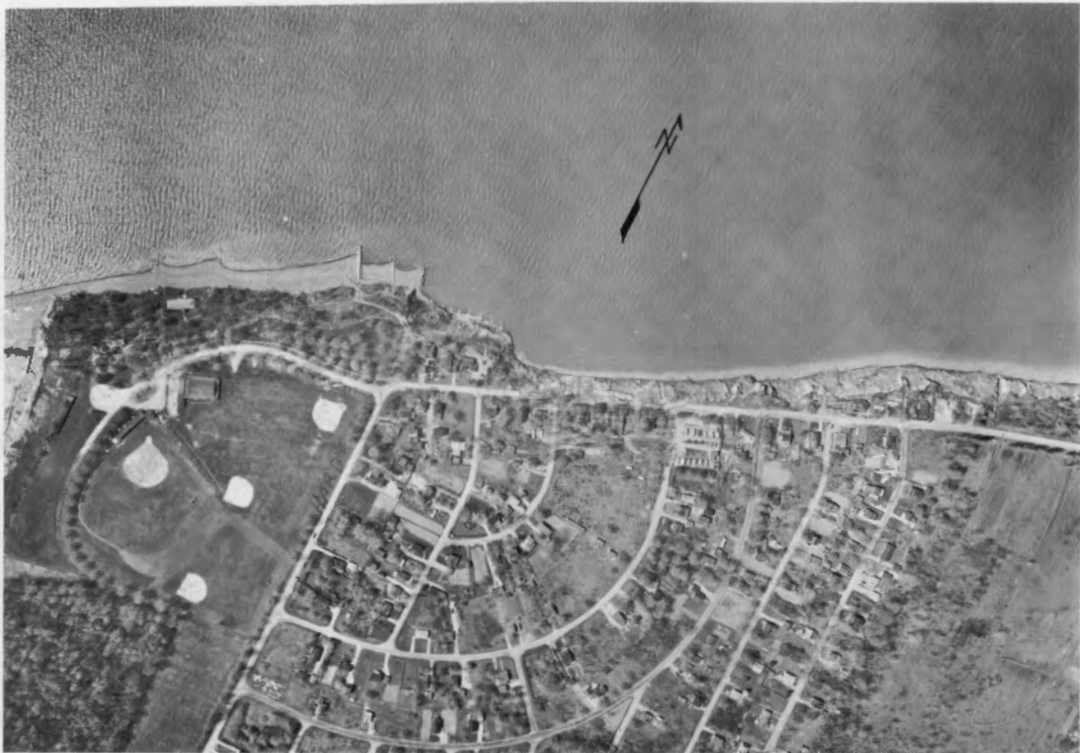
Figure 28.- Painesville Township Park and vicinity, two and one-half miles east of Fairport, Ohio. Compare condition of shore with that of fig. 27. Erosion in this area very serious. Photo taken 5/1/58. Water level 571.5.

few small areas are relatively stable, some of which have been stabilized artificially. Otherwise the banks are being lost rapidly. The breakwaters at Fairport definitely contribute to the rapid erosion in that they have cut off an excellent supply of sand in longshore movement.

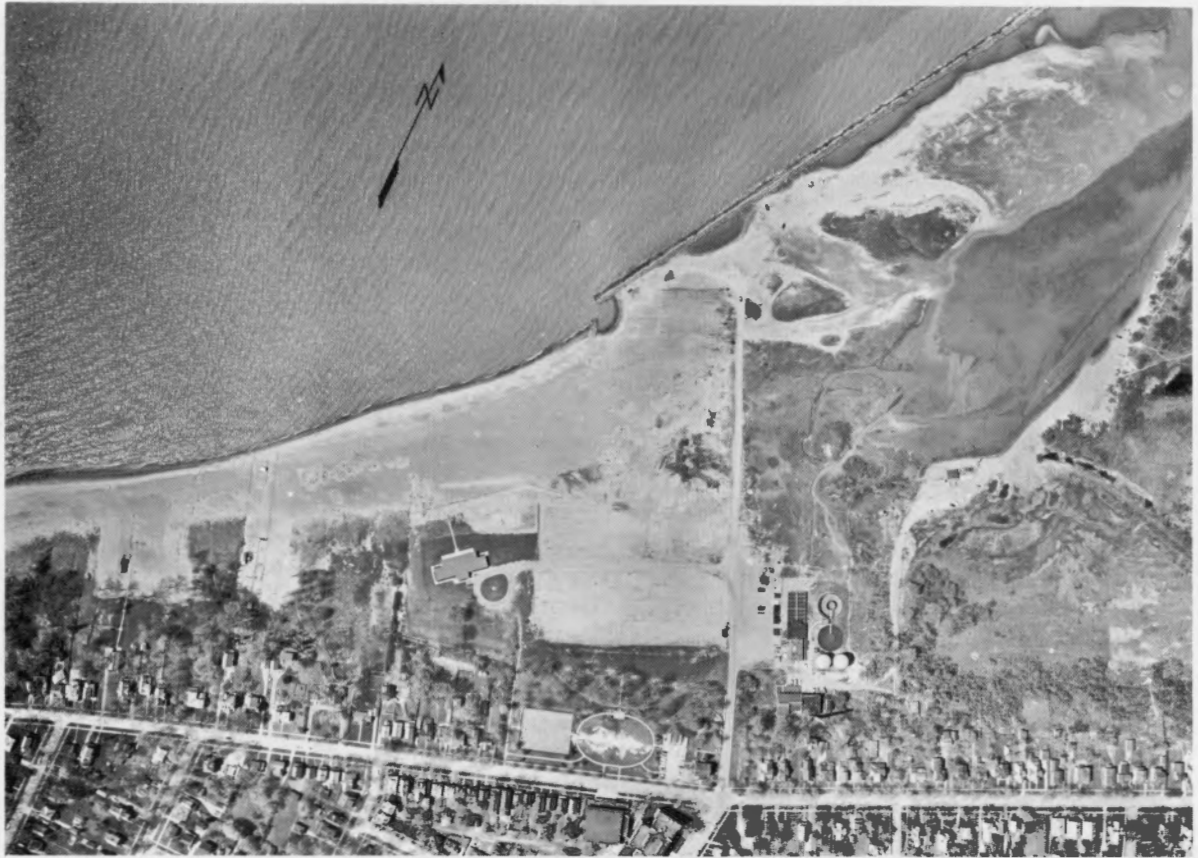
- Figure 30.- Walnut Beach at Ashtabula, Ohio. West harbor breakwater in upper right center. Note shore arm nearly covered by sand. Large sand deposit east of breakwater built from sand moving over and through wall. Photo taken 5/1/58. Water level 571.5.
- Figure 31.- Vicinity of metallurgical plant three miles east of Ashtabula River. Compare with fig. 30 and note absence of beaches and eroding character of shore banks. Bank east of plant rises to more than 60 feet above lake level. Photo taken 5/1/58. Water level 571.5.

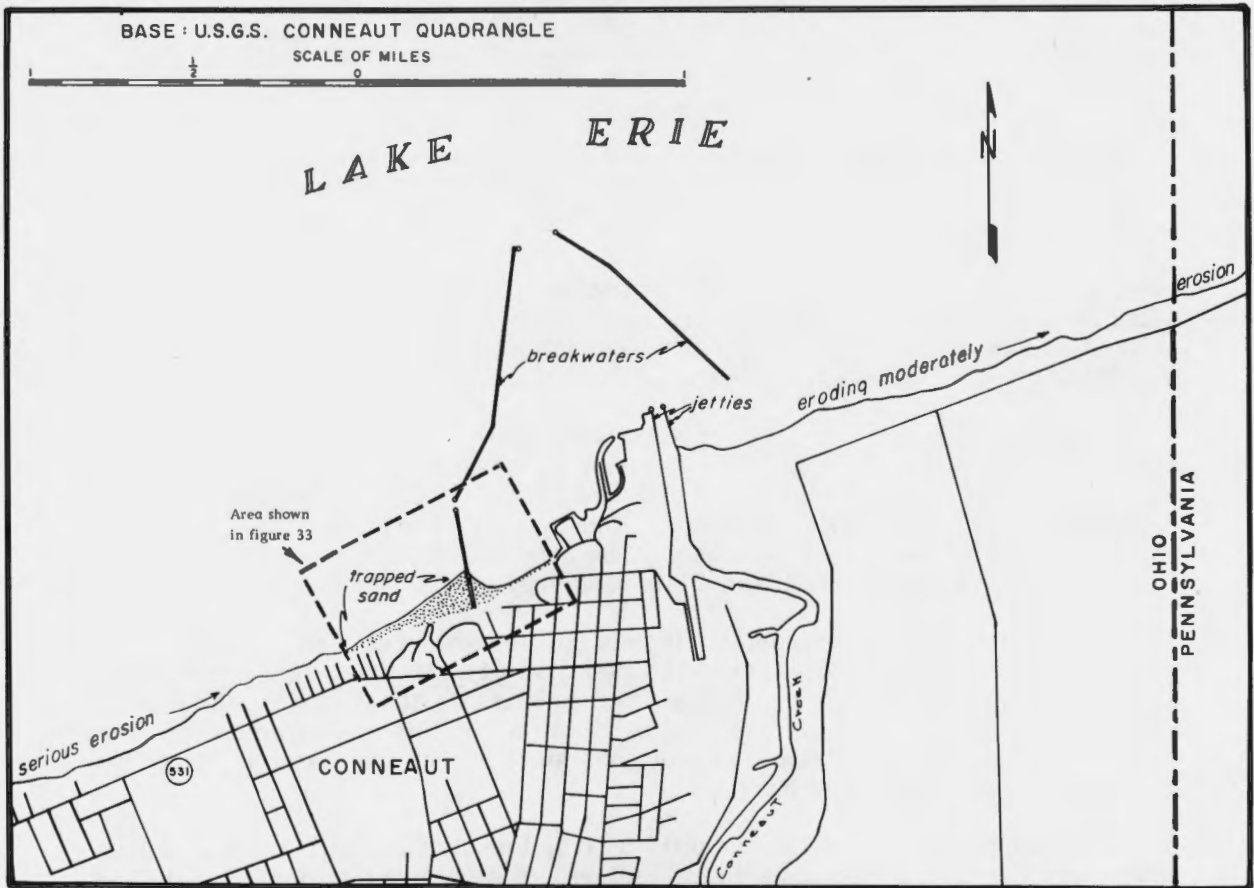
→ Figure 32.- Conneaut, Ohio, harbor breakwaters and shore conditions.

The Conneaut breakwaters, in summary, protect about 2,000 feet of shore to the west of the west breakwater. Unlike most structures of comparable size, they do not create a great erosion problem to the east, at least as far as the state line.

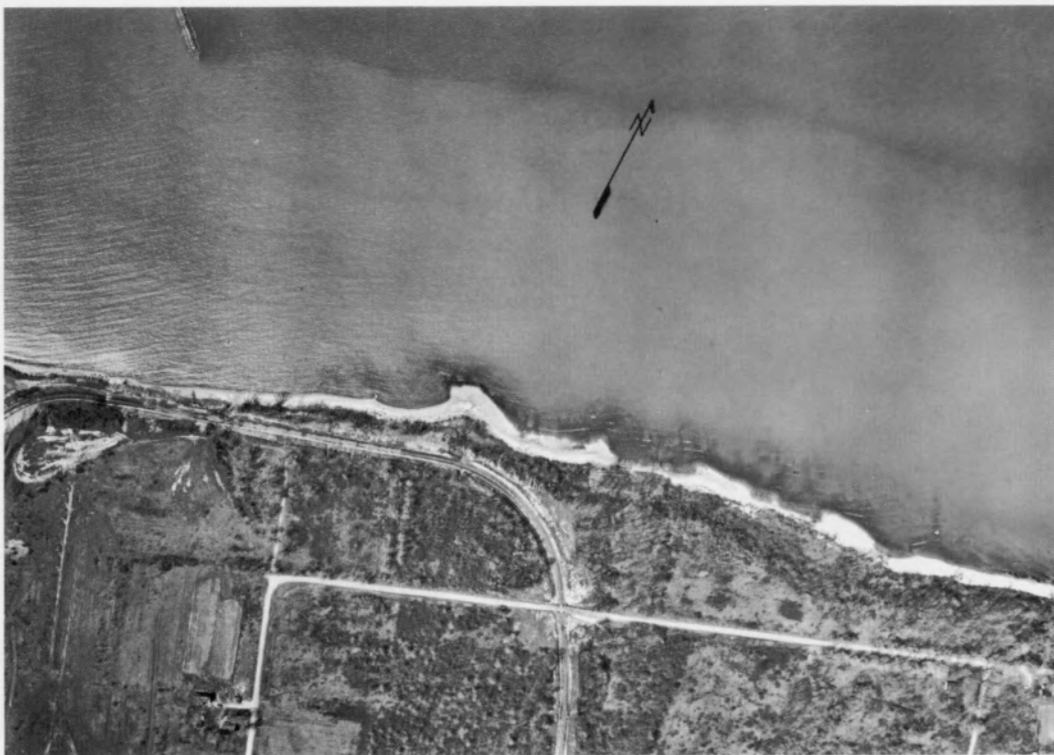
Shore erosion is not rapid from Conneaut to the state line although the conditions are those of erosion (fig. 34). Bedrock near water level, covered by pebbles and cobbles, apparently acts as shore protection. The harbor structures do, however, starve the shore to the east of sand. There is no evidence of sand passing the structures. Apparently the west breakwater traps nearly all sand in littoral drift, which is strongly toward the east.

Figure 34.- Shore just east of Conneaut, Ohio. Note relative stability of vegetation-covered banks. Irregular beaches and dark patches near water line are pebbles and cobbles lying on shale. Southeastern end of east breakwater shown in upper left corner of photograph. Photo taken 5/1/58. Water level 571.5.
