GUIDEBOOK NO. 1

# NATURAL AND MANMADE FEATURES AFFECTING THE OHIO SHORE OF LAKE ERIE

BY  
CHARLES H. CARTER

Columbus  
1973

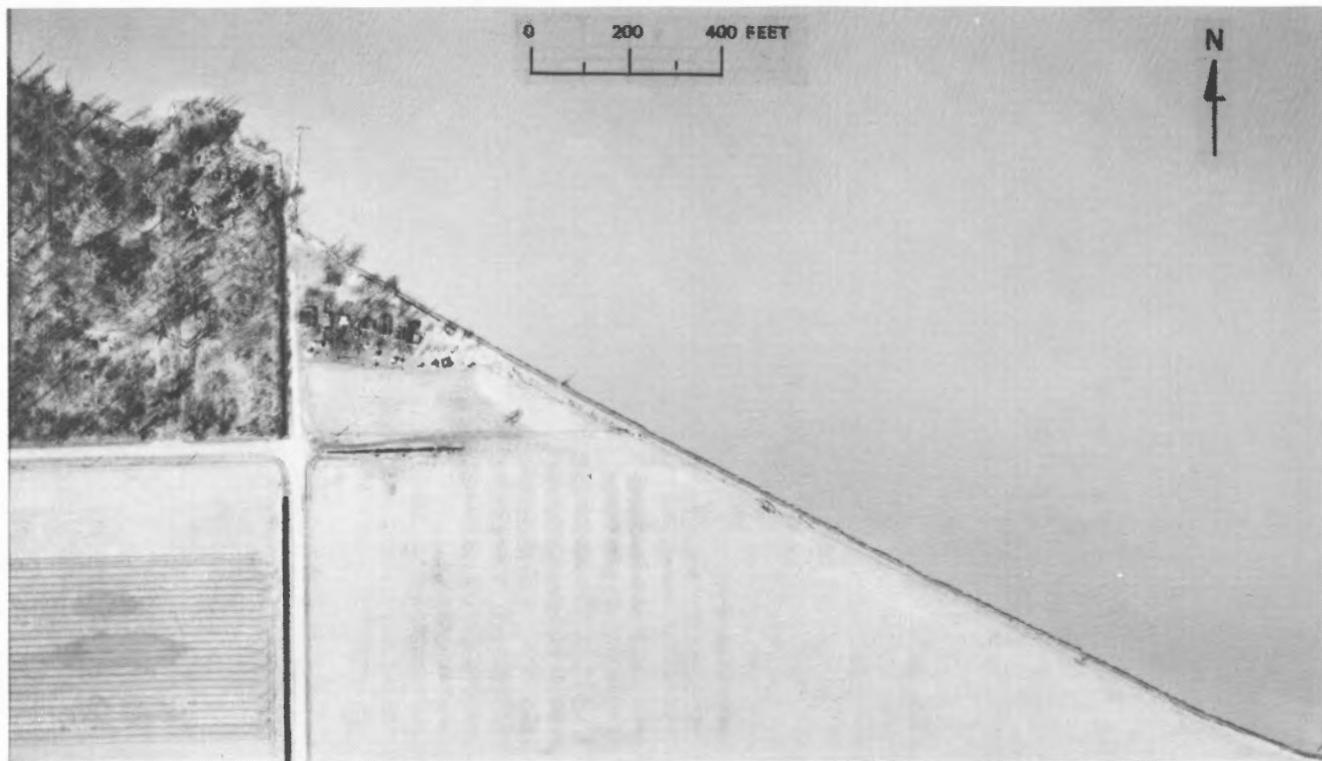
FIGURE 3.—STOP 1, South Shore Park. Low unprotected clay banks.

**SOUTH SHORE PARK** (*Oregon quadrangle*). Low unprotected clay banks on the south shore of Maumee Bay form an irregular shoreline. The beach and near-shore area are covered by a thin layer of sand (less than 1 foot thick). During a severe storm in November 1972 a layer of poorly sorted sand up to 1 foot thick was washed onto the clay banks; this washover fan was as much as 100 feet wide in places.

The unprotected portions of the shore are eroding at a rapid rate. This can be seen easily on an aerial photograph or a topographic map; areas of the shore that are protected by seawalls and other manmade structures project sharply into the bay, whereas the unprotected areas are embayed. This particular stretch of the shoreline receded 600 to 800 feet in the period 1877 to 1943 (U.S. Army Corps Engineers, 1945, pl. 2).

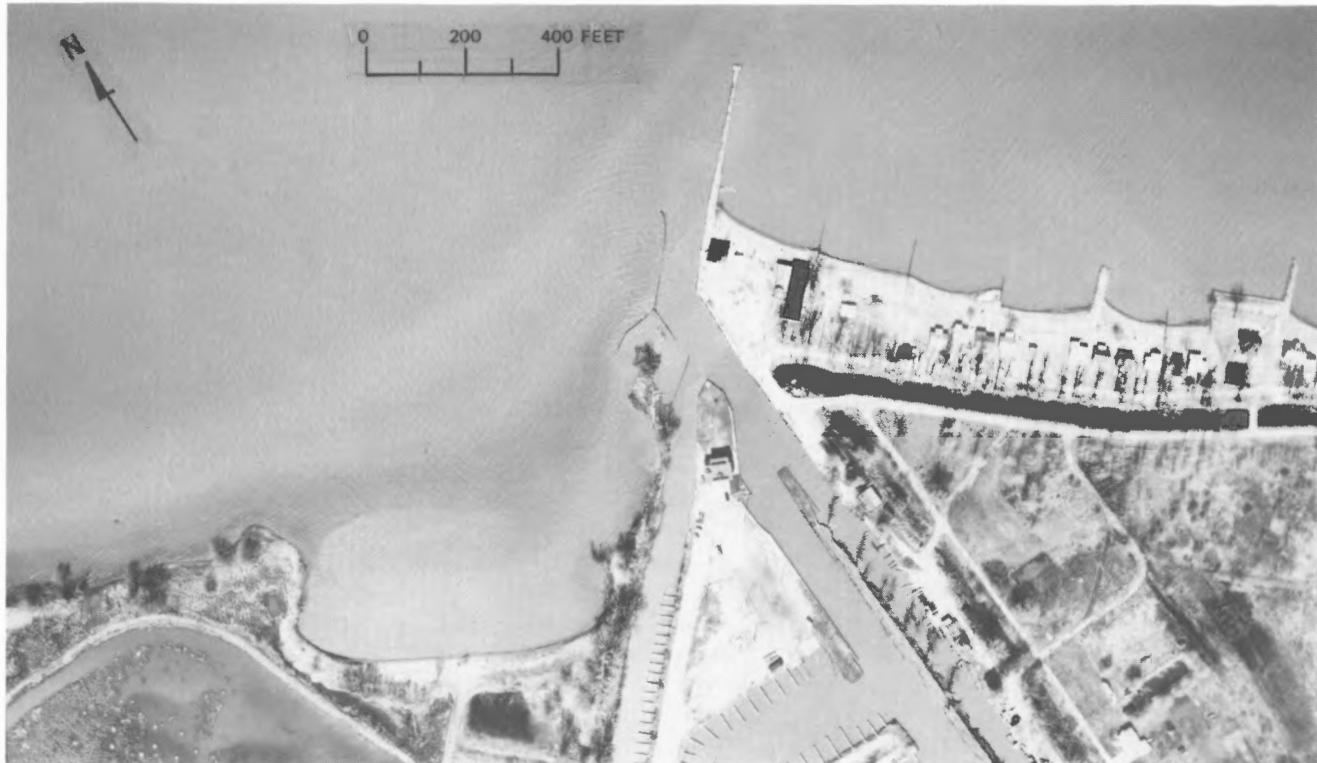
FIGURE 4.—STOP 2, Reno Beach, Lakemont Landing. A good example of a well-protected updrift (southeast) shoreline and an unprotected downdrift (northwest) shoreline.

**RENO BEACH, LAKEMONT LANDING** (*Reno Beach quadrangle*). Southeast of the Lakemont jetty this structure and many groins trap sand from the southeast-to-northwest littoral drift. The sand beaches and two dikes help protect the reclaimed marshland from waves and high water. However, northeast storms have overtopped and breached the dikes; they were damaged by a severe storm in November 1972, but have subsequently been repaired and strengthened.

leaving the marsh behind the barrier unprotected. The influence of the jetty and the other structures on the adjacent shoreline is not clearly known; the west pier was built in 1898 (U.S. Army Corps Engineers, 1946b, p. 23), and just west of the jetty the barrier beach had a minimum width of 200 feet as late as 1946 (U.S. Army Corps of Engineers, 1946b, index map). The loss of more than a mile of barrier beach is probably largely the result of storm activity and high water in the early 1950's (a March 1957 aerial photograph of the area does not show the barrier). However, the loss of sand from the littoral drift system to the jetty and groins to the southeast has had a detrimental effect on the down-drift shore.

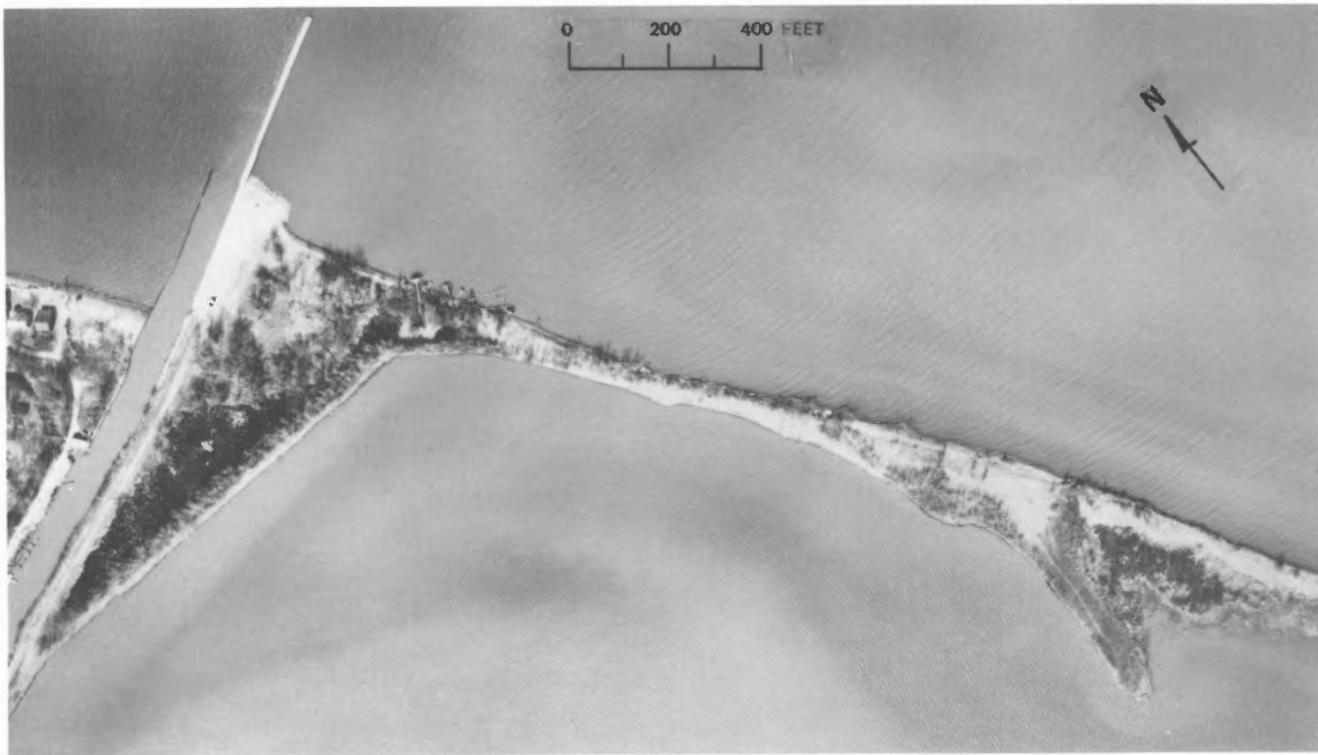
FIGURE 5.—STOP 3, Metzger Marsh. Jetty and sandspit. Note uprooted trees along the shoreline a few hundred feet southeast of the jetty.

structed along the shoreline during the high water of 1929 failed and was not repaired (U.S. Army Corps Engineers, 1946b, p. 15).

Since 1946 there has been a profound change in the shoreline for more than a mile southeast of Wards Canal. More than a square mile of marsh has been lost to the lake, and the only sand exposed along the reach is in the spit southeast of Wards Canal. The severe storms and associated high lake levels in the early 1950's, late 1960's, and early 1970's are probably the cause of the erosion. High water levels probably killed some of the marsh vegetation, enabling storm waves to more easily erode the nonresistant marsh shore. The shoreline along this reach receded an average of about 400 feet between 1877 and 1943 (U.S. Army Corps Engineers, 1945, pl. 2).

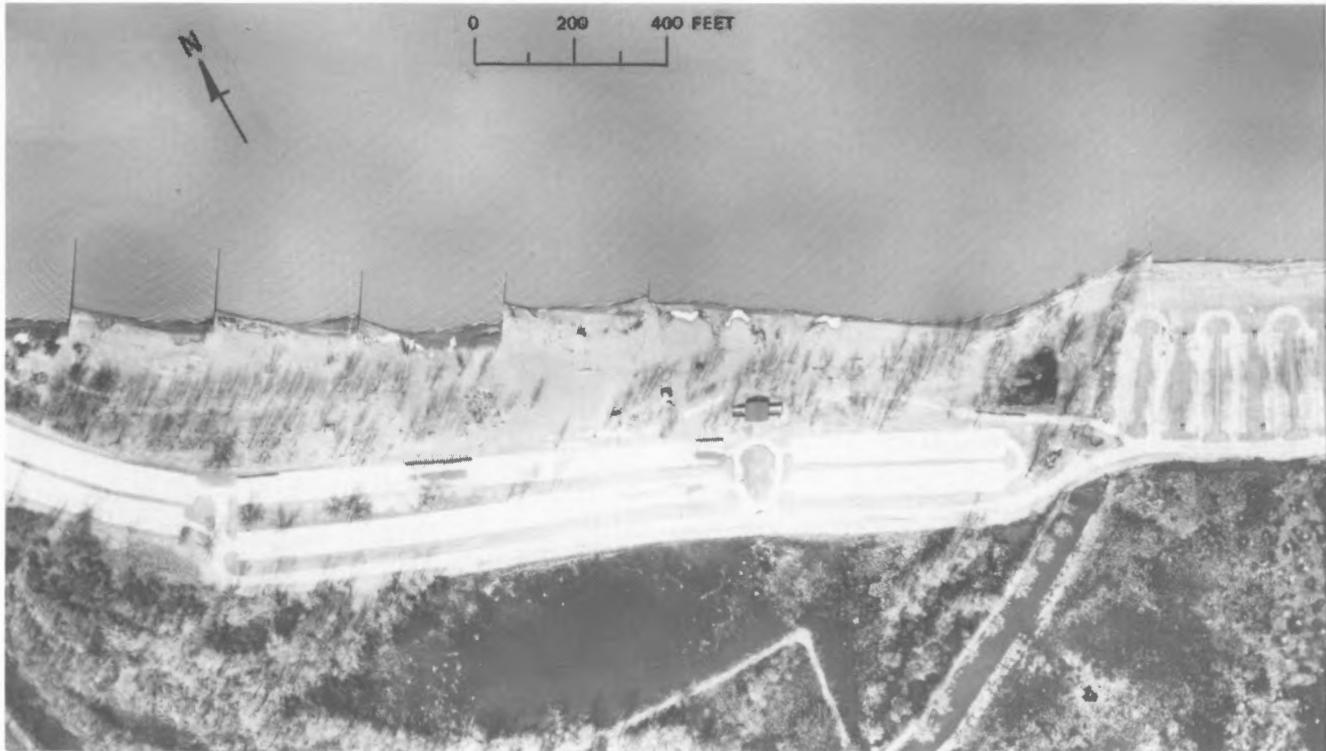
FIGURE 6.—STOP 4, Crane Creek State Park. Barrier beach, groins, and adjoining marsh.

**CRANE CREEK STATE PARK** (*Metzger Marsh quadrangle*). The park is essentially a barrier beach complex which lies between Lake Erie to the northwest and Magee Marsh to the southeast. The park shoreline can be divided into three stretches: western, central, and eastern. Along the western portion groins made of interlocking sheet-steel piling trap sand from the net southeast-to-northwest longshore drift; riprap (limestone and concrete) and two badly damaged groins give some protection to the low clay bank in the central stretch; the eastern portion is unprotected. Because of high lake levels and severe storms in the late 1960's and early 1970's a goodly amount of sand trapped by the groins in the western area has been lost. The narrow beach that fronted the shore in the central area is gone, and much of the riprap has been carried by waves onto the top of the bank. Farther east the natural shoreline has undergone severe erosion, and much of the sand barrier fronting the marsh is in danger of being lost.

surveyed by the U.S. Army Corps of Engineers, shows that in the western part of the park the shoreline was irregular and there were areas of erosion as well as of accretion (U.S. Army Corps Engineers, 1945, pl. 2). For example, a prominent embayment (about one-quarter square mile in area on the 1900 Oak Harbor 15-minute topographic map) east of the mouth of Crane Creek had been filled by 1943, probably because of a large groin (600 to 800 feet) that trapped a sizable amount of sand from the longshore drift (U.S. Army Corps Engineers, 1945, p. 7). Farther east, in the central and eastern parts of the park, the shoreline receded 100 to 200 feet. The present-day groin field appears to be beneficial in stabilizing part of the Crane Creek reach; moreover, the length of the groins is about 200 feet, allowing sand to bypass the structures and still remain within the littoral drift system. Construction of a few additional groins in the central and eastern areas of the shoreline could help protect those stretches from erosion. According to Pincus (1960, sheet A) ample sand to supply the drift system is located offshore directly east, and there appears to be more than an adequate supply moving along the shore.

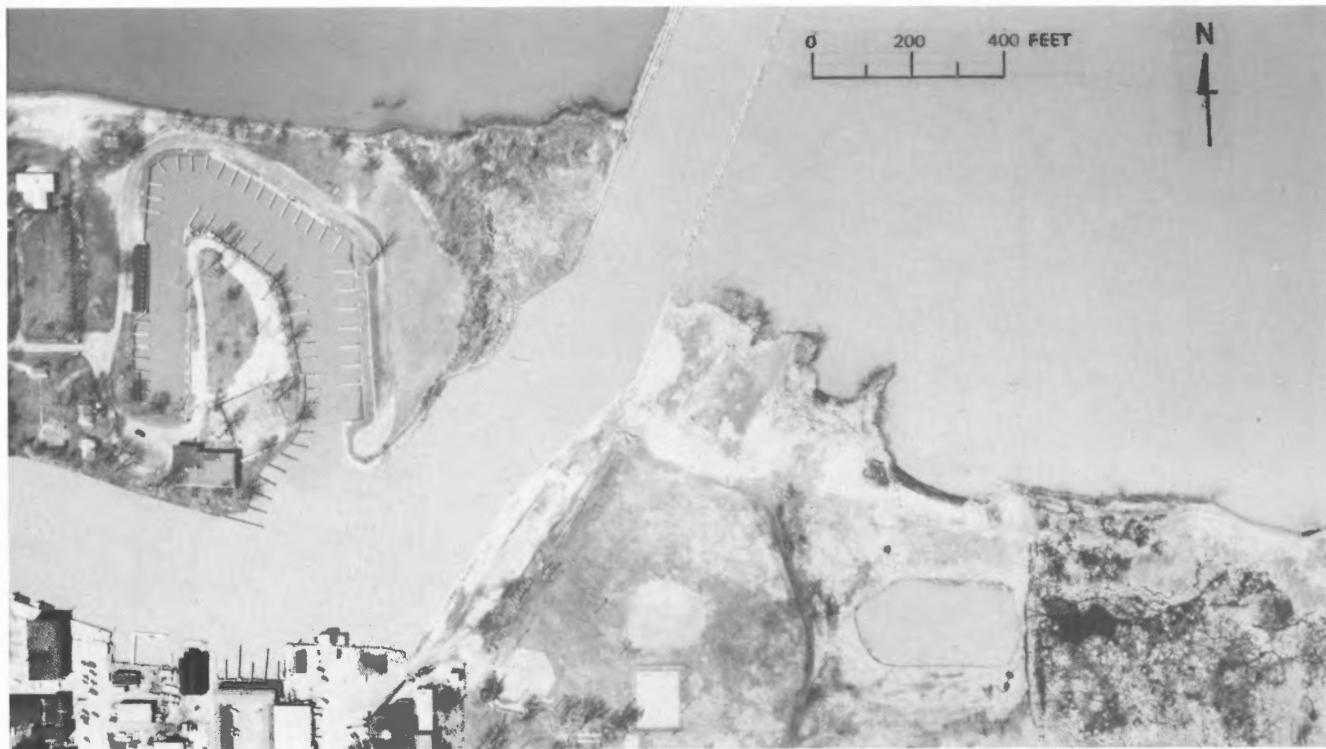
FIGURE 7.—STOP 5, Port Clinton. Riprap jetties and low-lying harbor area.

**PORt CLINTON** (*Port Clinton quadrangle*). Two jetties built of heavy riprap protect the entrance to the Portage River. Both jetties have trapped sand because of the convergence of two distinct littoral drift systems near the mouth of the river. Away from the jetties the shoreline is nearly unprotected except for a few narrow beaches (less than 50 feet wide) that front the shore west of the jetties.

The shoreline in the immediate vicinity of the jetties advanced lakeward from 1877 to 1943 because of the sand trapped by the jetties, whereas a few miles west of the jetties the unprotected shoreline receded 200 to 300 feet. East of the jetties the shoreline did not show a distinct erosional or depositional trend between 1877 and 1943 (U.S. Army Corps Engineers, 1945, pl. 3). Overall, the jetties appear to have a favorable effect on the shore, principally because of the atypical littoral drift systems.

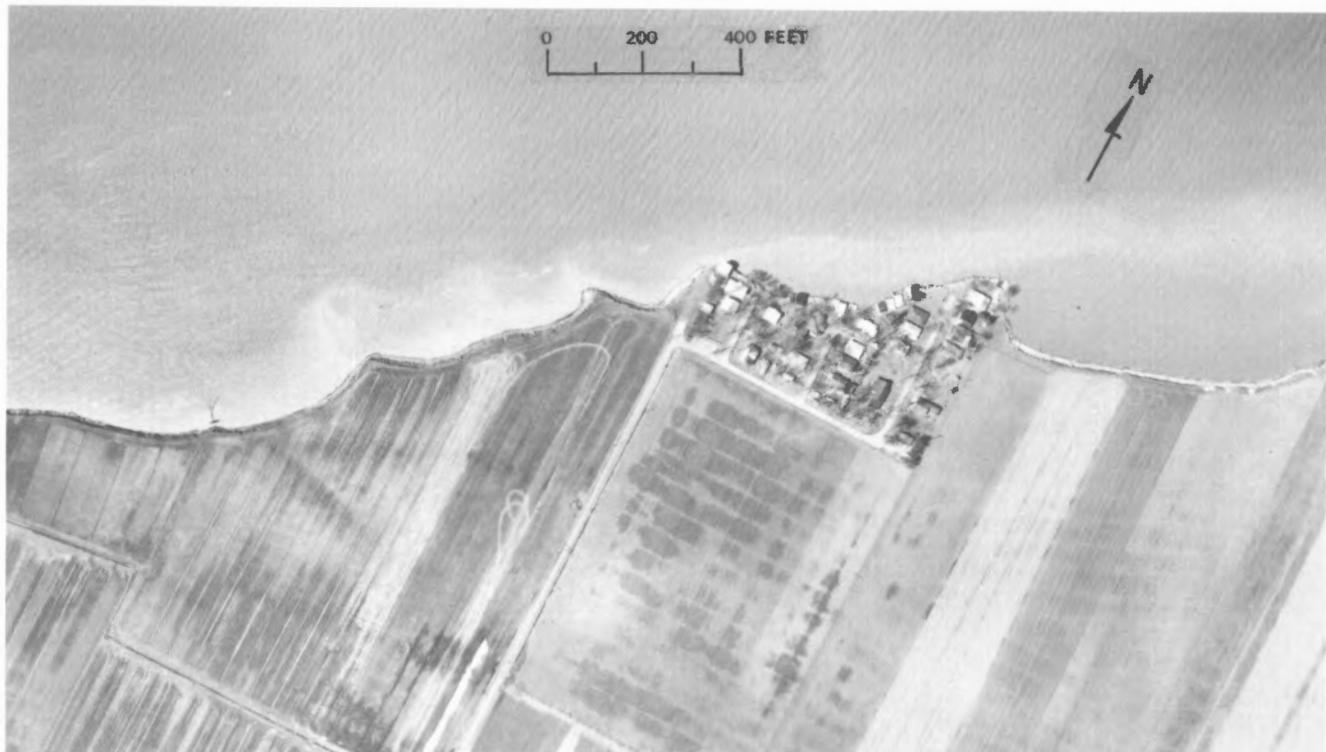
FIGURE 10.—STOP 8, Crystal Rock. Unprotected clay banks; waves breaking on nearly demolished manmade structure just offshore.

data from areas farther west where the annual rate of erosion has been 5 to 8 feet per year for a 125-year period (U.S. Army Corps Engineers, 1953a, p. 10). However, "Individual property surveys made during the period of record show that the rate of loss has not been constant, but varies greatly from year to year, being more rapid during times of high water stages" (p. 10).

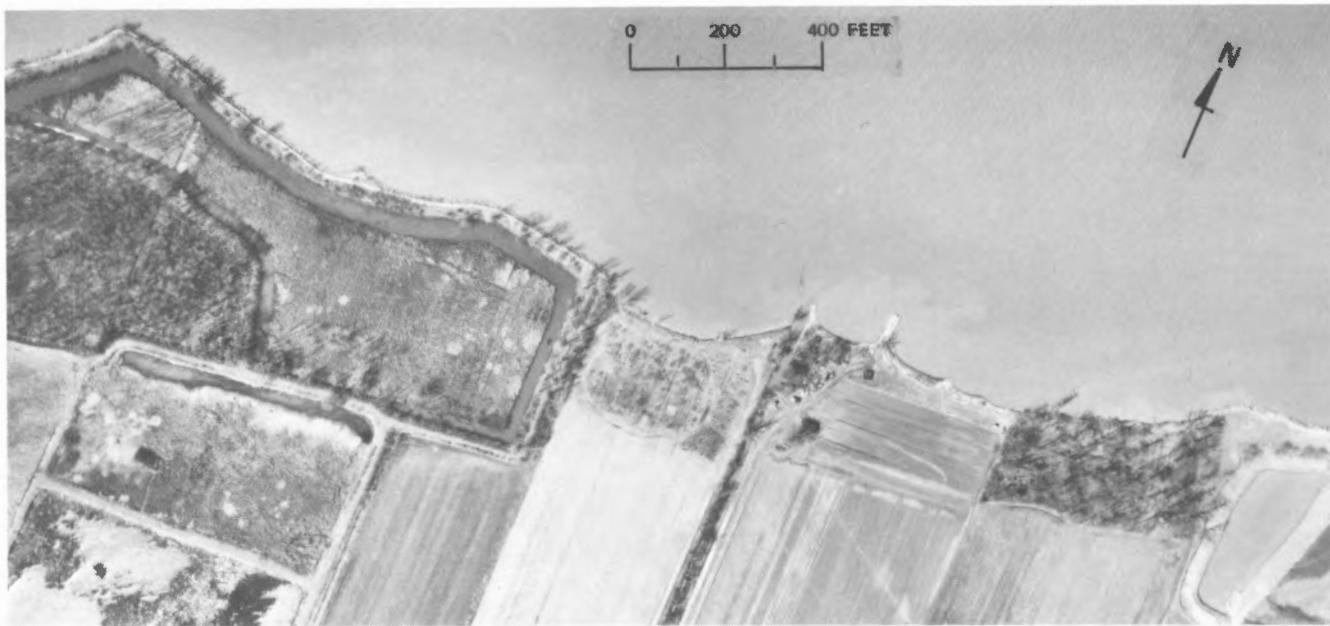
FIGURE 11.—STOP 9, Willow Point. Quarry-run stone dike adjacent to unprotected embayed shoreline.

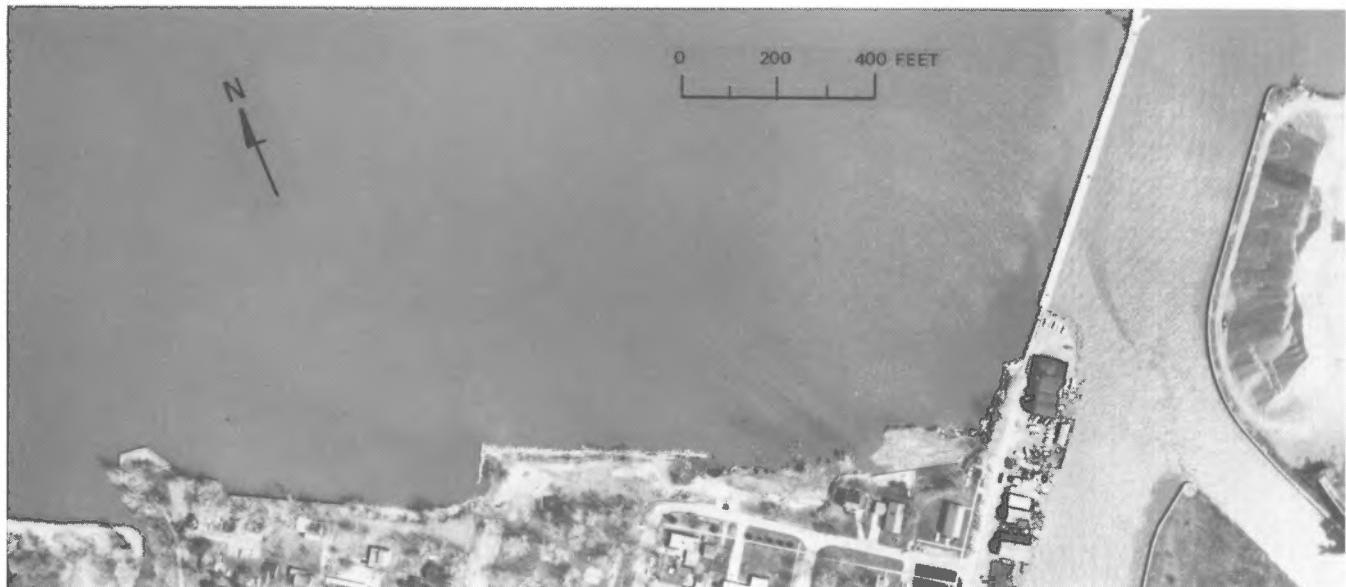
**HURON JETTIES** (*Huron quadrangle*). Two jetties, the west one of rubble-mound and stone-filled timber crib and the east one of rubble-mound construction, protect the entrance to the Huron River. The jetty system was begun in 1827; the jetties have subsequently been reinforced, repaired, and extended several times (U.S. Army Corps Engineers, 1946a, p. 11). The shore along the Huron reach is composed largely of lake clay, although there are a few exposures of till and/or shale. A sizable beach has accumulated on the east side of the jetties, whereas beaches are small or lacking on the west side, prompting construction of numerous structures to prevent or impede erosion.

Shore studies between 1847 and 1939 show that on the east side of the jetty system the shoreline is

slightly erosional, whereas west of the jetty system the shoreline is markedly erosional (U.S. Army Corps Engineers, 1946a, pl. 3). More specifically, within 1,000 feet of the east jetty, the position of the shoreline remained nearly unchanged, whereas within 2,000 feet of the west jetty the shoreline had retreated about 400 feet (U.S. Army Corps Engineers, 1946a, pl. 4). The combination of a predominantly southeast-to-northwest longshore drift and the jetty system has created this situation; the jetty system has trapped or forced sand far offshore on the east side, thereby depriving the west side of protective sand. Because of the jetty system erosion has been retarded on the east side and has been accelerated on the west side.

FIGURE 12.—STOP 10A, Huron jetties. West side of jetties; riprap seawall fronting Huron City Park.

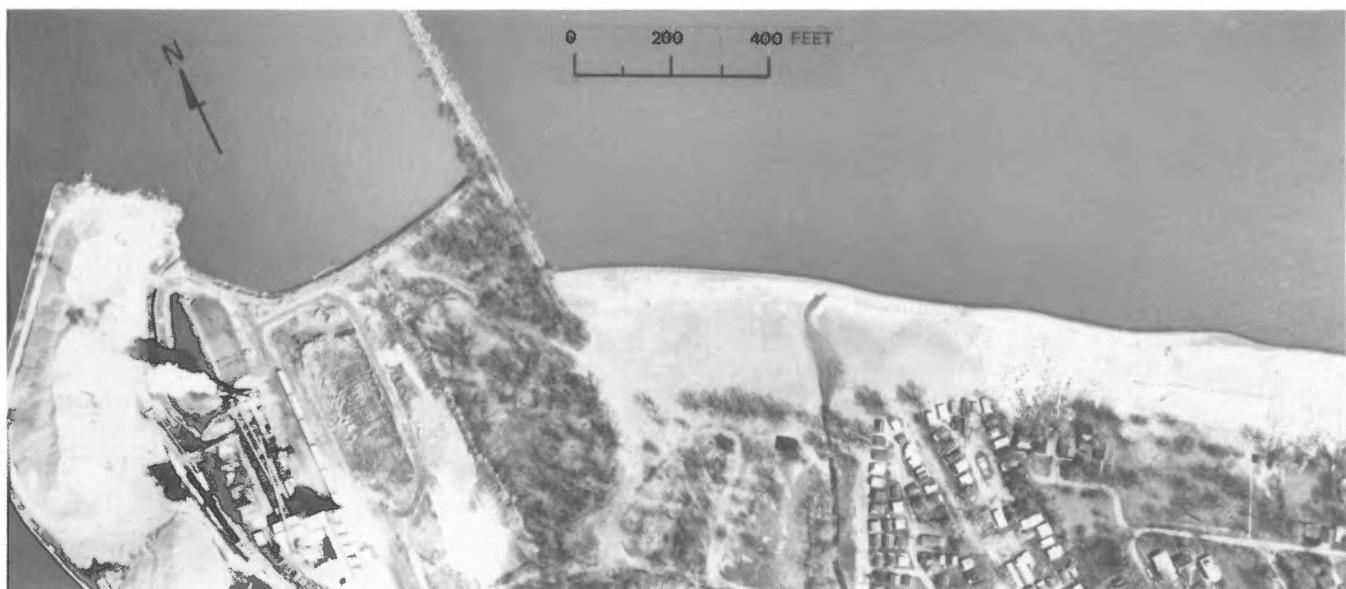
FIGURE 13.—STOP 10B, Huron jetties. Wide beach on east side of jetties.

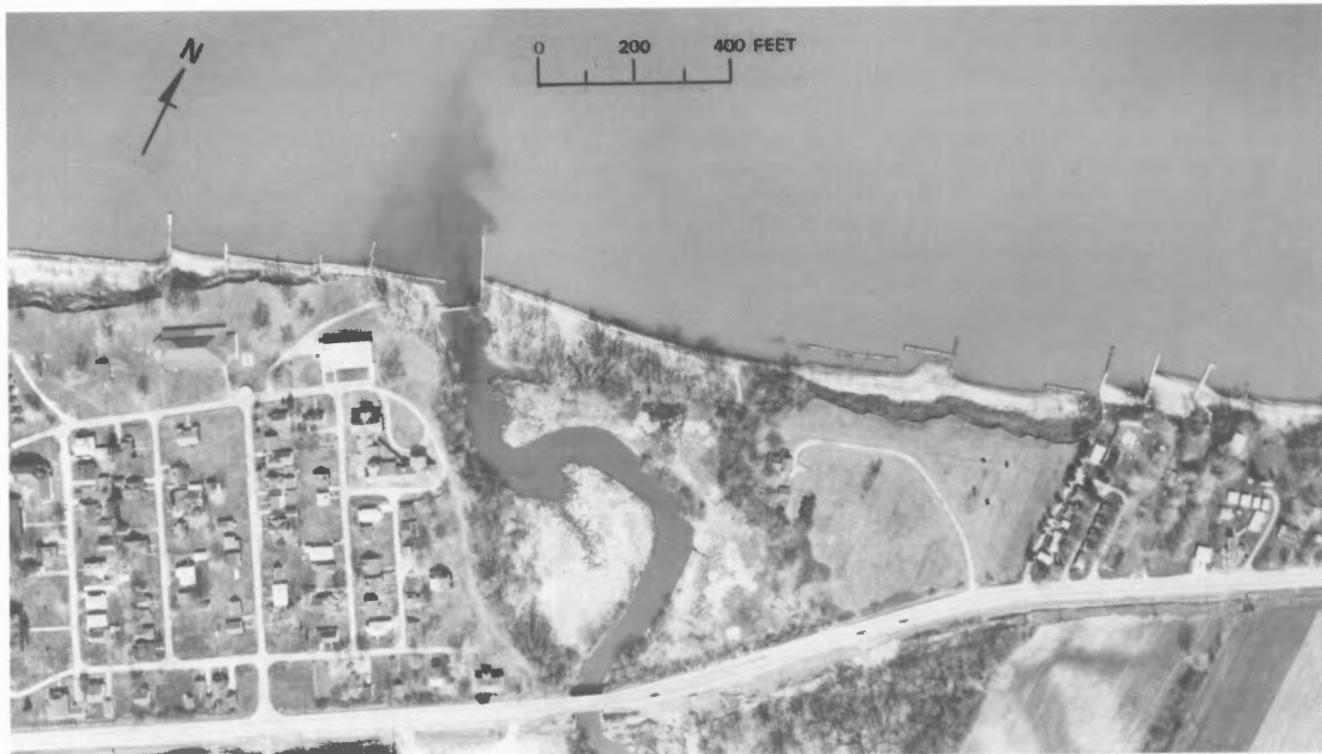
FIGURE 14.—STOP 11, Beulah Beach. Chappel Creek floodplain between steep till bluffs.

A comparison of the 1877 U.S. Lake Survey study

with the 1939 U.S. Army Corps of Engineers study shows that the bluff receded 200 to 250 feet in the Chappel Creek area in that period of time (U.S. Army Corps Engineers, 1946a, pl. V). This recession rate is comparable to the recession rate of 130 feet as determined from aerial photographs for the period between 1937 and 1968. The groins and bulkheads, by protecting the base of the bluff, have had a beneficial effect on the shore in this area. Furthermore these structures are small enough so that sand can bypass them and be distributed farther downdrift. The major erosion problem here is slope stability. The fine-grained surficial deposits need to be adequately drained, and the steep unstable bluff faces need to be sloped and protected by some kind of cover.

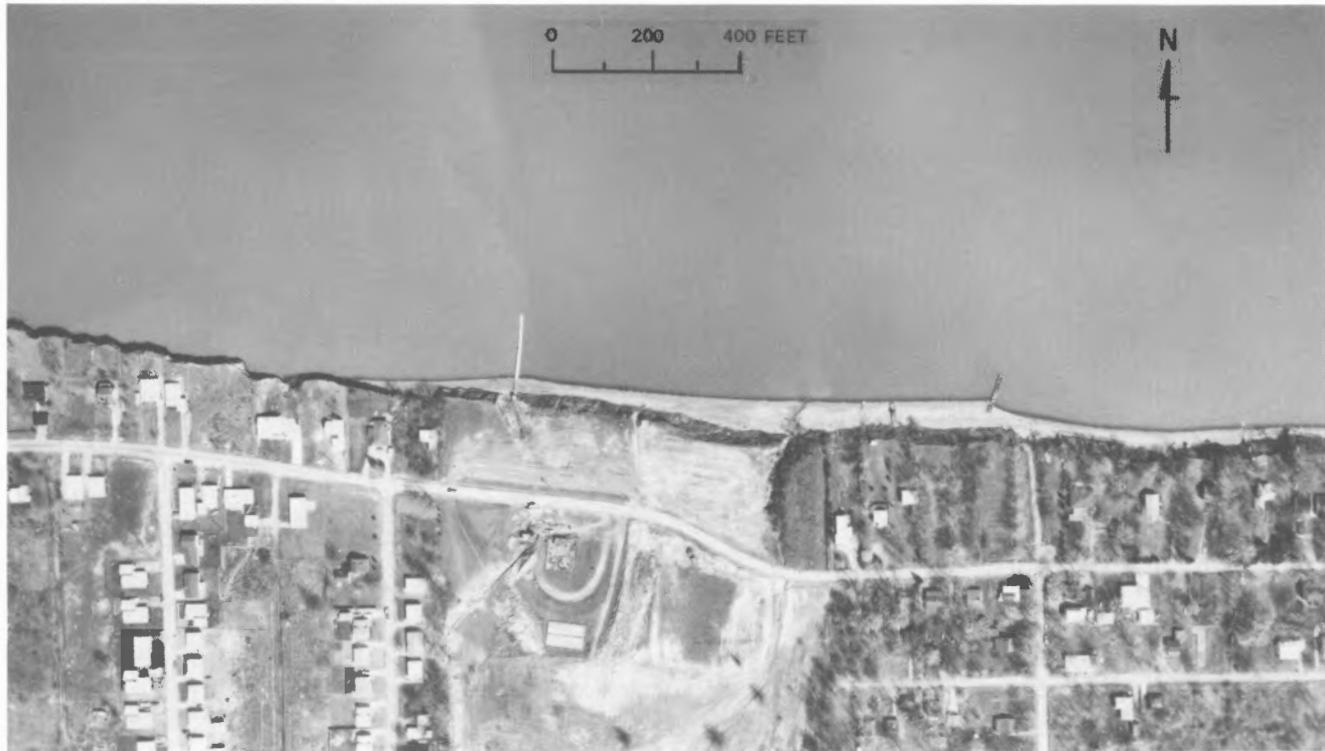
FIGURE 15.—STOP 12, Vermilion-on-the-Lake. Vertical shale bluff west of the groin and less resistant till bluff east of the groin.

study showed that the shoreline along this reach receded about 40 feet during that period (U.S. Army Corps Engineers, 1953c, p. 22). This is a small loss compared to the amount of recession that has taken place at many of the previous stops; the shale is relatively resistant in comparison to the surficial deposits of clay, sand, and till. The groin does not appear to have had an adverse effect on the downdrift (west) side because of the shale bluff; moreover, sand can probably bypass the groin and remain in the longshore drift system.

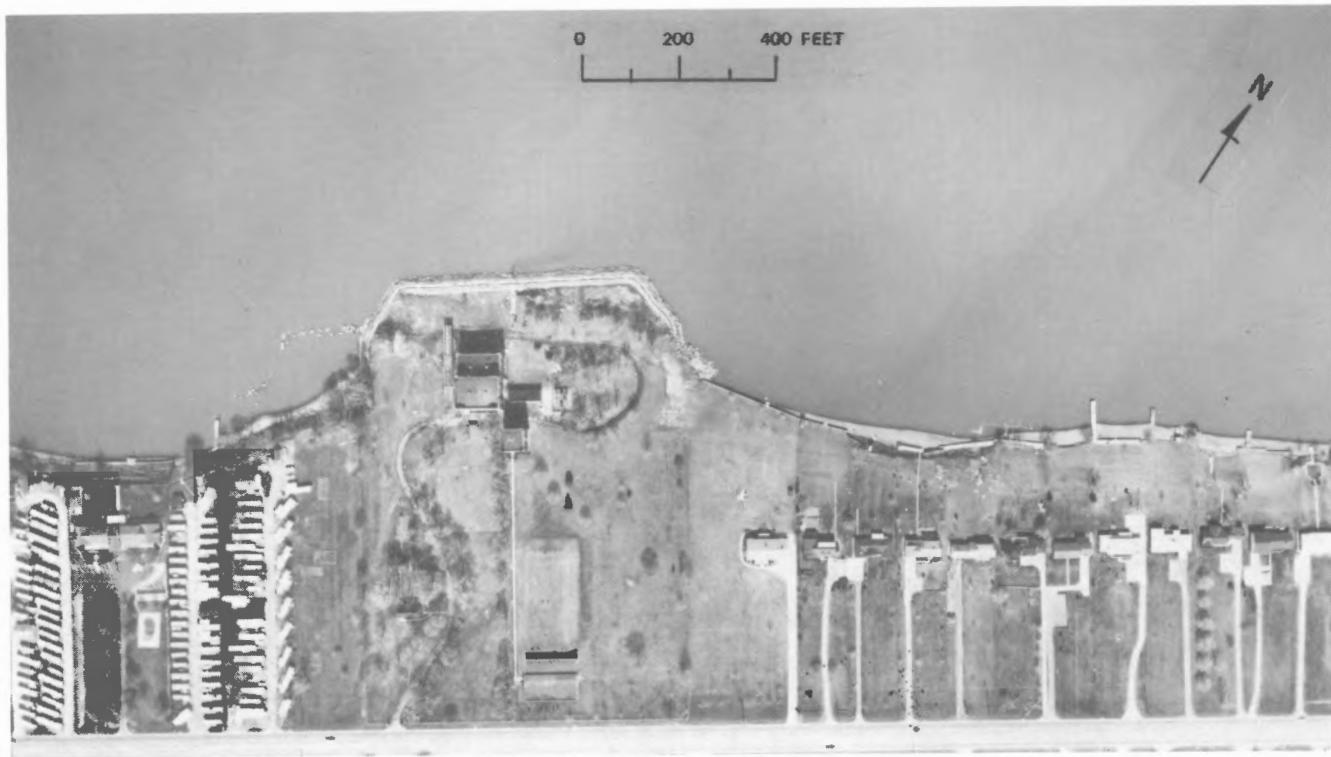
FIGURE 16.—STOP 13, Elyria waterworks. Rubble-mound seawall fronting the waterworks complex.

Comparison of an 1876 shoreline study with a 1948 study showed that "The average landward movement in this area has been about 115 feet with a maximum

movement of 180 feet about three-fourths mile west of Lorain Harbor" (U.S. Army Corps Engineers, 1953c, p. 22). To the east the jetty and breakwater system at the mouth of the Black River in Lorain has trapped some sand, especially inside the west breakwater; however, there is not a sizable buildup of sand on either side of the artificial structures as at Huron. The scarcity of sand is probably due in part to the resistance to erosion of the shale bluffs farther east at the point near Avon Lake as well as to the scarcity of sand-size sediment in the shale. Because of this scarcity this structure does not appear to have much influence on the sedimentary processes along the reach.

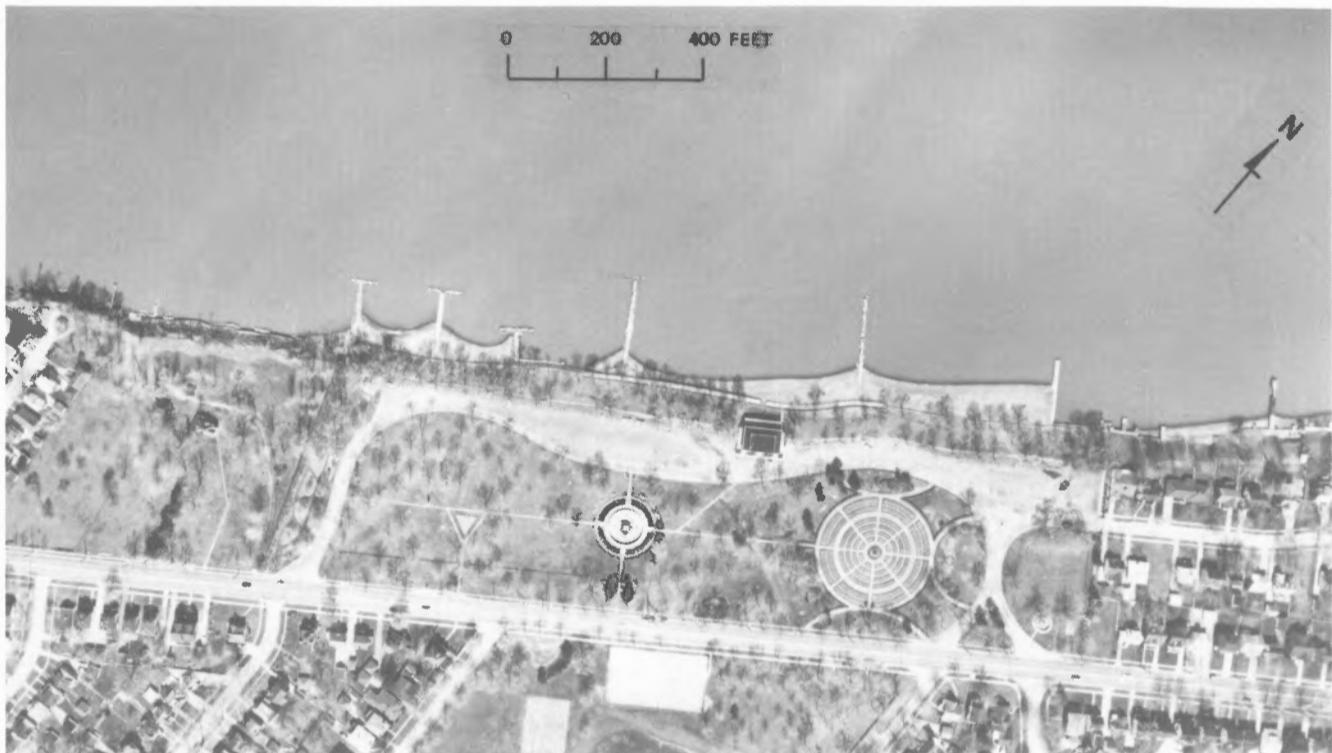
FIGURE 17.—STOP 14, Lakeview Park. Groins and associated beaches along the park shoreline.

from the northeast, at the same time creating, in the lee of the west jetty, an eddy that has caused sand on the west side of the harbor to move northeast. The Lakeview Park groins have trapped sand that otherwise would have accumulated inside the Lorain harbor west breakwater.

The reach between the Elyria waterworks and Lorain harbor receded an average of 115 feet from 1876 to 1948. Since 1948, recession of this part of the shore has been greatly reduced because of the large number of artificial structures, primarily groins and seawalls, that have been constructed; a 1968 aerial photograph shows that nearly all of the shoreline between the Elyria waterworks and Lorain harbor is protected in some way or another. The park groins especially appear to have a beneficial effect on the shoreline because the sand, if not trapped by the groins, would accumulate inside the breakwater and for all practical purposes be completely removed from the lake system.

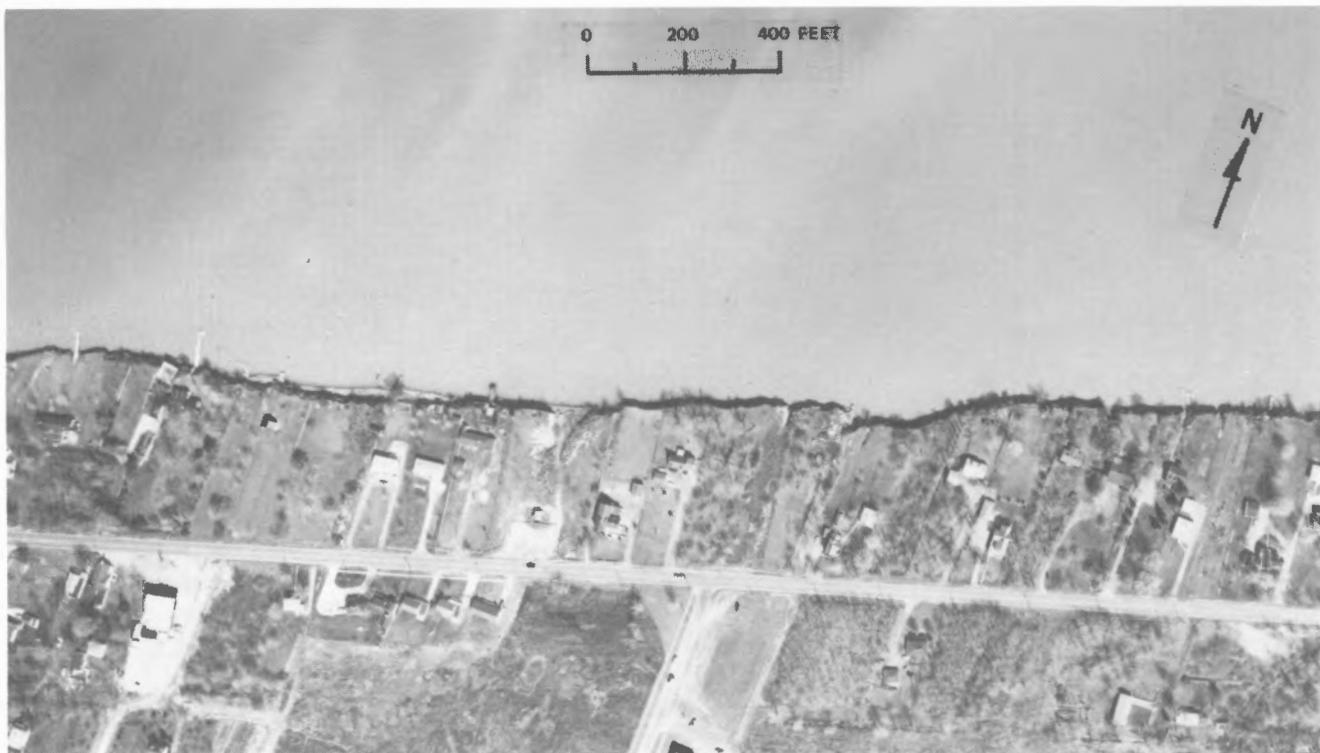
FIGURE 18.—STOP 15, Shellcove Park. Vertical shale bluff fronting the shoreline.

**SHELLCOVE PARK** (*Avon quadrangle*). An unprotected shale bluff, commonly capped by till, and pocket beaches make up the shore. A comparison of the 1901 Oberlin 15-minute topographic map with the 1963 Avon 7.5-minute topographic map indicates that the shoreline receded about 90 feet between 1901 and 1963. This is consistent with erosion rates of shale east of Vermilion (STOP 12). In general, the shoreline in this area is moderately stable except for a few topographic lows that are filled with more easily erodable till.

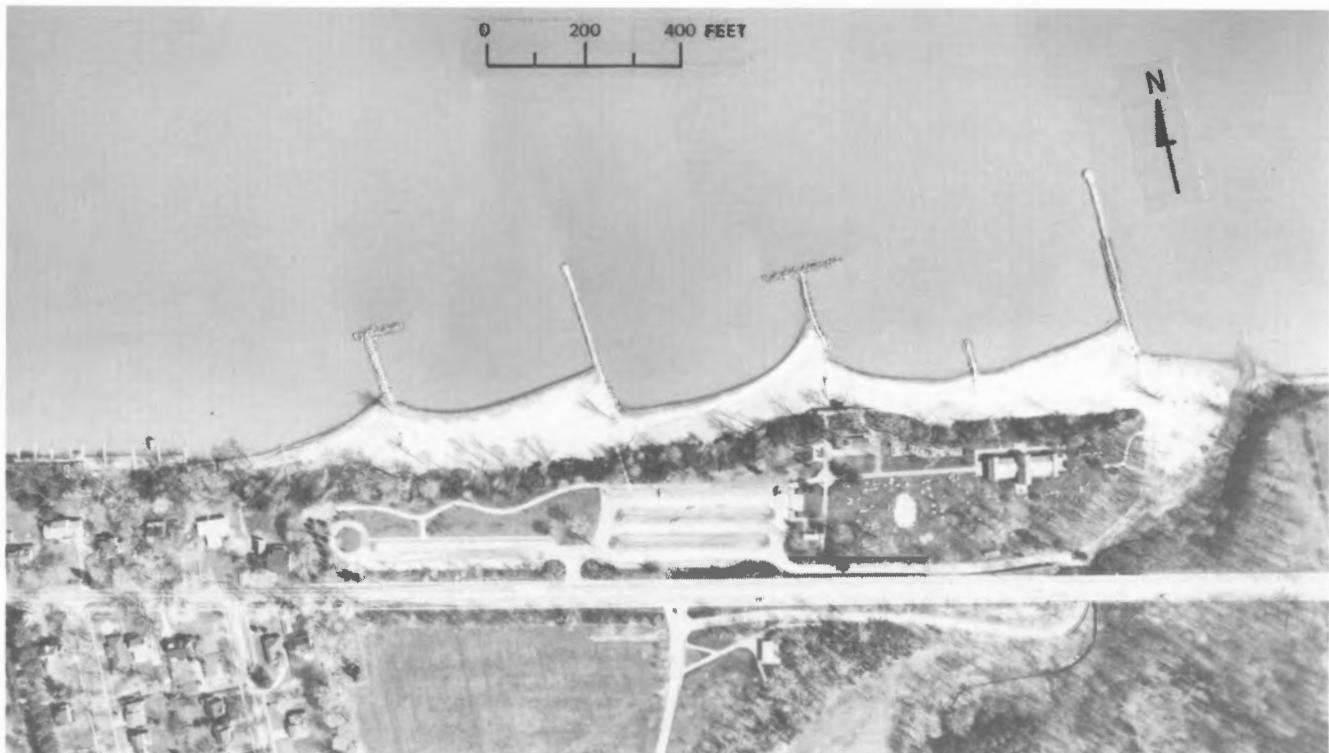
FIGURE 19.—STOP 16, Huntington Park. Groins, associated beaches, and shale bluff.

remained in nearly the same position, although there are local areas of erosion or deposition (U.S. Army Corps Engineers, 1950a, pl. 2). This is in contrast to the shoreline both east and west of the park, where the loss has been about 100 feet. Stabilization of the shoreline is probably due largely to the groins, which were constructed in 1933, although Porter Creek at the east end of the park has probably caused some disruption of the longshore drift, thus contributing to sand deposition. The broad beach has protected the bluff from waves; however, the unusually heavy precipitation in 1972 and 1973 has caused some of the more poorly drained areas to slump. Better drainage could have prevented the slumping because there is a more than adequate beach to dissipate wave energy, as well as protection in the form of sand deposits along most of the toe of the bluff. The groins do not appear to have had a significant effect on the downdrift (east) shore, which is largely a steep shale bluff.

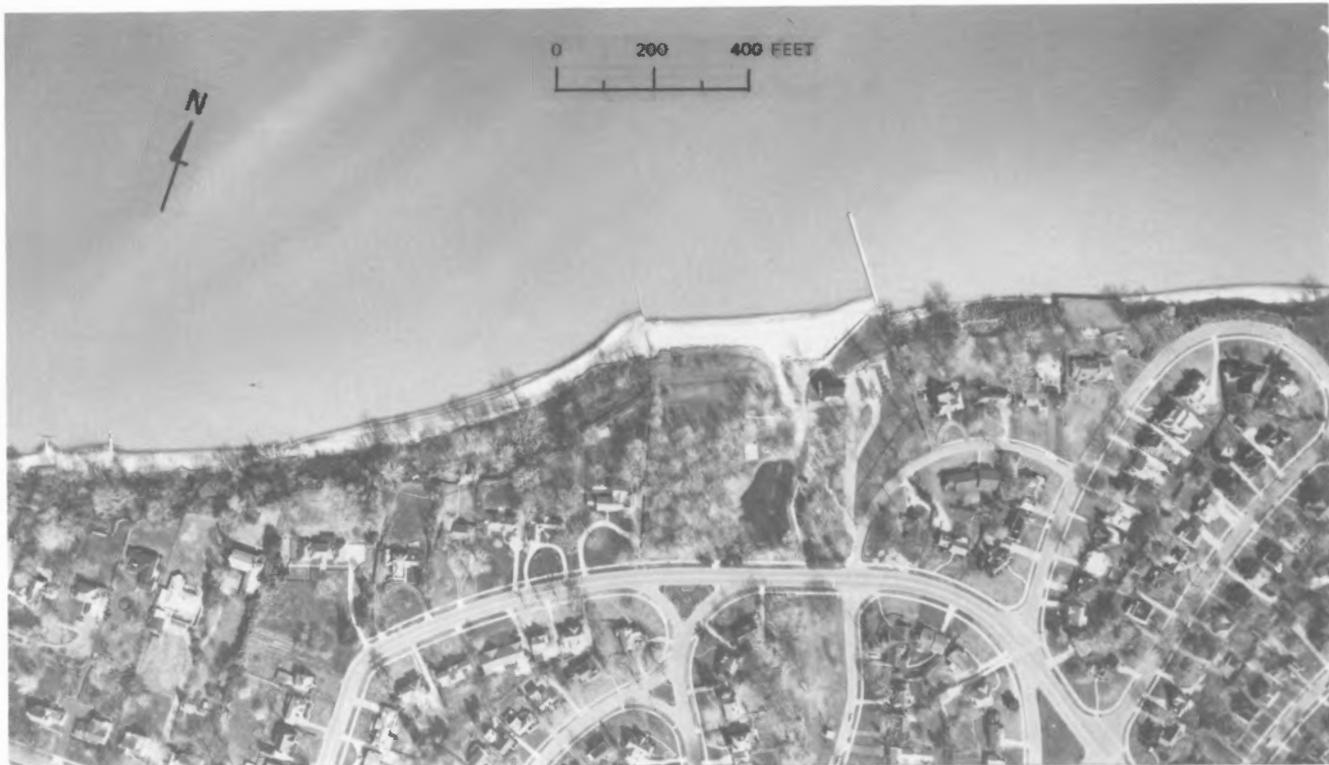
FIGURE 20.—STOP 17, Rocky River Park. Landscaped slope, beach, and V-shaped groin.

**ROCKY RIVER PARK** (*Lakewood quadrangle*). A concrete-block groin about 200 feet long traps sand from the net southwest-to-northeast longshore drift. The sand forms a 20-foot wide (April 1973) beach. A partly submerged groin forms the western boundary of the park, and there is a partially submerged riprap breakwater at the base of the 40-foot slope. The slope has been terraced and landscaped; it is composed of shale capped by till and lake sediments. Minor slumping has occurred along the toe of the lowest terrace (April 1973) because of inadequate drainage.

1947 survey shows that the position of the Rocky River Park shoreline, like that of the Huntington Park shoreline, did not change, whereas both east and west of the park the shore receded as much as 150 feet (U.S. Army Corps Engineers, 1950a, pl. 2). The present park reach appears relatively stable, although there is a drainage problem along the base of the lowest slope. The concrete-block groin has a beneficial effect on the updrift shore because of the sand it traps; the downdrift shore is protected by manmade structures and/or shale except for a few hundred feet of shoreline adjacent to the park.

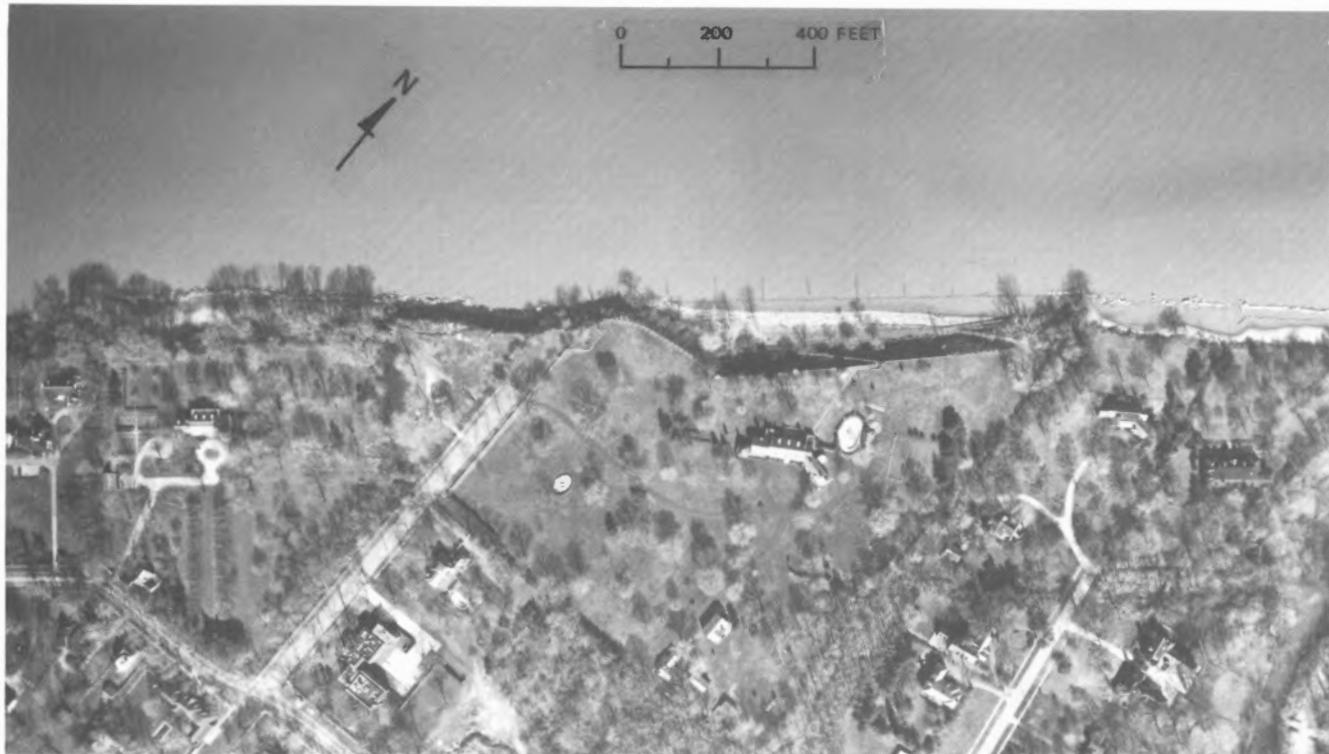
FIGURE 21.—STOP 18, Bratenahl Road. Severely slumped till bluff.

A 35- to 40-foot bluff composed of till overlain by glaciolacustrine sediments makes up the shore. There are severe drainage problems and associated slumps (April 1973) in this material, particularly near the contact between the sandy lake sediments and the till. A partially submerged sandstone-block breakwater (formerly a seawall?) in poor condition lies just offshore from the foot of the bluff; there are also several randomly positioned concrete blocks that help shield the

Comparison of an 1876 shoreline survey with a 1947 survey shows that the shoreline in this immediate area receded about 100 feet in that period (U.S. Army Corps Engineers, 1950a, pl. 2). This amount of erosion has been consistent along the unprotected areas of the Bratenahl reach. The major erosion problem here also is probably inadequate drainage, although during high-water periods the toe of the bluff is easily eroded by storm waves.

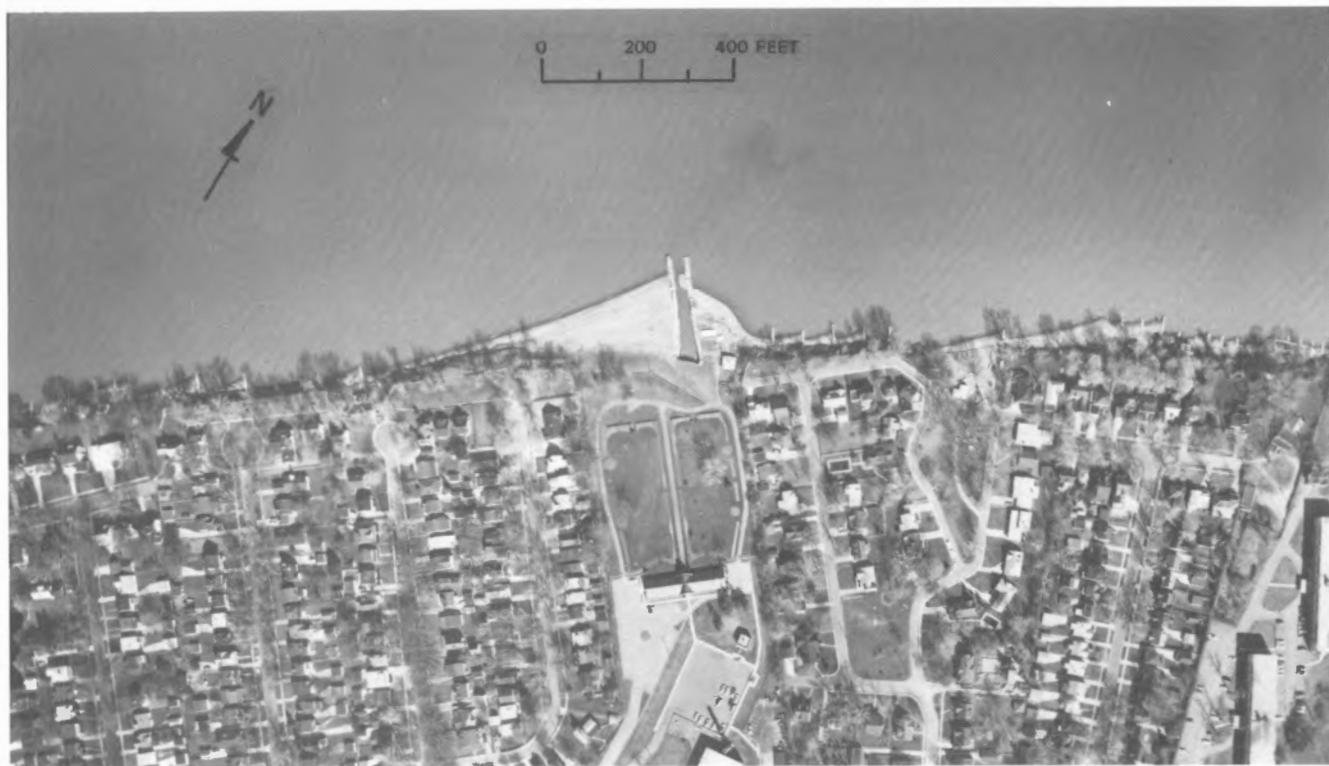
FIGURE 22.—STOP 19, Euclid Park. Landscaped slope, beach, and parallel piers.

The stable slope and substantial beach are pro-

tecting the park shore well. In addition several small groins (less than 50 feet long) on either side of the outfall have trapped sand to help protect the base of the bluff; however, in most places the bluff has not been sloped, and there is slumping in the till. The shoreline in this area is estimated to have receded as much as 100 feet between 1876 and 1953 (U.S. Army Corps Engineers, 1954, p. 39). Presumably the beach and stable slope will prevent erosion at Euclid Park. Furthermore, the beaches fronting the bluff both east and west of the park will help reduce the rate of erosion, although the need for adequate drainage to prevent slumping will still exist.
