GUIDEBOOK NO. 1

# NATURAL AND MANMADE FEATURES AFFECTING THE OHIO SHORE OF LAKE ERIE

BY  
CHARLES H. CARTER

Columbus  
1973

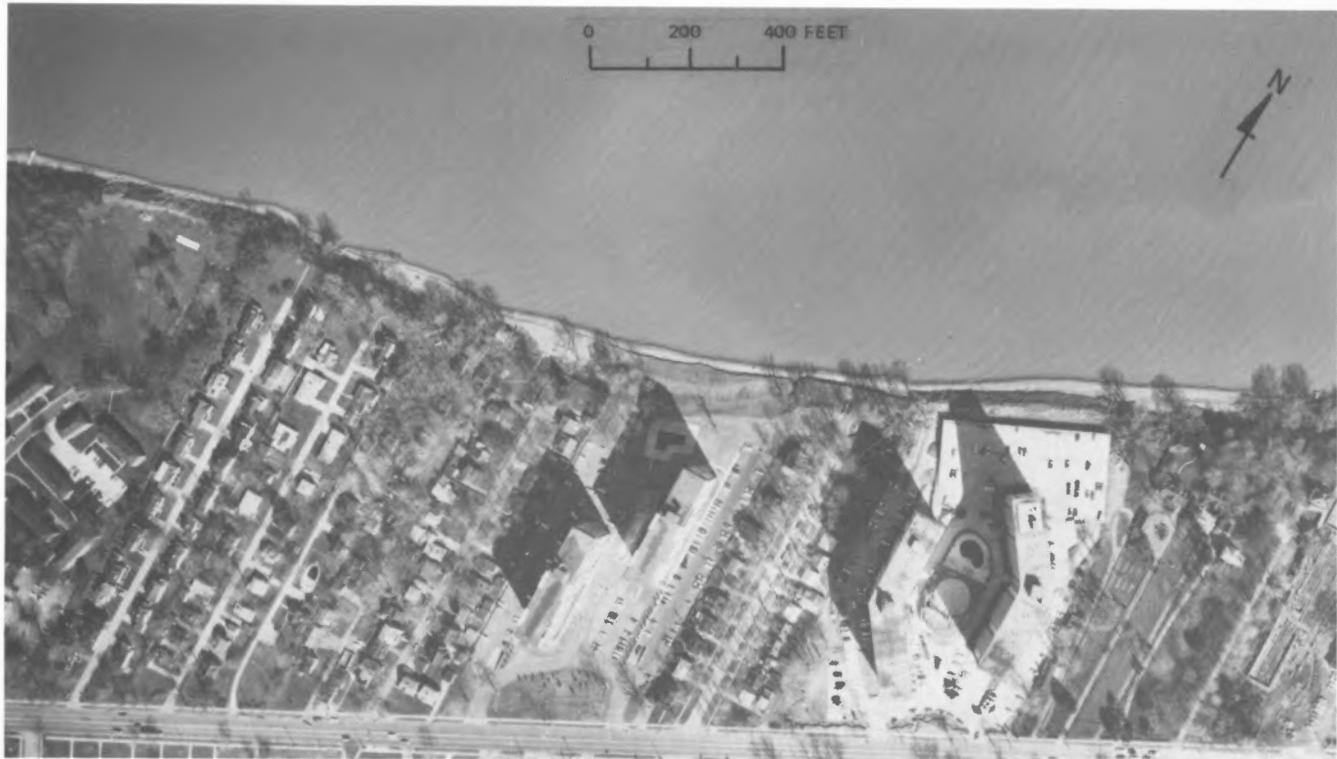
FIGURE 23.—STOP 20, Horizon House Apartments. Landscaped slope and narrow beach.

The concrete drain sections help protect the toe of the slope from direct wave attack as well as help support the slope. These sections, however, may not be massive enough to stand up under a severe storm. The gentle slope reduces the probability of slope failure, one of the primary causes of erosion in this area.

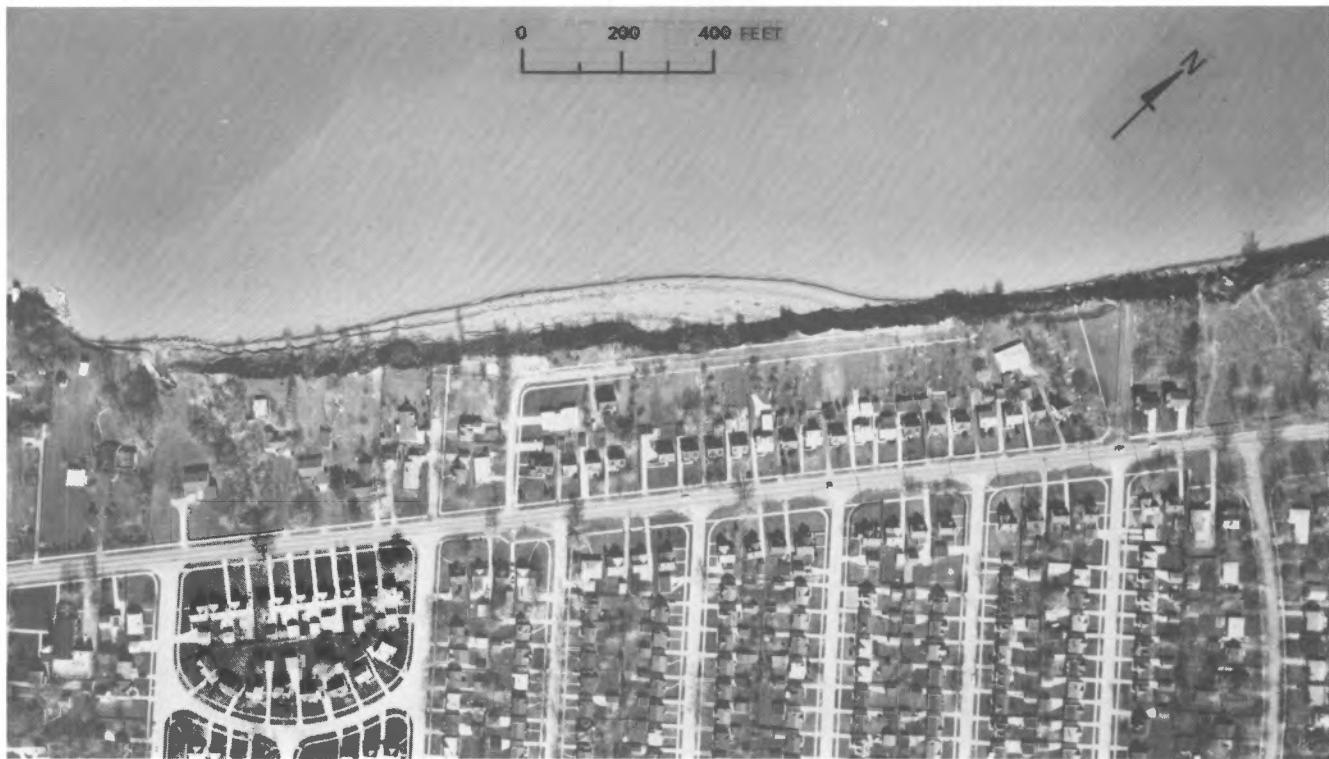
FIGURE 24.—STOP 21, East 325th Street. Steep till bluff and moderate beach.

**EAST 325TH STREET** (*Eastlake quadrangle*). A 30- to 40-foot till bluff is partially protected here by a 50-foot-wide beach (April 1973). There are large slumps in the upper half of the bluff, and in places the till has been undermined by small springs.

Erosion has been fairly rapid in this area because of inadequate drainage and the scarcity of protective structures. A comparison of profiles from an 1876 survey and a 1948 survey "...show[s] a landward movement of the shoreline of up to 200 feet; however, it is estimated that the movement of the bluffs has been somewhat less" (U.S. Army Corps Engineers, 1954, p. 21-22). Between 1938 and 1948 the bluff receded about 30 feet (U.S. Army Corps Engineers, 1954, p. 23).

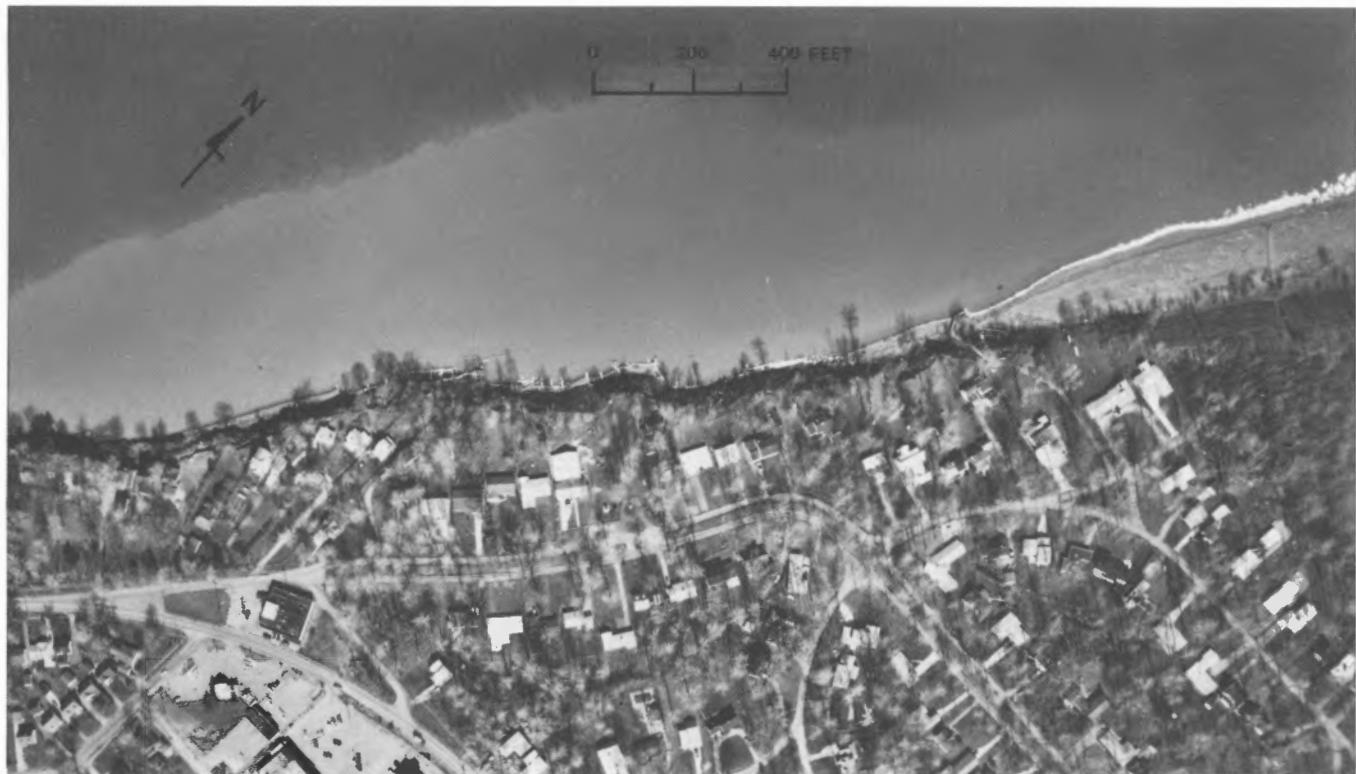
FIGURE 25.—STOP 22, Timberlake Village Park. Steep till bluff and moderate beach.

This stop is very similar in erosional history to the East 325th Street stop. However, farther east, the Cleveland Electric Illuminating Company's intake jetties, which were built in 1952, have trapped a sizable amount of sand as well as having "virtually stopped the longshore movement of sand from the southwest" (Hartley, 1964, p. 20).

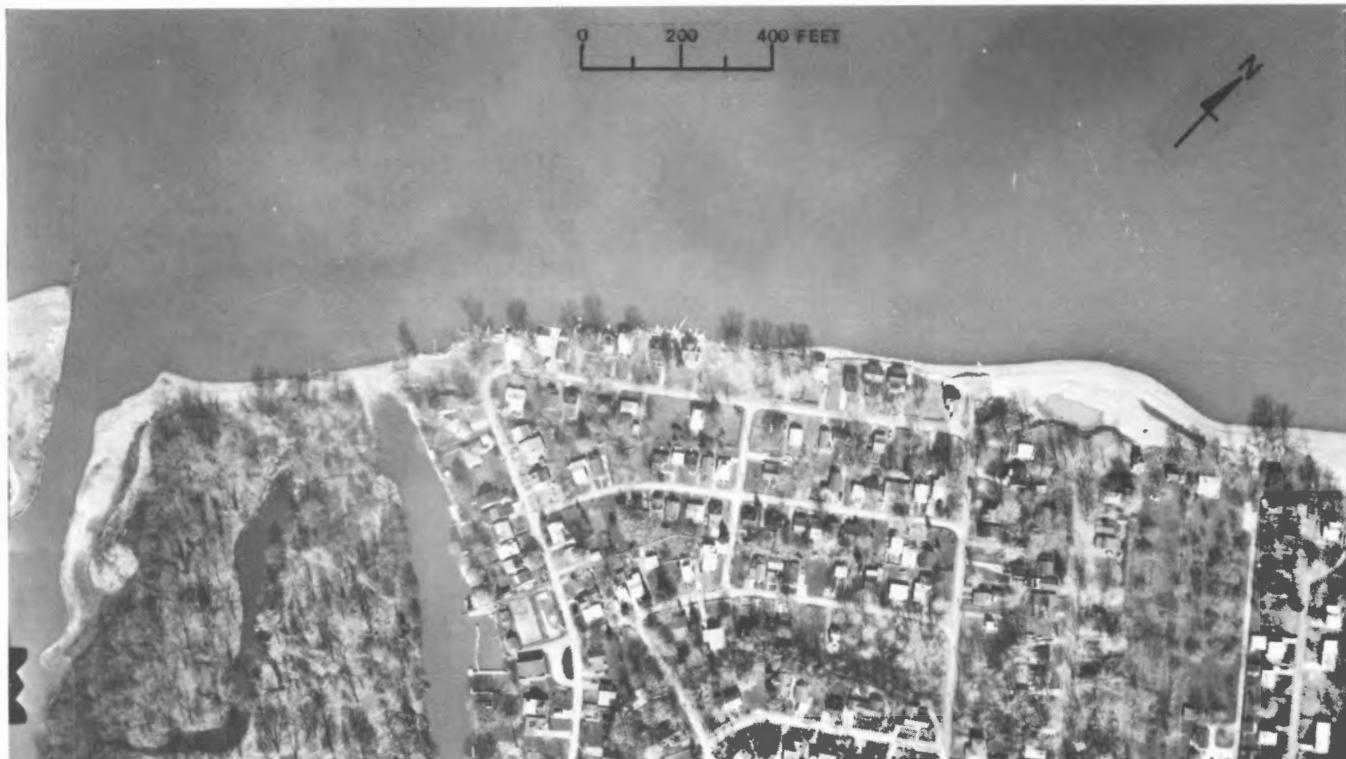
FIGURE 26.—STOP 23, Chagrin River. Homes adjacent to lake.

**CHAGRIN RIVER** (*Eastlake quadrangle*). The shoreline (April 1973) is adjacent to homes on the north side of Galilina Road. Most of the homes have suffered severe structural damage during storms.

This stretch of shoreline receded about 170 feet between 1876 and 1947; in 1947 a wide sand beach, low sand banks, and dunes fronted 3,000 feet of shoreline east of the Chagrin River (U.S. Army Corps Engineers, 1950b, p. 19). However, since construction of the Cleveland Electric Illuminating Company's intake jetties just to the southwest the beach has been eroding, probably largely because of sand removed from the littoral drift system by the western jetty (Hartley, 1964, p. 20). Beach nourishment and construction of a groin field to hold the sand should stabilize the shore in this area.

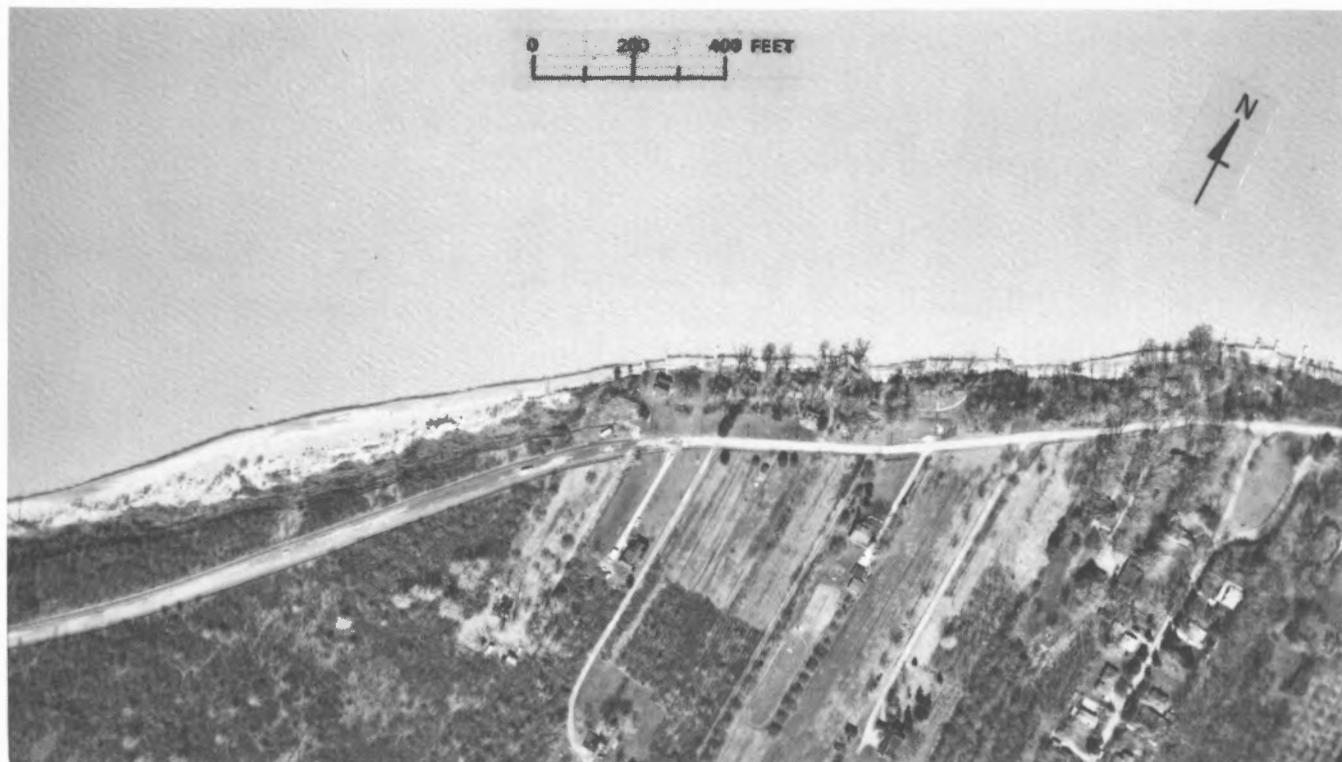
FIGURE 27.--STOP 24, Headlands Road. Badly slumped laminated clay and till bluff and narrow beach.

This reach is rapidly eroding. Between 1876 and 1947 the shoreline retreated about 330 feet (U.S. Army Corps Engineers, 1950b, p. 20, 21). The major cause of erosion appears (April 1973) to be inadequate drainage. Ground water lubricates and weakens the clay, which acts as a slip plane for the overlying till. Slumping takes place, and the bluff recedes. Storm waves carry away the slumped debris as well as attack the toe of the bluff, causing greater instability. Toe support, better drainage, and a landscape slope are corrective measures that would work here.

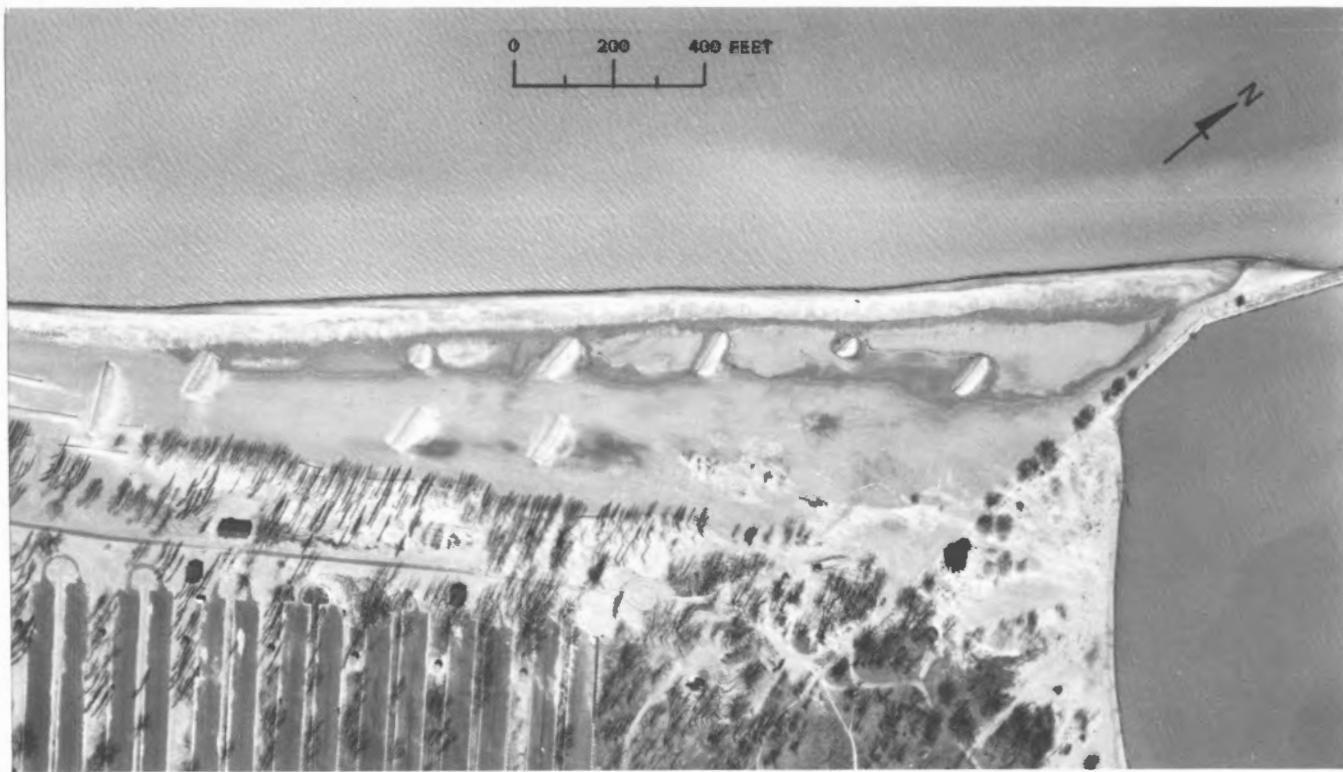
FIGURE 28.—STOP 25, Headlands Beach State Park. Rubble-mound jetty and extensive beach with well-developed dunes.

"The Fairport west breakwater has probably had a greater effect on a greater length of shore than any other structure on Lake Erie. The effect is also probably the most serious because it interferes with sand movement from one of the largest source areas along the lake shore. According to the U.S.-Ohio Beach Erosion Control Study of the area, more than 700,000 cubic yards of sand were removed by dredging from the outer Fairport harbor between 1932 and 1947. All of this material came from longshore drift from the west. If this material could have been placed on the shore to the east, it presumably could have created a beach 75 feet wide, throughout the nine-mile eroding stretch."

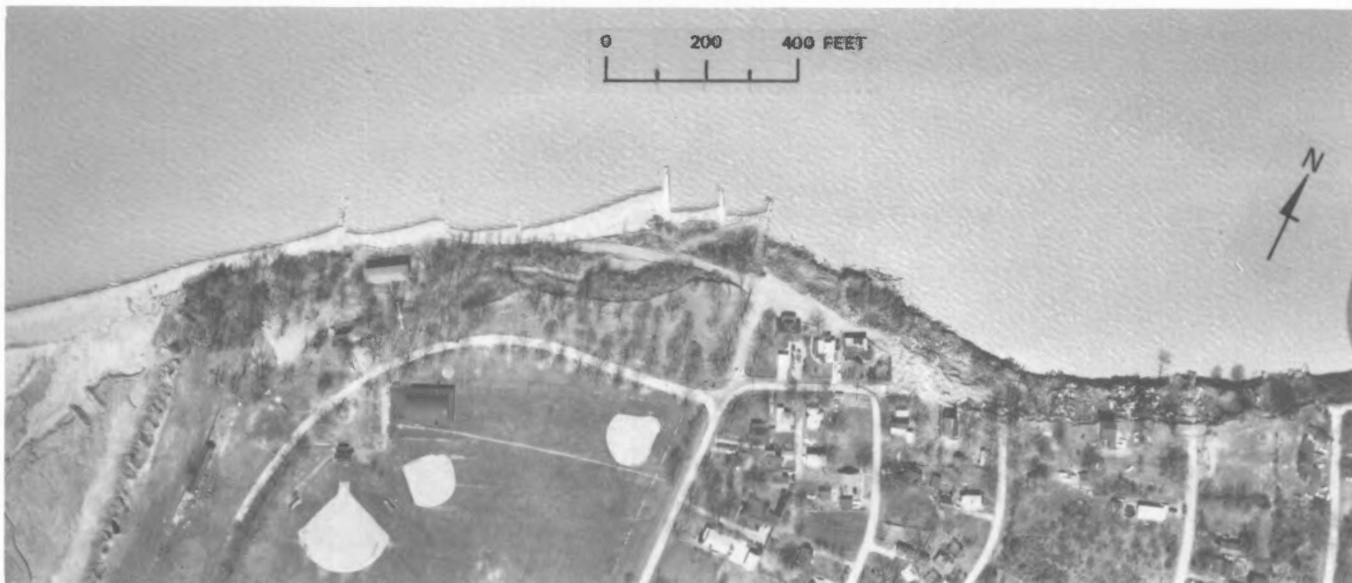
FIGURE 29.—STOP 26, Painesville Township Park. Groins and badly slumped till bluff.

**PAINESVILLE TOWNSHIP PARK** (*Perry quadrangle*). Three medium-sized concrete-block groins (up to 150 feet long) in fair to good condition have trapped some sand from the net southwest-to-northeast littoral drift. The sand makes up a narrow beach (less than 20 feet wide) west of the westernmost groin, whereas the other groins are partially submerged, and the shoreline is at the base of the slope (April 1973). The brush-covered slope is made up of boulder till capped by glaciolacustrine sands and clays. Near the base of the bluff is a poorly defined laminated clay zone 1 to 2 feet thick. The till has slumped in several places and there are many small debris flows (on the order of a few feet). The slope surface is very irregular and hummocky, and there is a prominent seep at what is probably the contact between the till and the glaciolacustrine deposits. This evidence, in addition to tension cracks parallel to the shoreline, indicates severe slumping.

The groins, by trapping sand, have had a stabilizing influence on the park shoreline; however, as is the case in many similar areas along the shore, inadequate drainage during periods of above-average precipitation

appears to have caused severe erosion problems. Ground water is held at the till-glaciolacustrine contact, and the overlying sediment becomes saturated and eventually slumps. Possibly the most significant cause of shoreline recession here, however, is the laminated clay near the base of the bluff. As at Stop 24, this clay may act as a slip plane for the overlying materials. Erosion along this reach has been estimated at 1 to 2 feet a year (Ohio Division Shore Erosion, 1961, p. 7).
