Common Problems for Small Dams with Concrete Channel Spillways

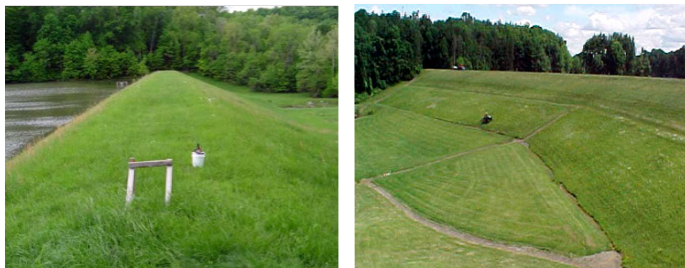
An excellent grass cover will reduce erosion and is easily maintained.

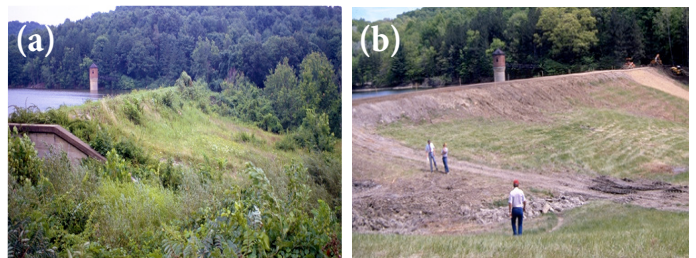
(a) Embankments covered with trees and brush makes inspection difficult. (b) Cleared of trees and brush, this embankment is much easier to inspect, but needs a good vegetal cover.

Trees and brush must not be permitted on embankment surfaces or in vegetated earth spillways. Extensive root systems can provide seepage paths for water. Trees that blow down or fall over can leave large holes in the embankment. Brush hinders visual inspection, provides a haven for burrowing animals, and retards growth of grass vegetation.

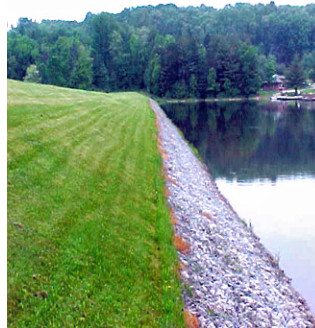
This slope is well maintained with rock riprap along the shoreline.

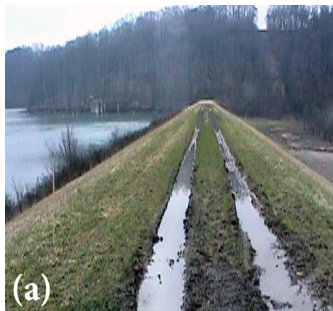
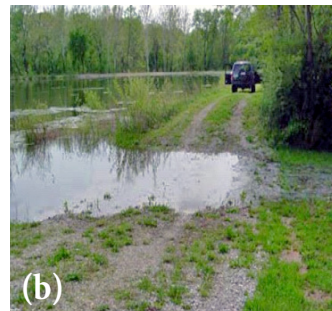
(a) Embankment crests with vehicle ruts will collect water and weaken the embankment. (b) Crest beginning to overtop in low area. This could lead to erosion and failure of the dam.

Vehicular traffic should be discouraged, especially during wet conditions, to avoid ruts. Water collected in ruts may cause localized saturation, thereby weakening the

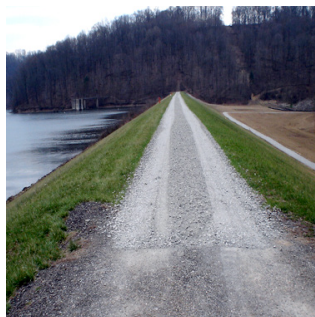
Crest with a good cover that will reduce the effects of vehicular traffic.

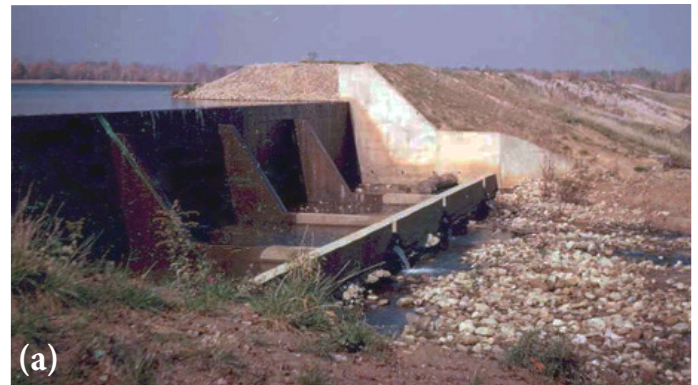
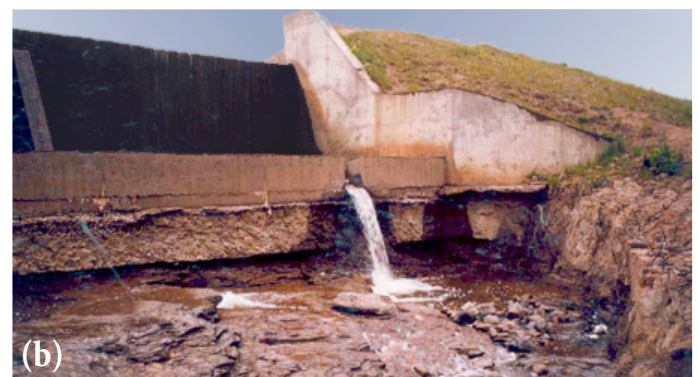
(a) A spillway outlet area as originally constructed. (b) Severe erosion has undermined the spillway outlet and threatens the overall structural safety of the spillway.

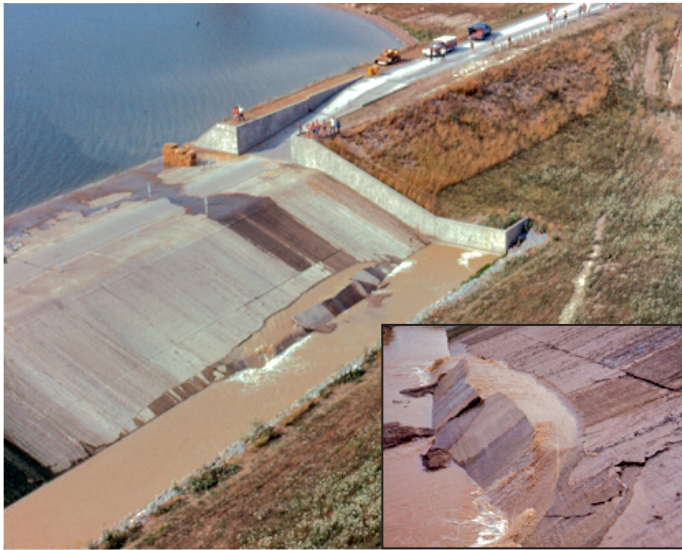
This dam is failing because of seepage under the spillway.

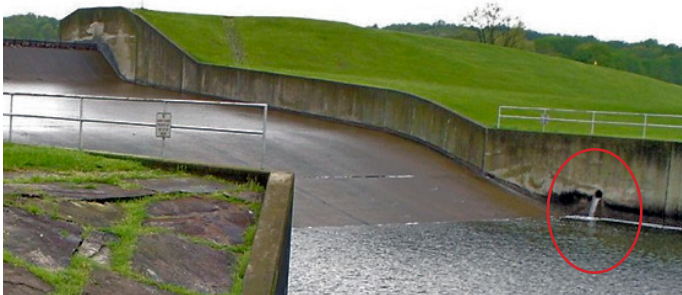
A properly designed spillway includes a drainage system for collecting seepage under the spillway. The picture shows flow discharging from the spillway's drainage system.

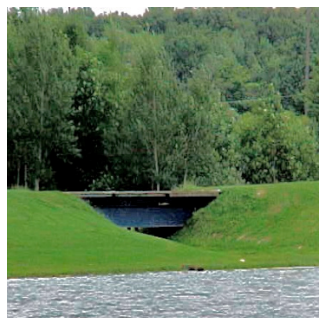
This bridge blocks much of the spillway, reducing its ability to convey water.

A spillway must remain unobstructed to maintain its flow capacity. Obstructions such as fish screens, walkways, vegetation, and bridge piers should be cleared from the spillway inlet. Loss of flow capacity could cause the dam to overtop and fail.

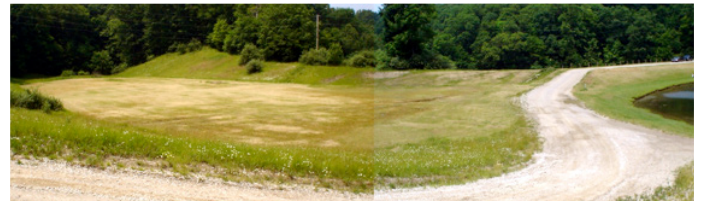
This open-channel emergency spillway is clear of trees, brush and other obstructions. Also note the good grass cover.

control matting. Grass-lined channels should be mowed at least twice per year to maintain a good grass cover and to prevent trees, brush, and weeds from becoming established. Poor vegetal cover can result in extensive and rapid erosion when the spillway flows.
