# Biological and Water Quality Study of the Big Walnut Creek Basin 2000

Delaware, Fairfield, Franklin, Licking,  
Morrow, and Pickaway Counties, Ohio

OEPA Technical Report DSW/EAS 2003-11-10

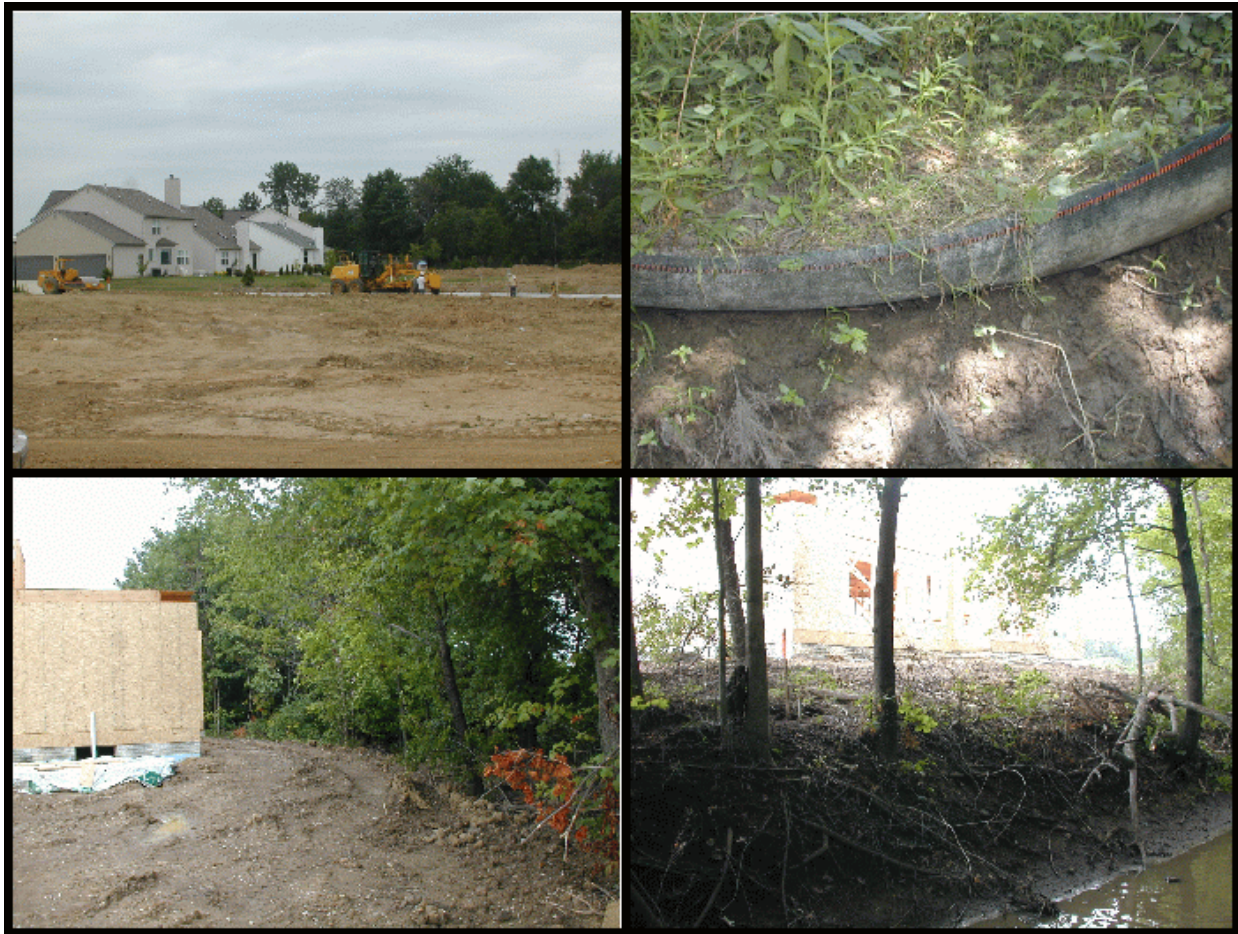
**Figure 43.** Construction in the Rocky Fork basin. Upper left, cluster development in the vicinity of Walnut Street. Upper right, a properly constructed silt fence along the bank of Sugar Run. Lower panels, new home construction lacking proper erosion controls, and encroaching on and destroying the riparian zone.

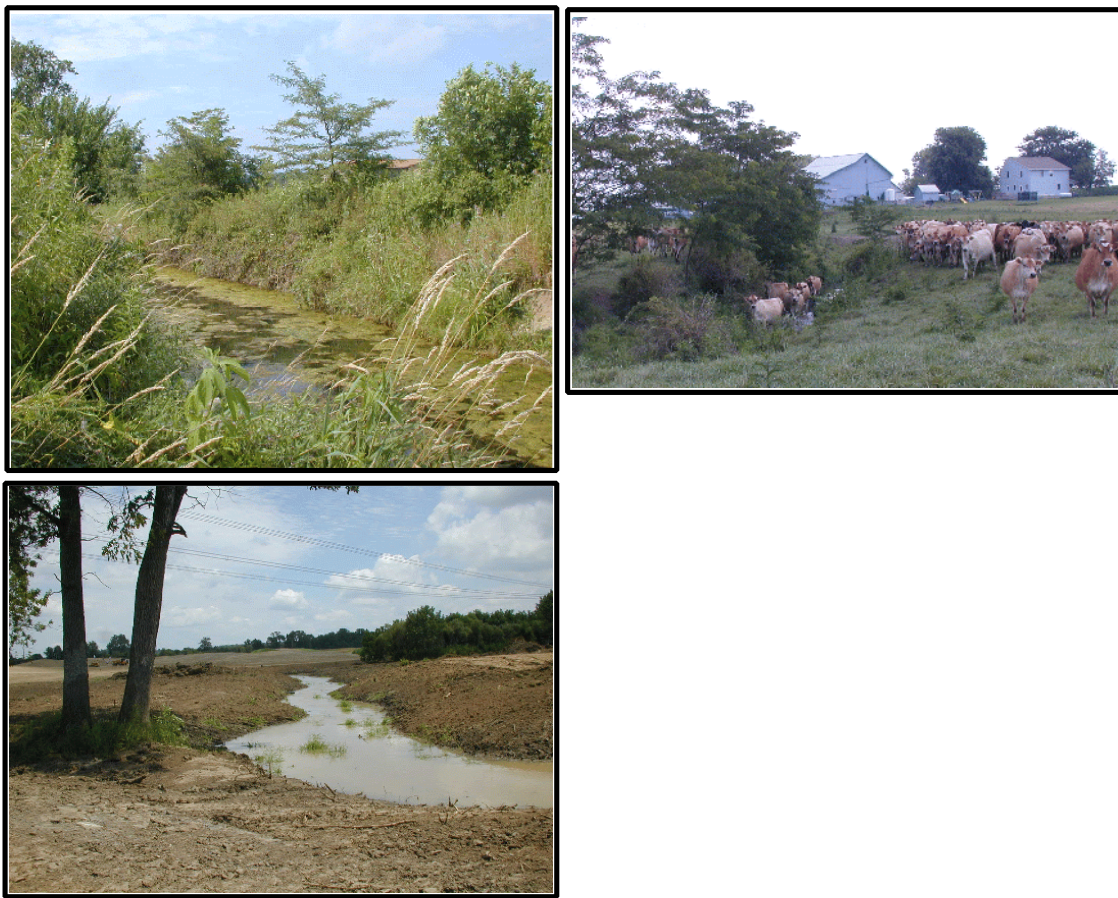
**Figure 45.** Habitat conditions in the Rattlesnake Creek subbasin of Big Walnut Creek. Clockwise from top left: sparse riparian vegetation allowing full sunlight to the stream in the North Fork; unfenced livestock in the East Fork; and construction in the South Fork.
