2014 and 2015 Biological and Habitat Studies of 30 Rivers and Streams in Ohio Evaluating Section 319(h) and SWIF/GLRI Projects

Division of Surface Water
Ecological Assessment Unit

June 2018

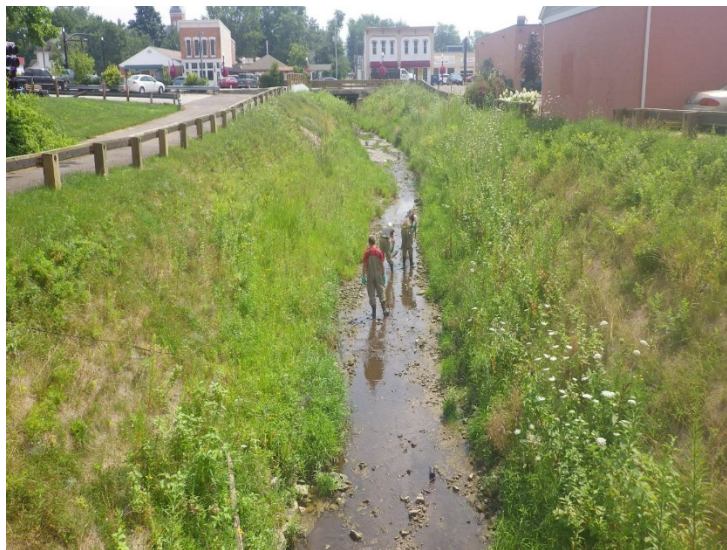
Figure 19 — Town Run between 4th and 5th Streets in Marysville (RM 0.2), post-restoration sampling 2015.

Illicit sewage discharges were discovered during the pre-project monitoring. These pollution issues have been addressed by the City of Marysville as part of this restoration project. The improved water quality conditions were reflected in the post-project monitoring fish IBI scores (Table 42, Table 43, Figure 20). The fish community score in the project area went from poor quality to full attainment of the WWH aquatic life use. Conversely, macroinvertebrate community health narratives were unchanged. This was most likely due to the highly eutrophic conditions encountered during the 2009 sampling which were still present in the 2015 sampling with algae covering the substrates.
