# Biological and Water Quality Study of the Stillwater River Basin

Darke, Miami and Montgomery Counties

OHIO EPA Technical Report EAS/2014-10-08

Biological and Water Quality Study of the  
Stillwater River Basin  
Darke, Miami, and Montgomery Counties, Ohio  
2013

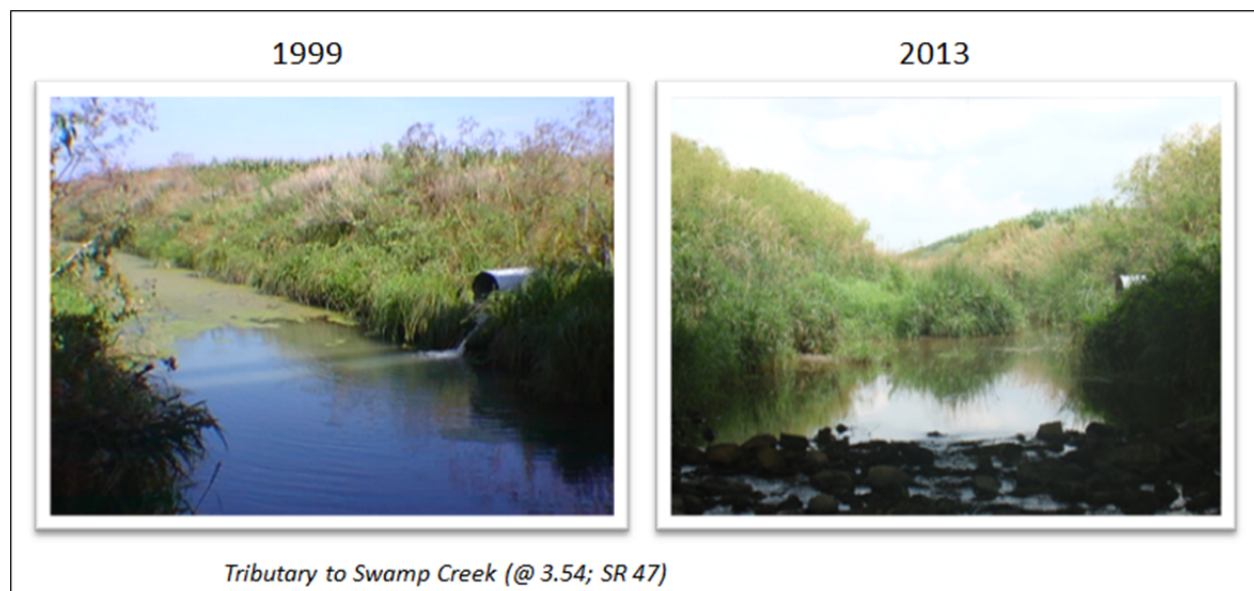
Figure 3. Photographs of an unnamed tributary to Swamp Creek taken at SR 47 in 1999 and 2013. The floating mat of filamentous algae seen in the 1999 photograph is unequivocally diagnostic of nutrient over-enrichment. That condition was not observed in 2013.
