HEADWATERS OF BLACKLICK CREEK

HUC:05060001 15 03

Nine-Element Nonpoint Source Implementation Strategic Plan (NPS-IS Plan)

Developed by:

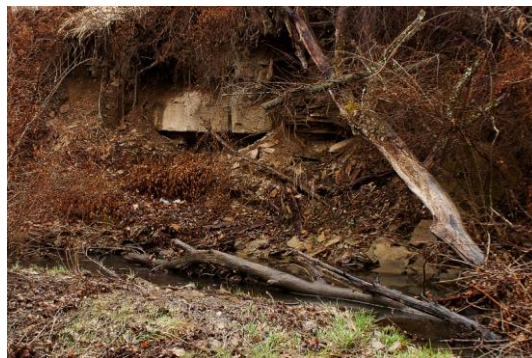
Figure 9: Exposed sandstone bedrock along a "Little Jordan Run" in Reynoldsburg

The subsurface geology is less uniform than this description would suggest. The creek crosses several buried valleys in Plain and Jefferson Townships, largely following one as it enters Reynoldsburg (Bates, 2007). Much of the bedrock is shale, although there are areas where Berea sandstone (see Figure 9) is close to the surface, as evidenced by old sandstone quarries in Reynoldsburg within the watershed. In contrast, the depth of glacial till can reach 300' in

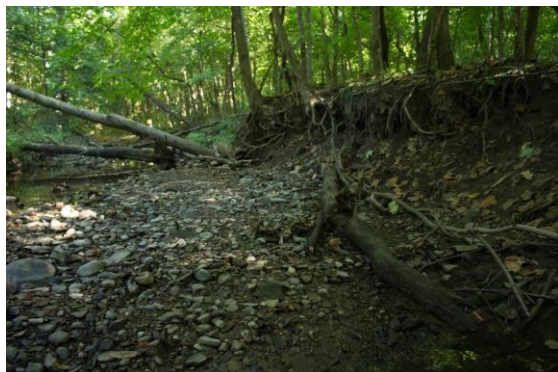
Figure 22: Dysart Run Tributary near 2016 sampling site

In the summer and early fall of 2016, MBI sampled two sites on Dysart Run, using Level 3 methods. The first site coincided with the Ohio EPA's sampling site in 2000 at RM 3.0. In 2016, the stream was found to be in attainment for both macroinvertebrates and fish (IBI – 44). The ICI score had improved from Fair to Marginally Good. The second site was on the Unnamed Tributary to Dysart sampled by the Ohio EPA in 2000 (see Figure 22). Here the fish continued to be in attainment (IBI – 48), while the macroinvertebrates were not (fair to poor (final narrative assessment not complete). In both cases, QHEI scores were acceptable, 65.5 for the first site and 76.5 for the second site.

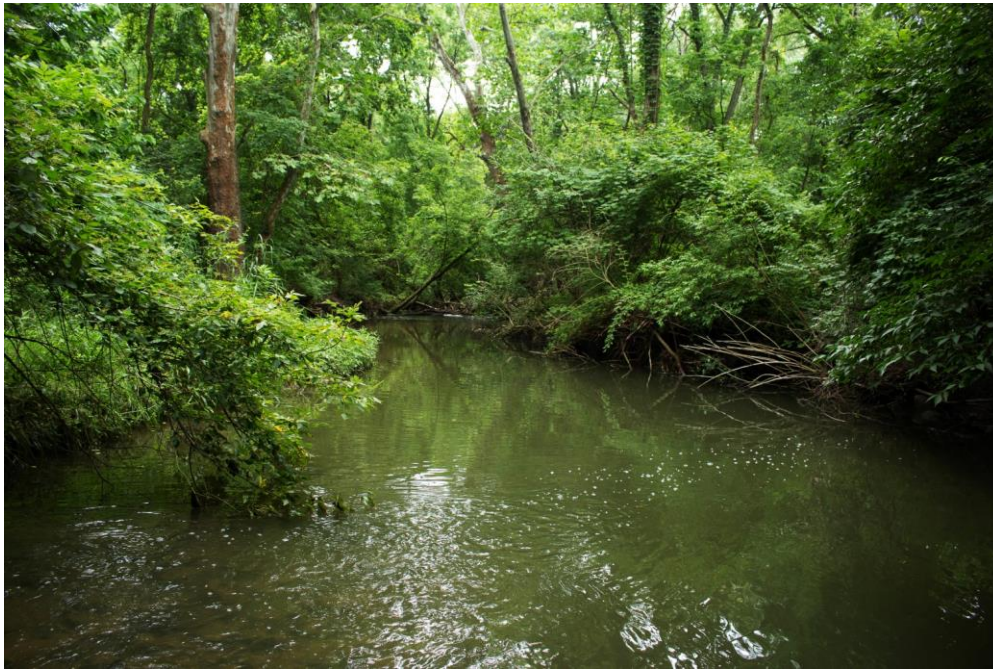
Figure 23: North French Run adjacent to French Run Elementary School

The impairments identified for French Run are identified primarily as urban runoff and land development, with HSTS contributing to a moderate degree. Urban runoff and HSTSs are also identified as sources of impairment in North French Run (see Figure 23). Looking for ways to address the effluent from discharging HSTSs is a challenge facing the entire Headwaters Blacklick Creek HUC-12. The strategies for the critical area to be focused on at this point in the development of the plan, Dysart Run, are all relevant to these subwatersheds as well.
