Boston Run - Cuyahoga River Watershed (HUC 041100020405)

Nine-Element Nonpoint Source Implementation Strategic Plan

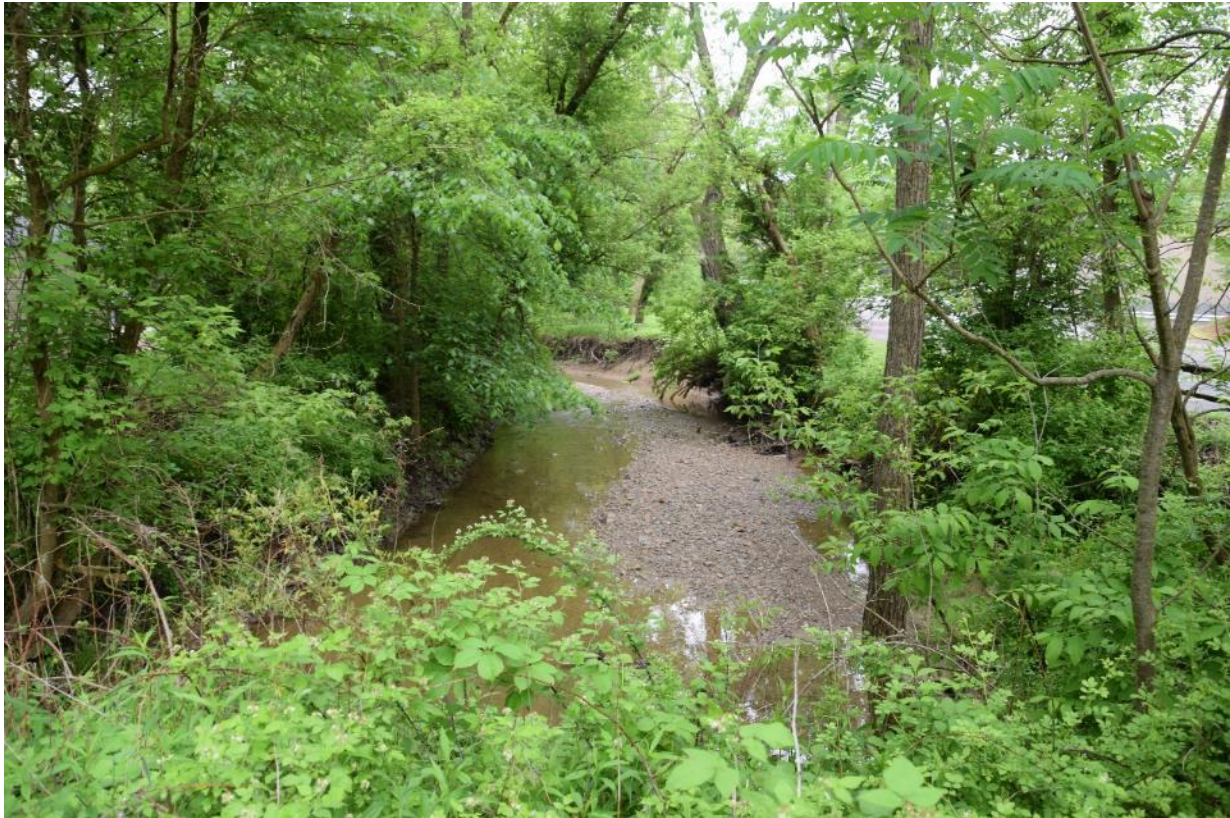
Characterizing the Boston Run-Cuyahoga River watershed, known impairments and causes, and proposed projects wherein attainment goals are discussed.

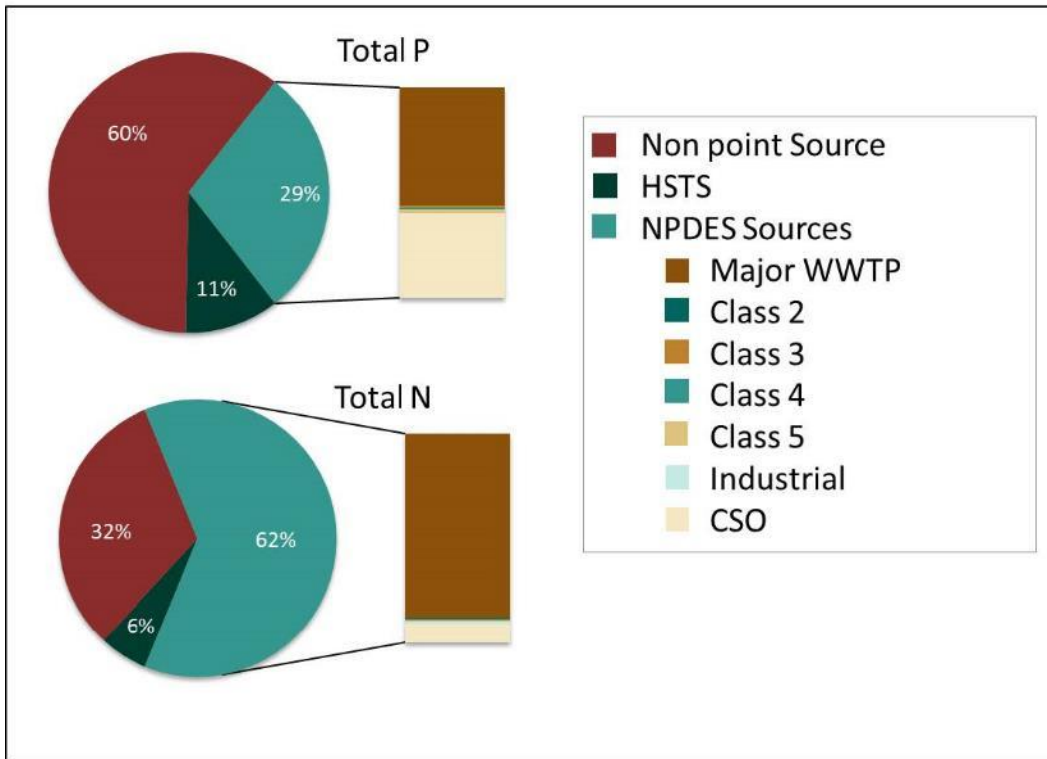
Figure 9: Cuyahoga River Annual Phosphorus-Nitrogen Mass Balance Calculations [20]

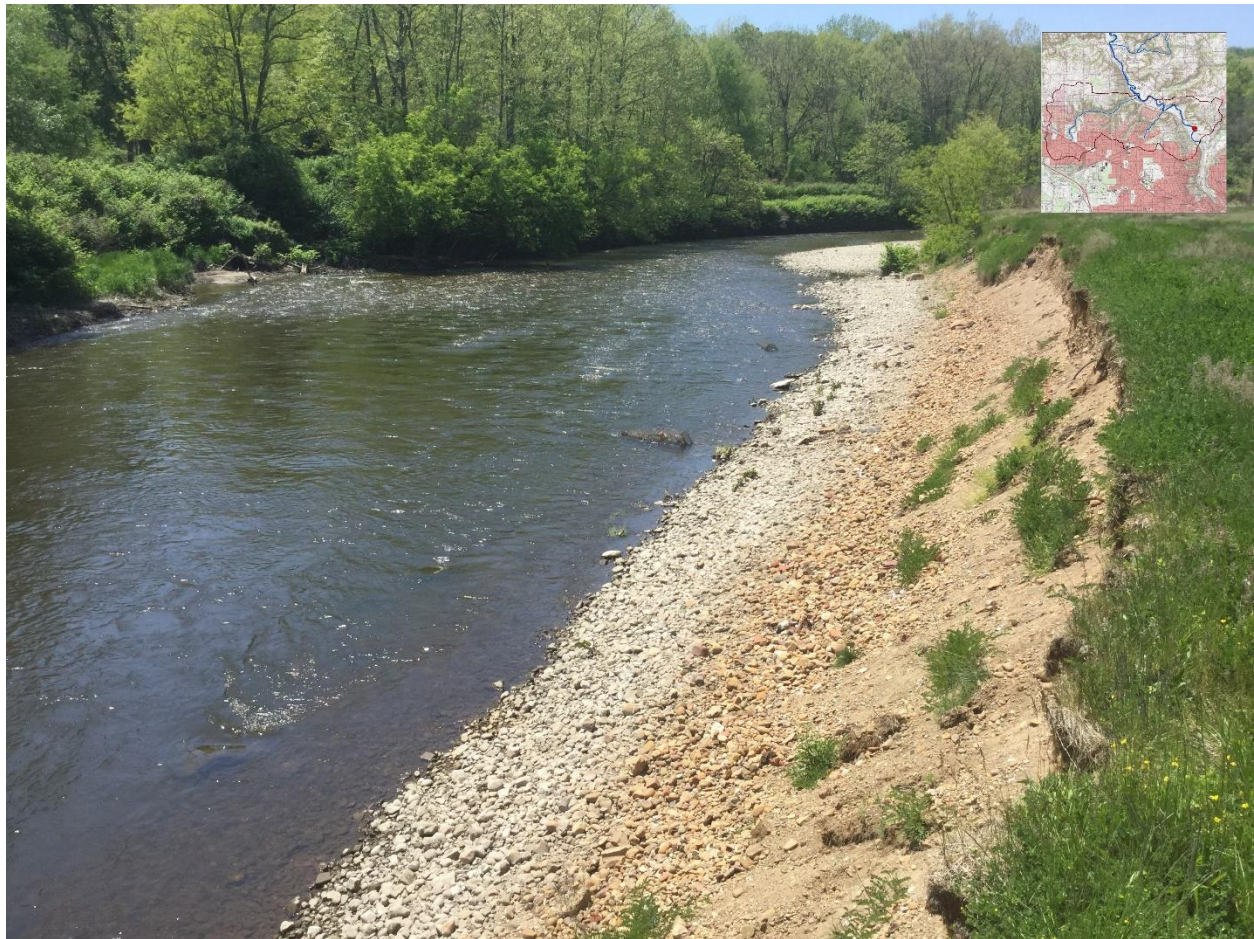
*Image 6: Eroded Bank of Cuyahoga River in the Former Valley View Golf Course
Erosion due to lack of riparian buffers. Photo courtesy of Summit Metro Parks*

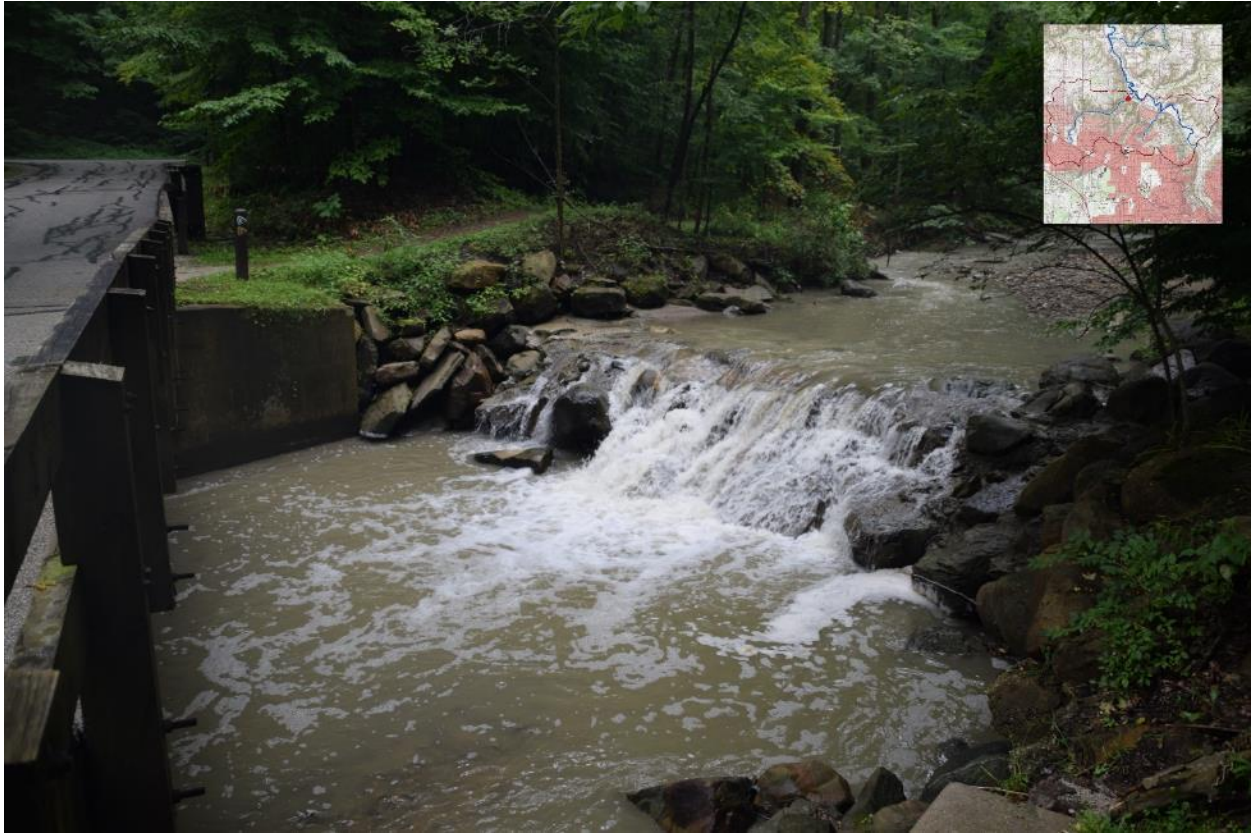
Image 7: Critical Area 1 - Fish Passage Barrier on Sand Run, Mingo Pavilion Road Crossing

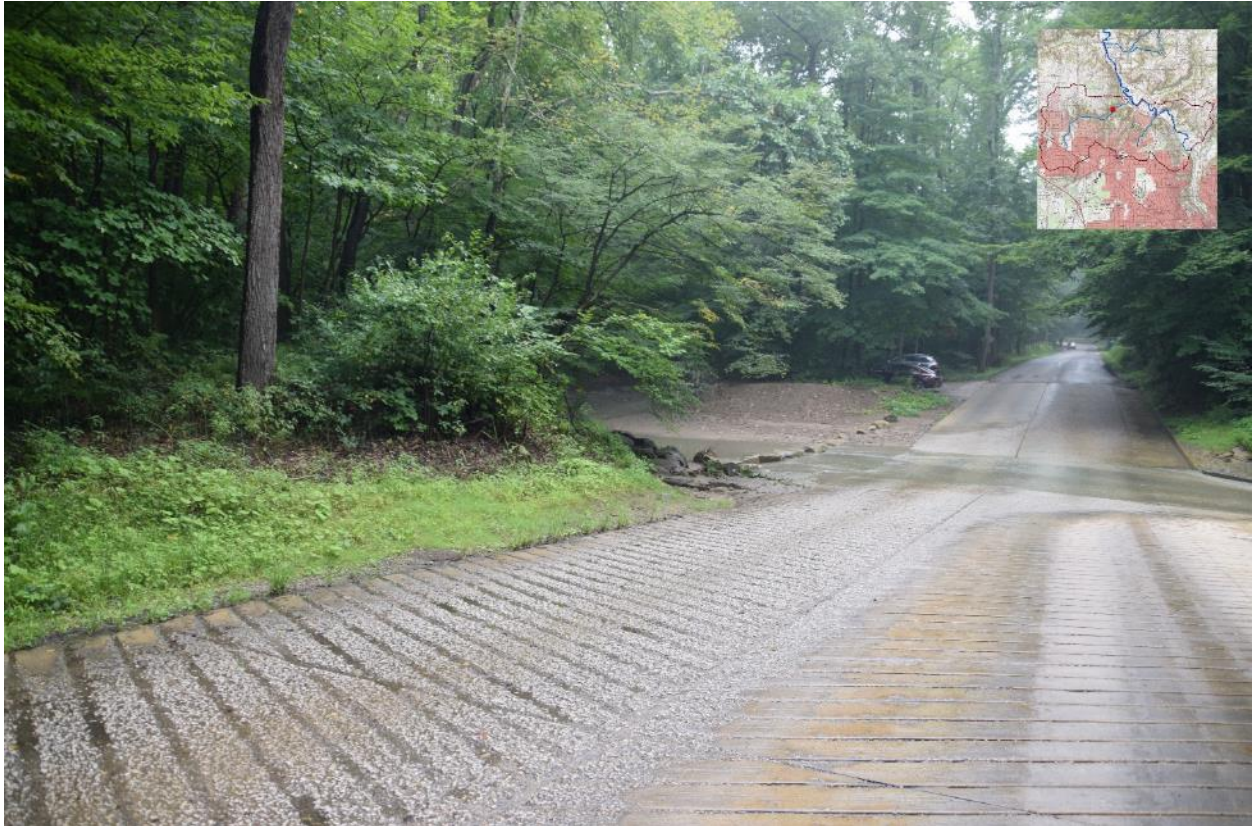
Image 8: Critical Area 1 - Sand Run Parkway / Sand Run Ford
