**CHAGRIN
RIVER
WATERSHED
PARTNERS**

Nine-Element Nonpoint Source Implementation Strategic Plan (NPS-IS Plan)

Chagrin River: East Branch Chagrin River HUC-12
(04110003-04-01)

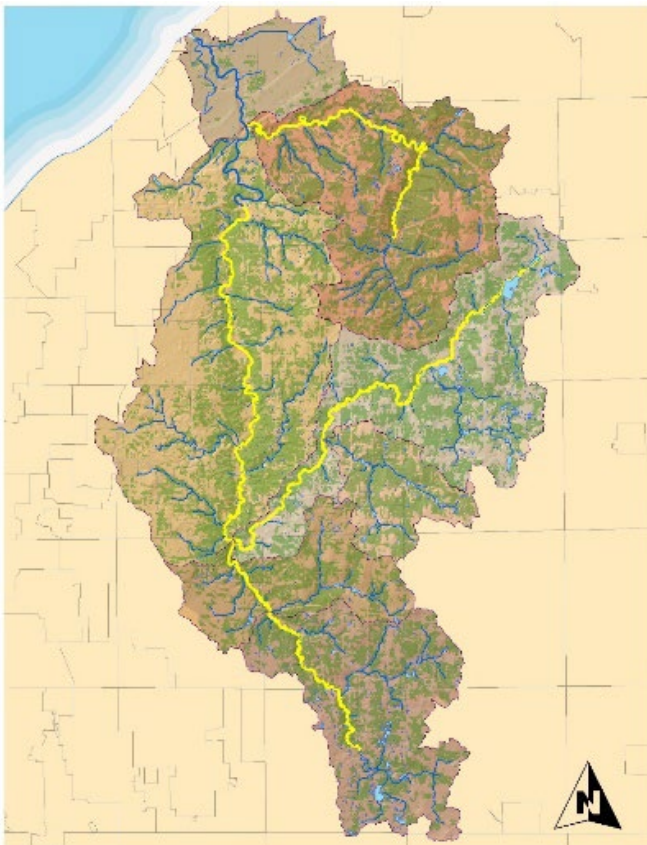
Figure 1: Scenic River designations in the Chagrin River watershed (highlighted in yellow)

Seventy-one miles of the Chagrin River have been designated as a State Scenic River. The original designation of 49 miles includes the Aurora Branch from S.R. 82, 12 miles downstream to its confluence with the main stem of the Chagrin, 23 miles of the main stem from its confluence with the Aurora Branch downstream to US Rt. 6, and 15 miles of the East Branch from Heath Road Bridge downstream to its confluence with the main stem was made in 1979. The river’s Scenic designation was extended in November 2002 to include the headwaters of the Chagrin, also known as the Upper Main Branch of the Chagrin, from the Woodiebrook Road bridge to the confluence with the Aurora Branch of the Chagrin River in Bentleyville. Scenic designated reaches of the river are characterized by exceptional aquatic habitat and adjacent high quality forests.

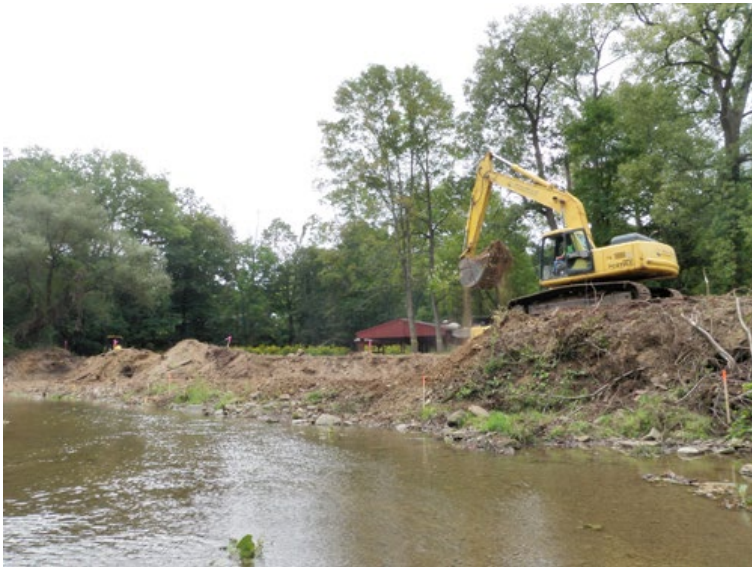
Figure 18: Before restoration at Holden Arboretum: 10-foot-tall levee blocked floodplain access

Chagrin River Watershed Partners has made progress in addressing causes and sources of impairment in the East Branch-Chagrin River HUC-12. In 2005, Holden Arboretum purchased 50 acres along Wisner Road, north of Kirtland-Chardon Road. The property includes a mix of natural areas and farm buildings and supports an ongoing horse stable operation. Nearly a half mile of the State Scenic East Branch of the Chagrin River flows through the property. Previous owners developed a 385-foot-long and 10-foot-tall earthen levee that prevented the river from accessing a 3-acre floodplain. Two small streams to the East Branch were channelized and modified by past land uses. In 2013, Holden Arboretum worked with The Chagrin River Watershed Partners and Lake Soil and Water Conservation District to select and hire a contractor to remove the levee, restore an accessible floodplain, restore a headwater stream and stabilize a second headwater stream. After earthwork was completed Holden Arboretum staff planted thousands of tree and shrub species to ensure this floodplain is stable and provides a wide range of water quality and flood management functions. This project was funded in part by Ohio EPA through their Section 319 program.

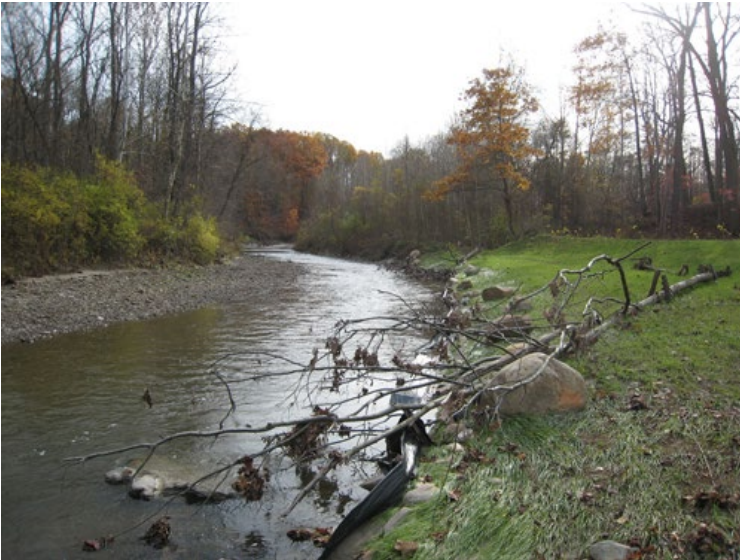
Figure 19: Post-restoration at Holden Arboretum: restored East Branch streambank

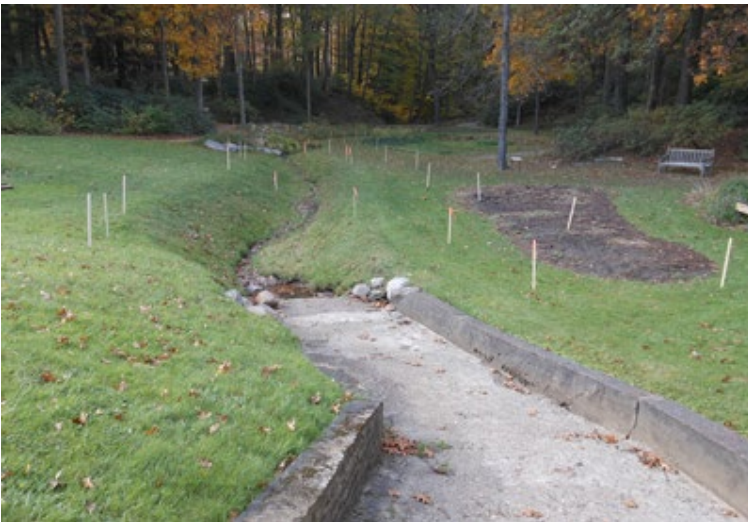
Figure 20: Pre-restoration: Holden Arboretum's headwater stream to Pierson Creek

Holden Arboretum also received funding from Ohio EPA's Section 319 program to restore 350 linear feet of headwater stream that flows from the outlet of Heath Pond and ultimately to Pierson Creek. The stream is in the rhododendron gardens just downstream of Heath Pond. The restoration created 415 linear feet of meandering stream channel with floodplain access and a modified outfall from Heath Pond. This restoration project protects Pierson Creek by reducing streambank erosion, replanting the stream corridor and maintaining cool water temperatures.

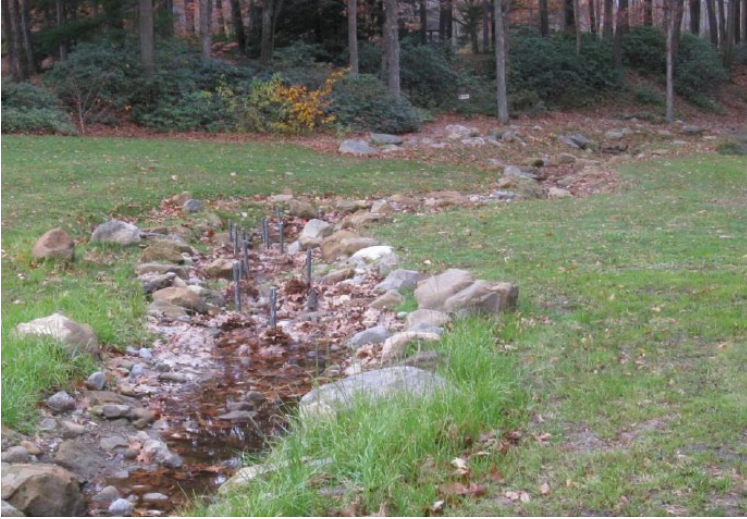
Figure 21: Post-restoration: Holden Arboretum's headwater stream to Pierson Creek

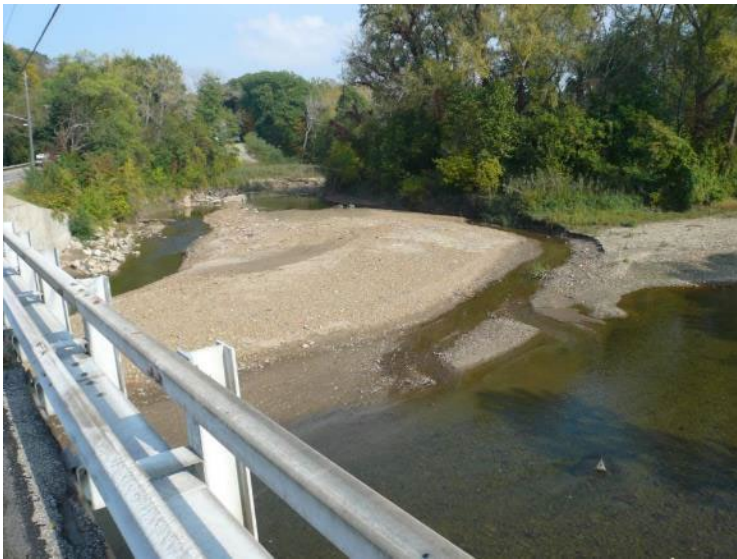
Figure 23: Streambank erosion and material deposition at the confluence of the East Branch with the mainstem of the Chagrin River. (CRWP, July 2013)

The East Branch downstream of RM 2.4 to the mouth has significant streambank erosion along this reach and at the confluence of the East Branch and mainstem of the Chagrin River. For example, in 2009, CRWP observed streambank erosion and a lack of woody riparian vegetation on the East Branch at approximately RM 1.8 at the Kirtland County Club. In 2018, a Rosgen (2001) Bank Erosion Hazard Index (BEHI) assessment near the confluence of the East Branch and the mainstem of the Chagrin River indicated a score of 38 (High) with Very High Near Bank Stress. A QHEI assessment at this location in 2018 indicated a score of 68.5 (“Good” narrative rating), which is below the QHEI target for this HUC-12’s ALU attainment status. Erosion at this location also threatens the full attainment of WWH at downstream locations on the Chagrin River, including at RM 4.95.

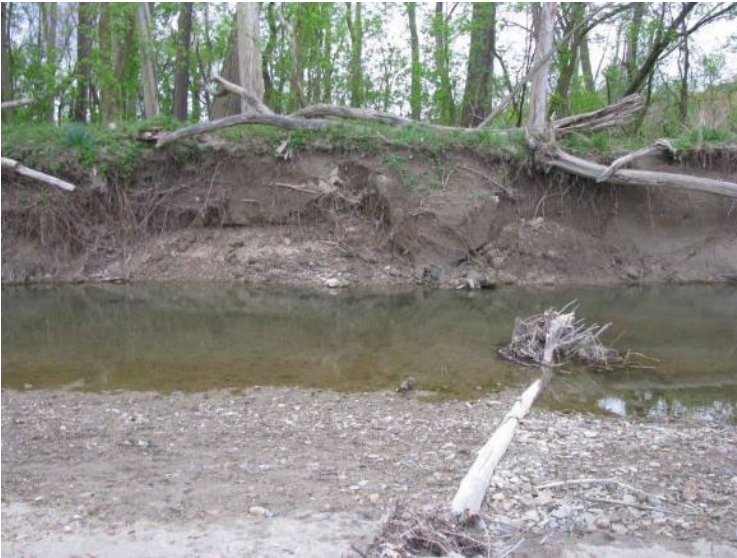
Figure 24: Streambank erosion along the East Branch near its mouth (facing left bank downstream). (City of Willoughby, May 2012)

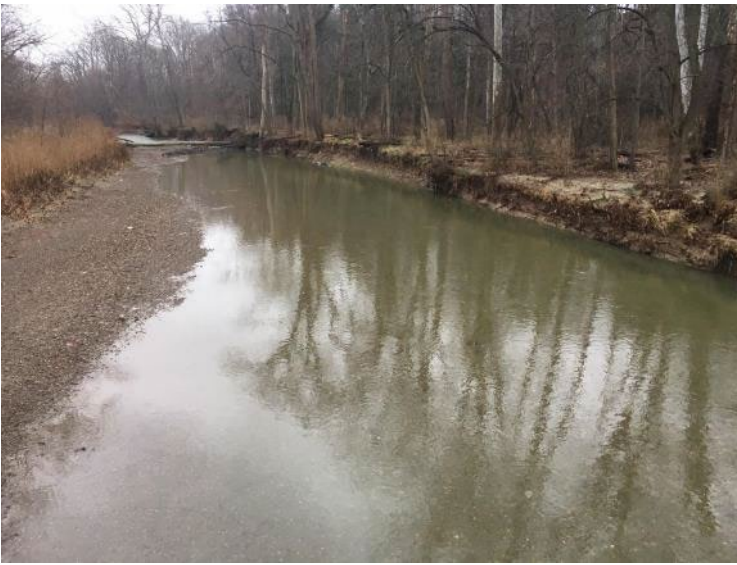
Figure 25: The East Branch at RM 2.4. Erosion is evident on the streambanks. (CRWP, January 2017)

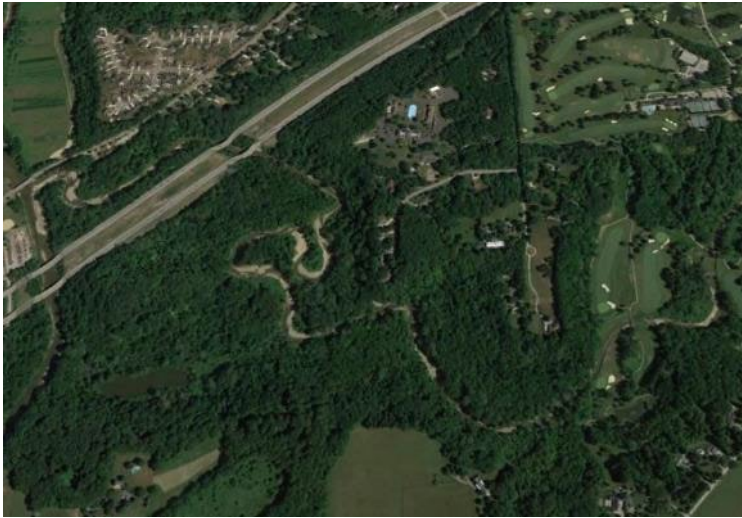
Figure 26: Material deposition due to streambank instability can be observed for lower reaches of the East Branch (showing approximately RM 2.2 on the far right of image to the East Branch mouth on the far left of image). (Google Earth, June 2016)

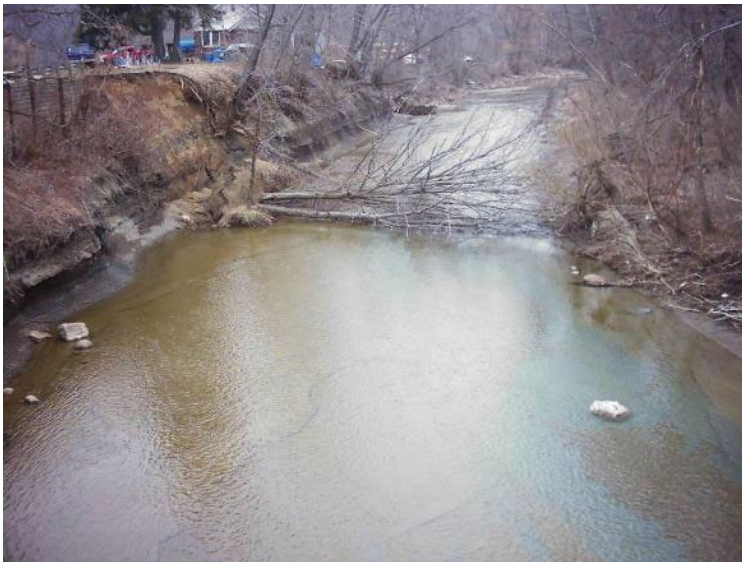
Figure 27: Streambank erosion (left bank downstream) along East Branch RM 3.5 (facing downstream from State Route 615 bridge). (CRWP, March 2009)

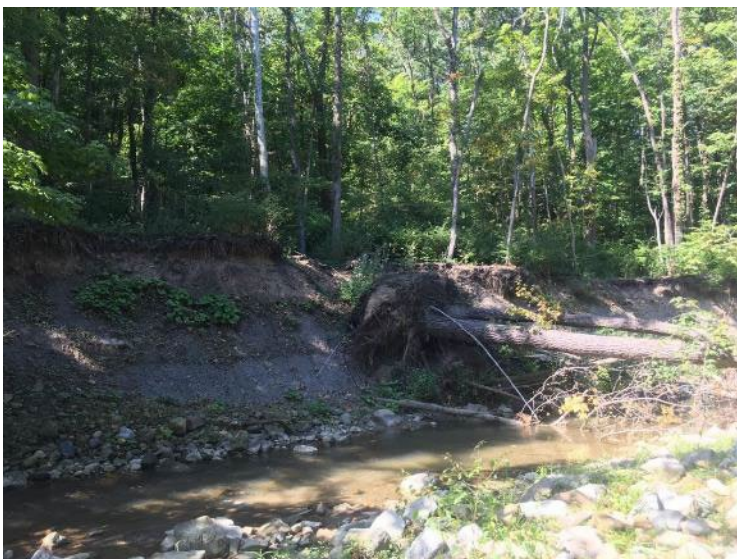
Figure 28: Streambank erosion at approximately East Branch RM 14.7. (CRWP, April 2012)

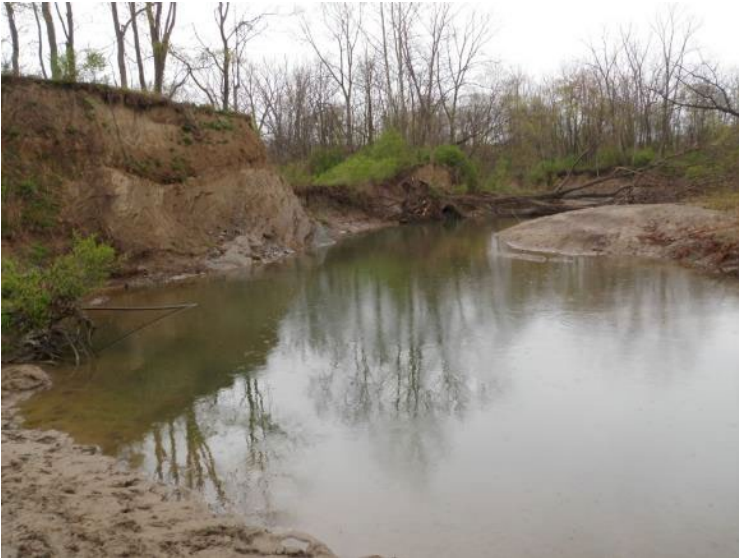
Figure 29: Streambank erosion (left bank shown) on the East Branch at RM 13.2 in the City of Kirtland. (CRWP, September 2016)

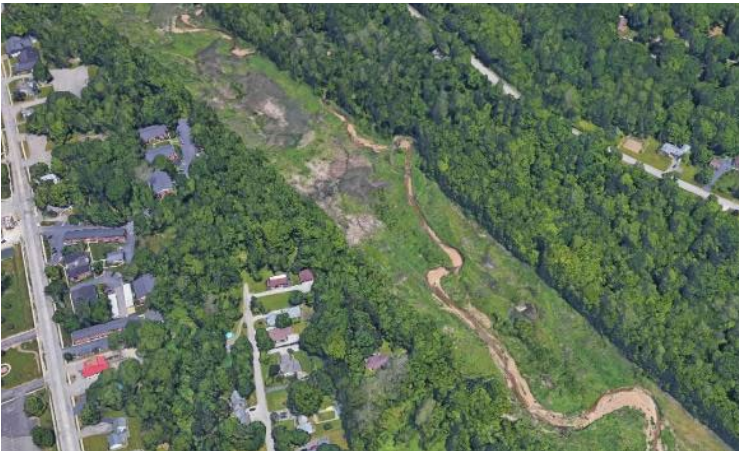
Figure 30: Aerial view of Stoney Brook (approximately RM 0.8) indicating removal of riparian vegetation in a utility corridor (facing north/upstream). (Google Earth, 2016)

Stoney Brook (Trib. To E. Br. Chagrin R. @RM 3.57) is a CWH stream in partial attainment. It flows into the East Branch through mainly private park and into open parkland surrounding the East Branch. Stoney Brook's watershed is protected through riparian setback regulations in the City of Kirtland and large areas of open space protected by Lake County Metroparks. However, the riparian corridor in the area is impacted by removal of vegetation in an adjacent utility corridor (CRWP 2008) and this lack of riparian vegetation has contributed to streambank erosion and slumping. Open canopy conditions have also contributed to a macroinvertebrate community with a high relative density of facultative filtering caddisflies and midges (*Chagrin River TSD 2006, p. 139*).

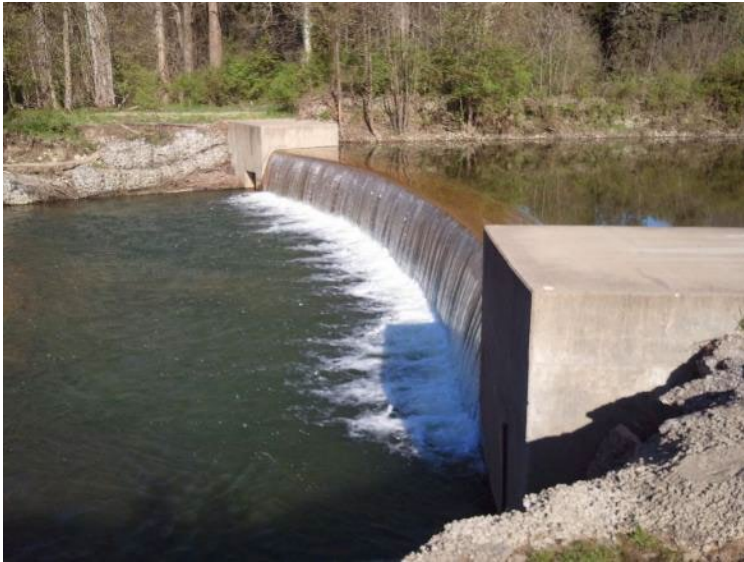
Figure 32: A dam on the East Branch at RM 2.0 (Kirtland Country Club) may impede fish migration across the structure and contribute to nonattainment of the East Branch upstream (RM 2.4). (CRWP, 2011)

Branch upstream (RM 2.4). FWS also noted that the Kirtland Country Club dam is likely not an effective lamprey barrier, however Ohio EPA staff and FWS staff still felt this may be an important structure to maintain as the East Branch of the Chagrin may have good habitat for the invasive lamprey. However, severe erosion has also been observed around the dam abutments, and removal would improve the overall habitat and water quality of this reach of the East Branch. Therefore, the removal of Kirtland Country Club Dam should be explored as a future project for this critical area. Kirtland Country Club, in conversations with CRWP, has indicated a willingness to consider work on a removal project in conjunction with grant funding and may be able to contribute the project with a budgeted cash match. Coordination with Ohio EPA and FWS on project review and approval prior to any implementation would be critical.

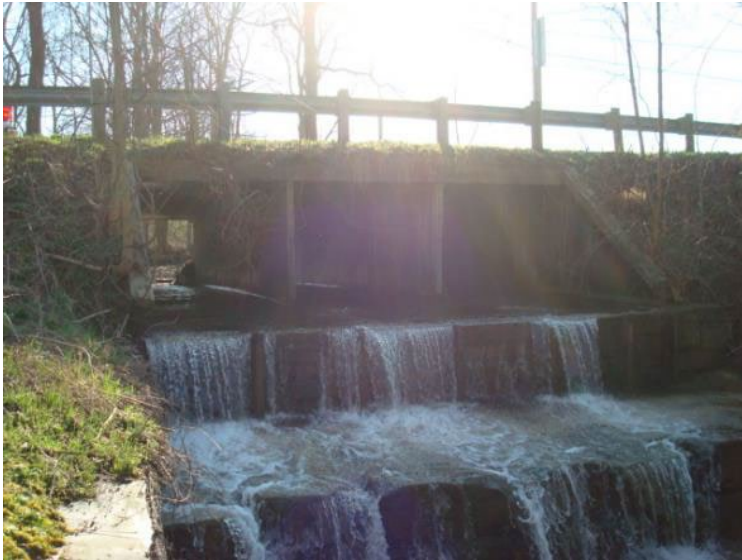
Figure 33: The Heath Road bridge over Harris Creek is a fish migration barrier to upper reaches of this tributary.

Harris Creek (tributary to the East Branch at RM 14.62) is in partial attainment of its CWH ALU designation at RM 0.1. Sampling by the Ohio EPA in 2003 – 2004 indicated an exceptional macroinvertebrate community including eight coldwater taxa. However, habitat alteration was causing an impairment in fish community; nonpoint sources of impairment included bridge construction (fish barrier). A timber box structure forms step waterfalls and a plunge pool downstream of the Heath Road bridge, creating a vertical drop that inhibits coldwater fish recolonization and salamander migration to reaches upstream of this structure. Removal of this fish barrier by modifying the structure under the bridge will result in improved fish diversity at this site (*Chagrin River TSD 2006*, p. 28, 138).

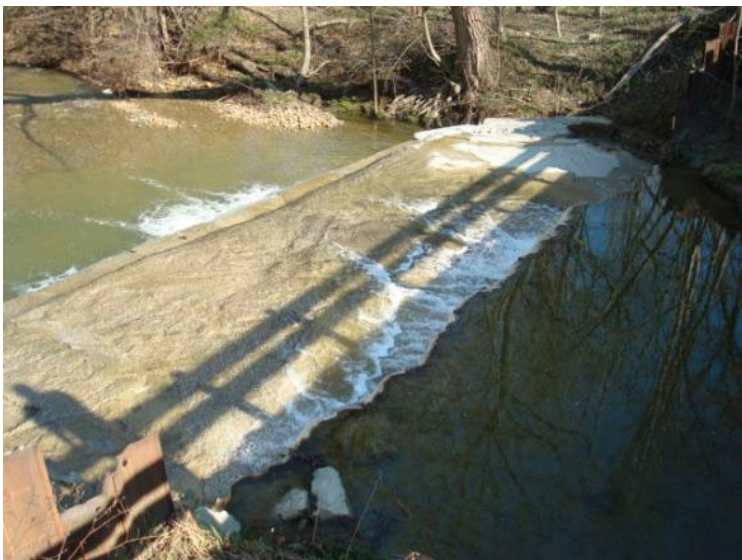
Figure 34: The Sperry Road bridge and associated silt trap are barrier to fish migration on an unnamed tributary to the East Branch (tributary enters the East Branch at RM 14.80).

An unnamed tributary to the East Branch at RM 14.80 is in partial attainment of its CWH ALU designation at RM 0.1. This stream indicated a marginally exceptional fish community and six coldwater macroinvertebrate taxa during Ohio EPA sampling in 2003 – 2004. Southern redbelly dace, a declining fish species that prefers low turbidity, was noted in this stream. The Sperry Road bridge crossing and associated silt trap, installed in the mid-1990s, have been indicated as the source of fish community impairment at this site. Modification of this structure is recommended to allow fish migration to upstream reaches and improve attainment status (*Chagrin River TSD* 2006, p. 29; WAP 2011, p. 78).

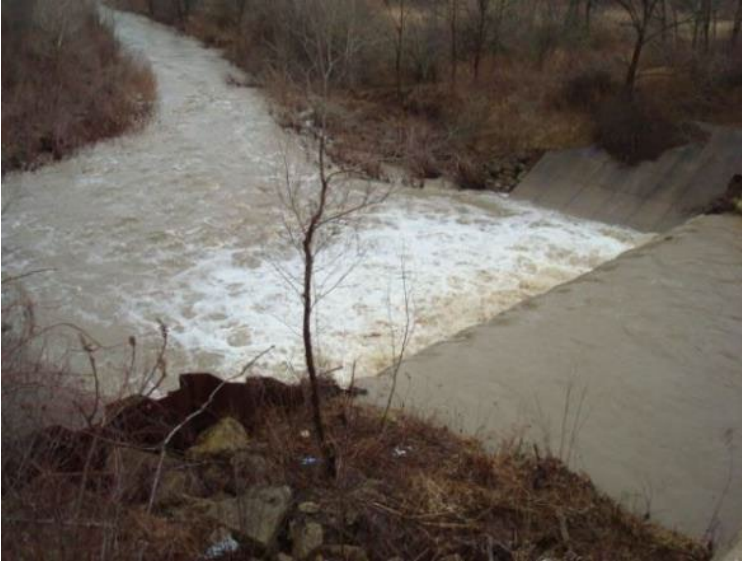
Figure 35: Sheet pile dam and concrete dam is a fish barrier on the East Branch at RM 15.1

The East Branch at RM 15.1 is affected by a structure downstream of Mulberry Road. As observed during a CRWP landowner visit in 2012, a steel sheet pile dam with a smaller concrete dam below it is a barrier to fish migration at this site.

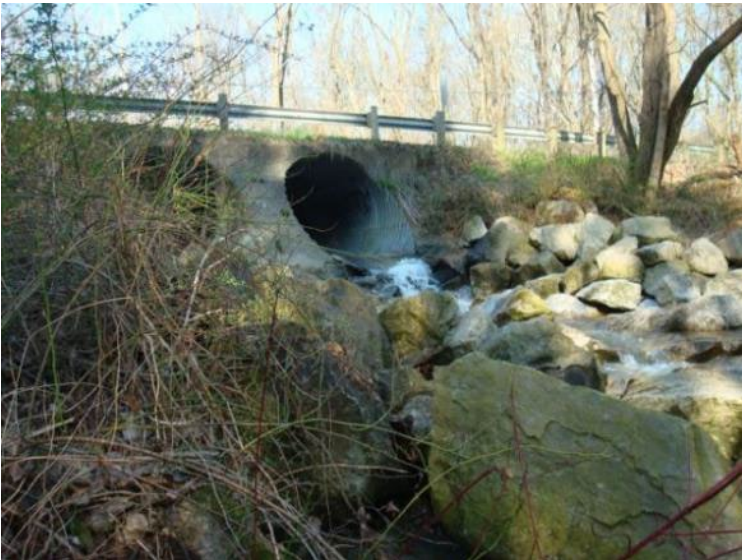
Figure 36: Unnamed tributary to East Branch at RM 15.35 is impaired by a perched culvert that acts as a fish barrier.

An unnamed tributary to East Branch at RM 15.35 is in partial/full attainment of its CWH/EWH designation. Sampling by Ohio EPA in 2003 – 2004 indicated the causes of impairment at this site as habitat alteration, flow alteration, and sedimentation. Nonpoint sources of impairment included a bridge on Sperry Road with a perched culvert that acts as a barrier to fish migration to upstream portions of this stream. Rip-rap was added to this structure in 2006 – 2007.

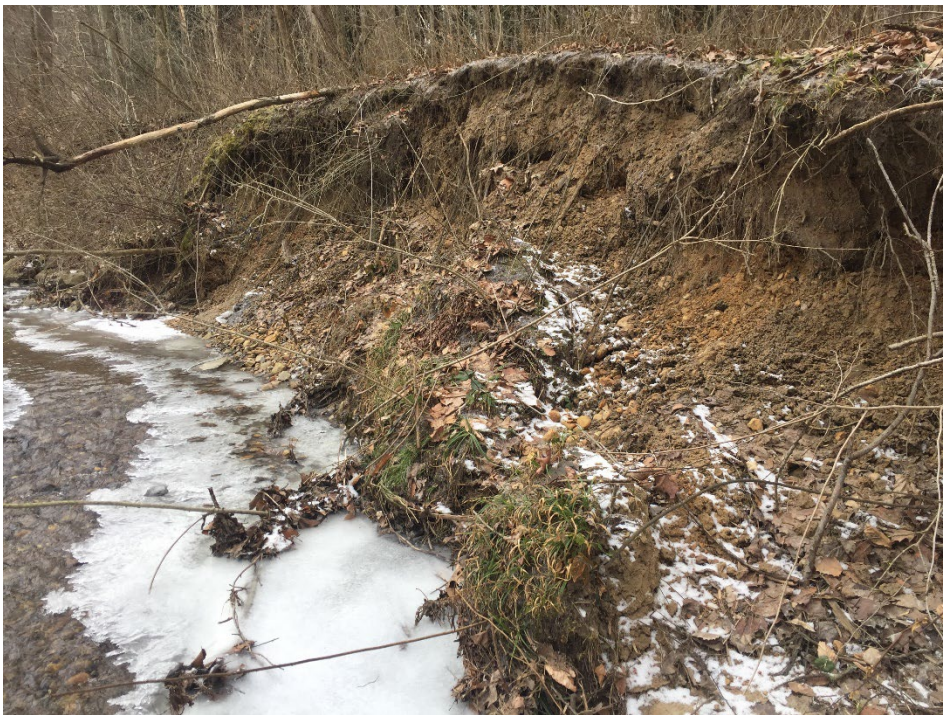
Figure 37: Streambank erosion and siltation on Sunnybrook, a tributary to the East Branch.

Sunnybrook (tributary that drains to the East Branch at RM 16.0 and located at Geauga Park District's Sunnybrook Preserve) is exhibiting streambank erosion and siltation due to the effects of damming in the early 20th century. Although the dam has breached, its remnants are still impacting habitat conditions. Sampling of Sunnybrook in 2006 by Geauga Park District indicated good reproducing populations of coldwater species such as redbreast dace (*Clinostomus elongatus*) (Pira 2007). Additional sites impaired by riparian vegetation removal and streambank erosion have also been identified by CRWP through landowner site visits, project scoping with member communities, and other field assessments.
