**Nine-Element Nonpoint Source
Implementation Strategic Plan
(NPS-IS plan)
Olentangy Watershed
Headwaters Olentangy River HUC-12
[05060001 08 01]**

Version 1.0 June, 2021)

**Crawford Soil & Water
Conservation District
3111 State Route 98
Bucyrus, OH 44820**

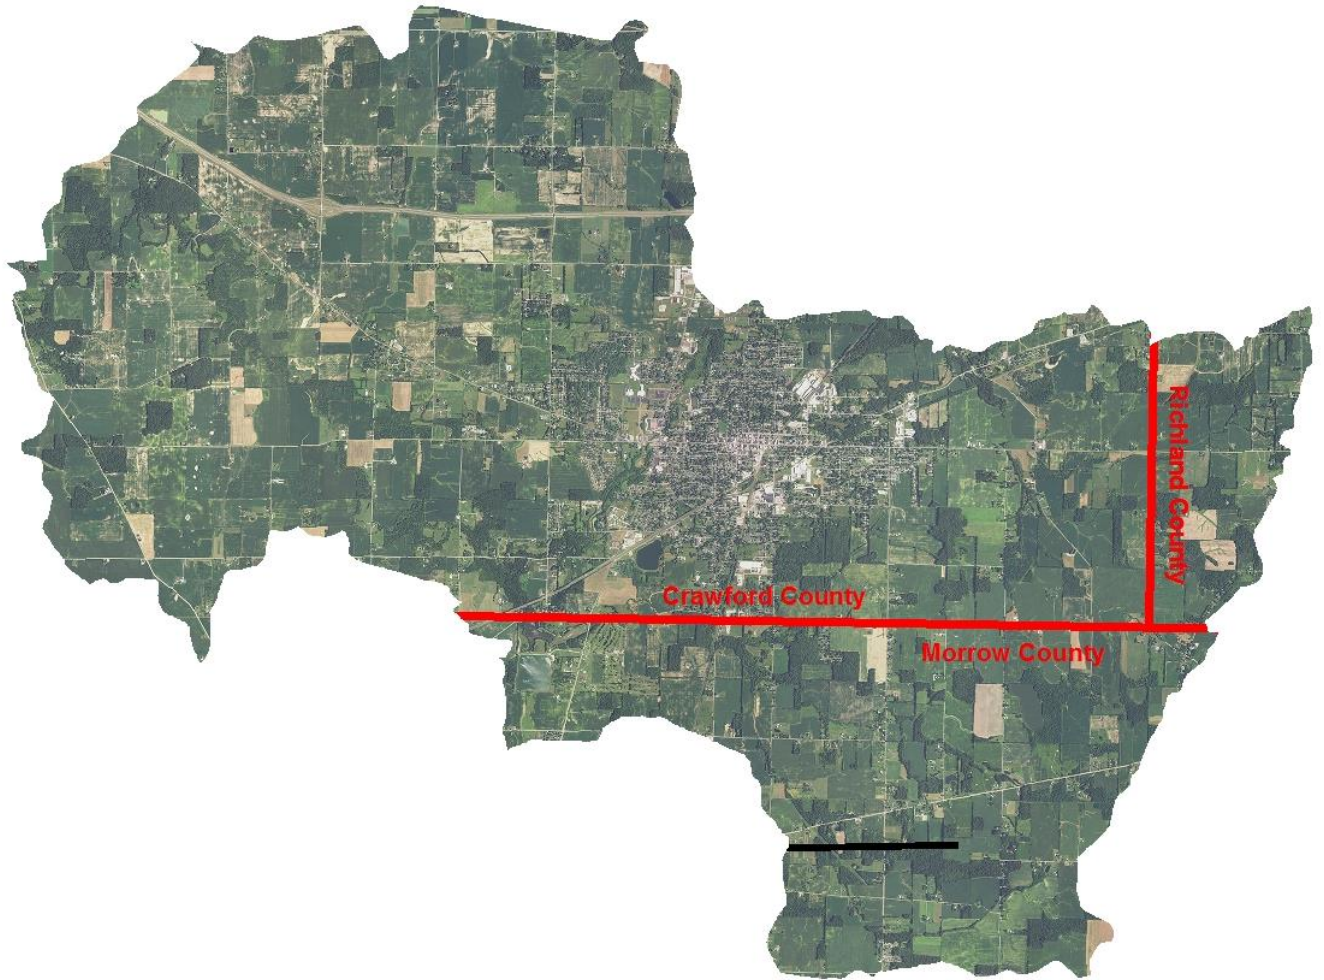
Figure 3: (Not to scale) Map shows the watershed split between Crawford, Morrow, and Richland Counties.

There are 22,546 acres in the Headwaters Olentangy Watershed in Crawford County. 1,707 in Richland, and 7,465 in Morrow County. The average topographical grade is 0-2% slopes. The predominant soils are Bennington-Condit, Wadsworth-Condit, and Rittman-Bennington soils. These soils were formed in mainly glacial till on uplands. They are nearly level or gently sloping, with somewhat poorly to very poorly drained soils. (USDA SCS, 1979 & 1993). “These [steep shale] banks are often dissected by ravines which cut through and expose the underlying rock strata including the Ohio black shale, noted for its presence of large “ironstone” concretions.” (ODNR, 2018)

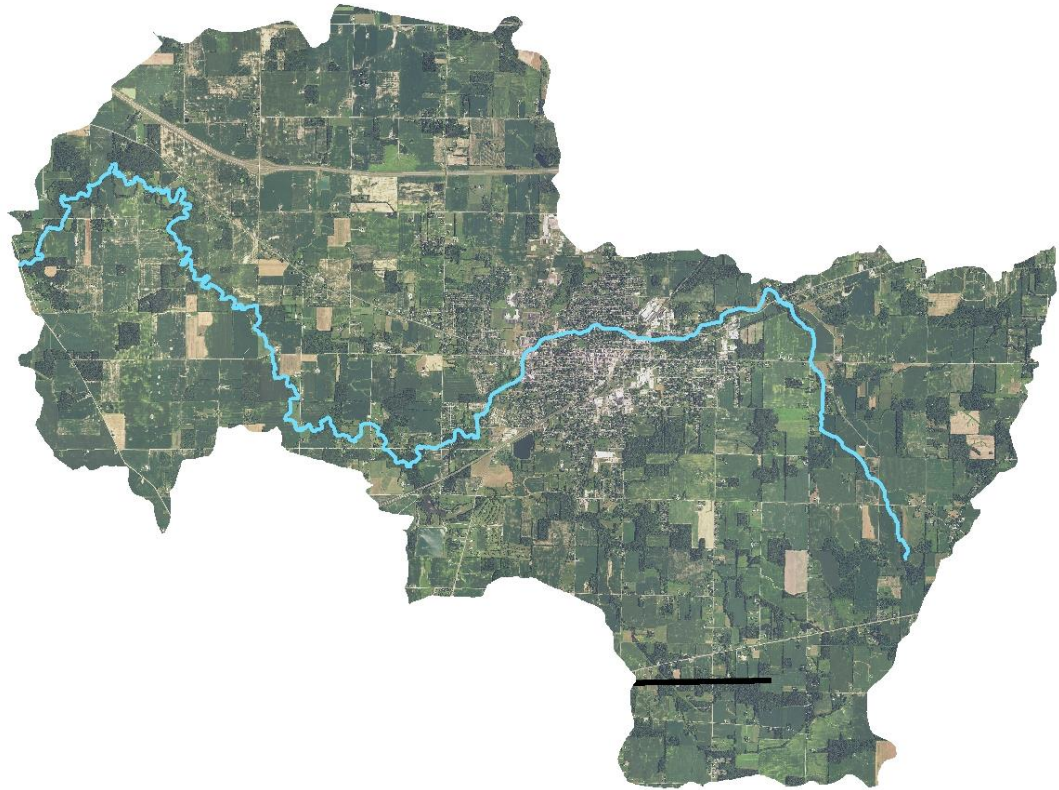
Figure 4: Map shows the flow of the Olentangy River starting on the east end of the watershed and travelling west. The length of the Olentangy main-stem within this HUC-12 is approximately 21.8 miles.

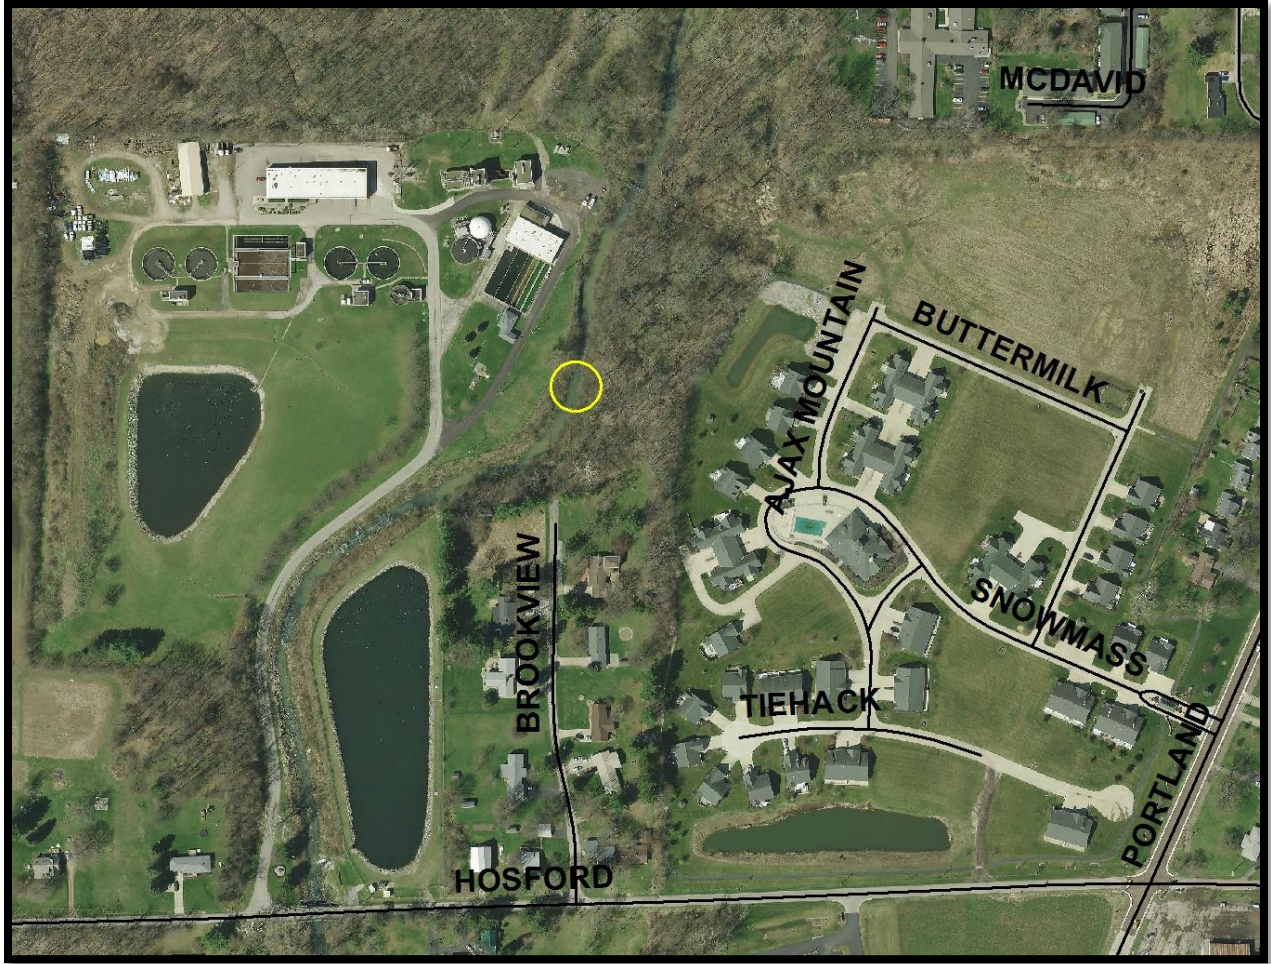
Figure 12: (Not to scale) RM 85.9 at WWTP which is non-attainment status according to the OEPA.

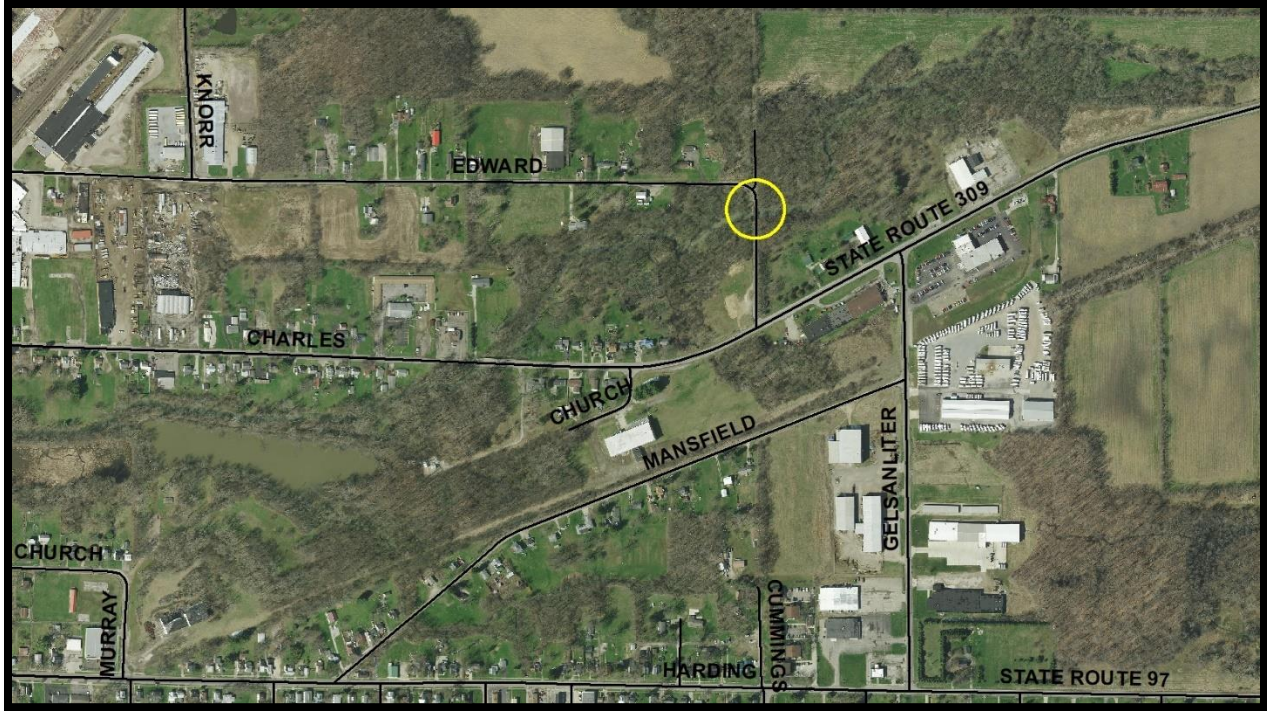
Figure 14: (Not to scale) RM 89.3 at Edward Street in Galion is currently listed as full attainment.

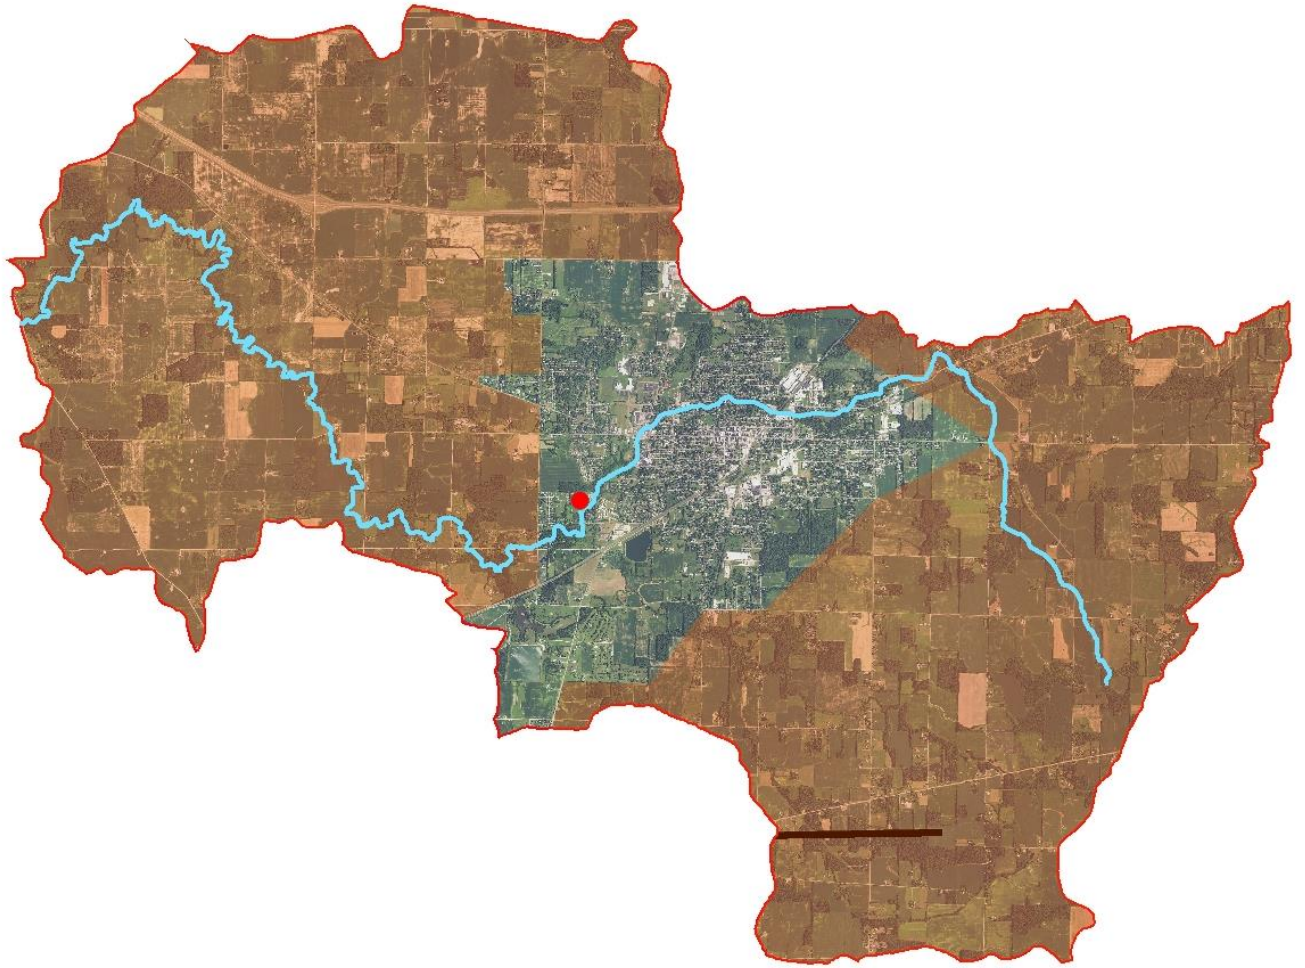
Figure 16: (Not to scale) Map details the area for Critical Area 1 “Prioritized row-crop agriculture lands” (shaded area) which is further explained in section 3.2.1. (Crawford SWCD, 2018) The WWTP is denoted with a red circle. The Olentangy River is lined in light blue.

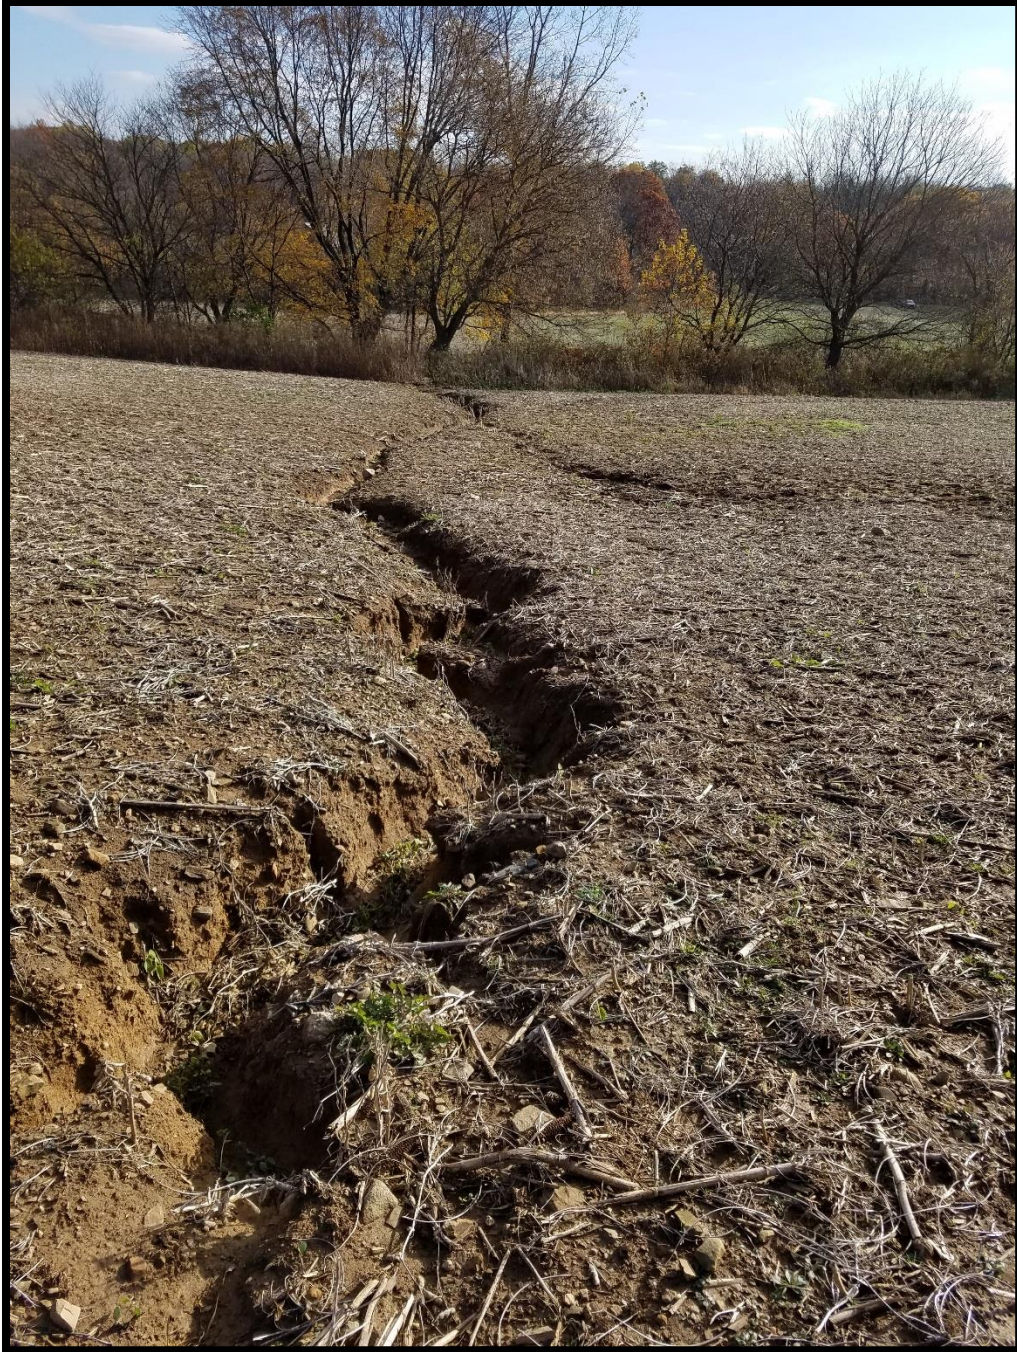
Figure 18: Photo shows common gullies found pinched between two slopes. These can lead to direct losses of sediment and nutrients to waters of the state.

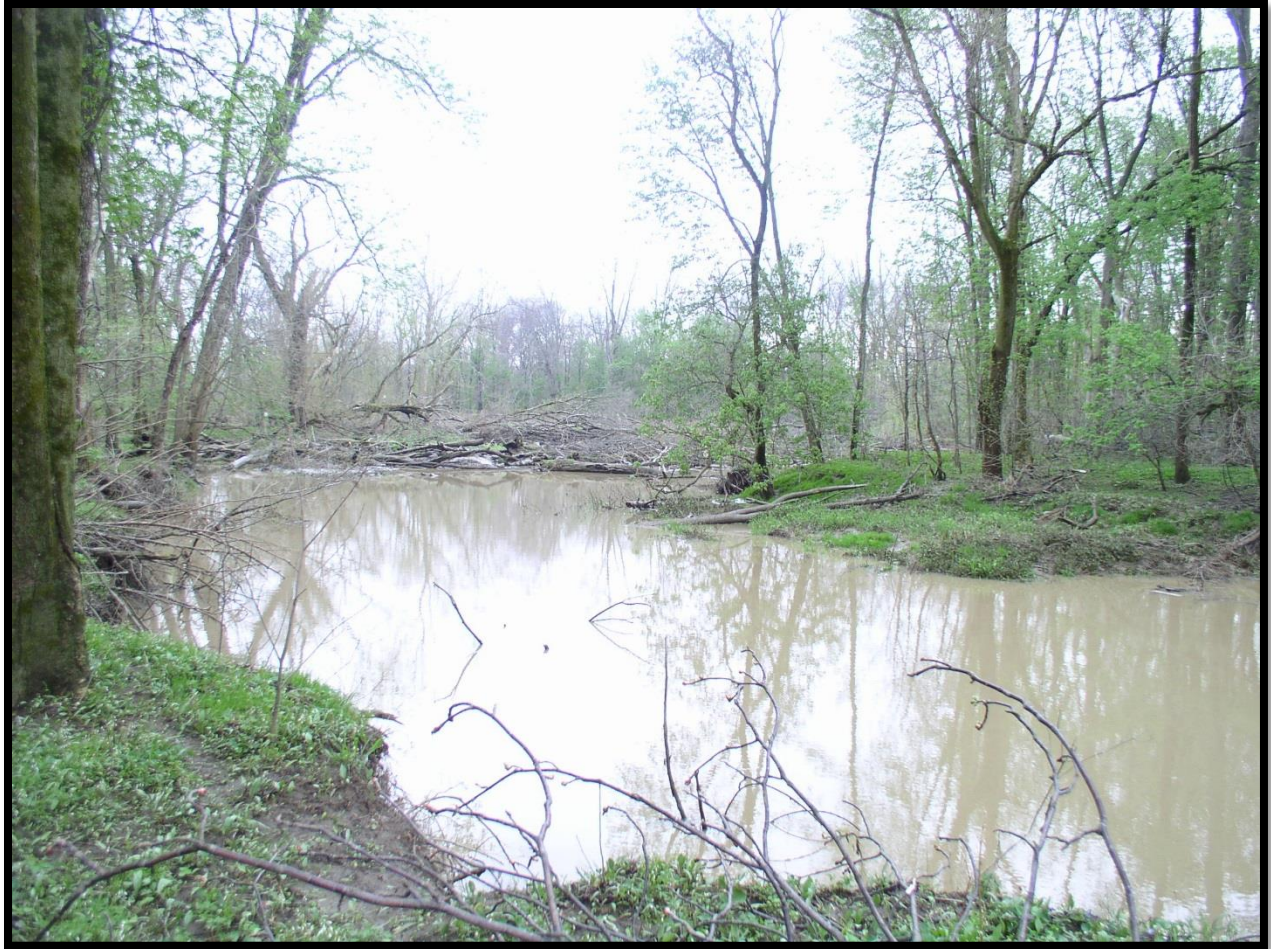
Figure 19: Photo shows a log jam in the flooded Olentangy River. Flash flooding is occurring more often and many of the ditches and parts of the Olentangy River do not have a functioning floodplain to help manage for the increase in water and sediments. Increased floods due to reduction in flow by log jams further increase sedimentation and nutrient loads through bank erosion, and flooding of adjacent farm fields.

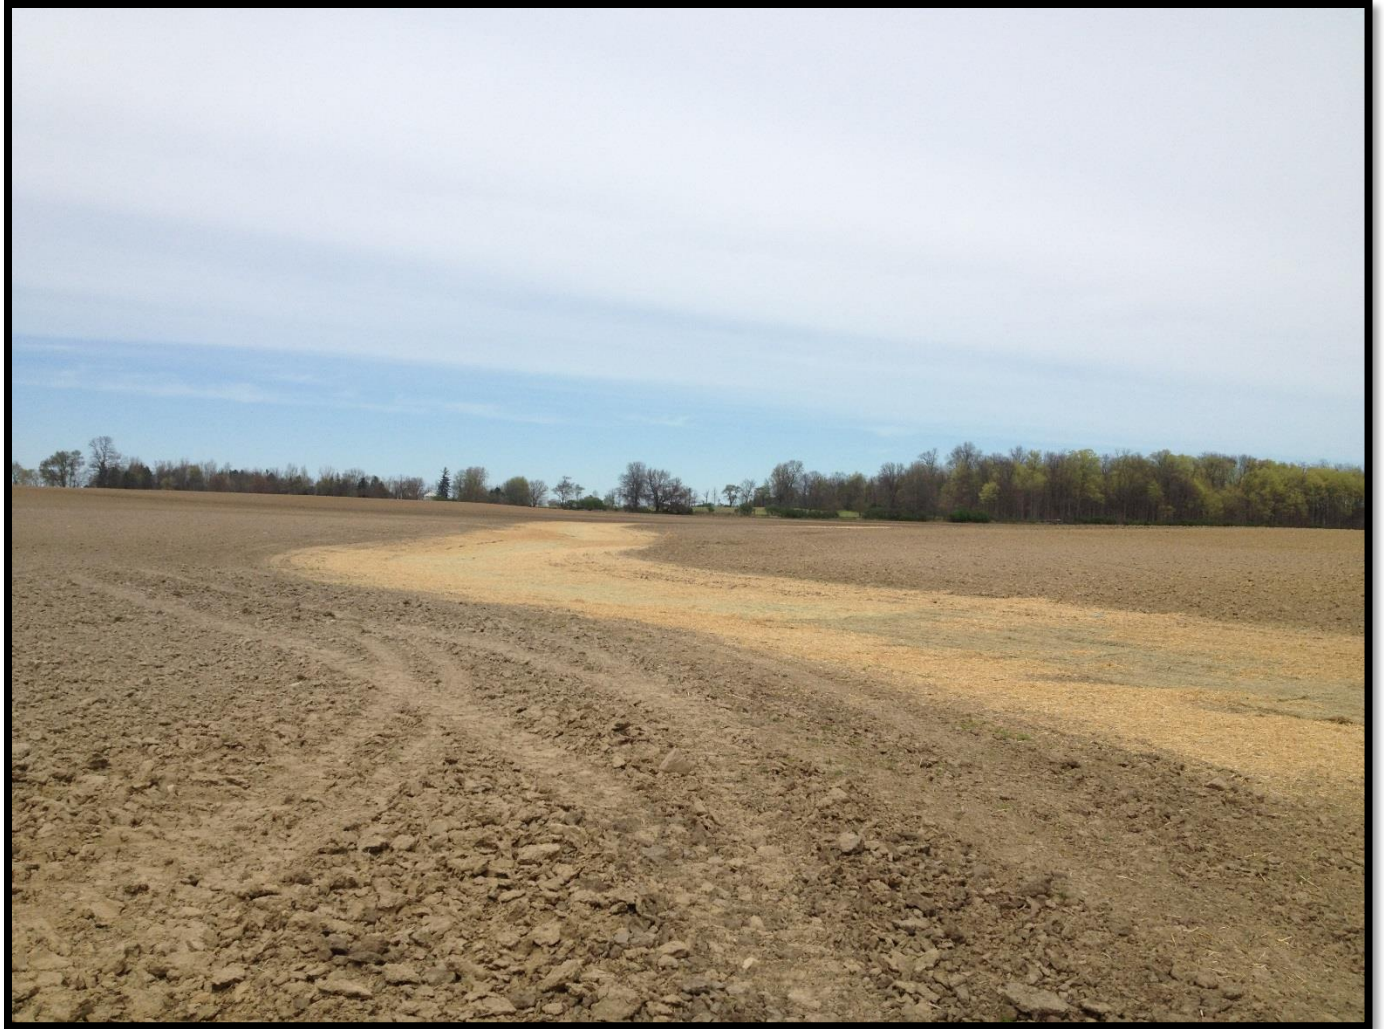
Figure 20: A recently constructed waterway in a tilled field. Where one resource concern was addressed there is now the concern for sediment to directly go into the waterway due to farming practices. Therefore, stressing the need for BMP's to solve resource concerns.

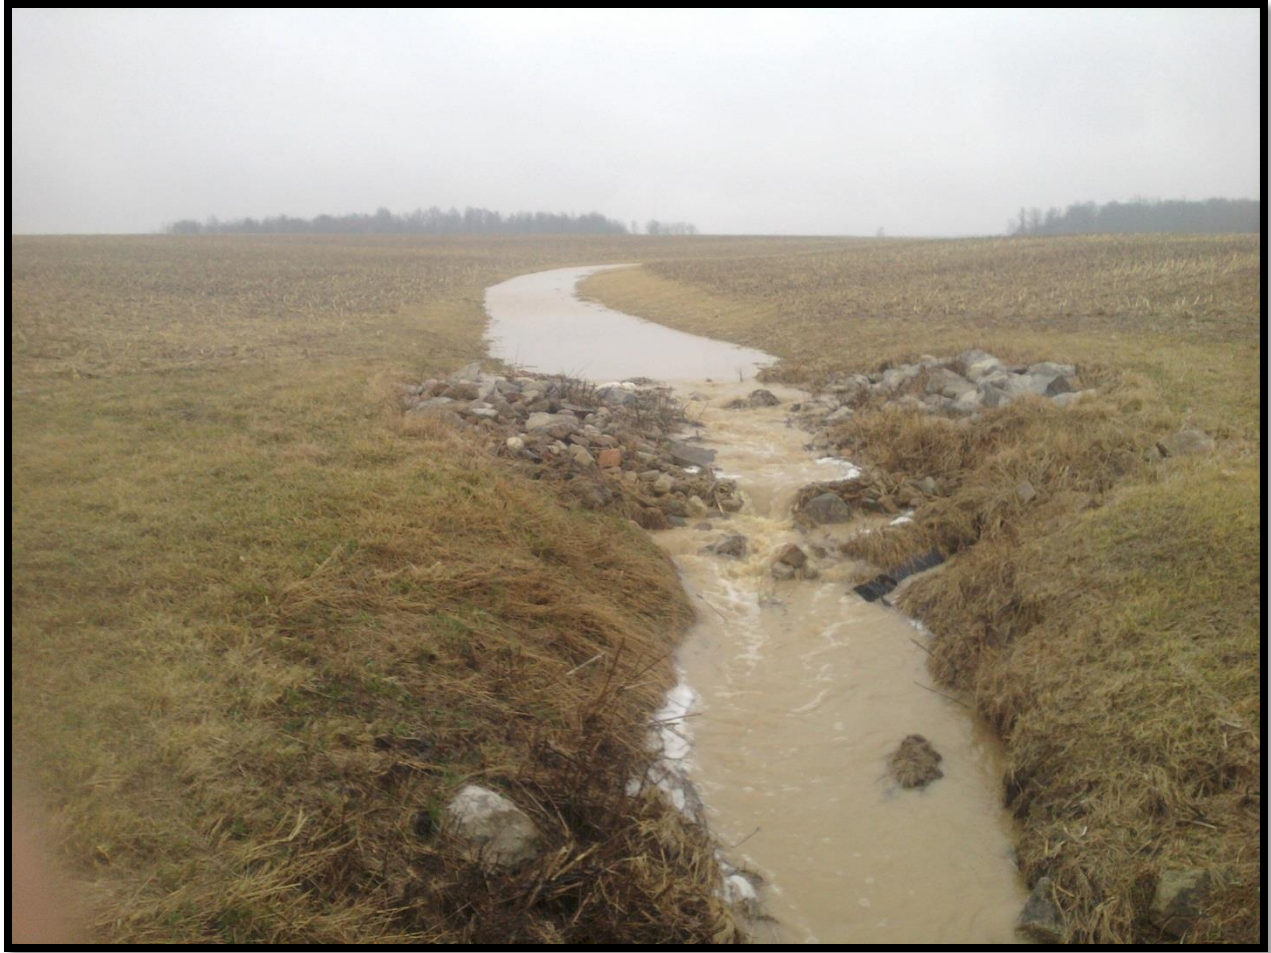
Figure 21: Runoff waters containing sediment and nutrients are the highest contributor of NPS loads (i.e., volume X concentration) annually. Implementing a variety of BMP's could improve the water quality and reduce the nutrient load before it reaches waters of the state.

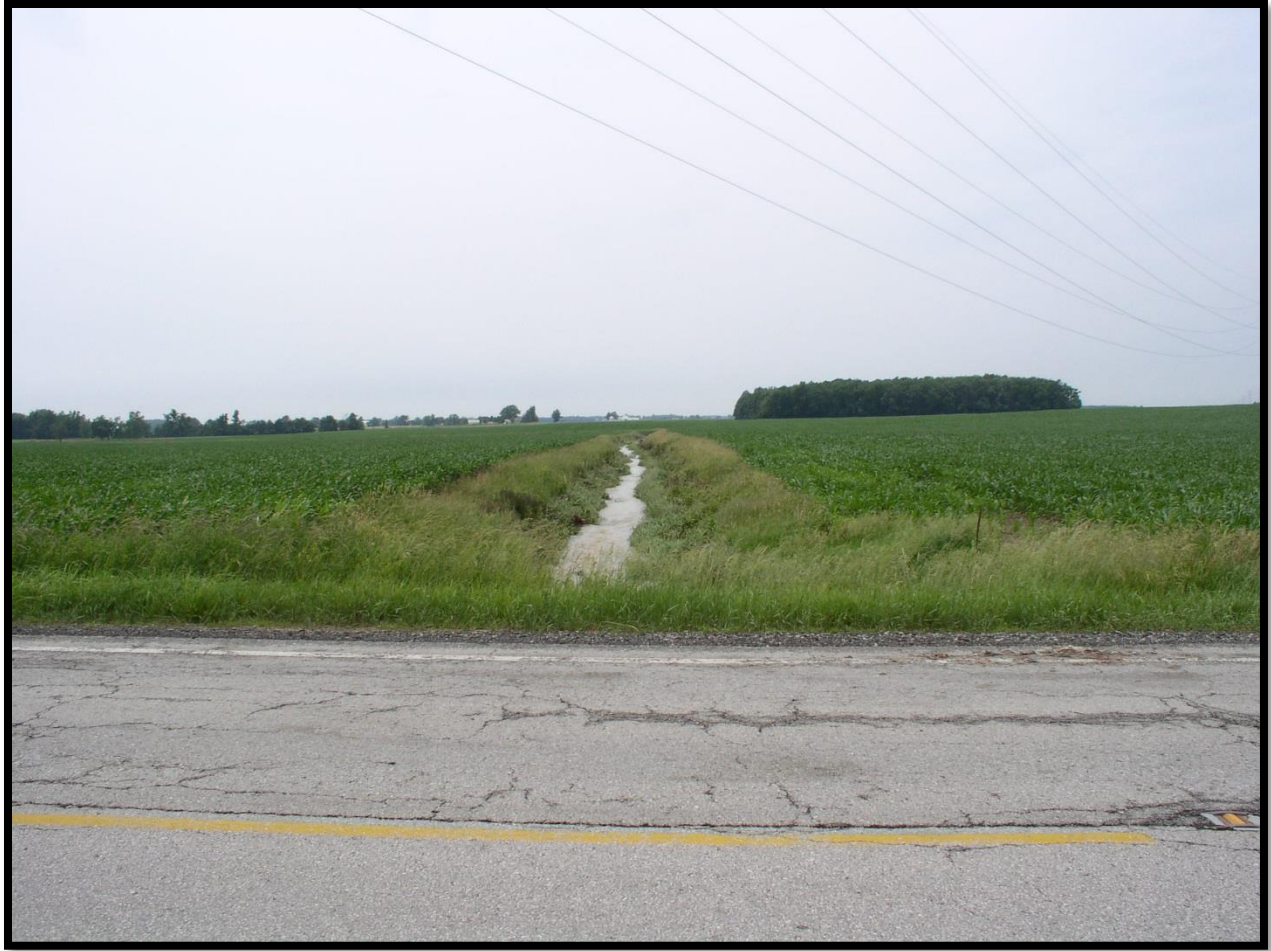
Figure 22: A drainage ditch with the crop field being farmed close to the edge of the bank. Adding buffers along the drainage ditch helps reduce nutrients and sediments that would have the potential to runoff directly into the ditch without being filtered.

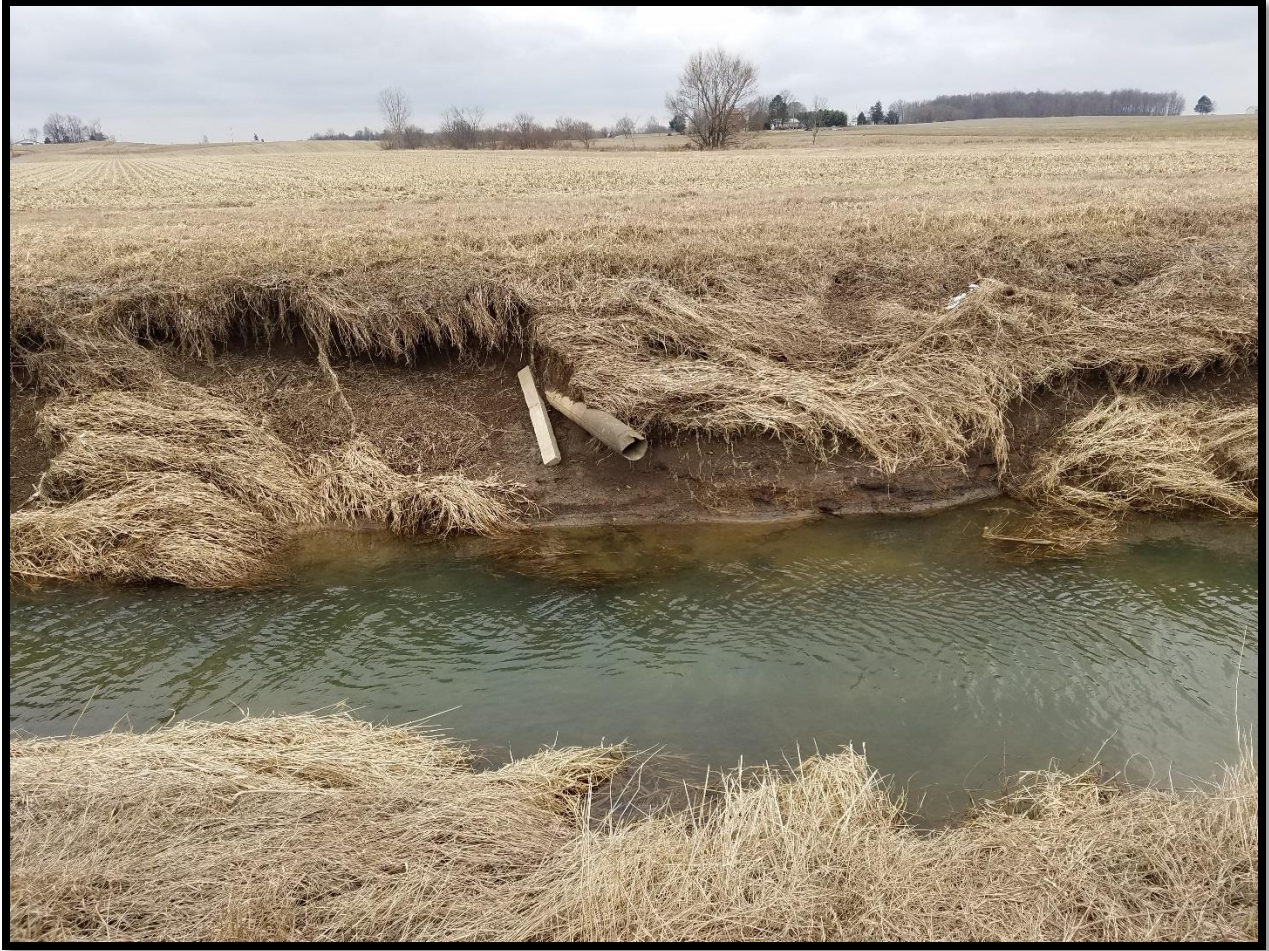
Figure 23: Severe ditch bank erosion along an intermittent stream in Crawford County. Erosion as severe as this can be a safety hazard and is a source of sedimentation in downstream reaches, and a possible nutrient runoff site from adjacent crop fields.

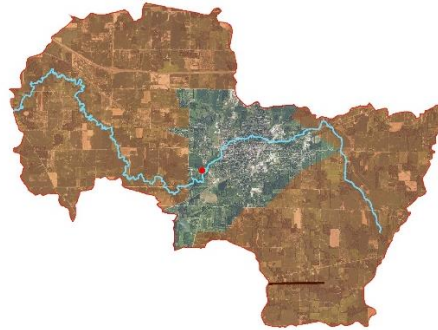
Figure 24: (Not to scale) Highlighted in orange is Critical Area 1 – “Prioritized row-crop agriculture lands”

There are approximately 25,354 acres in this critical area focusing on the Headwaters Olentangy HUC-12. Strategic placement of riparian buffer and conservation farming practices will help distribute, slow down, and filter runoff from fields. Having a minimum setback of 30’ per side from farming practices and converting to filter strip, wildlife corridor, tree planting, or other riparian practice could vastly reduce the sedimentation/siltation impacts and create a wildlife habitat in an established riparian corridor.

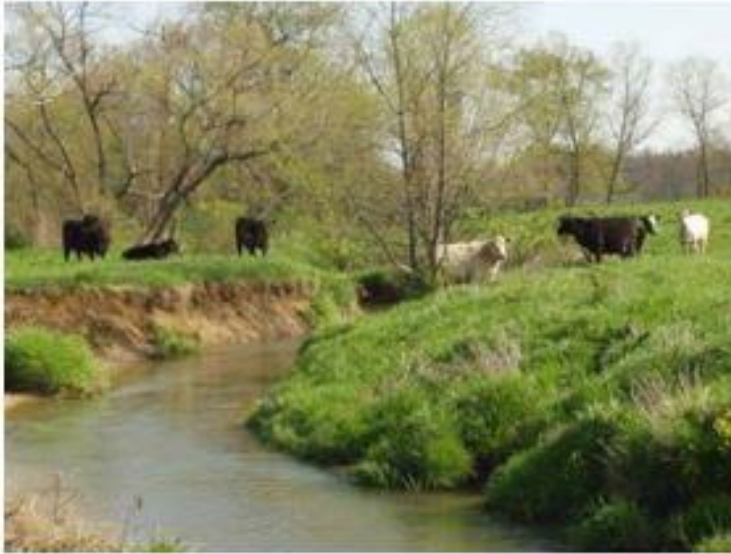
Restricting livestock access to streams and waterways is an extremely effective and relatively simple solution to reducing sediment and nutrient losses. This photo shows the wear that cattle accessing the stream have caused.

Figure 27: Photo from the Nonpoint source Management Plan Update explaining the benefits of livestock exclusion fencing along the stream. Photo was not taken in this watershed. (OEPA, 2013) “Livestock with stream access are found along the Olentangy River mainstem at Taylor Road, Iberia Road, Galion New Winchester Road, and Crawford Marion Line Road.” (OEPA, 2007) These locations are in both of the critical areas.

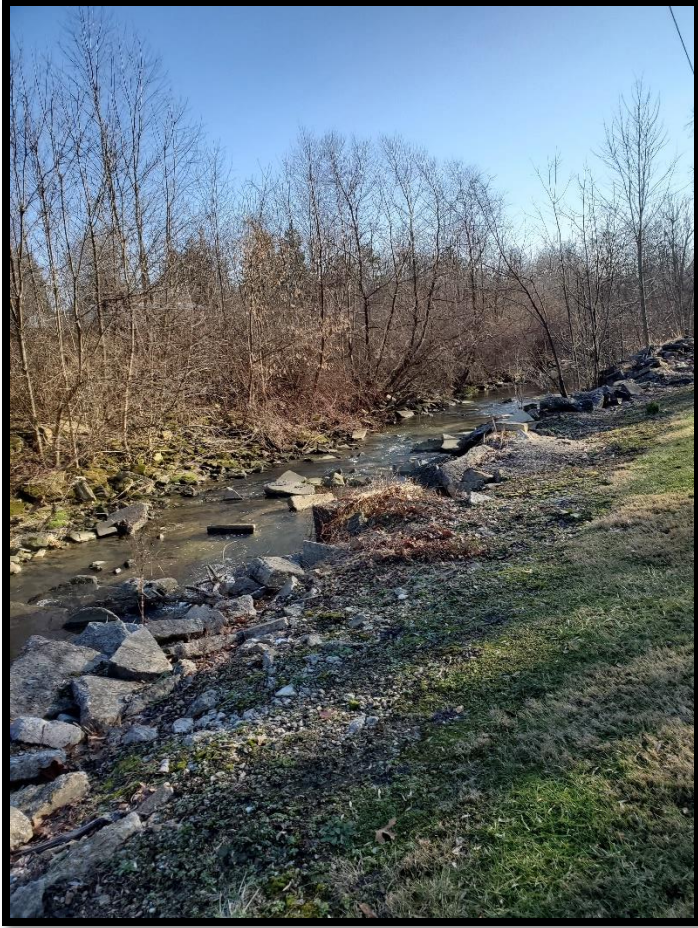
Figure 28: Shows the Olentangy River just south of the WWTP at Hosford Rd.

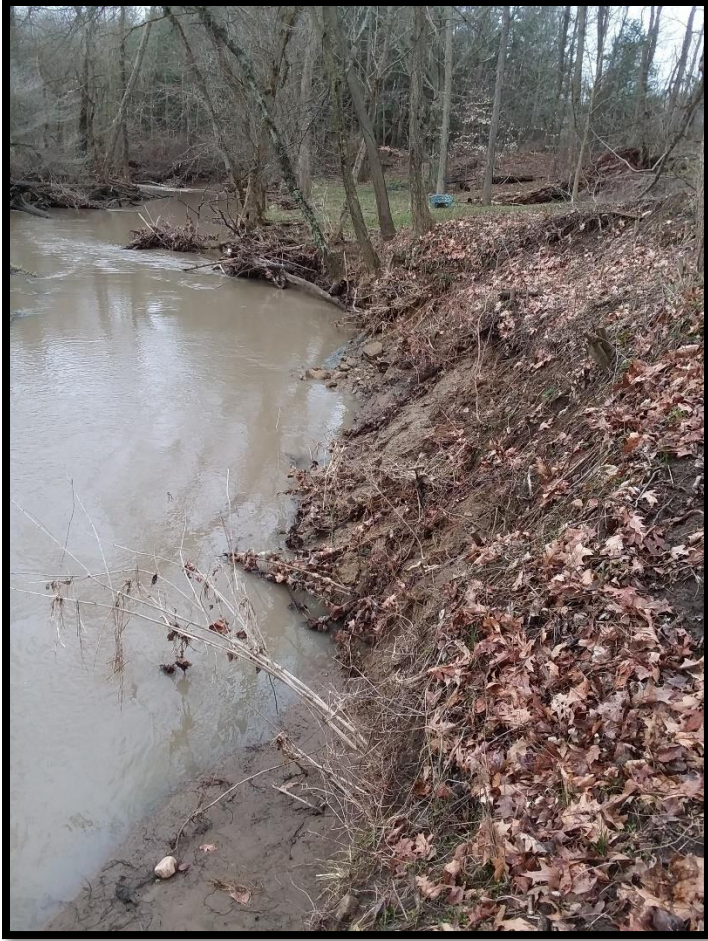
Figure 29: Common streambank erosion that can be found along the Olentangy River.

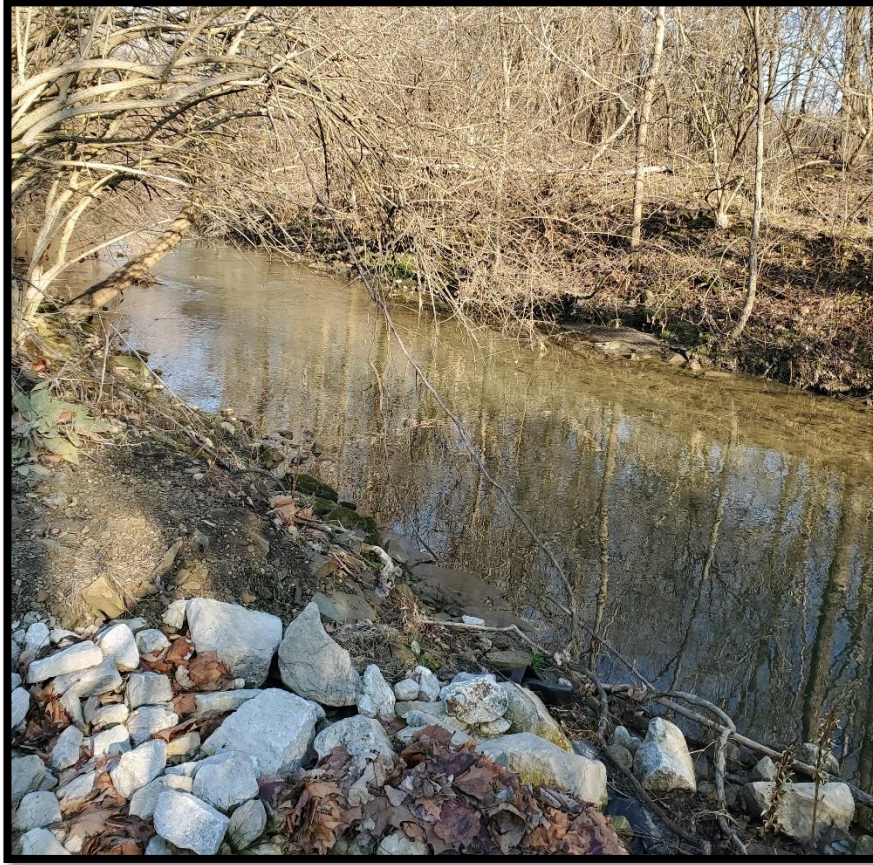
Figure 30: Shows the Olentangy Riverbank north of the WWTP.
