Nine-Element Nonpoint Source Implementation Strategy (NPS-IS) for North Turkeyfoot Creek HUC-12 (04100009 04 02)

Prepared for:
Fulton Soil and Water Conservation District

Prepared by:
Civil & Environmental Consultants, Inc.
Toledo, Ohio

Version 1.0 Approved: August 10, 2022

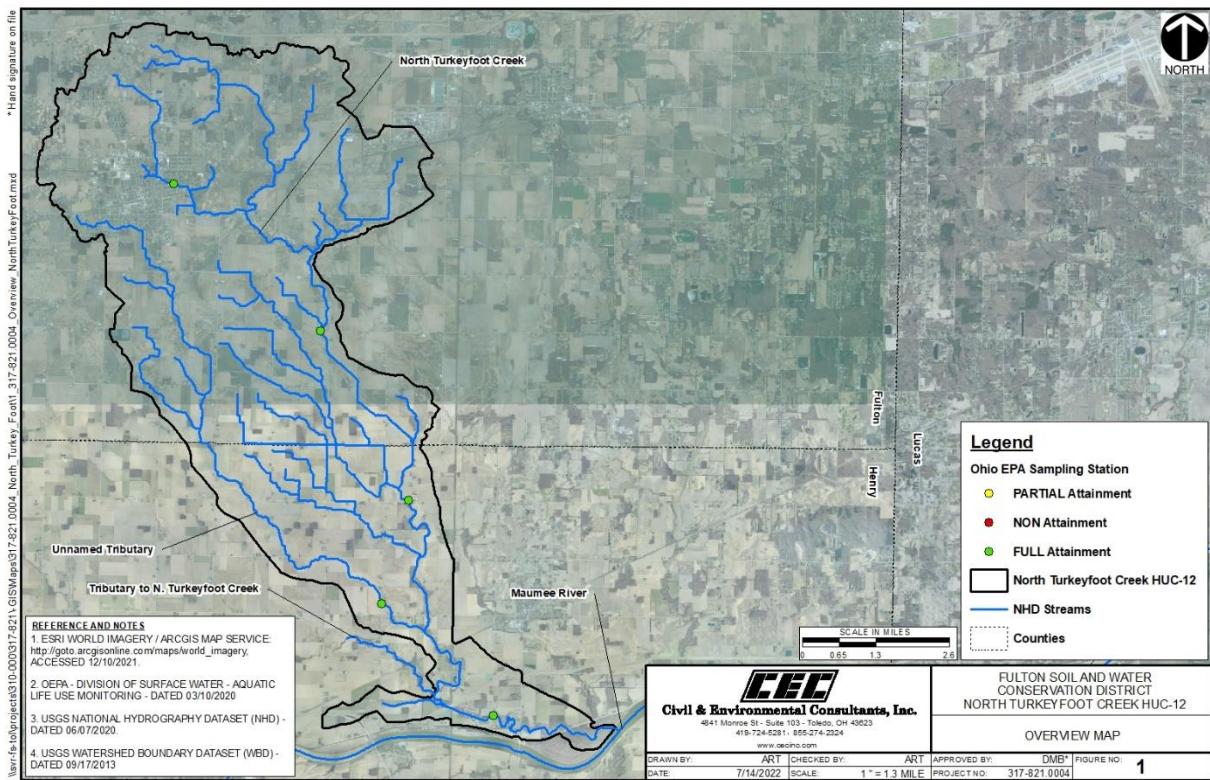
Figure 1: North Turkeyfoot Creek HUC-12 Overview

The **North Turkeyfoot Creek Hydrologic Unit Code (HUC-12 (04100009 04 02)** is located in southcentral Fulton County and northcentral Henry County, Ohio. It contains a watershed of 50.01 square miles (Figure 1). The **North Turkeyfoot Creek HUC-12** contains the entirety of North Turkeyfoot Creek, a direct tributary to the Maumee River, which begins north of Wauseon in Fulton County. The watershed is primarily rural, and the dominant land use is cultivated cropland (~82%). The **North Turkeyfoot Creek HUC-12** lies within the Western Lake Erie Basin (WLEB) watershed, which currently is the focus of state funding for nutrient reduction efforts due to the estimated loadings of total phosphorus and dissolved reactive (soluble) phosphorus that flows into the tributaries of the Maumee River and eventually, Lake Erie.

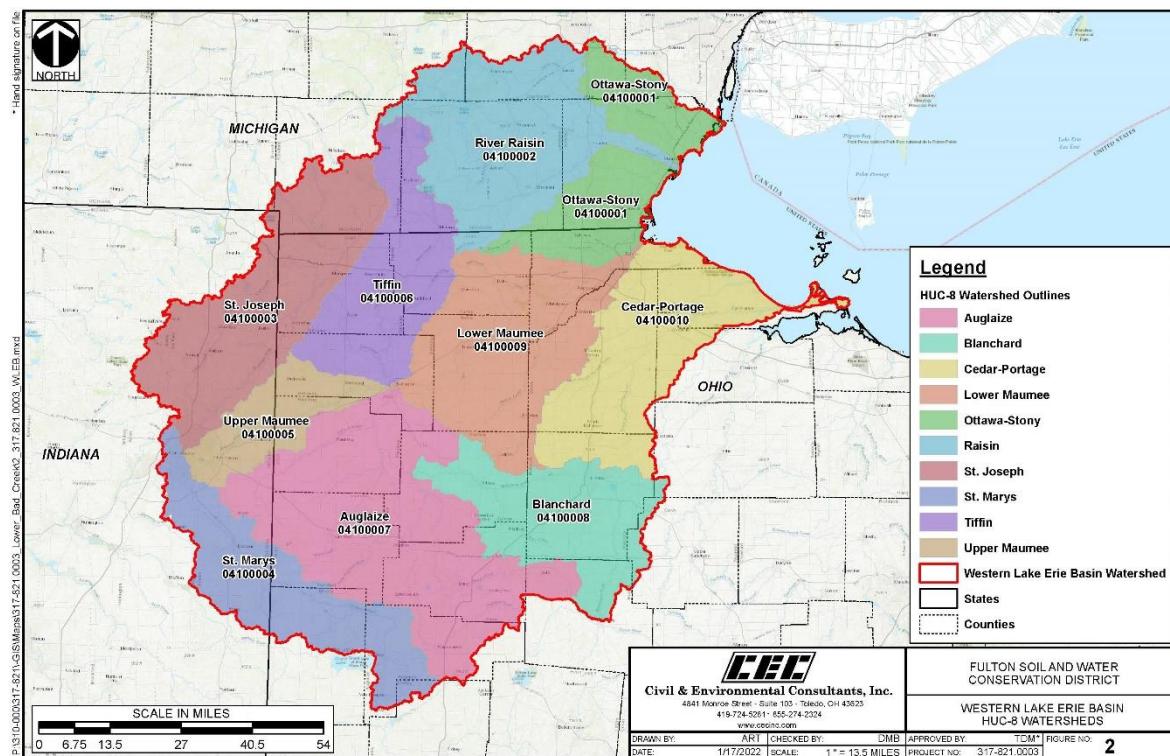
Figure 2: Western Lake Erie Basin Watershed

The WLEB is composed of approximately 7,000,000 acres across the tri-state area of Ohio, Indiana and Michigan (Figure 2). The largest direct tributary to the WLEB is the Maumee River, flowing 137 miles through 18 counties in Indiana and Ohio. The WLEB watershed is broken into several sub-basins at the

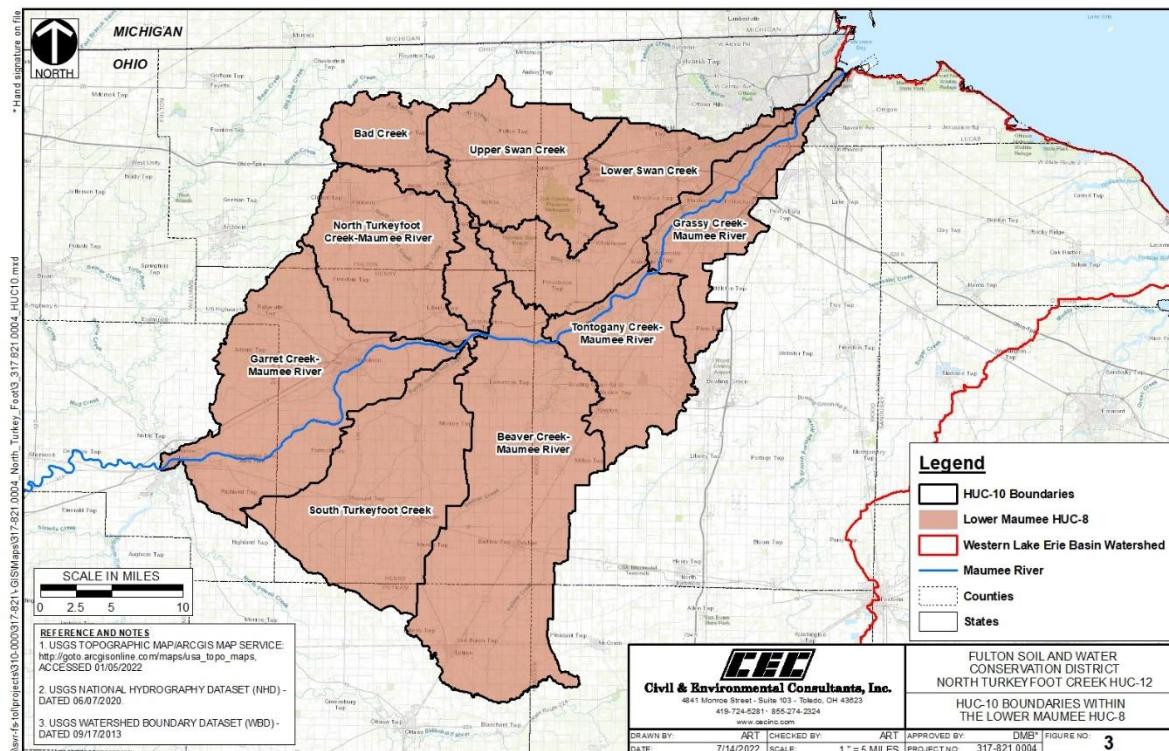
Figure 3: HUC-10 Watersheds of the Lower Maumee HUC-8

The Maumee River is officially formed by the confluence of the St. Joseph and St. Marys Rivers in Fort Wayne, Indiana, and flows easterly to drain all or part of 17 Ohio counties, two counties in Michigan, and five counties in Indiana (American Rivers, 2021). Larger direct tributaries to the Maumee River include the Auglaize, St. Joseph, St. Marys and Tiffin Rivers and Swan Creek, which is the only large tributary located in the Lower Maumee HUC-8. Other notably-sized direct tributaries located within the Lower Maumee HUC-8 include Bad Creek, Beaver Creek, and South Turkeyfoot Creek. The Lower Maumee HUC-8 can be broken down into nine main HUC-10 watersheds: the *Bad Creek HUC-10*, *Upper Swan Creek HUC-10*, *Lower Swan Creek HUC-10*, *Grassy Creek-Maumee River HUC-10*, *Tontogany Creek-Maumee River HUC-10*, *Beaver Creek-Maumee River HUC-10*, *South Turkeyfoot Creek HUC-10*, *Garret Creek-Maumee River HUC-10* and the *North Turkeyfoot Creek-Maumee River HUC-10* (Figure 3).

The *North Turkeyfoot Creek-Maumee River HUC-10* is further divided into three HUC-12 watersheds, one of which is the **North Turkeyfoot Creek HUC-12**. The **North Turkeyfoot Creek HUC-12** contains the entirety of North Turkeyfoot Creek, a direct tributary to the Maumee River at RM 37.92 (Figure 3). The **North Turkeyfoot Creek HUC-12** is similar in land use characteristics as the greater HUC-10 watershed and supports mainly agricultural activities. Formerly, lands in this region formed a large wetland complex known as the Great Black Swamp. Once drained, the Great Black Swamp yielded the fertile soils that are cultivated today.

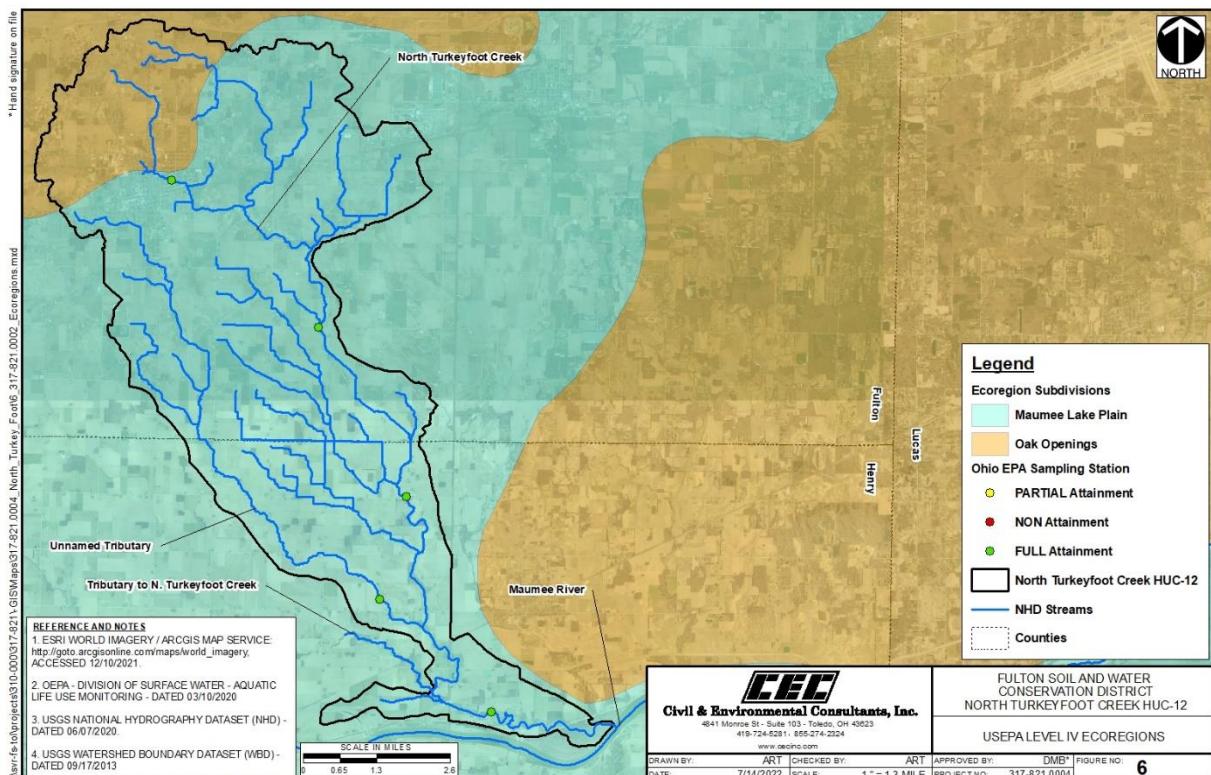
Figure 6: US Level IV Ecoregions

The HELP ecoregion can be classified into five smaller (Level IV) ecoregions with distinct characteristics. The **North Turkeyfoot Creek HUC-12** spans two of these ecoregions (Figure 6). The majority of the sub-watershed lies in the Maumee Lake Plain, a poorly drained region containing clayey lake deposits, water-worked glacial till, and fertile soils. A small portion of the northwestern part of the sub-watershed lies in the Oak Openings ecoregion, an area characterized by low, often wooded, sand dunes, and paleobeach

ridges that are situated among broad nearly flat agricultural plains. Streams in these ecoregions are sluggish with low gradients and have high suspended sediment loads that endanger aquatic life (USEPA, undated map). Streams that drain various moraines and beach ridges throughout the ecoregion may also receive cold groundwater inputs, which may help ameliorate negative water chemistry and poor habitat effects (Ohio EPA, 2020b).

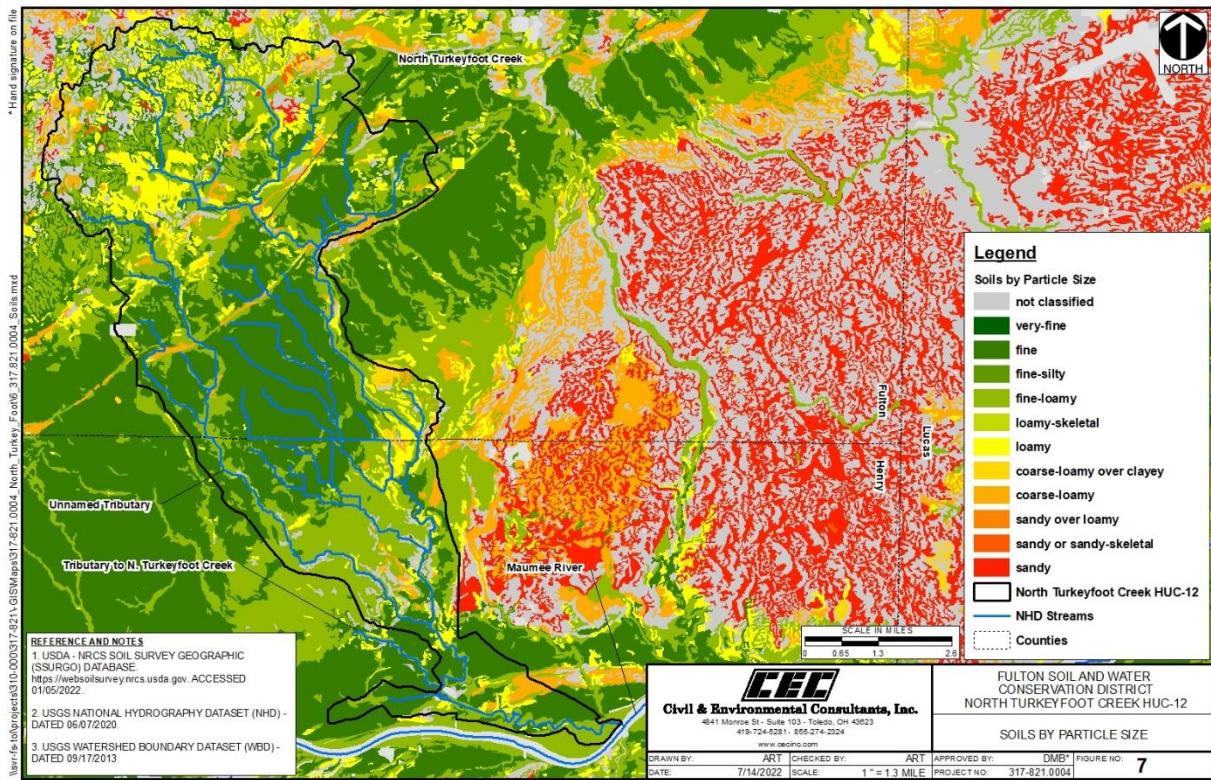
Figure 7: Soils Classified by Particle Size

Soils within the **North Turkeyfoot Creek HUC-12** are dominated by fine grained soils, with interspersed pockets of loamy soils (Figure 7). In the Oak Openings area of the watershed the soils tend to be sandier and much better drained. Throughout the sub-watershed, lacustrine soils overlay Devonian limestone and dolomite bedrock in thicknesses ranging between 120 and 210 feet thick (ODNR, 2004; ODNR 2006a). These poorly draining soils were a driving factor for the existence of the Great Black Swamp. Artificial drainage was installed within this swamp to utilize the highly productive land in the watershed for agricultural purposes. The replacement of these ecoregions by productive farmland has contributed to low gradient rivers with high suspended sediment loads endangering biota. Natural wetland areas shown in the US Fish and Wildlife (USFWS) National Wetlands Inventory (NWI) throughout the **North Turkeyfoot Creek HUC-12** today are sparse (Figure 8).

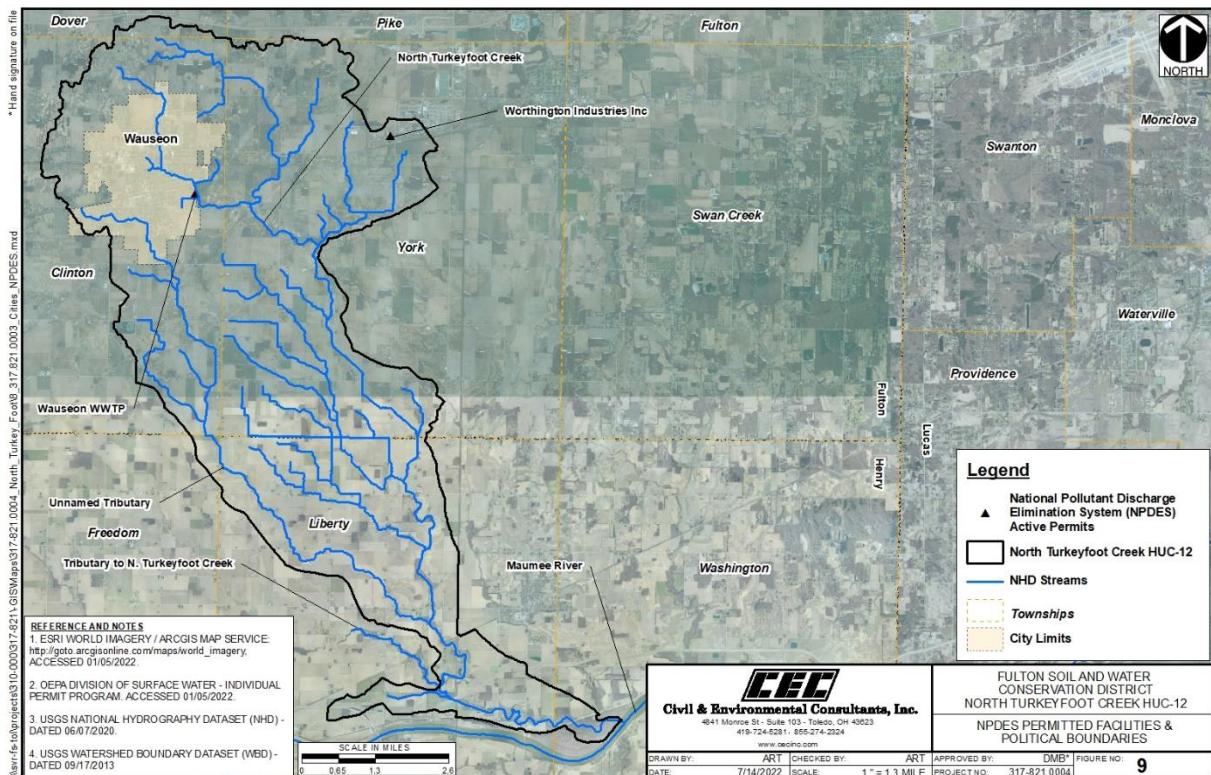
Figure 9: NPDES Permitted Facilities and Political Boundaries in the North Turkeyfoot Creek HUC-12

The largest population concentration in the **North Turkeyfoot Creek HUC-12** is primarily rural except for the city of Wauseon (Figure 9). Wauseon is home to approximately 7,568 people across its 5.35 square mile (3,422 acres) footprint (U.S. Census Bureau, 2020). Approximately 98% of the city is contained within the **North Turkeyfoot Creek HUC-12** boundaries. Wauseon operates its own wastewater treatment plant (WWTP), which began operations in 1989. The WWTP covers more than 11 acres of land and has sufficient capacity to expand to a peak flow of 4.4 million gallons per day (MGD) (Wauseon, 2022). The system is a partially combined system, receiving storm and sanitary flows. Wauseon does not operate under a Municipal Separate Storm Sewer System (MS4). The City's water treatment plant (WTP) is supplied by two aboveground reservoirs that draw water from two area creeks and a raw line from Napoleon that draws water from the Maumee River (Wauseon, 2022). In the event the water from the Maumee River is not suitable for treatment, Wauseon has the ability to send it to Napoleon for treatment.

Currently, there are two National Pollutant Discharge Elimination System (NPDES)-permitted facilities located within the **North Turkeyfoot Creek HUC-12** (Table 3). The USEPA documents NPDES permit compliance through the Enforcement and Compliance History Online (ECHO) database (USEPA, 2022). Results discussed here cover the three-year (12 quarters) compliance history from April 1, 2019 through March 31, 2022. The Wauseon WWTP has had reported effluent exceedances in low level mercury, nitrogen as ammonia (NH₃), dissolved oxygen (DO) and pH. Worthington Industries is located in the southeastern section of the sub-watershed, in an industrial corridor bordered by Delta. Worthington

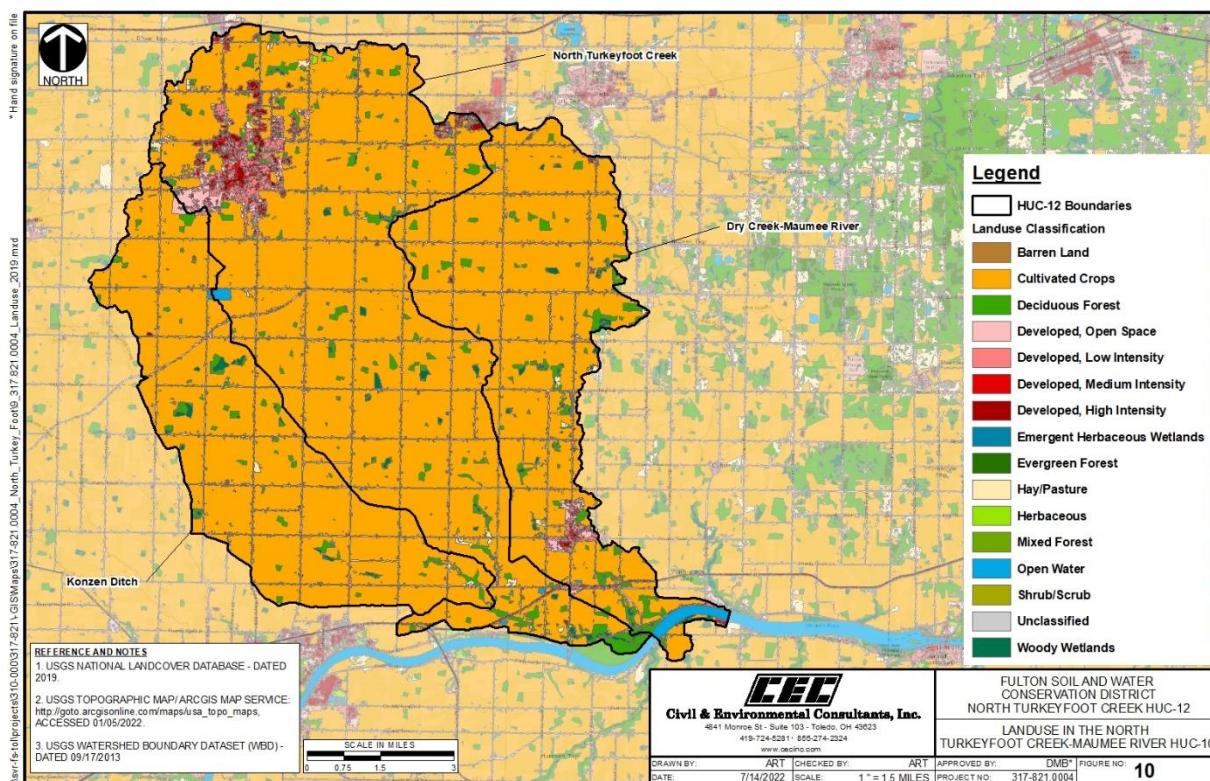
Figure 10: Land Use in the North Turkeyfoot Creek-Maumee River HUC-10

Land use within the **North Turkeyfoot Creek HUC-12** is fairly homogenous (Figure 10). Approximately 82% of land use is cultivated cropland (Table 4). The 2017 United States Department of Agriculture (USDA) Census of Agriculture lists soybeans as the largest field crop harvested in both Fulton and Henry Counties ($\geq 45\%$), while corn accounts for 35-44% of crops in Fulton County and 25-34% of crops in Henry County. In general, farms are of medium size in Fulton County and Henry Counties, with the average operation covering 250 and 279 acres, respectively (USDA, 2019). While livestock operations do exist in the sub-watershed, estimated counts of animals are generally low and smaller farms are scattered throughout the sub-watershed (Table 5). No large Concentrated Animal Feeding Operations (CAFOs) or Ohio Department of Agriculture (ODA)-permitted Confined Animal Feeding Facilities (CAFFs) are located within the sub-watershed.

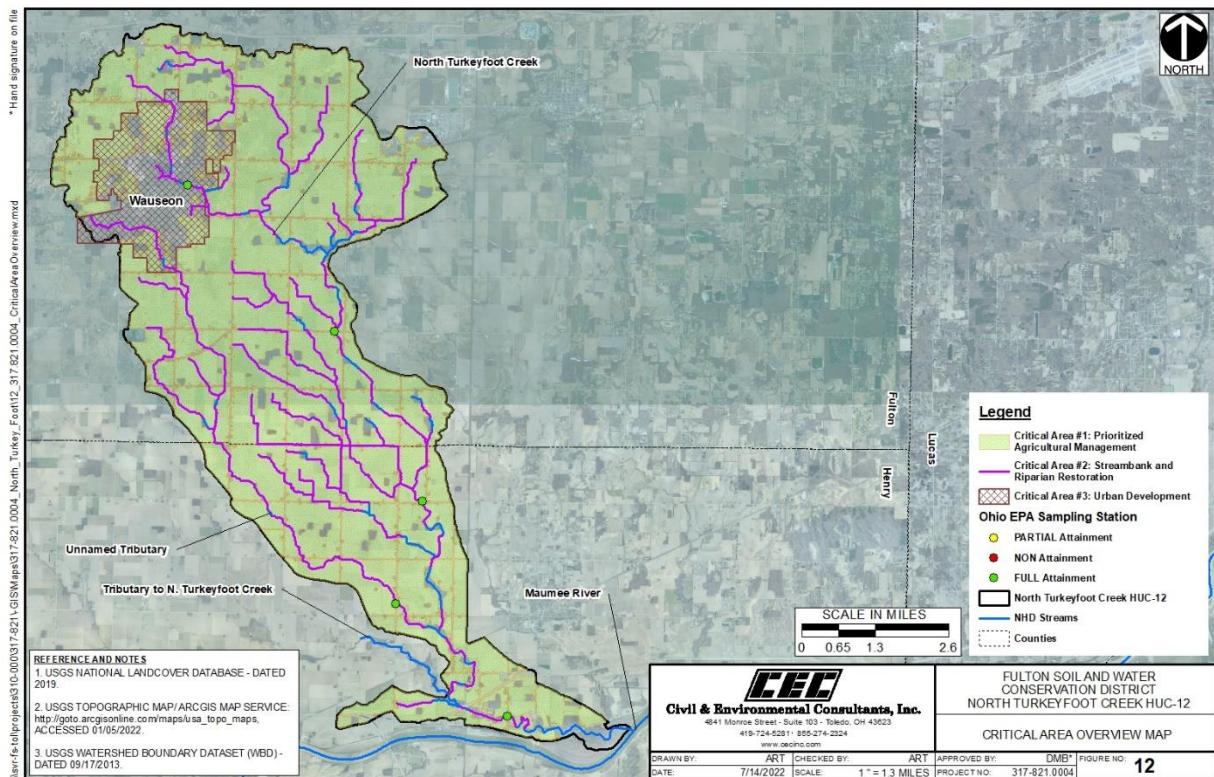
Figure 12: North Turkeyfoot Creek HUC-12 Critical Area Overview²

Overall, five sampling sites are located in North Turkeyfoot Creek and one sampling site is located within an unnamed tributary to North Turkeyfoot Creek in the **North Turkeyfoot Creek HUC-12**. All locations are in *Full Attainment* of the WWH designation; however attainment at RM 17.9 has been identified as *Threatened*. Despite the sub-watershed's *Full Attainment* status, improvements are important for the continued maintenance of water quality standards and for the reduction of nutrient loss to far-field waterbodies. Excessive nutrient loss may be decreased by the implementation of agricultural BMPs that manage surface flow and stabilize soil loss from row crop fields. In addition, BMP implementation that reduces soil loss also simultaneously helps reduce nutrient loss, as nutrients are adsorbed to soil particulates. In the **North Turkeyfoot Creek HUC-12**, enrichment signatures have been identified in North Turkeyfoot Creek, and the Wauseon Reservoir has been put on a watch list due to high in-stream nitrate-nitrite levels in North Turkeyfoot Creek near the back-up intakes.

Three critical areas have been identified within the **North Turkeyfoot Creek HUC-12** (Figure 12). Two critical areas will address far-field effects of nutrients in Lake Erie, the end receiving waterbody of drainage from the **North Turkeyfoot Creek HUC-12** (Table 15). However, many BMP implementation

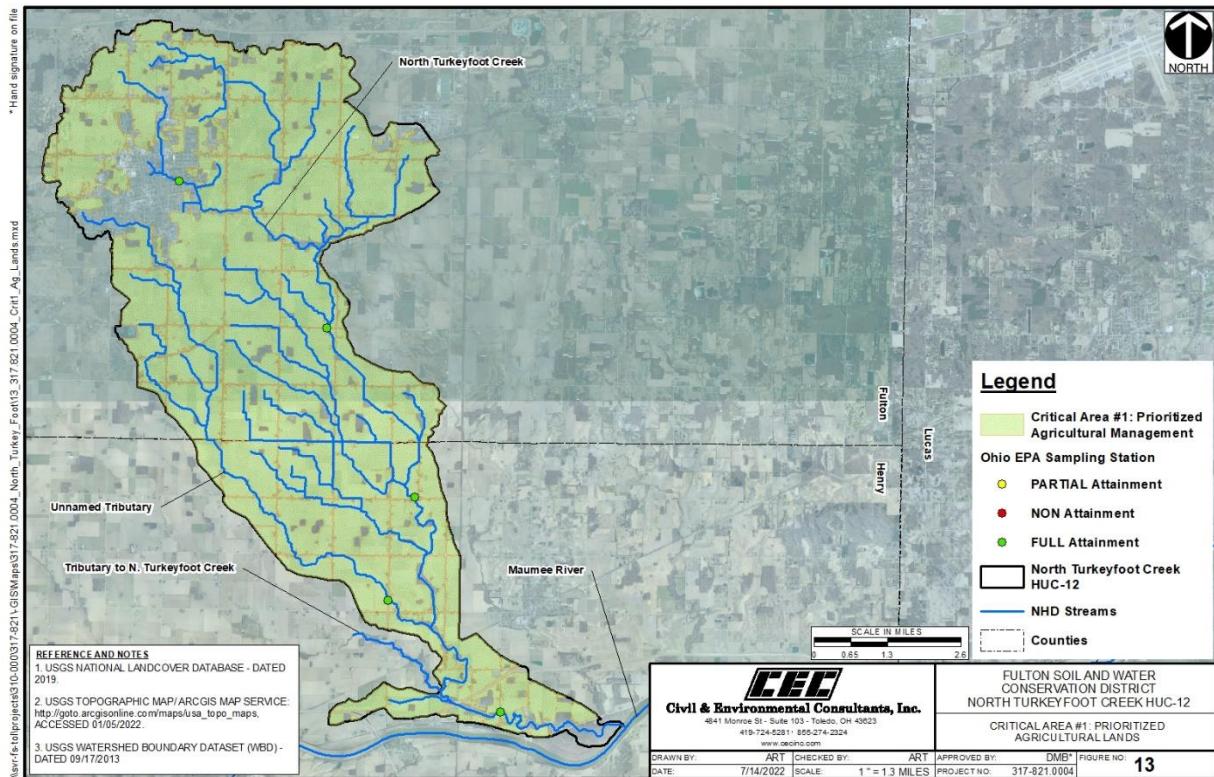
Figure 13: North Turkeyfoot Creek HUC-12 Critical Area #1

- Lands directly adjacent to streams or drainage waterways;
- Lands with recurrent gully erosion;
- Lands with uncontrolled or unfiltered subsurface drainage water;

- Lands without a current (<3 years) nutrient management plan or soil test; or,
- Lands with high soil phosphorus levels (>40 ppm Mehlich).

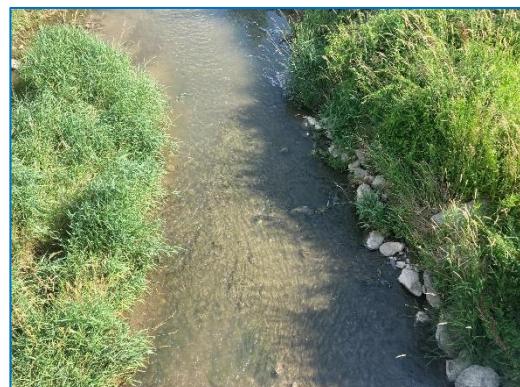
Silty substrates can inhibit macroinvertebrate community performance.

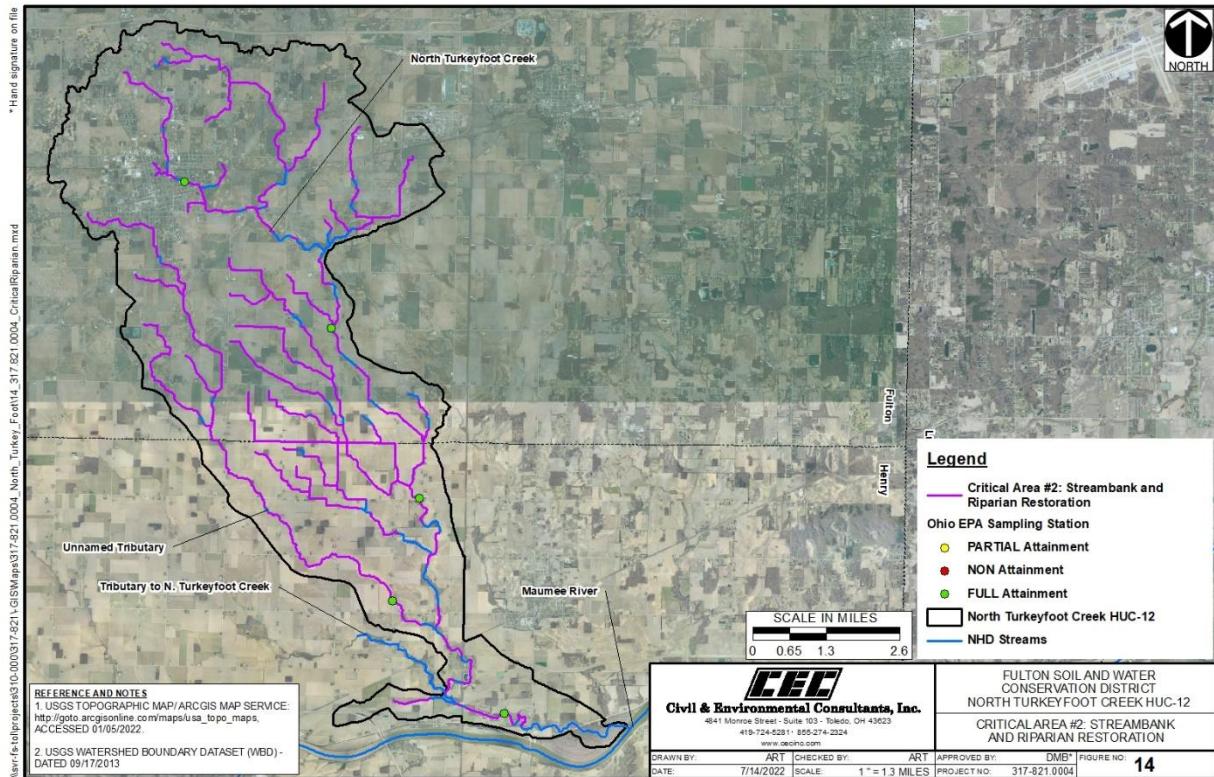
Figure 14: North Turkeyfoot Creek HUC-12 Critical Area #2

immediately adjacent to the waterbody or upland to address the sources of pollutant loads.”— *Critical Area #2* includes the riparian and in-stream segments of approximately 72.4 miles of waterways, and a 75-foot buffer width on each side. The potential for restoration of approximately 1,300 acres of riparian corridor exists in *Critical Area #2*.

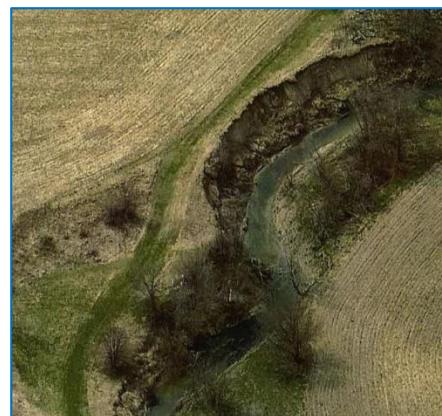
Aerial view of sloughing streambanks in Fulton County.

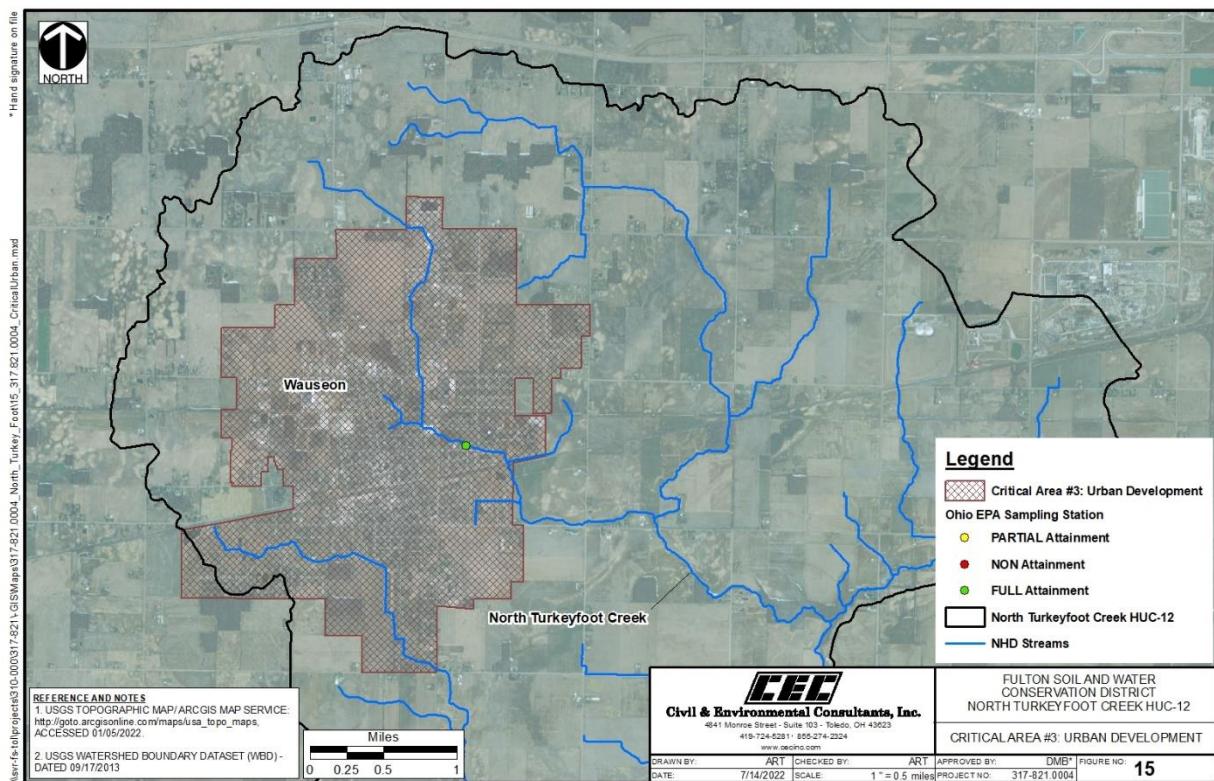
Figure 15: North Turkeyfoot Creek HUC-12 Critical Area #3

Critical Area #3 contains the concentration of developed land in the City of Wauseon (Figure 15). Wauseon is home to approximately 7,568 people (U.S. Census Bureau, 2020) and spans 3,422 acres, mostly contained (98%) within the **North Turkeyfoot Creek HUC-12** boundaries. The remaining 2% lies to the western adjacent sub-watershed, the **Konzen Ditch HUC-12**. Approximately 2.6 miles of North
