Big Creek

Nonpoint Source Implementation Strategy

Version 1.1

Tetra Tech, Inc.

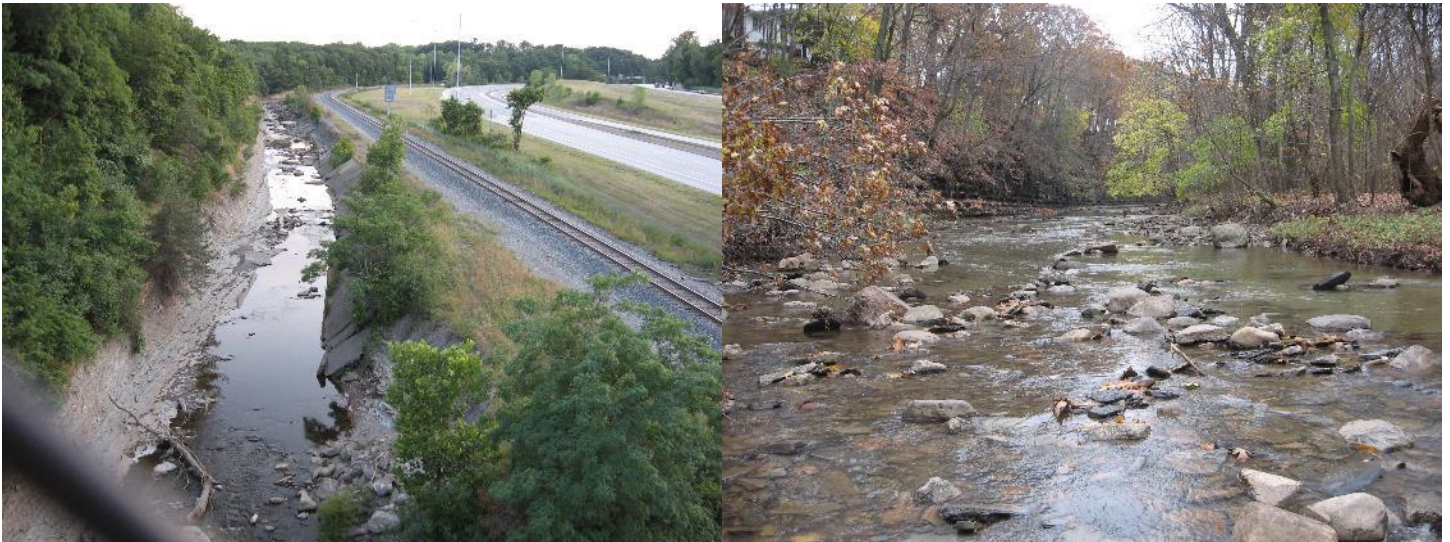
Figure 9. Big Creek along I-71 (left) with poor fish habitat and East Branch (right) with good habitat.

As measured by the QHEI, fish habitat has been assessed at several locations along Big Creek and its tributaries. Fish habitat is generally *good* in Big Creek and its tributaries (Figure 9), as measured by the QHEI. However, a few locations have *excellent* or *fair* habitat. QHEI scores from the past decade are summarized in Table 9 in Section 2.4

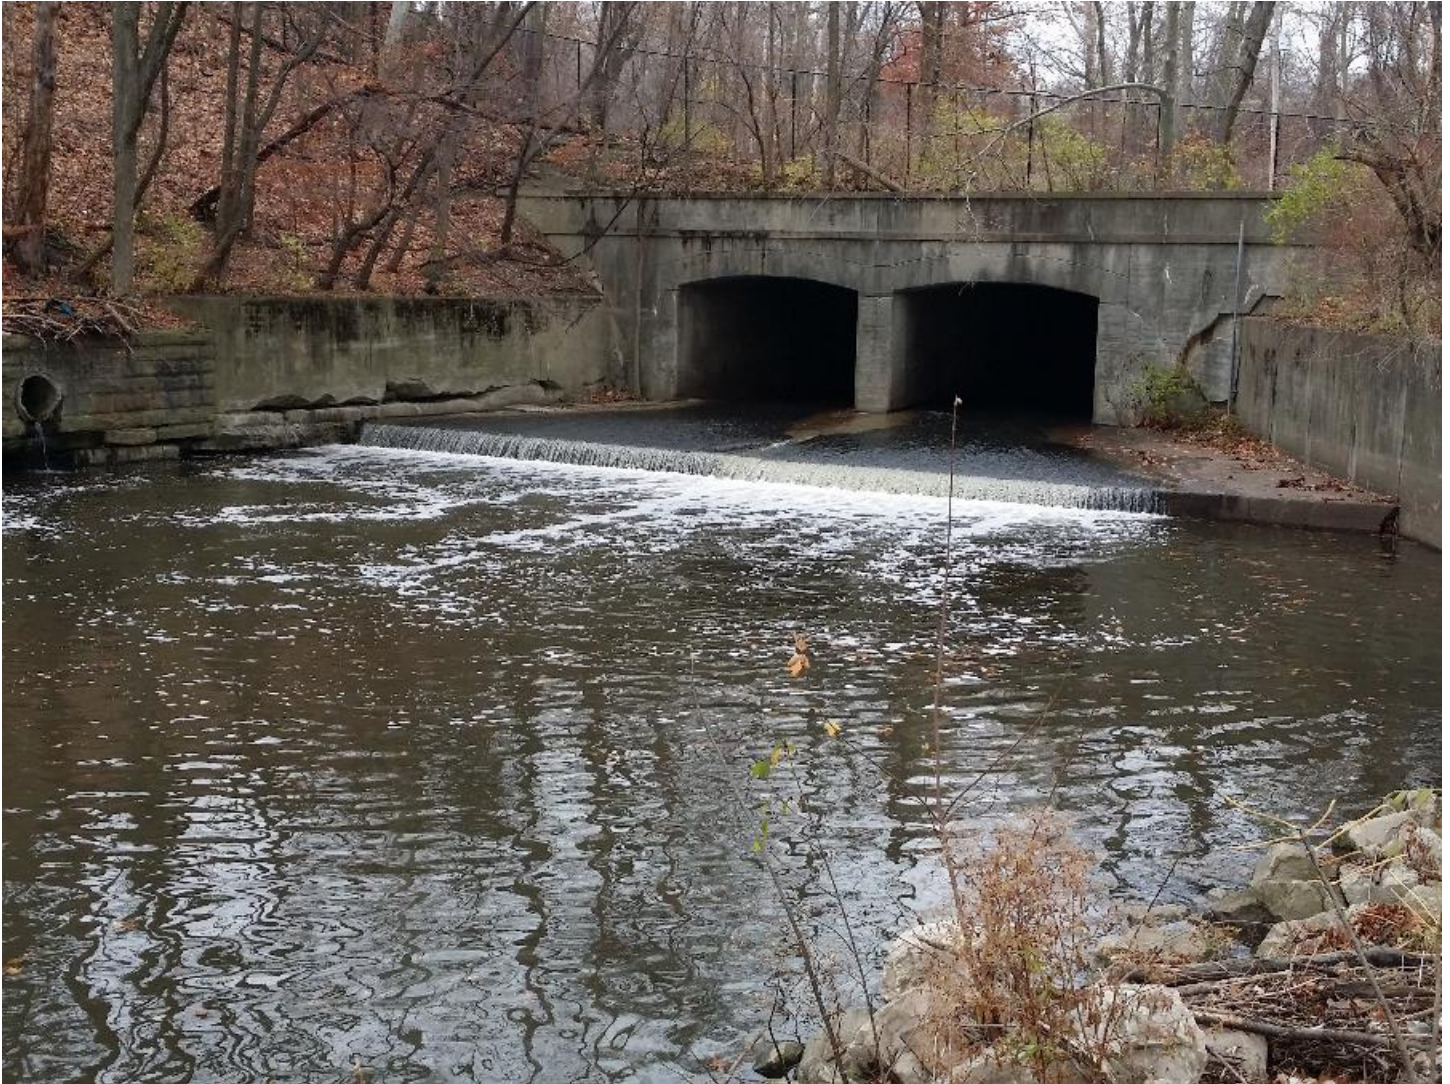
Figure 11. Double barrel culvert of Big Creek at the Cleveland Metroparks Zoo.

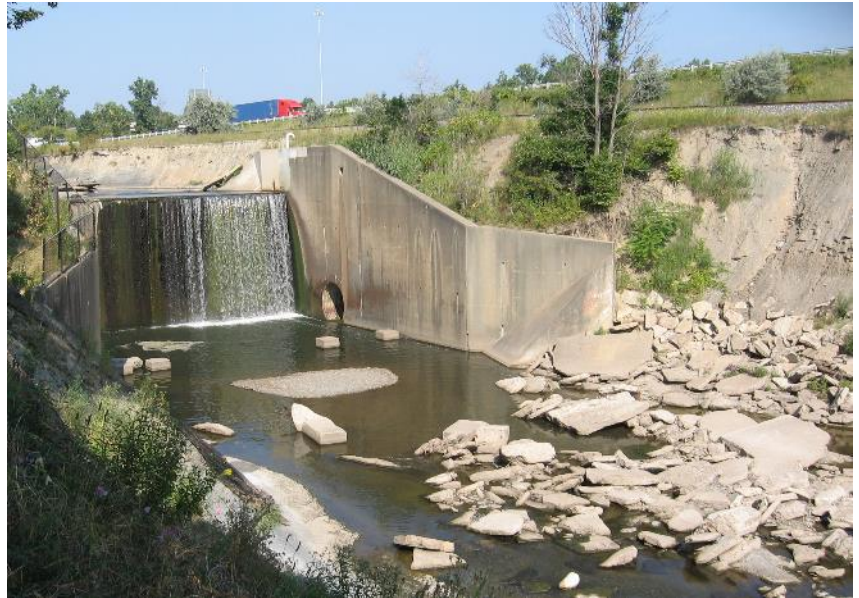
Figure 14. Big Creek drop structure along I-71.

- Objective 2** Restore 5,800 lineal feet of bank habitat along lower Big Creek
 - Along I-71, Big Creek is a concrete channel. However, many concrete panels have begun to fail, exposing underlying shale.

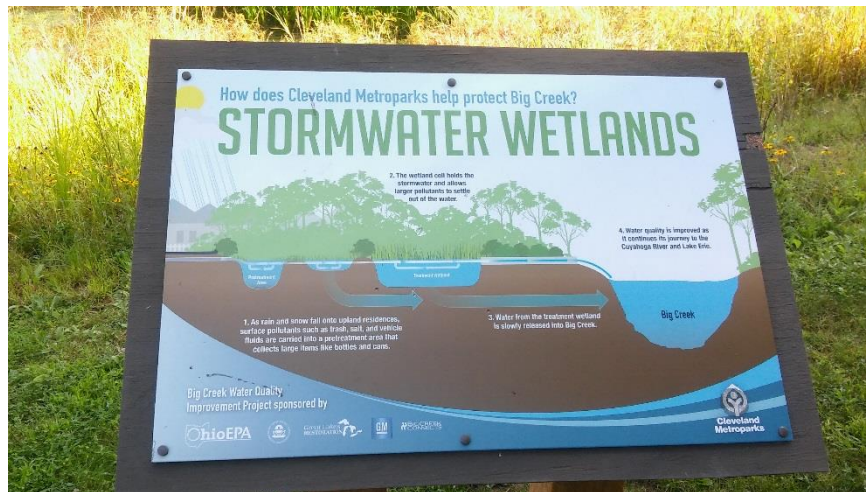
Figure 25. Completed stormwater project in the Big Creek Reservation.

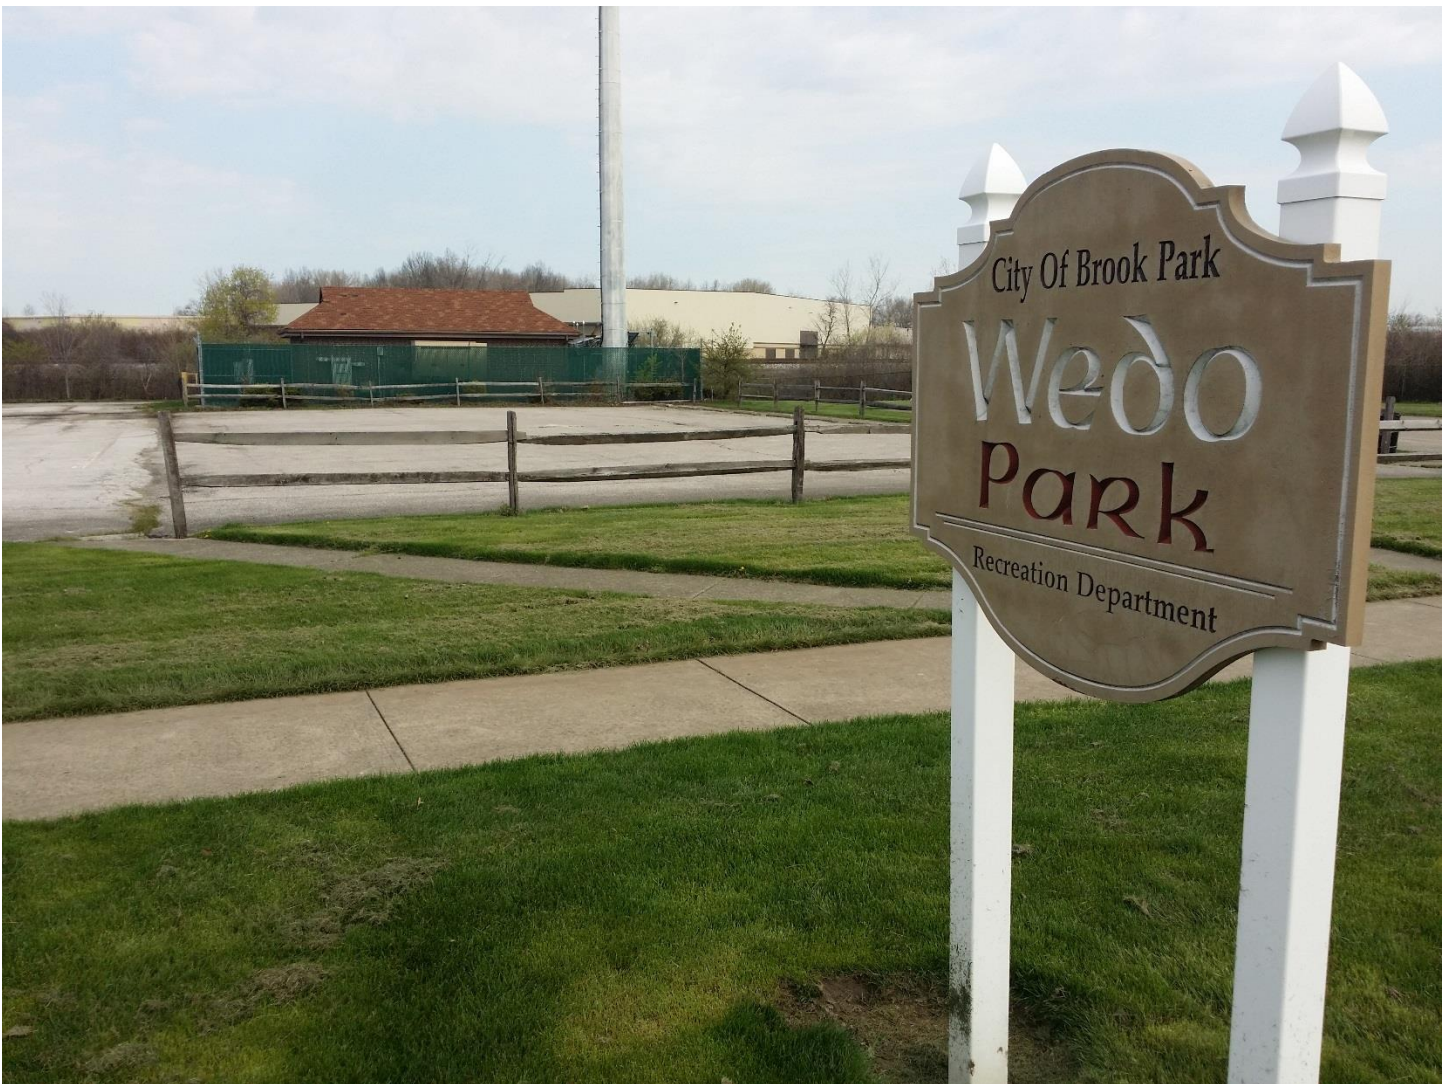
Figure 28. Project #6 in Table 23 propose to install a detention basin in Wedo Park.
