ARCOLA CREEK WATERSHED ACTION PLAN

DECEMBER 21, 2012

Written by Maurine Orndorff,
Watershed Coordinator
Lake County Soil & Water Conservation District
125 E. Erie Street, Painesville OH 44077
morndorff@lakecountyohio.gov
440.350.5863

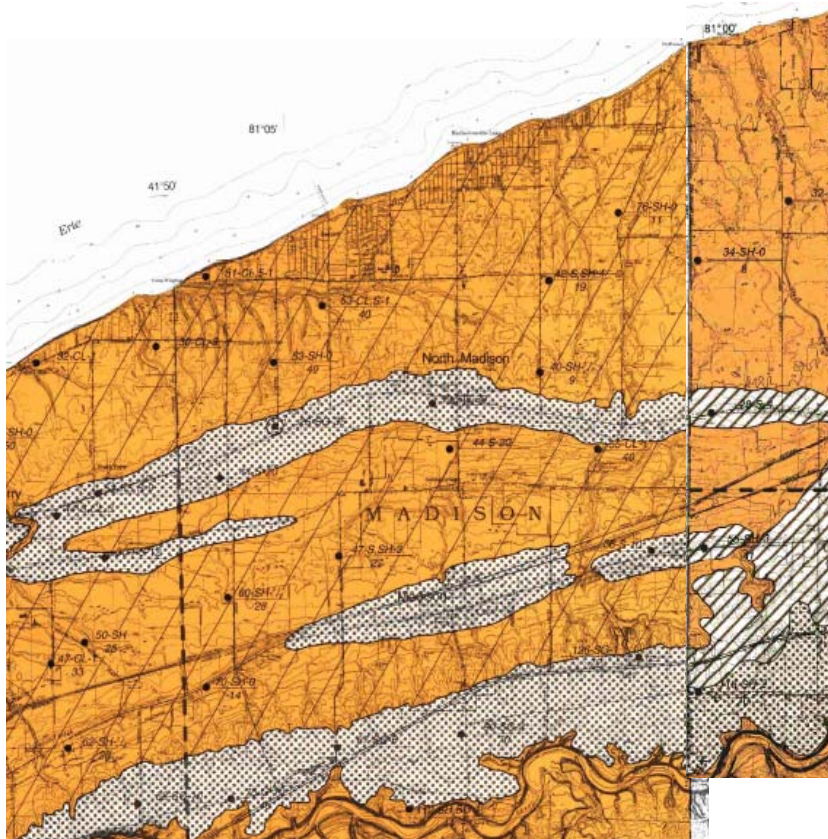
Figure 34: Groundwater Resources (ODNR Statewide Aquifer Mapping Project)

The flow regime is non-confined. Wells in the watershed are typically shallow, and are in shale bedrock except in beach ridge locations. The wells in the shale bedrock are drilled through the Ashtabula Till, which is an unconsolidated glacial aquifer. Figure 35, Arcola Creek Aquifers, shows two types of aquifers in the watershed: Beaches and No Significant Recharge Areas.

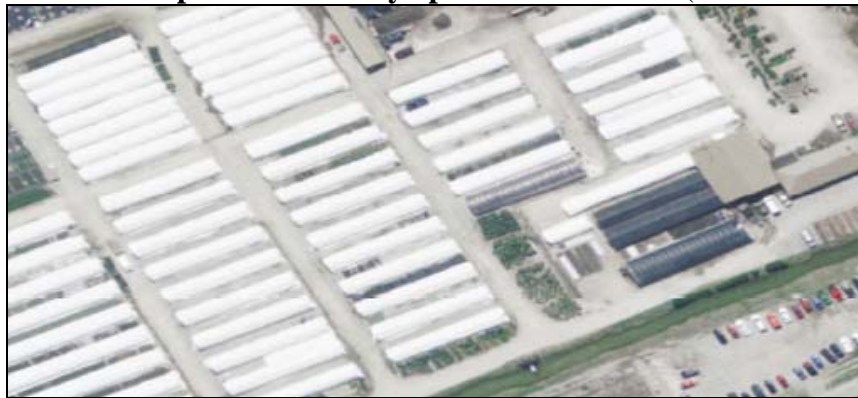
Figure 40: Orthophoto of nursery operation in winter (Lake SWCD files)

Nursery nutrients are at the top of the list of issues of concern in the watershed by the non-agricultural population, but whether this is a real or perceived issue will need to be determined as a part of the watershed planning process.
