Biological and Water Quality Study of the Rocky River and Select Tributaries

Biological and Water Quality Study
of the
Rocky River and Select Tributaries
Sampling Years 2014-2015

Prepared by
State of Ohio Environmental Protection Agency

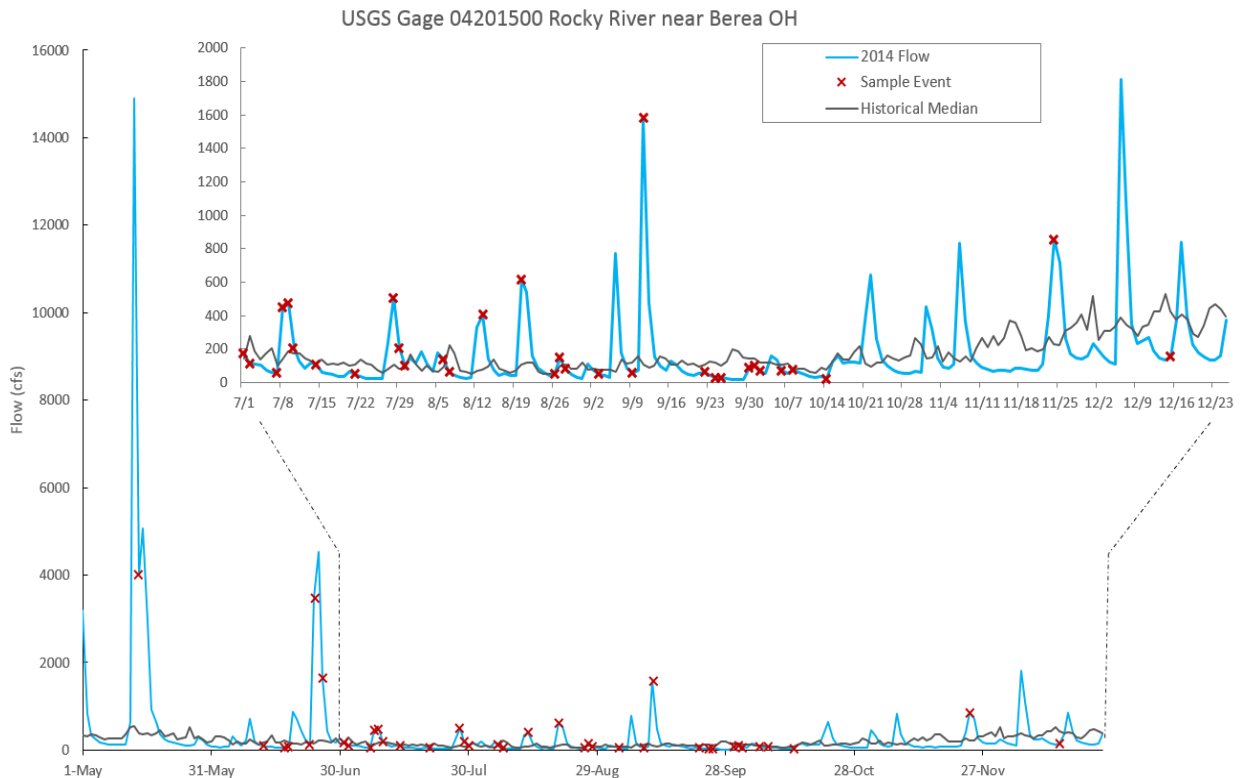
Figure 15. Flow conditions in the Rocky River during the 2014 sampling season, the upper inset showing July through December at finer streamflow scale (USGS 2014).

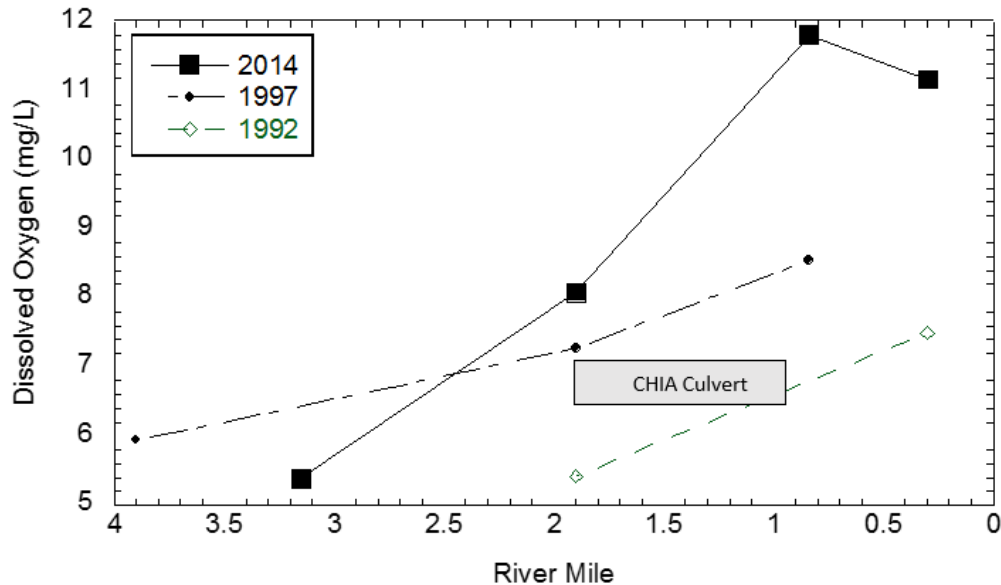
Figure 19. Longitudinal median concentrations of dissolved oxygen, Abram Creek, 1992-2014.

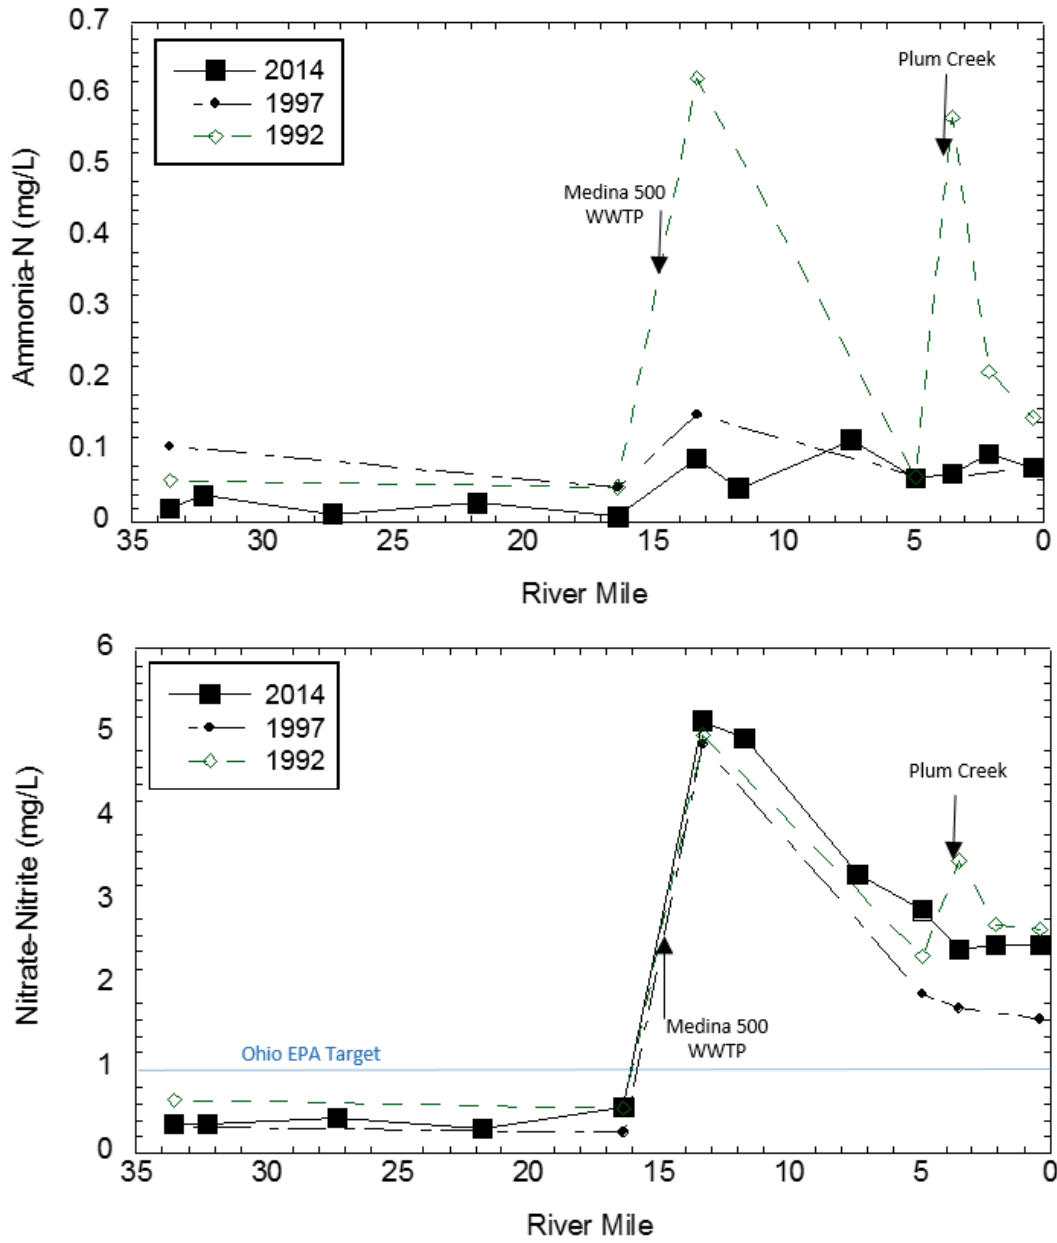
Figure 20. Logitudinal median concentrations of ammonia and nitrate-nitrite-N, West Branch Rocky River, 1992-2014.

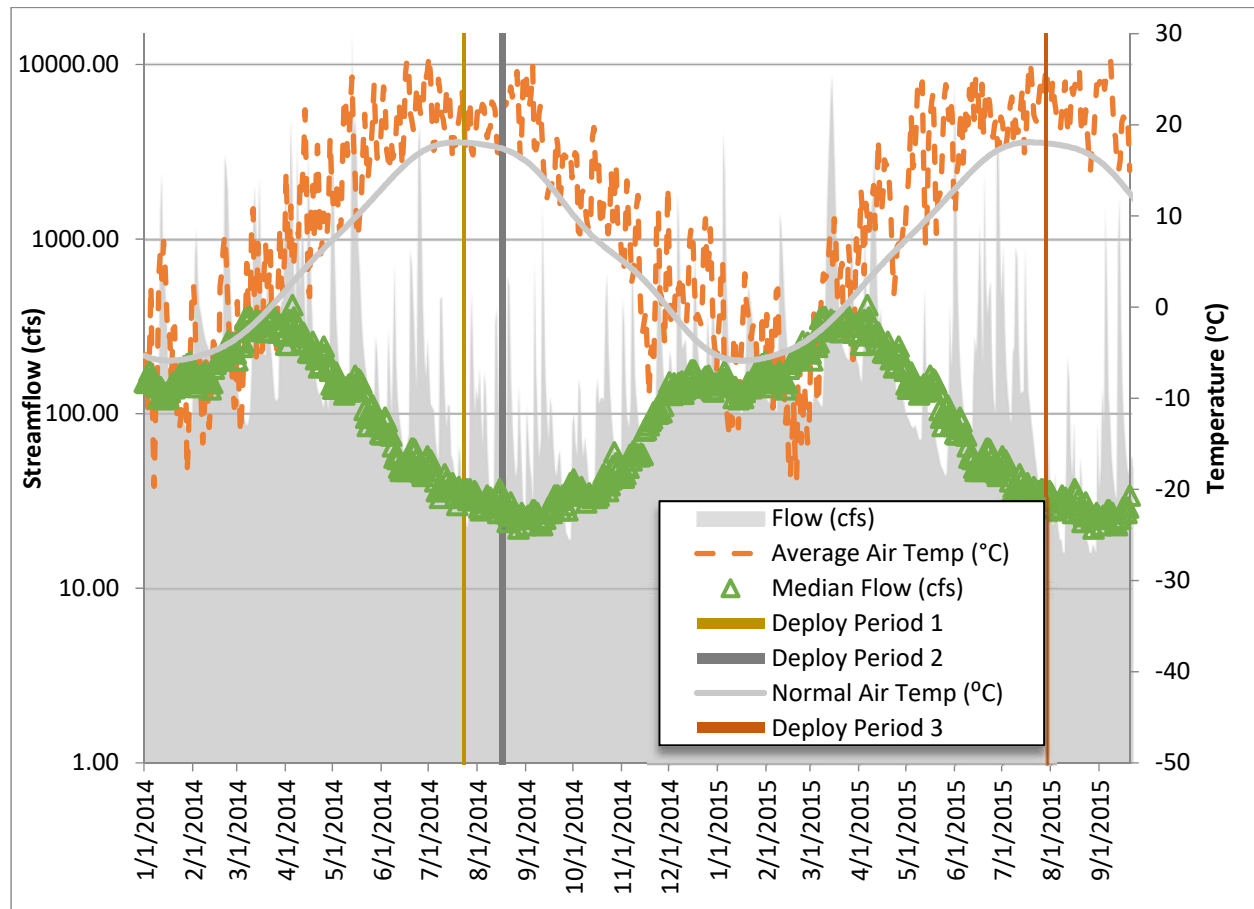
Figure 24. Graph of average daily streamflow relative to the daily median streamflow (USGS 04201500 Rocky River near Berea OH) including the average daily stream temperature (USGS 04201500 Rocky River near Berea OH), average daily air temperature and normal daily air temperature (NOAA-GHCND:USW00014820) for the sampling season.

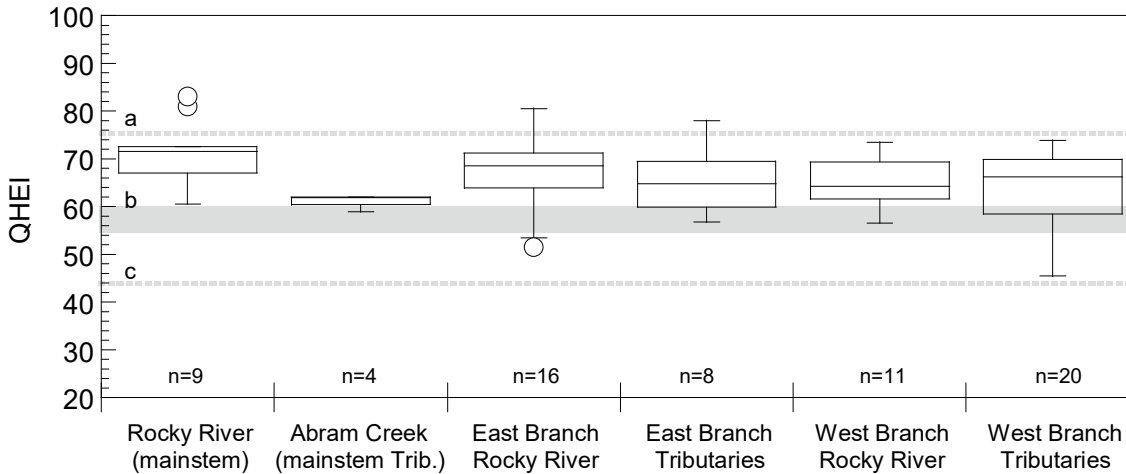
Figure 29. Performance of the QHEI by subbasin and affiliated tributaries, Rocky River watershed, 2014. Dashed lines a and c define generic exceptional and deficient habitat benchmarks. Shaded area b defines WWH benchmark for headwaters and wading streams, 55 and 60, respectively.

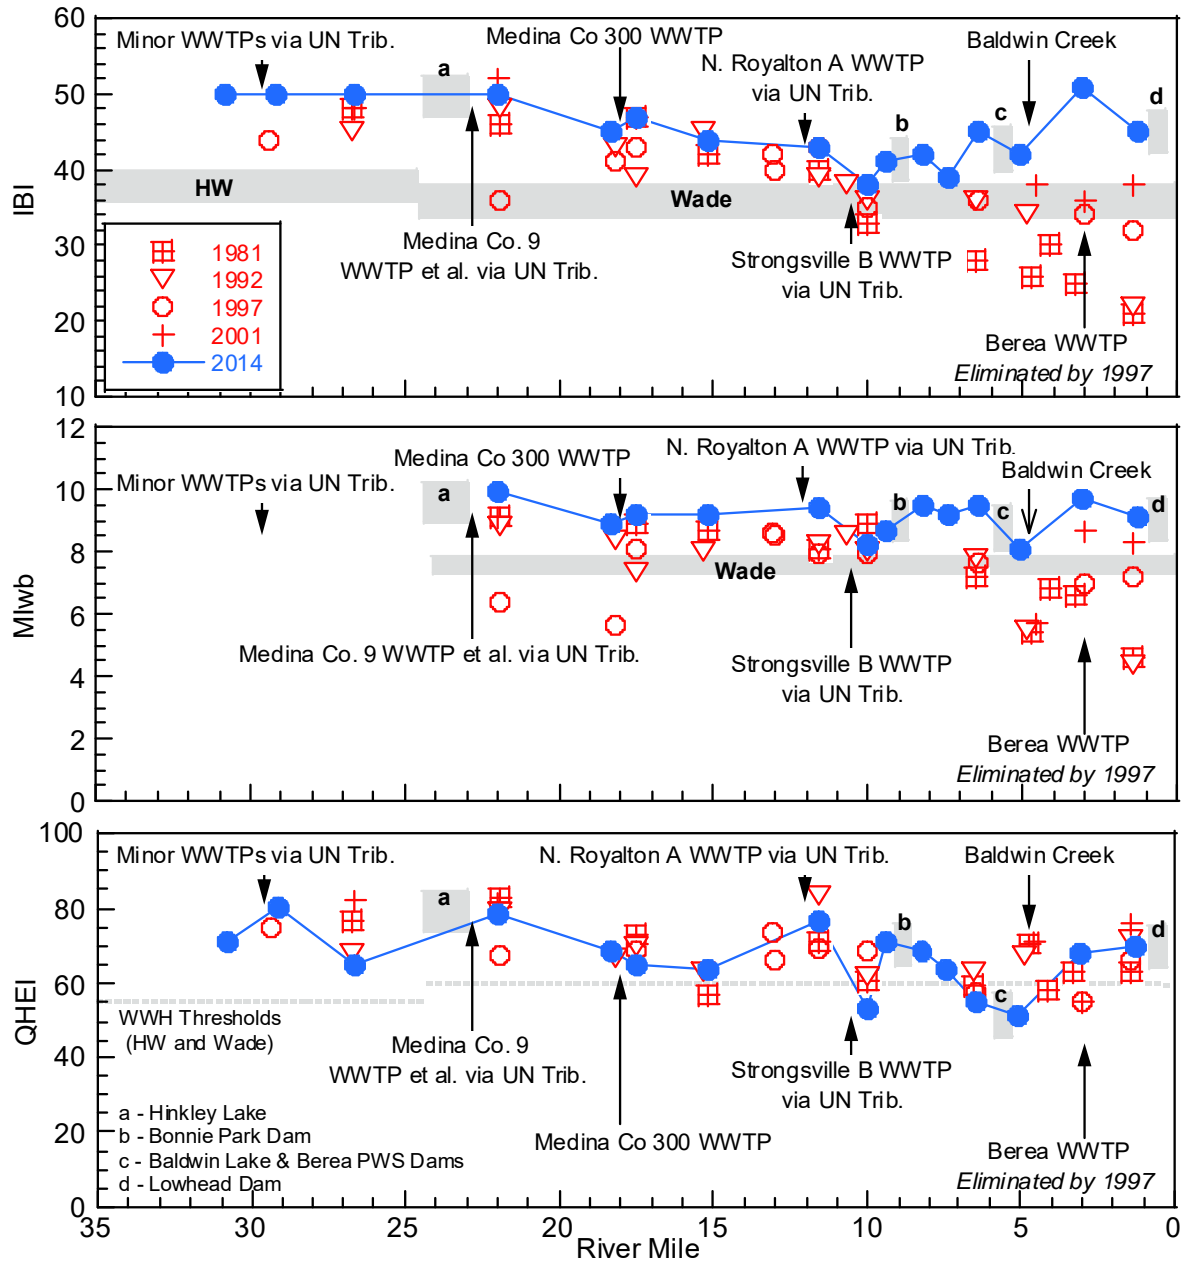
Figure 36. Longitudinal performance of the IBI, MIwb, and the QHEI, East Branch Rocky River, 1981-2016. Grey-scale horizontal bars represent the WWH biocriteria and areas of non-significant departure for IBI and MIwb. Arrows identify significant direct points of discharge for NPDES permitted entities, confluence(s) of direct tributaries, or other pollution sources. Horizontal dashed lines indicate WWH benchmarks for headwater and wading sites. All constituent waters of the Rocky River study area are contained within the ELOP ecoregion.

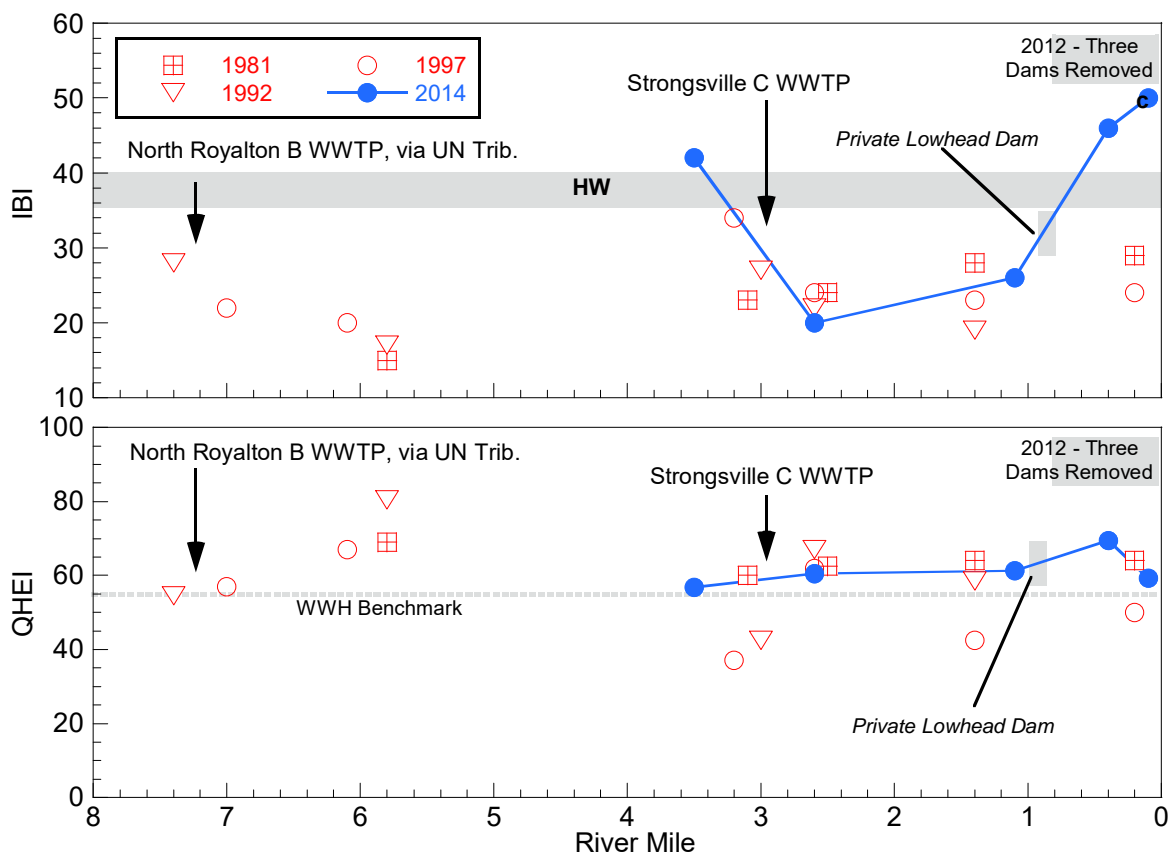
Figure 37. Longitudinal performance of the IBI, QHEI, Baldwin Creek, 1981-2016. Grey-scale horizontal bars represent the WWH and EWH biocriteria and areas of non-significant departure for IBI. Arrows identify significant direct points of discharge for NPDES permitted entities or confluence(s) of direct tributaries. Horizontal dashed lines indicate QHEI, WWH benchmark. All constituent waters of the Rocky River study area are contained within the ELOP ecoregion.

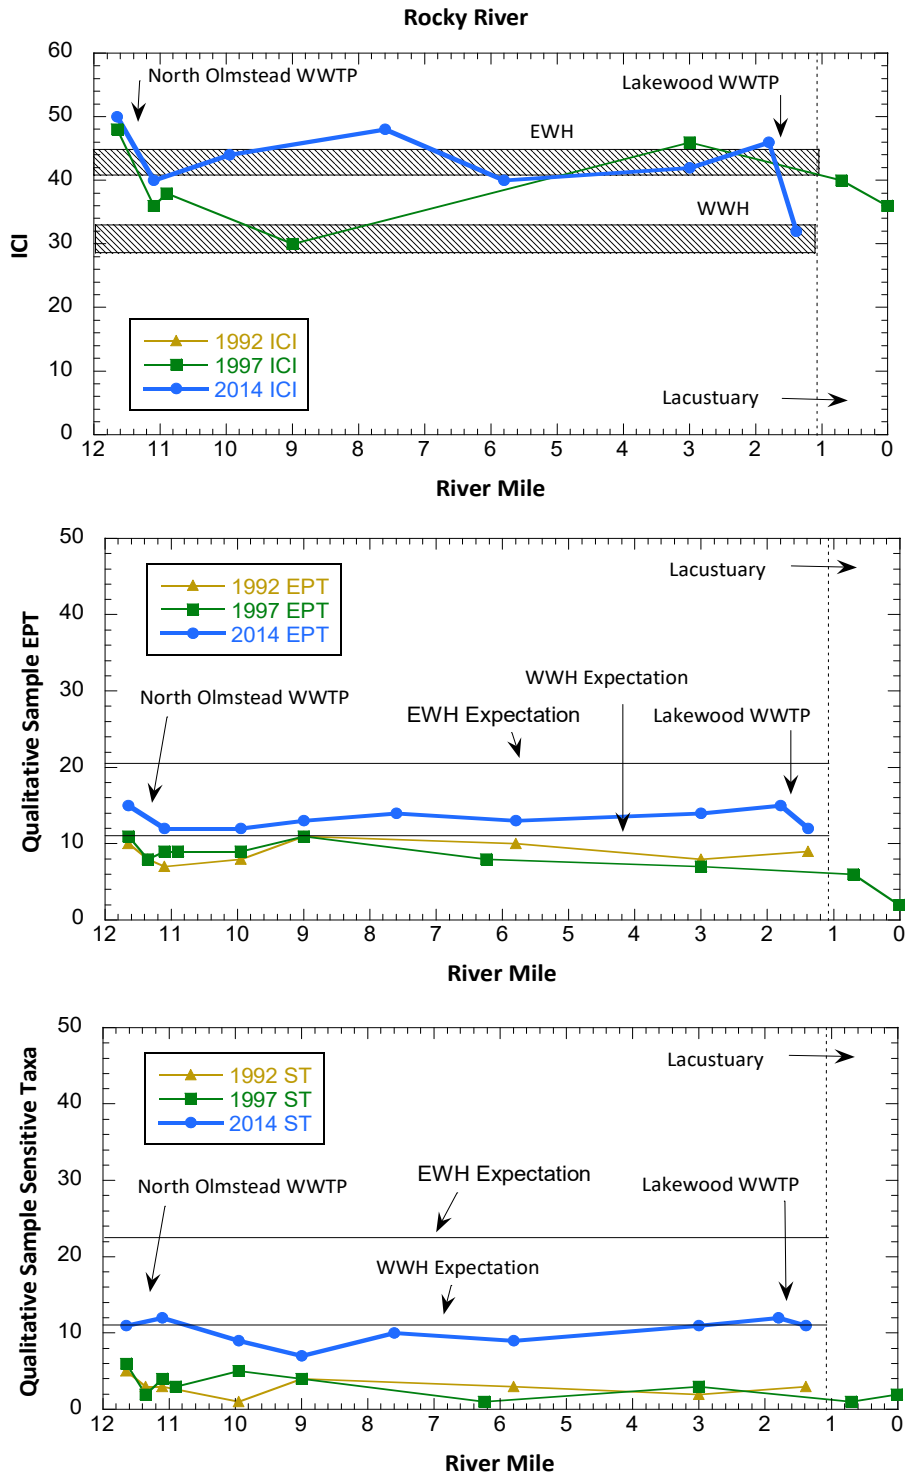
Figure 42. Longitudinal trend of the Invertebrate Community Index (ICI), number of EPT taxa (EPT) in the qualitative sample, and number of sensitive taxa (ST) in the qualitative sample in the Rocky River, 1992-2014.

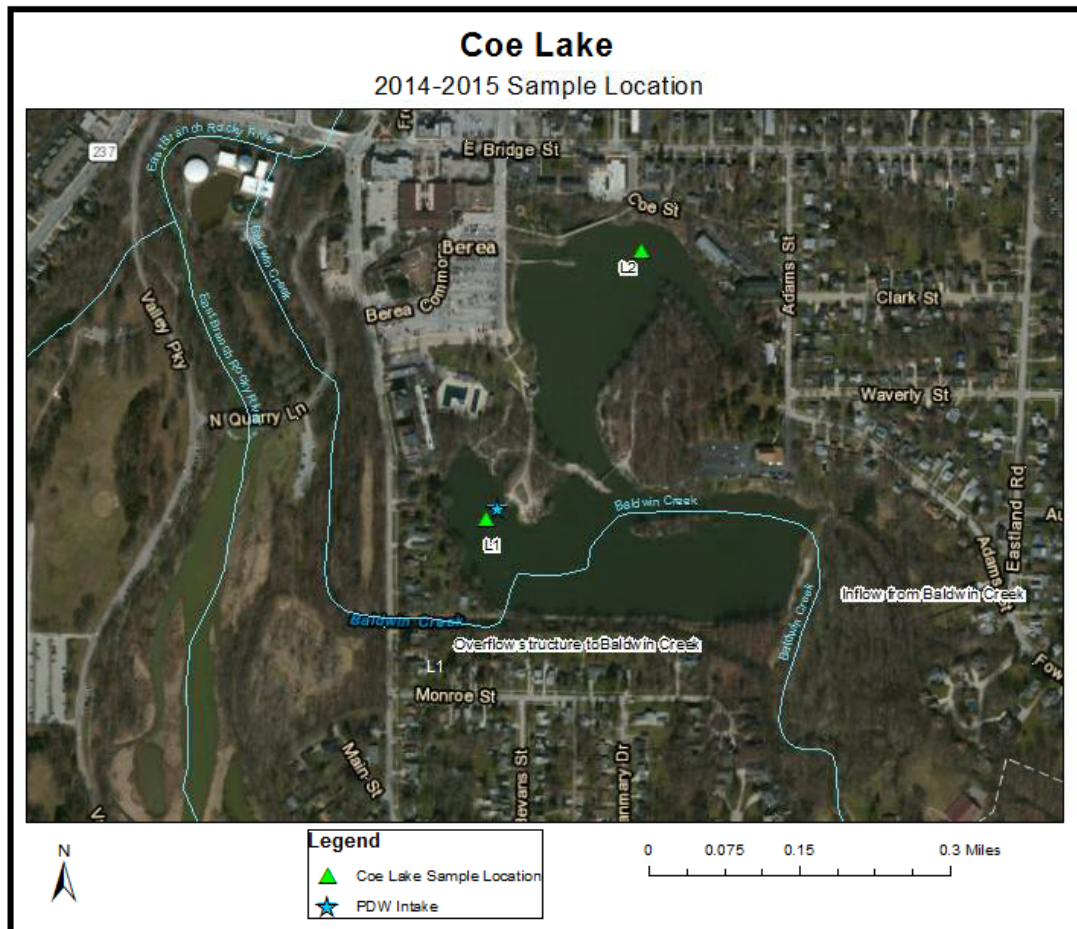
Figure 53. Coe Lake Sampling Locations.

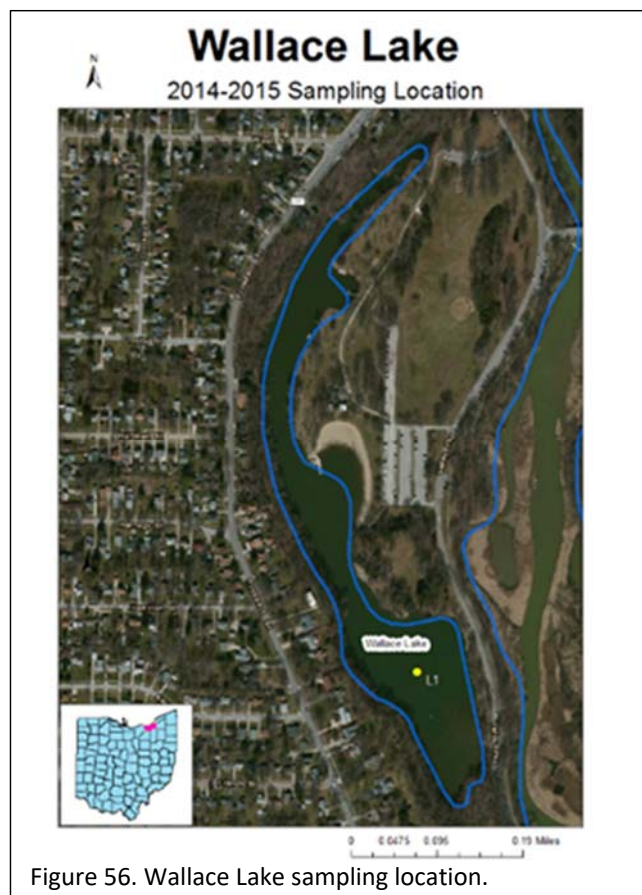
Figure 56. Wallace Lake sampling location.
