Biological and Water Quality Study of the Sandusky River Watershed and Muddy Creek

Ohio EPA Technical Report AMS/2022-SANDRV-2

Division of Surface Water

September 2025

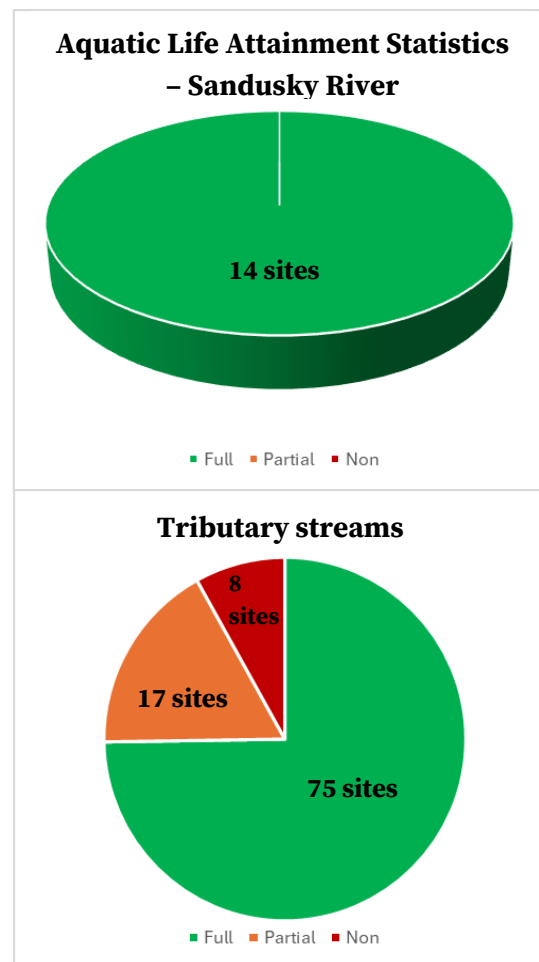
Figure 1 – Pie chart displaying the attainment status of sites for their respective aquatic life criteria from the current survey.

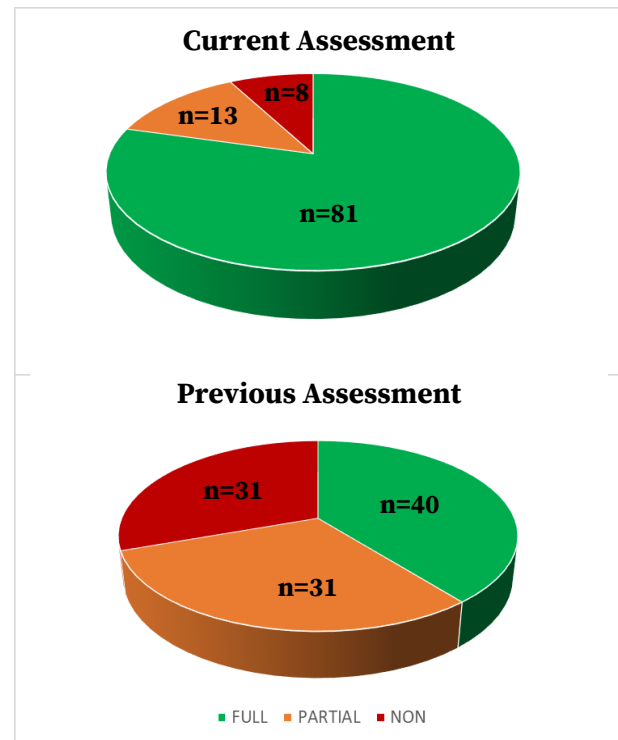
Figure 2 – Pie charts displaying the aquatic life use attainment status from sites in the current survey paired with their last full assessment (n=102).

The current survey documented substantial improvements compared to these historical efforts (Figure 2). Of the 113 sites sampled during the most recent survey, 102 sites had historical biological data with a prior ALU assessment. As water quality conditions in the watershed have improved over time, the number of sites in *full attainment* of the aquatic life use criteria increased from 40 sites (39%) in prior surveys to 81 sites (79%) in the 2022 assessment. There has also been a corresponding decrease in the number of sites in both partial and non-attainment since their previous assessment. The improved water quality conditions throughout the watershed can be attributed primarily to better treatment of permitted effluent and reductions in non-point source sediment and nutrient loadings related to modern tillage and agricultural soil conservation practices (Miltner 2015, Richards et. al 2009).

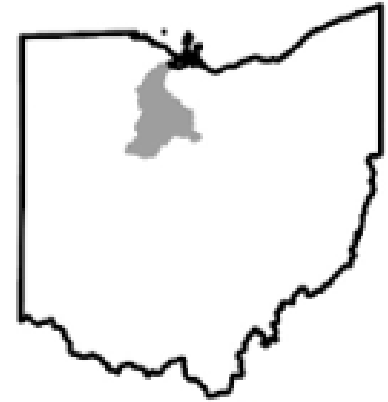
Figure 3 – The Sandusky River and Muddy Creek watersheds in Ohio.

A total of 115 biological, 112 water chemistry, six sediment chemistry, 10 fish tissue, and 62 bacteria stations were sampled during the survey. The Sandusky watershed location in Ohio is shown in Figure 3. Sampling stations are displayed in Figure 4 and listed in Table 2. Please [email](#) us for biological, chemical or bacteria data requests.

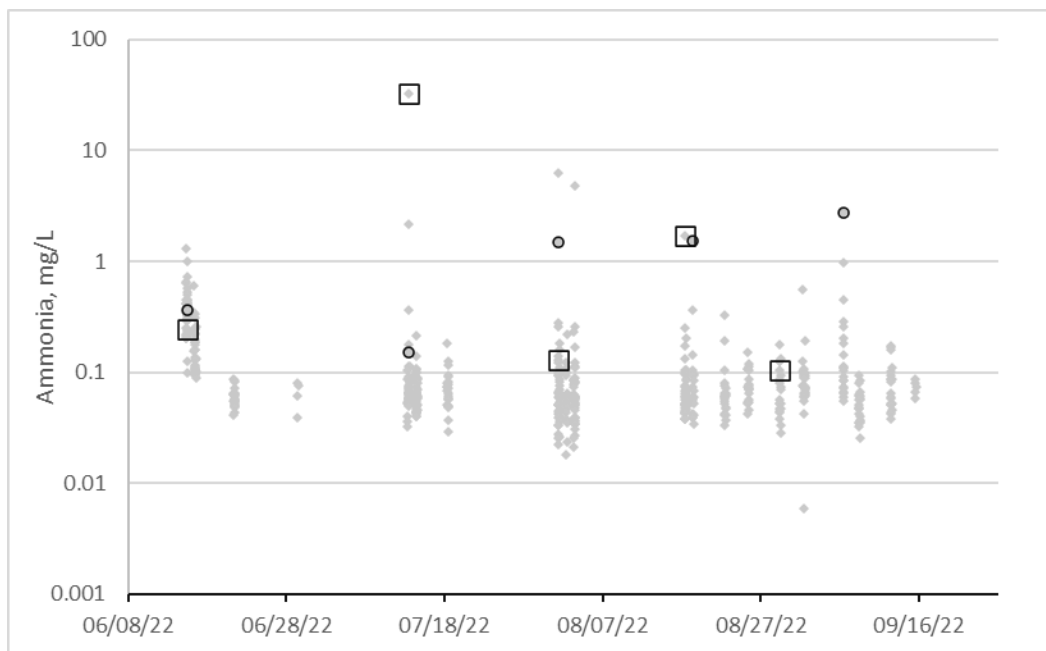
Figure 17 – Scatter plot of total ammonia concentrations in surface water grab samples displayed by date from sites all survey sites, 2022. Samples from Allen Run RM 1.18 and Tymochtee Creek RM 49.44 are displayed by open squares and circles, respectively.

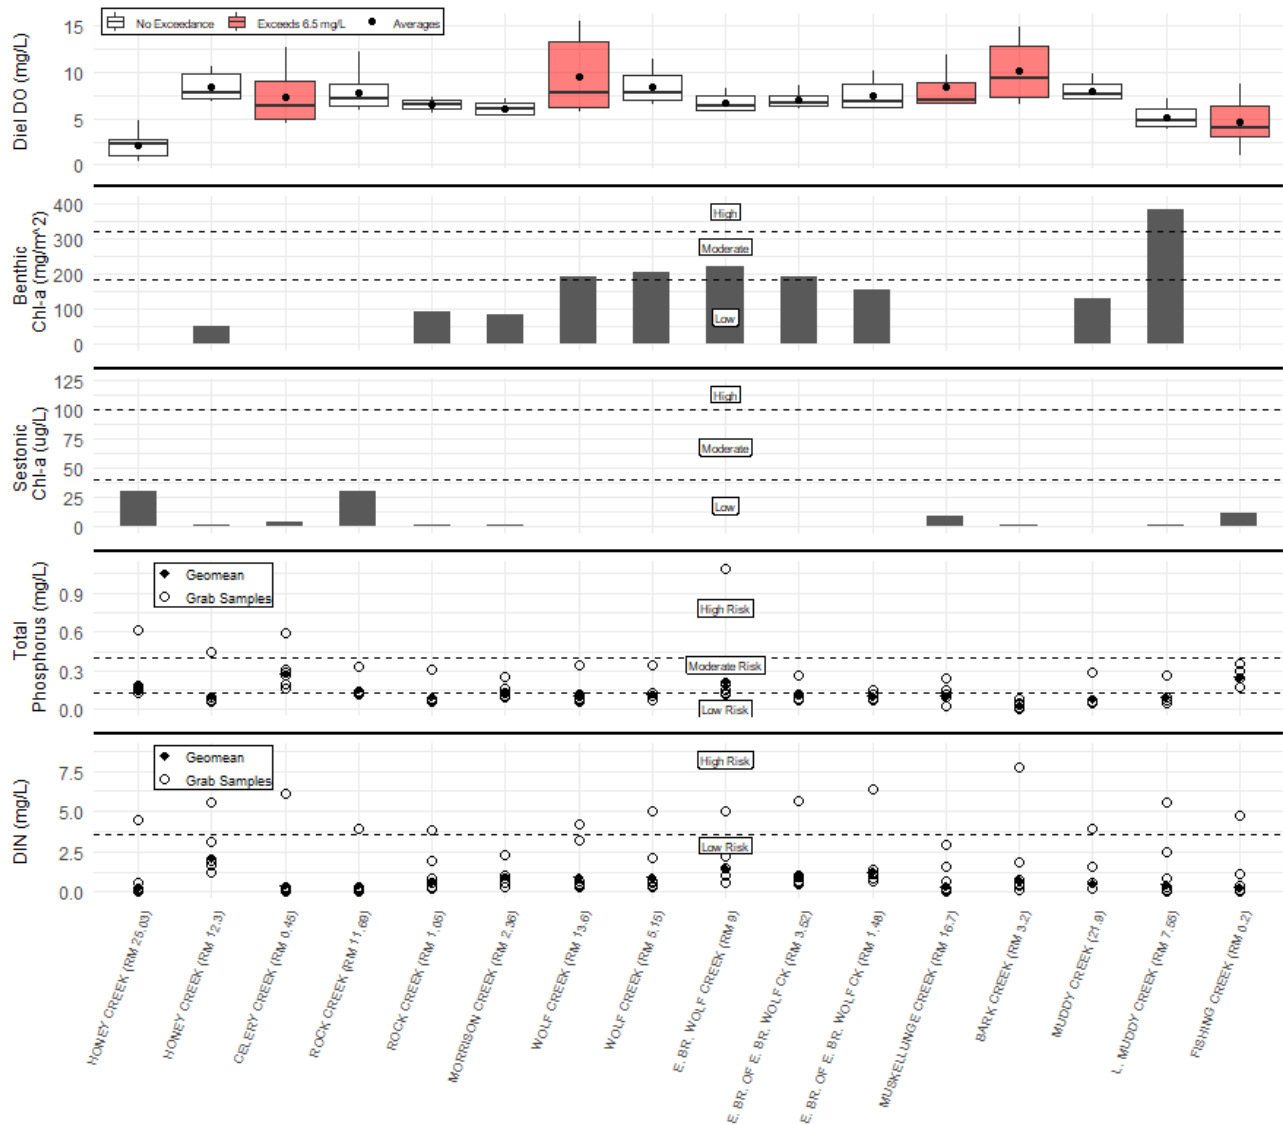
Figure 20 – Representation of diel DO, benthic/sestonic chlorophyll- α , TP and DIN used to evaluate the impact of nutrients on tributaries to the Sandusky River.

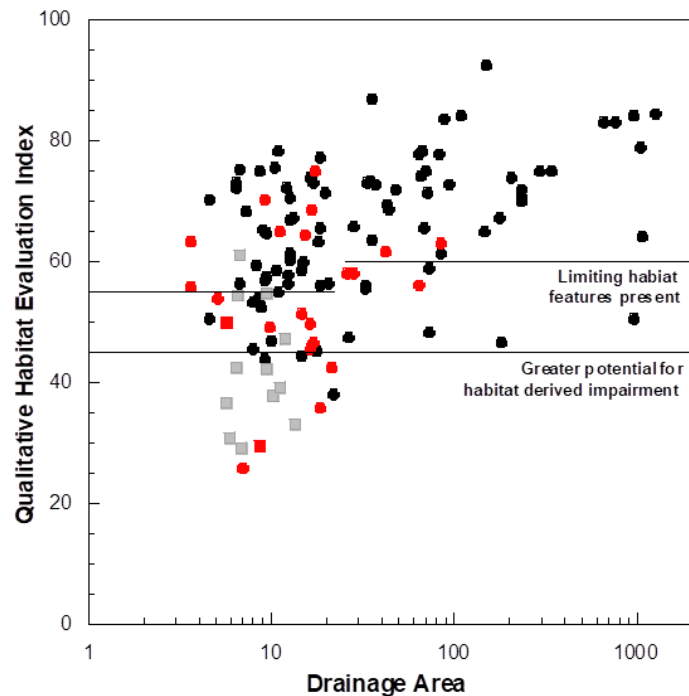
Figure 21 – QHEI scores displayed by drainage area from the current Sandusky survey, 2021-2023. Sites with one or more organism groups failing to achieve requisite criterion are identified in red. Sites with sub-use CWA aquatic life use designations (MWH or LRW) are indicated by grey squares.

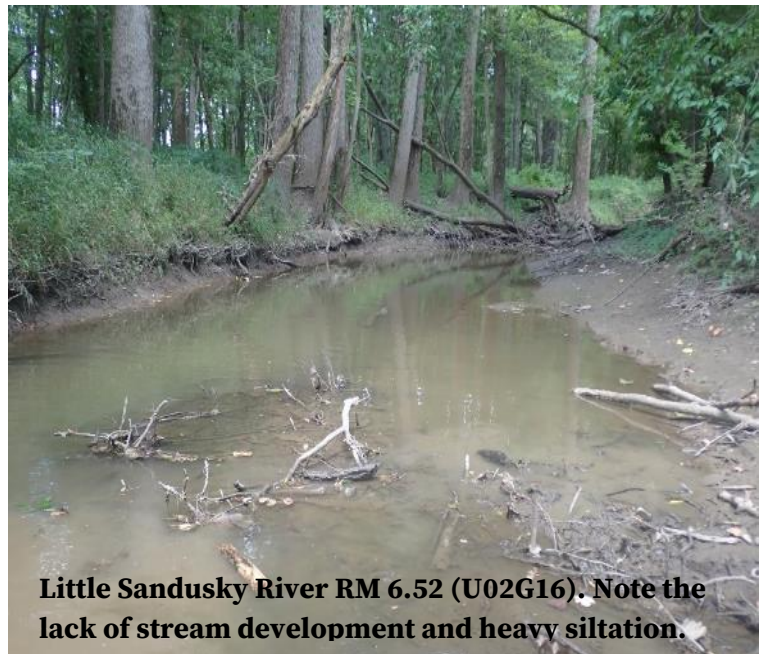
Little Sandusky River RM 6.52 (U02G16). Note the lack of stream development and heavy siltation.

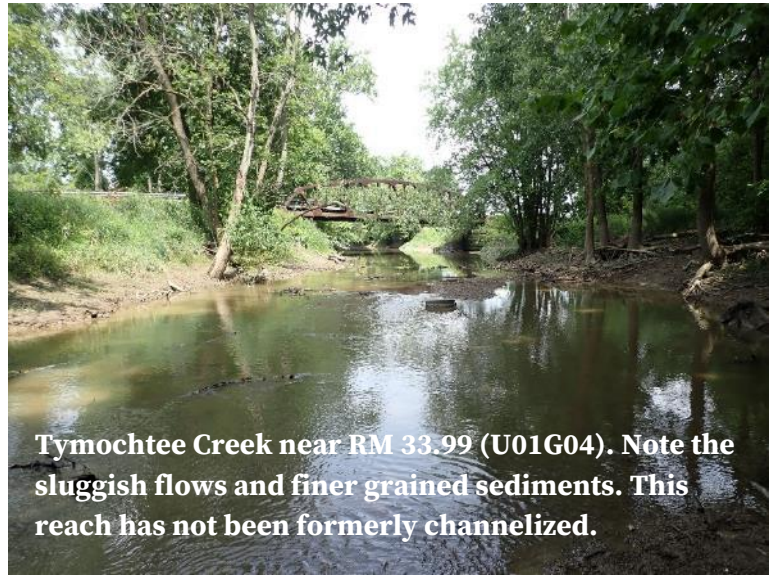
Tymochtee Creek near RM 33.99 (U01G04). Note the sluggish flows and finer grained sediments. This reach has not been formerly channelized.

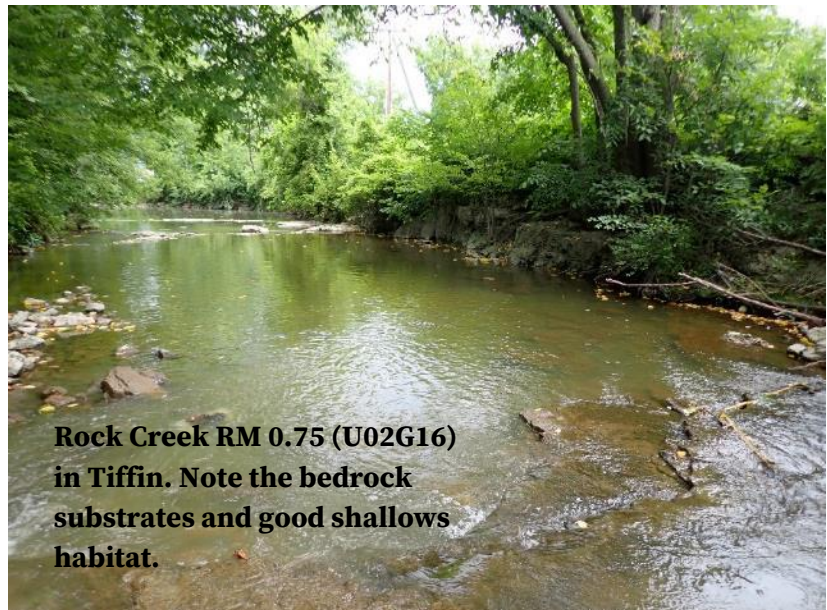
Conditions here were decidedly different from the upper reaches, being higher gradient and flowing over exposed limestone bedrock (pictured above).

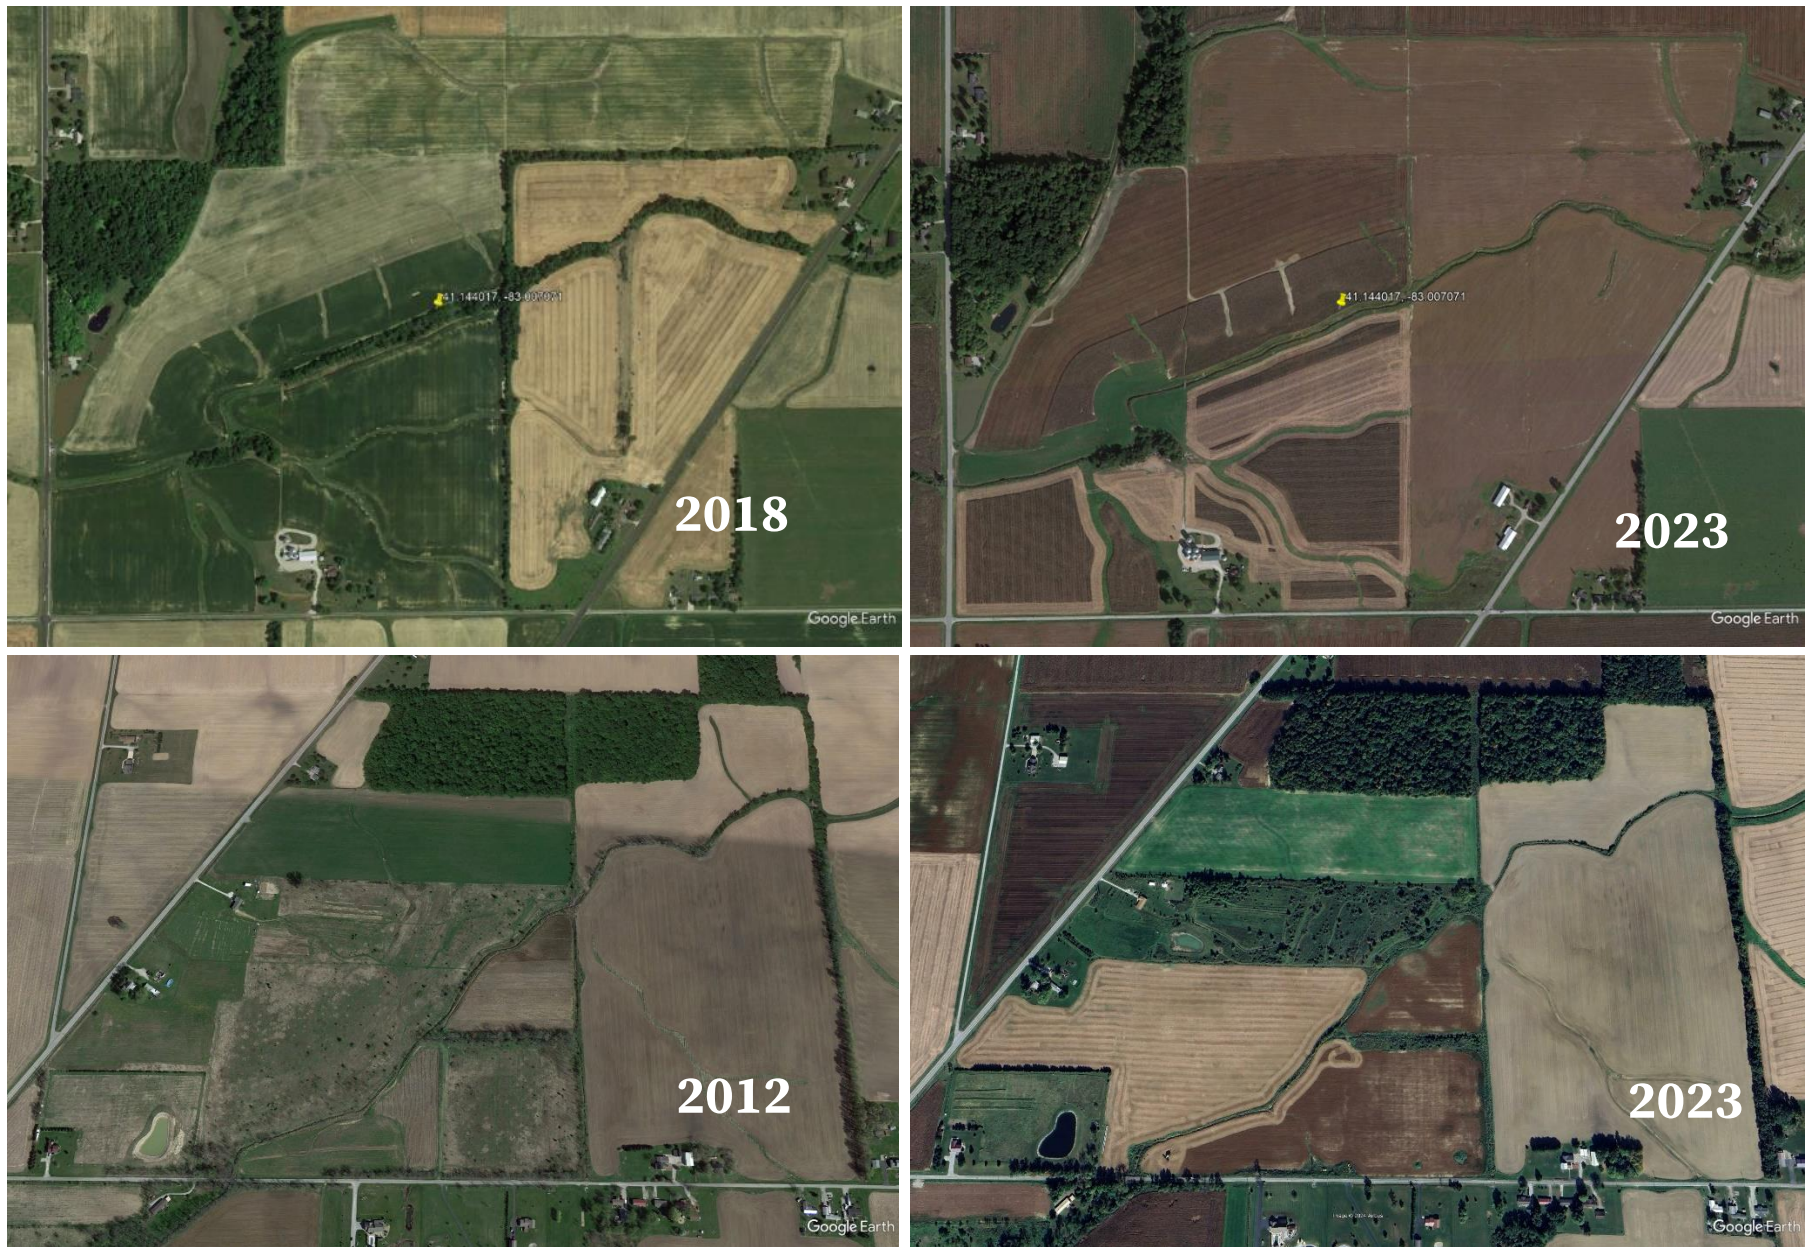
Figure 22 – Time-lapse aerial imagery displaying segments of upper Morrison Creek.

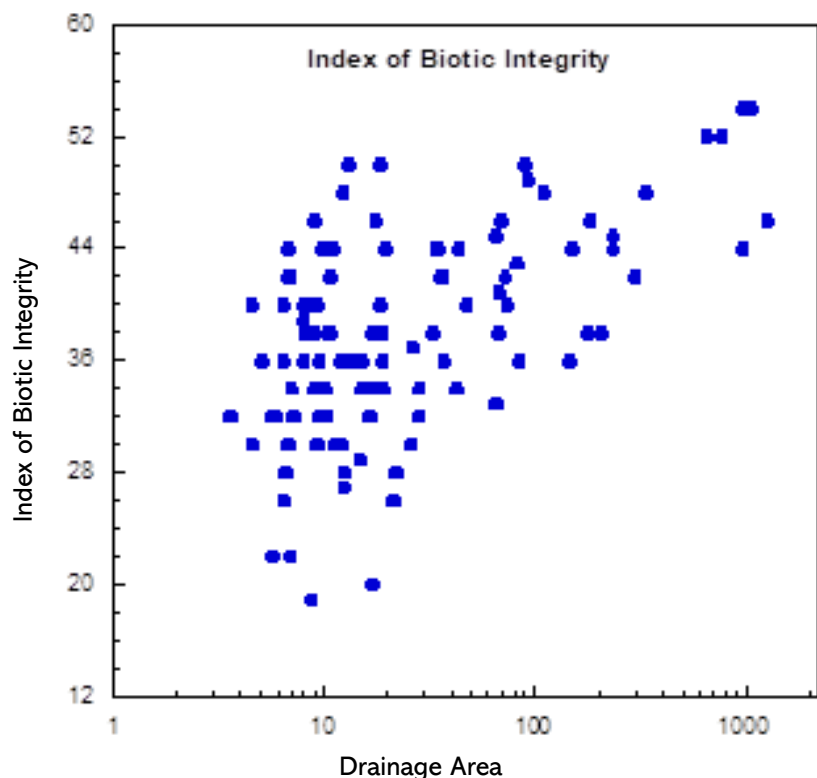
Figure 23 – Scatter plot of all IBI scores displayed by drainage area from the Sandusky River survey, 2021 & 2022.

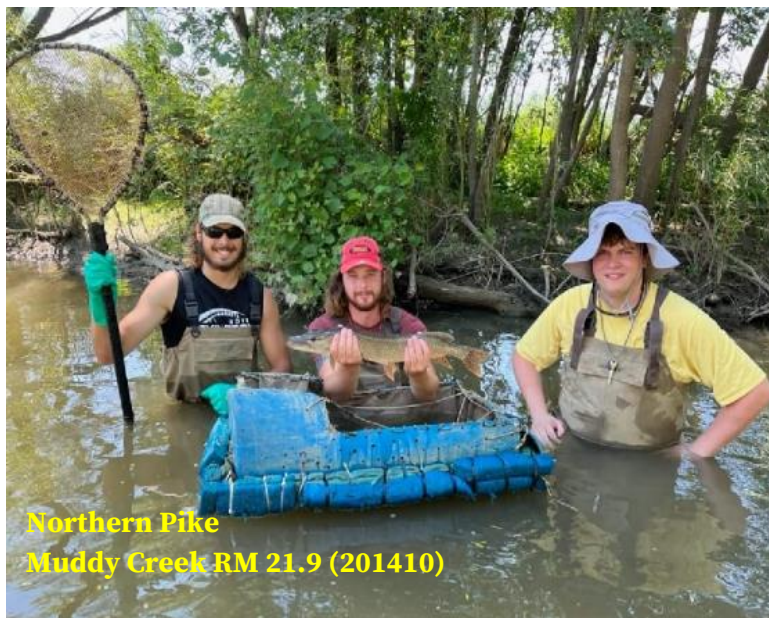
Northern Pike
Muddy Creek RM 21.9 (201410)

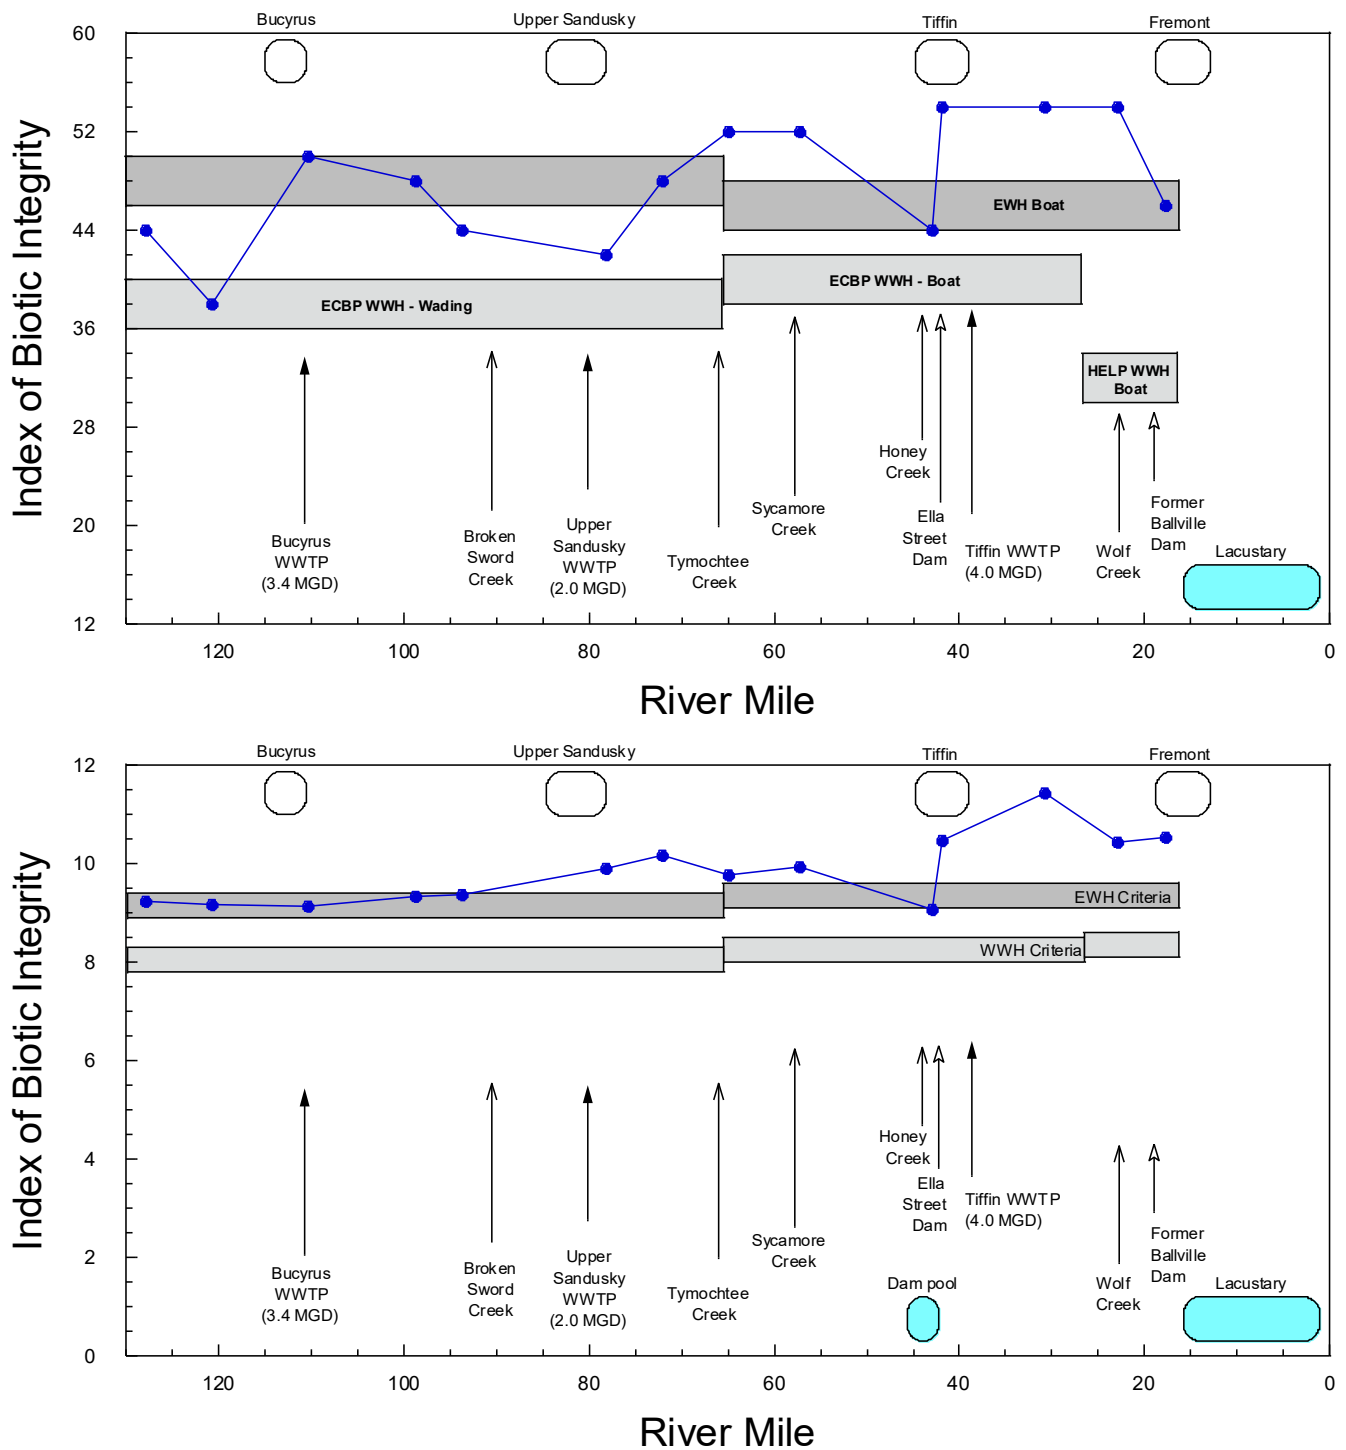
Figure 26 – Longitudinal display of IBI (top) and MIwb (bottom) scores from the Sandusky River mainstem, 2021-22.

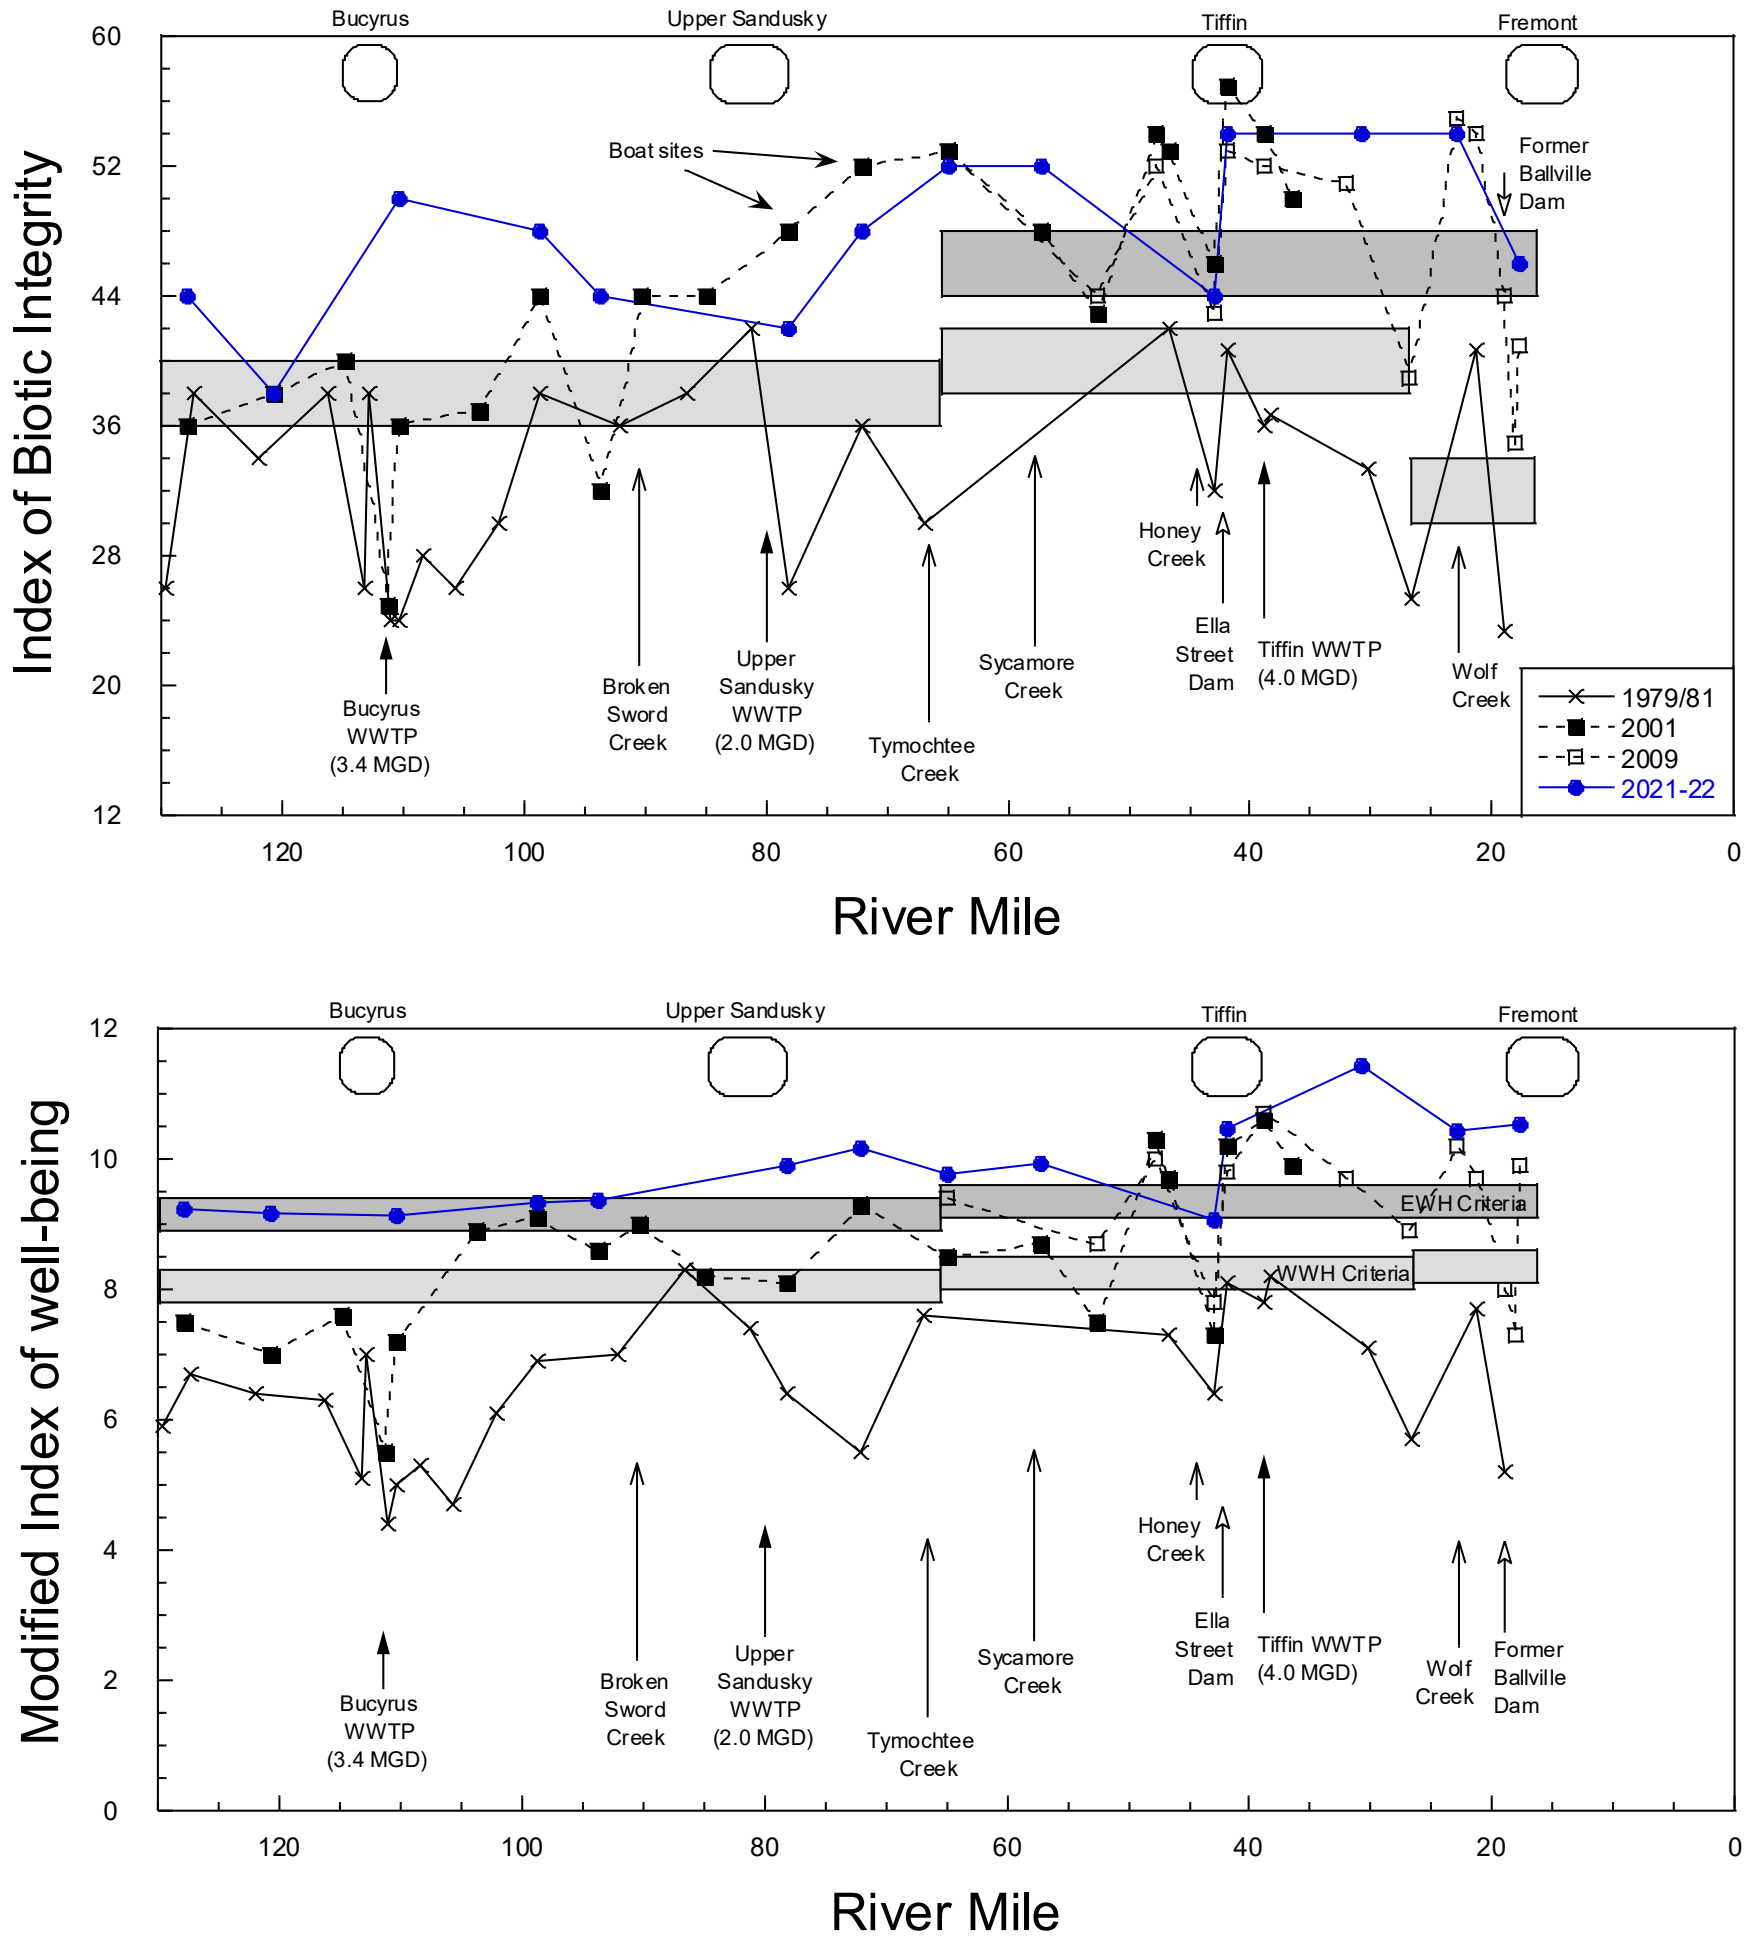
Figure 29 – Longitudinal display of IBI (top) and MIwb (bottom) scores from the Sandusky River mainstem from 2021/22, 2009, 2001, and 1979/81. Scores are displayed upstream to downstream.

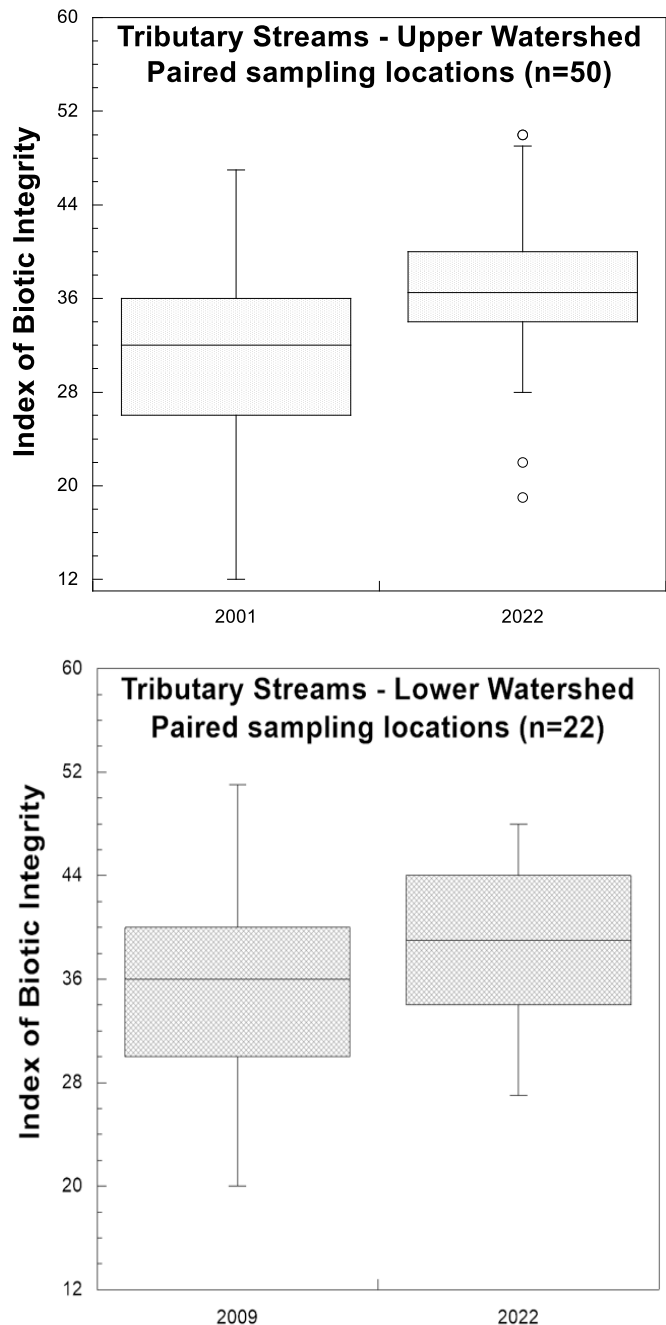
Figure 30 – Index of Biotic Integrity scores from paired sampling locations during the previous major surveys in the upper and lower portions of the watershed – 2001, 2009, and 2022.

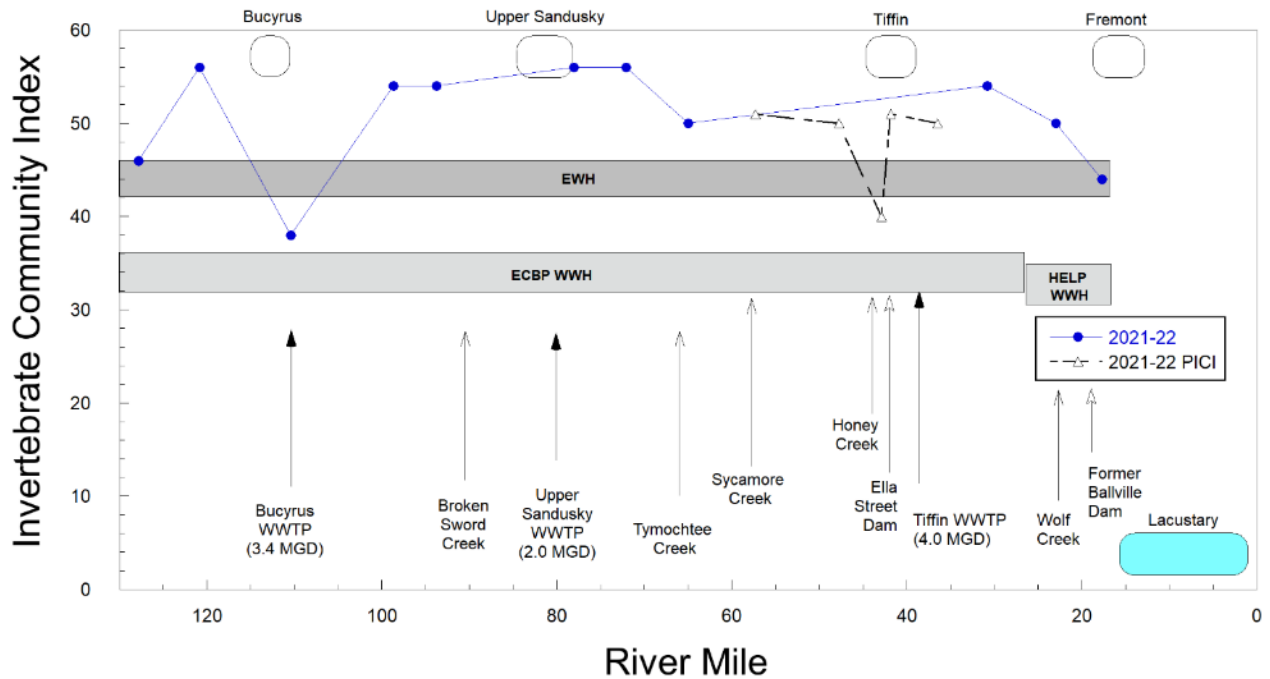
Figure 32 – Longitudinal macroinvertebrate ICI scores from the Sandusky River mainstem, 2021-2022. The predicted ICI was used where an ICI score wasn’t available.

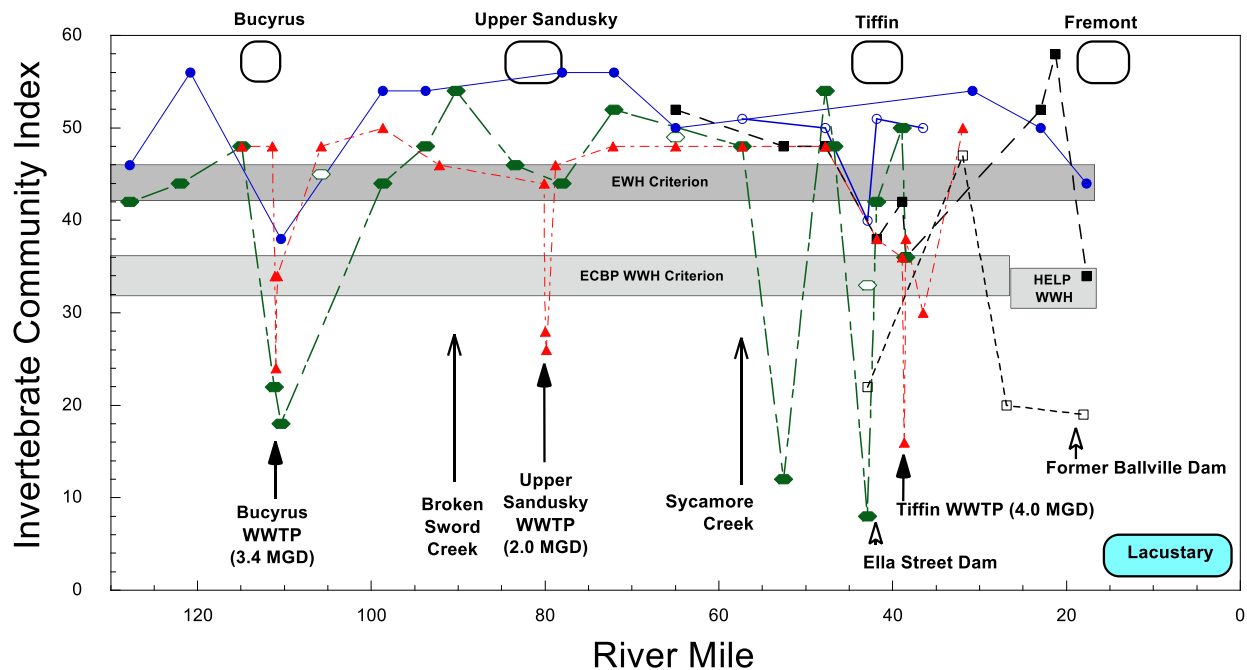
Figure 34 – Longitudinal display of ICI scores from the Sandusky River mainstem from 2022 (blue), 2009 (black), and 2001 (green), and 1991 (red). Predicted ICI scores based on qualitative sampling are used for display when an ICI score isn't available; these are indicated by the open-faced symbols.

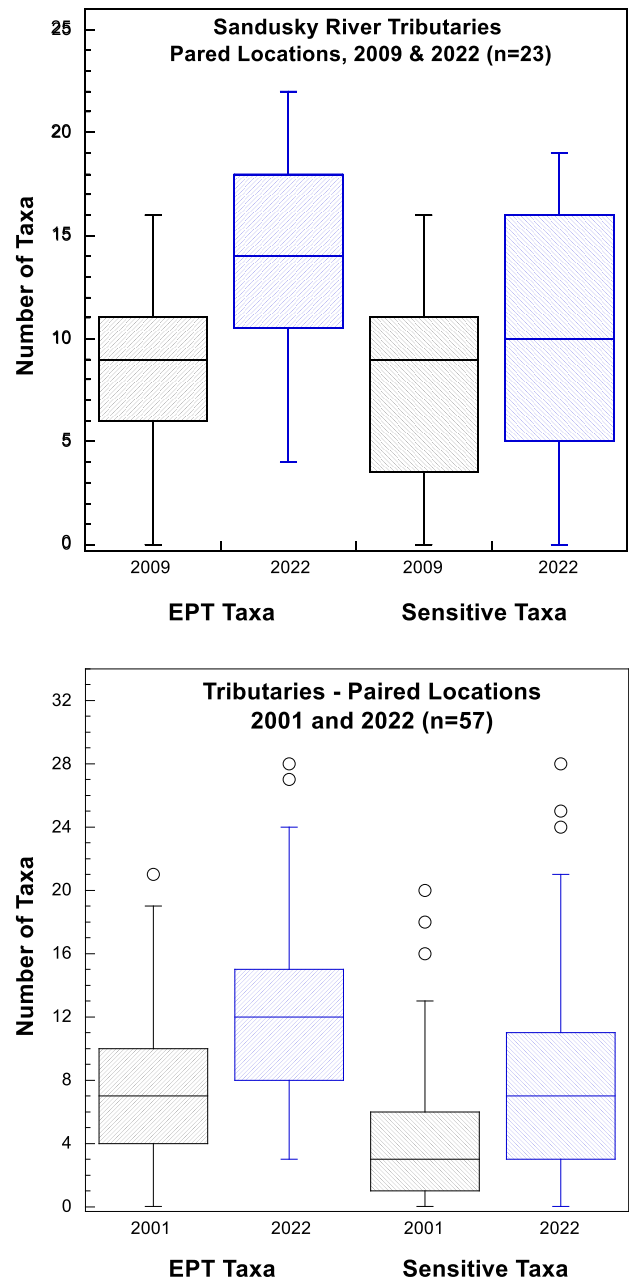
Figure 35 – Box plots displaying the numbers of EPT and sensitive taxa from paired locations in 2022, 2009, and 2001.

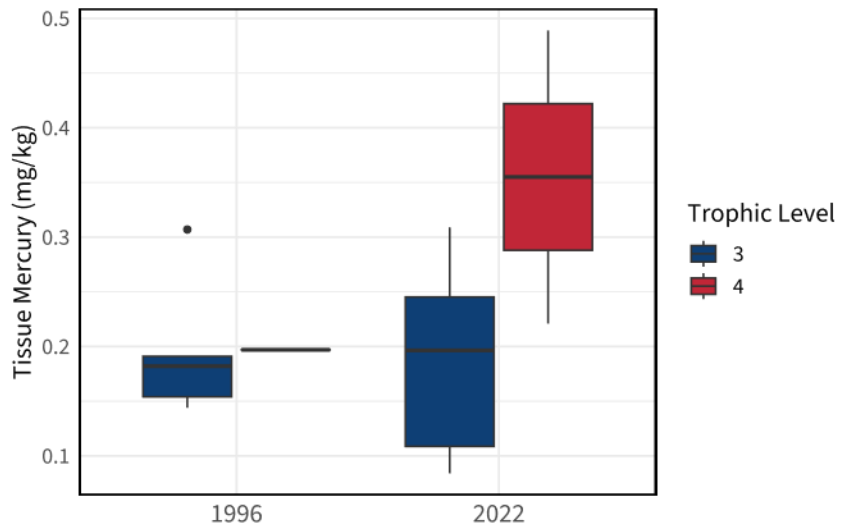
Figure 47 – Fish tissue mercury levels in trophic level 3 and trophic level 4 species collected from Broken Sword Creek in 1996 and 2022.
