Loading Analysis Plan and Supporting Data Acquisition Needed for the Tiffin River Watershed

Total Maximum Daily Load Development

Ohio EPA Technical Report AMS/2012-TIFFI-3

July 2023

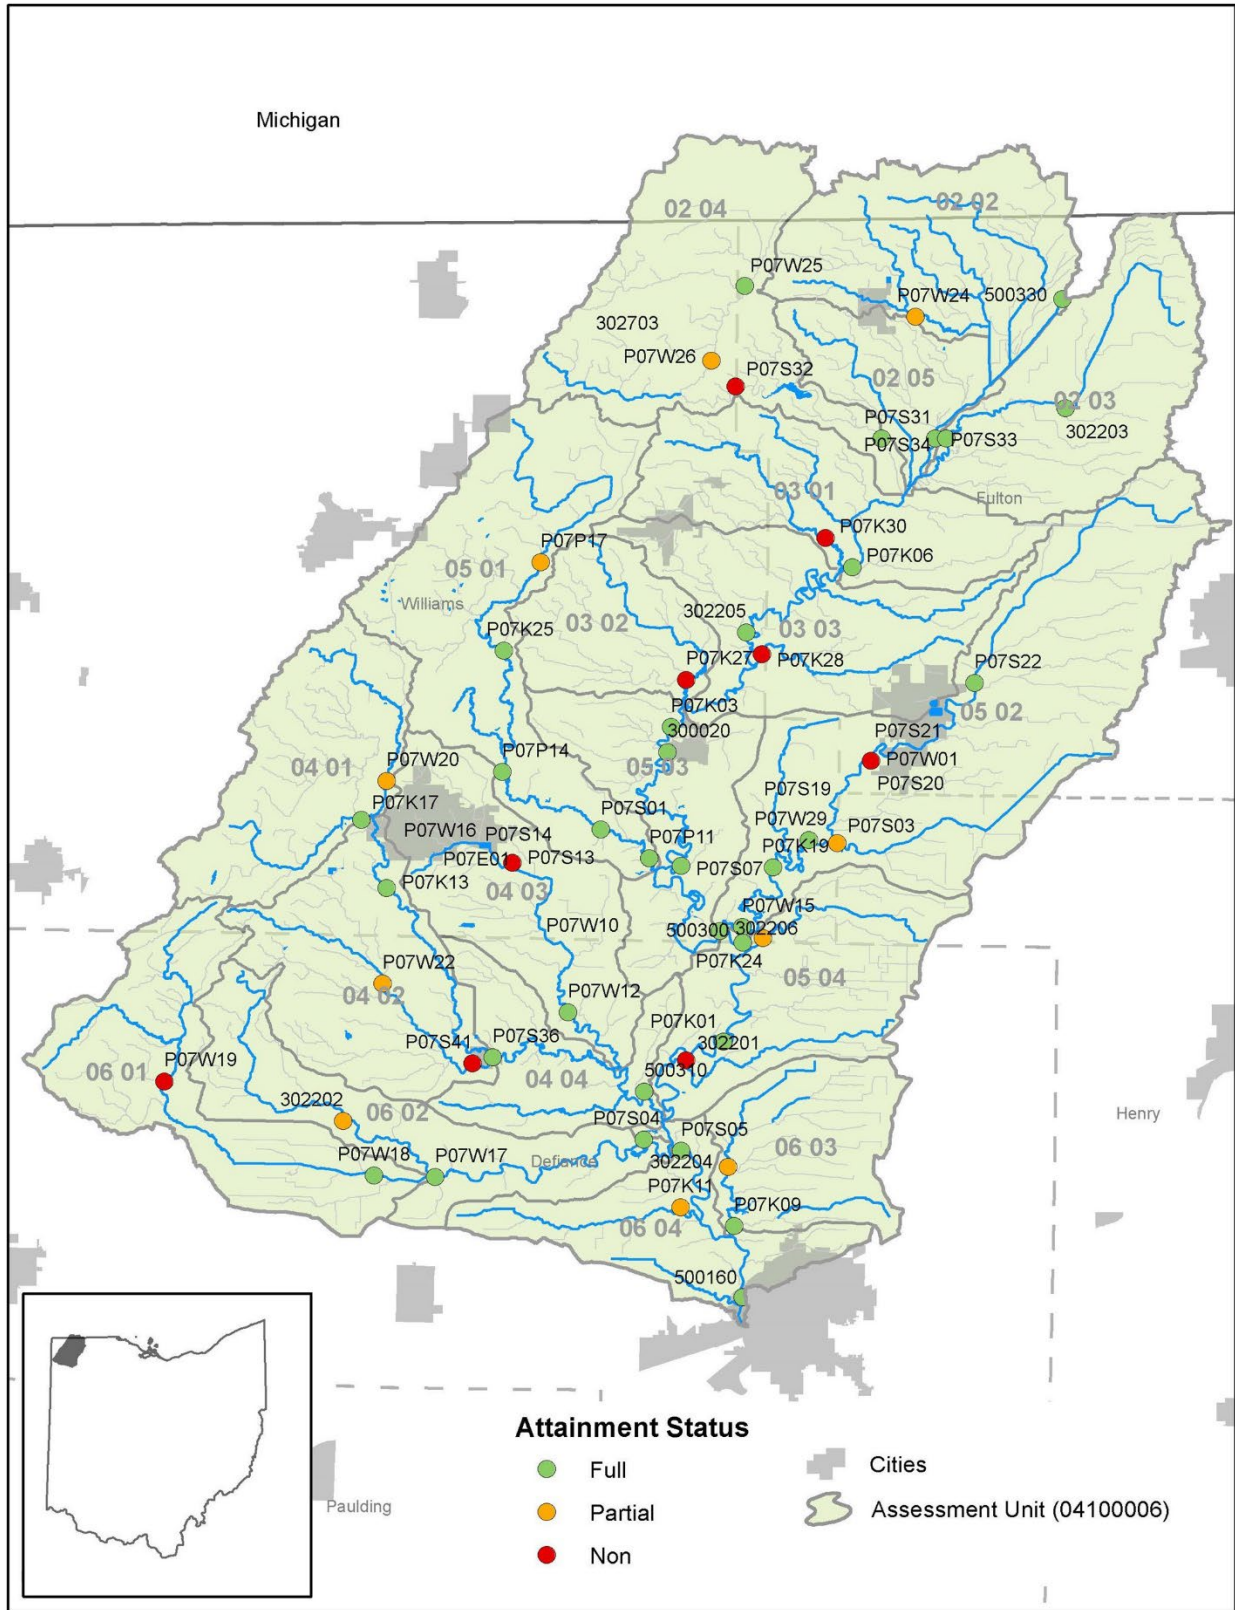
Figure 1 — Map summarizing ALU attainment status in the Tiffin River watershed from 2012-2014.

Aquatic Life Use (ALU) attainment details are documented in the biological and water quality report (Ohio EPA, 2015). The attainment status for each site is shown in Figure 1. Table 1 lists assessment sites not meeting their ALU designation. This table also contains the cause(s) and source(s) of impairment for each site.

Assessment for ALU was completed in 22 streams in the Tiffin watershed located in Defiance, Fulton, Williams, and Henry counties. Of the 52 sites sampled for ALU, 33 locations (63.5%) were in full attainment, 10 locations were in partial attainment (21.4%) and 9 locations (17.3%) were in non-attainment.

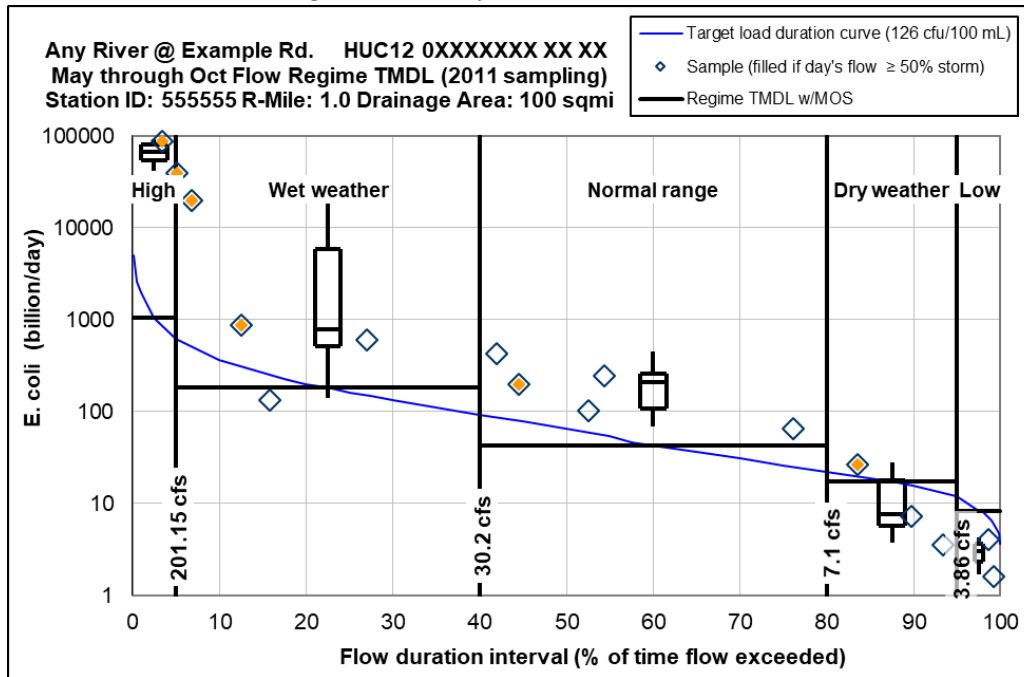
Figure 2 – Example load duration curve.

Due to these mechanisms of delivery, the sources of pathogens in surface waters can be determined to a certain extent via the level of stream flow observed. Therefore, Ohio EPA proposes using the load duration curve (LDC) framework for recreation use TMDLs. LDCs are an empirical method of determining TMDL pollutant loading and needed reductions. The main advantage of the use of LDCs is in this method's ability to differentiate loads from various types of sources based on stream flow regime. While this is a fairly basic modeling method, relationships between bacteria source contributions and flow regimes are straight forward. In-stream processes and interactions between pathogen sources are assumed conservative (i.e., not occurring) in this method. Figure 2 shows an example LDC with corresponding TMDL calculations represented in Table 6.

The primary contact recreation geometric mean criterion of 126 colony forming units per 100 mL *E. coli* will be used as the target concentration for the recreation use TMDL. As shown as the blue curve in the example load duration curve of Figure 2, above, this target concentration is converted into a load throughout the calculated flow regime. The black horizontal lines in Figure 2 and the “Total Maximum Daily Load” row in Table 6 show the TMDL values for five flow regime categories. This TMDL is the median of the curve load within each flow regime category.
