# Total Maximum Daily Loads for the Mohican River Watershed

Draft Report for Public Review  
Division of Surface Water  
December 2, 2014

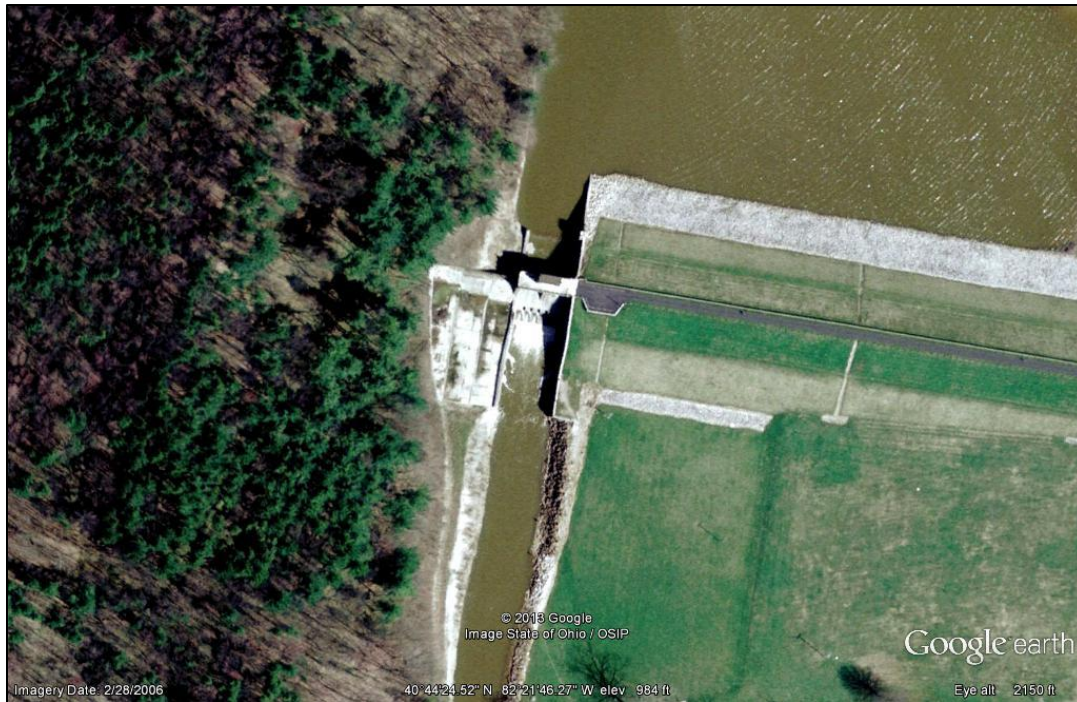
**Figure 4-3. Charles Mill Dam – shows bottom discharge.**
