# Total Maximum Daily Loads for the Paint Creek Watershed

Final Report  
July 19, 2012

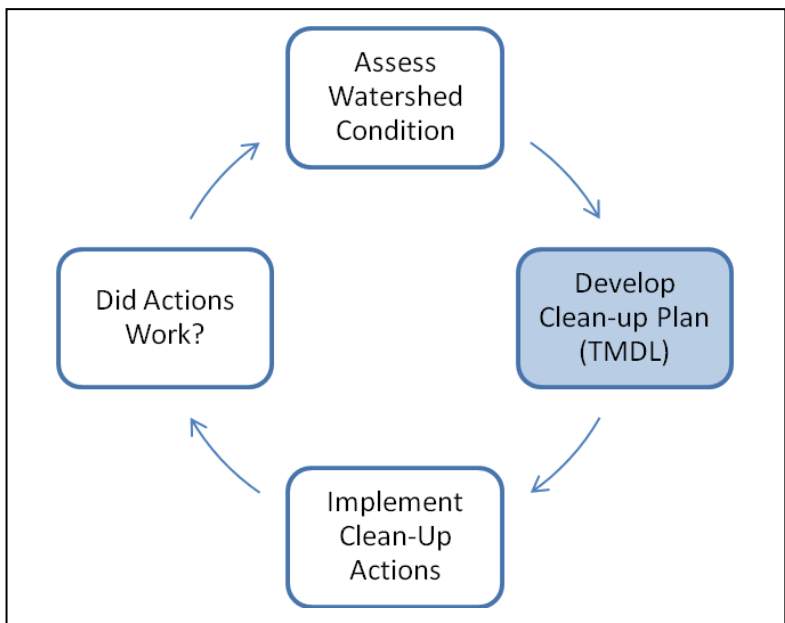
**Figure 1-1. Overview of the TMDL project process.**

In the simplest terms, a TMDL can be thought of as a cleanup plan for a watershed that is not meeting water quality standards. A TMDL is defined as a calculation of the maximum amount of a pollutant that a waterbody can receive and still meet water quality standards and an allocation of that quantity among the sources of the pollutant. Ultimately, the goal of Ohio's TMDL process is full attainment of water quality standards (WQS), which would subsequently lead to the removal of the waterbodies from the 303(d) list. Figure 1-1 shows the phases of TMDL development in Ohio.

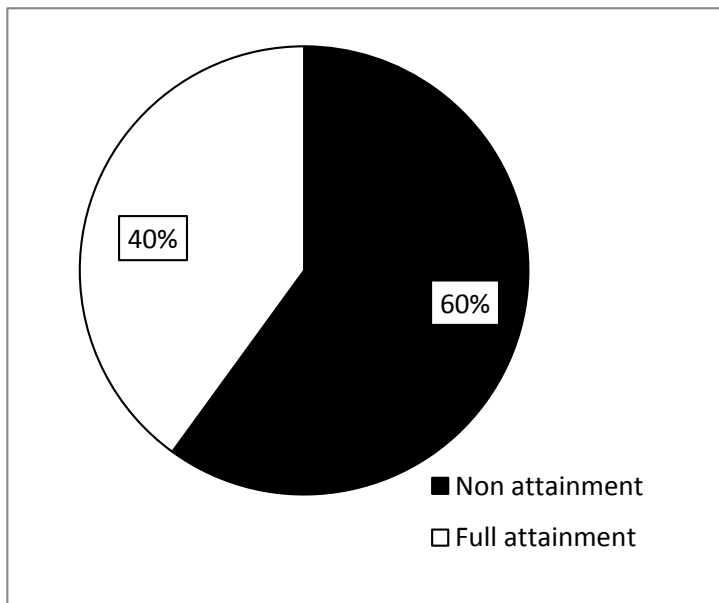
Figure 3-3. Attainment status for recreation uses in the Paint Creek watershed.

The attainment status of sampling sites for recreation use is shown in Figure 3-3. Non-attainment of water quality standards for recreation use

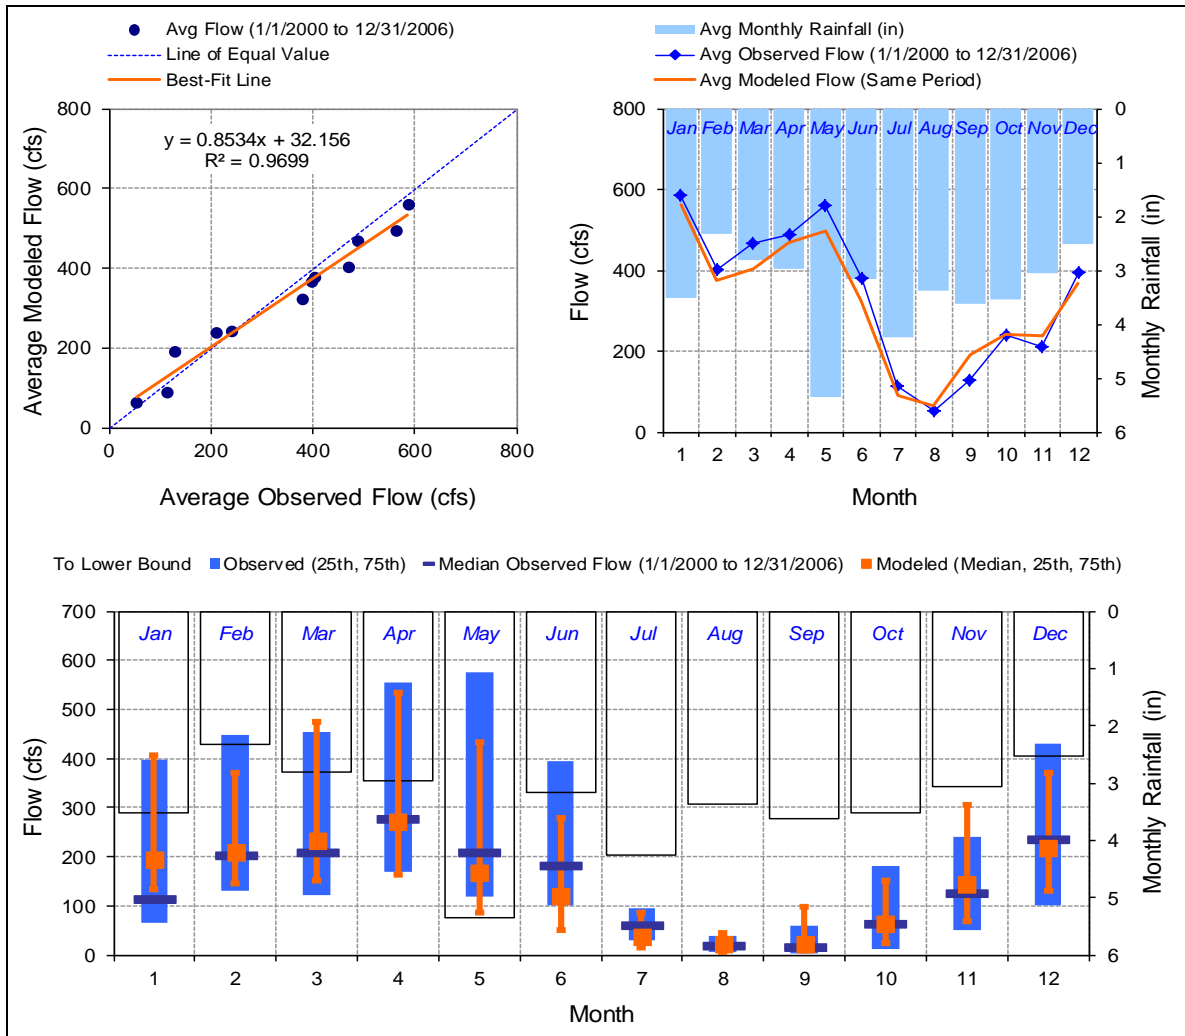
Figure 4-5. Additional modeled vs. observed flow plots for the assessment site of the USGS gage on Paint Creek at SR-753.
