**CHAGRIN
RIVER
WATERSHED
PARTNERS**

Black Brook NPS-IS

Nine-Element Nonpoint Source
Implementation Strategy Plan (NPS-IS)

HUC-12: 04110002 01 05

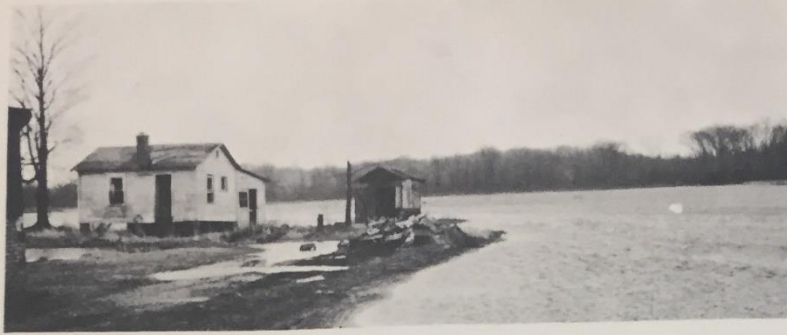
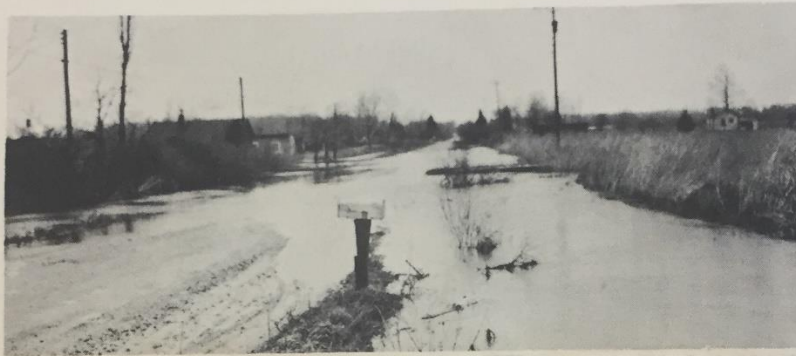
Flooding — A common sight in Black Brook

Flooding and poor drainage are an annual occurrence on 1,200 acres of the watershed. Because of this, crop returns are variable and portions of the valuable muck remain idle.

Large floods occurring in May, 1956; July, 1958; February, 1959; and March, 1963 resulted in extensive damage to roads, bridges, and homes.

Enlargement of present ditches to handle floodwater is impossible because of lack of room between the road and the residences.

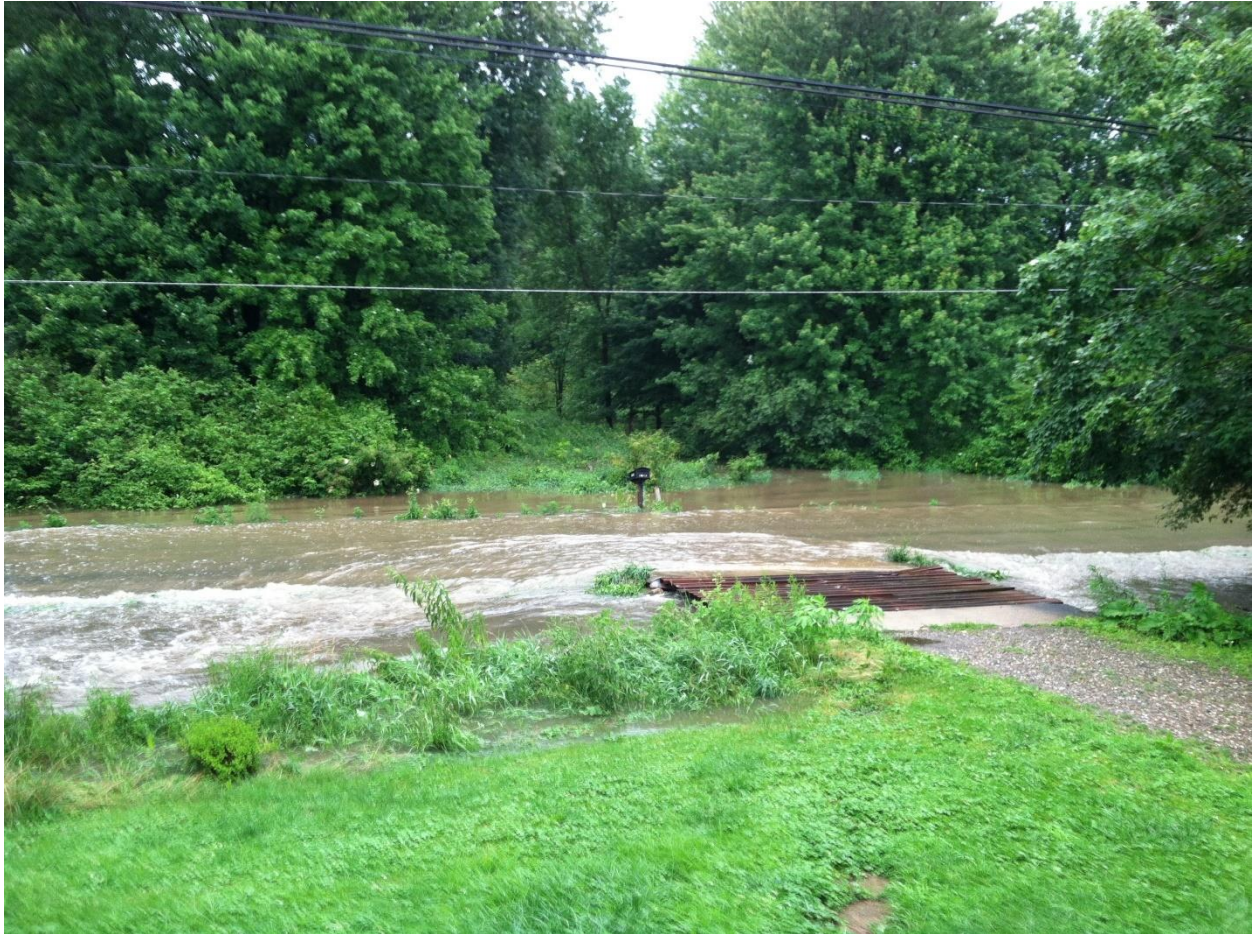
Figure 9: Overflowing ditches along Mantua Center Road. Photo taken July 11, 2013 by resident.

Farms and residential areas continue to flood, and residents have expressed concern about increased flooding that may be due to increased upstream development. Most of the residents experiencing flooding problems area in Zone A, with the floods posing a health and safety risk. Although the Black Brook ditches run on both sides of Mantua Center Road, the flooding tends to be worse on the east side and driveways are often underwater.

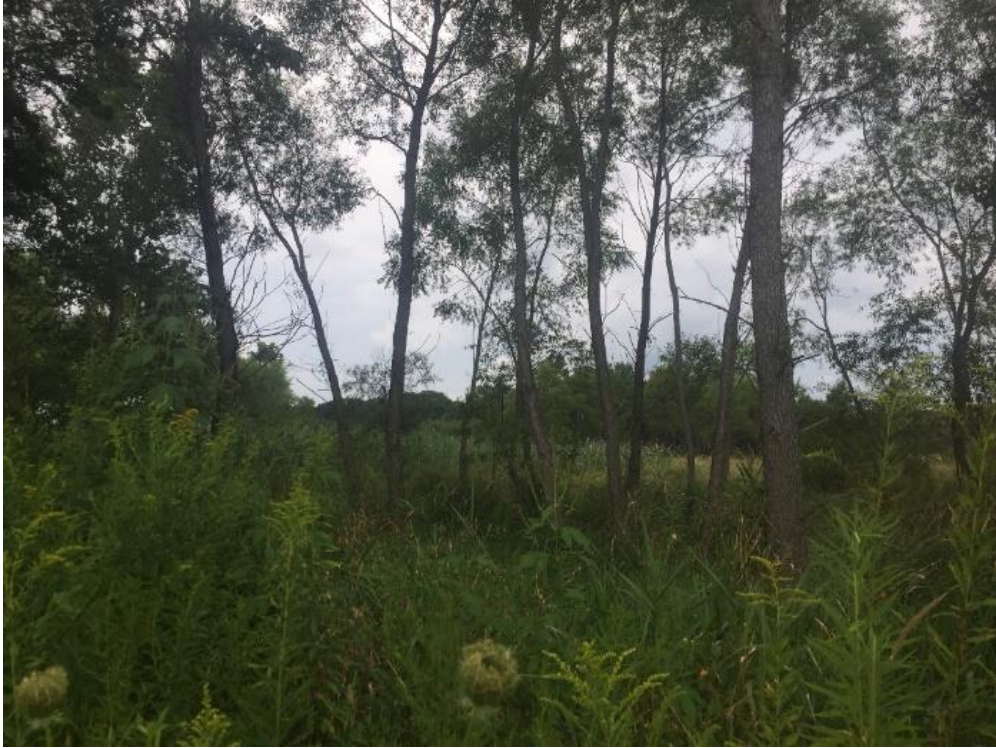
- The Black Brook Conservancy District owns three properties (no structures) west of Mantua Center Road: 23-015-00-00-024-000 (8 acres), 23-015-00-00-022-000 (10 acres), and 23-015-00-00-021-000 (10 acres). These properties could be used to help with flood control.

Figure 16: Black Brook Conservancy District land. August 17, 2017. Photo by Alicia Beattie.

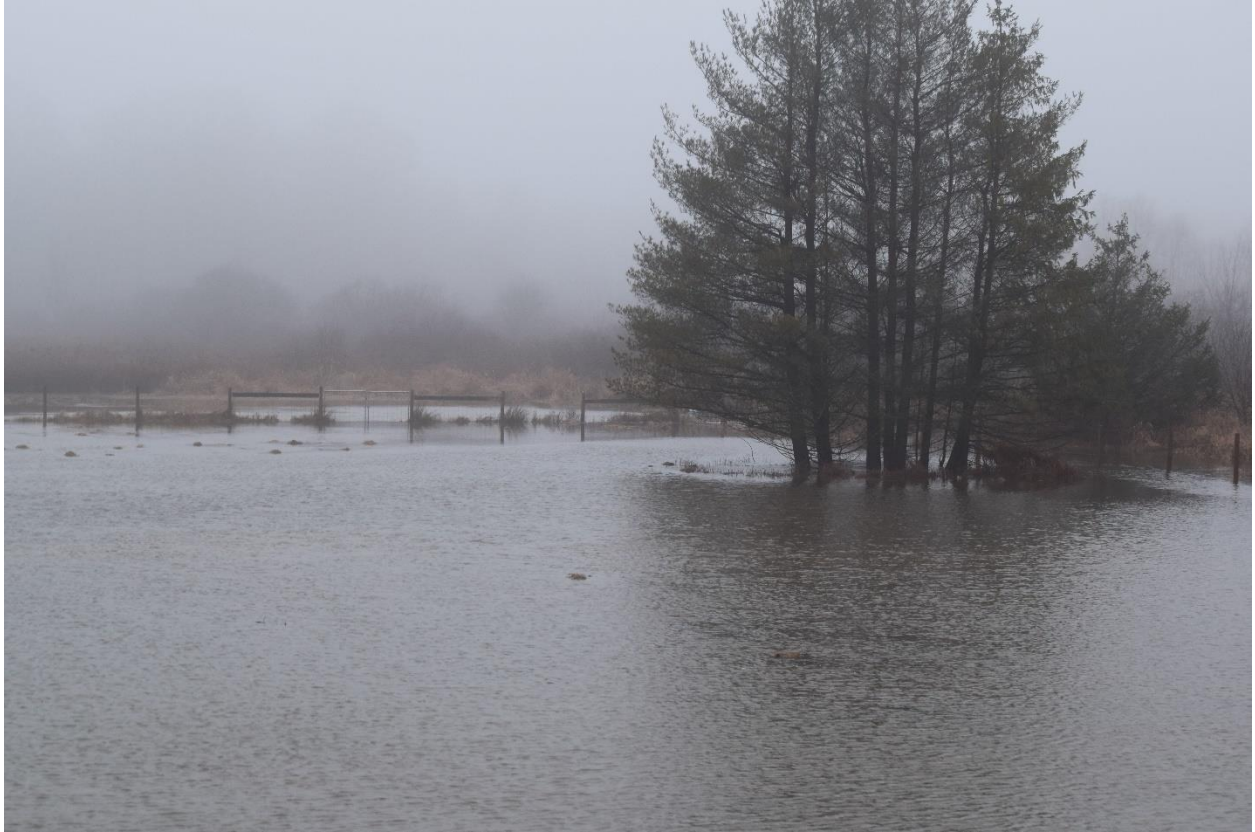
Figure 22: Flooding on residential property along Mantua Center Road. January 12, 2017.

This area includes the riparian areas of Black Brook as well as numerous wetland complexes throughout the HUC-12. These wetlands serve critical functions in terms of filtering water and minimizing flooding during heavy rains and major weather events. In the late 19th century, a road today named Mantua Center Road was built with 8-foot deep ditches on either side and the surrounding swamps were drained. This area was farmed for celery, carrots, and green onions. However, flooding continued to create problems for the farmers. Today, many residents living along Mantua Center Road continue to experience flooding during large rain events.

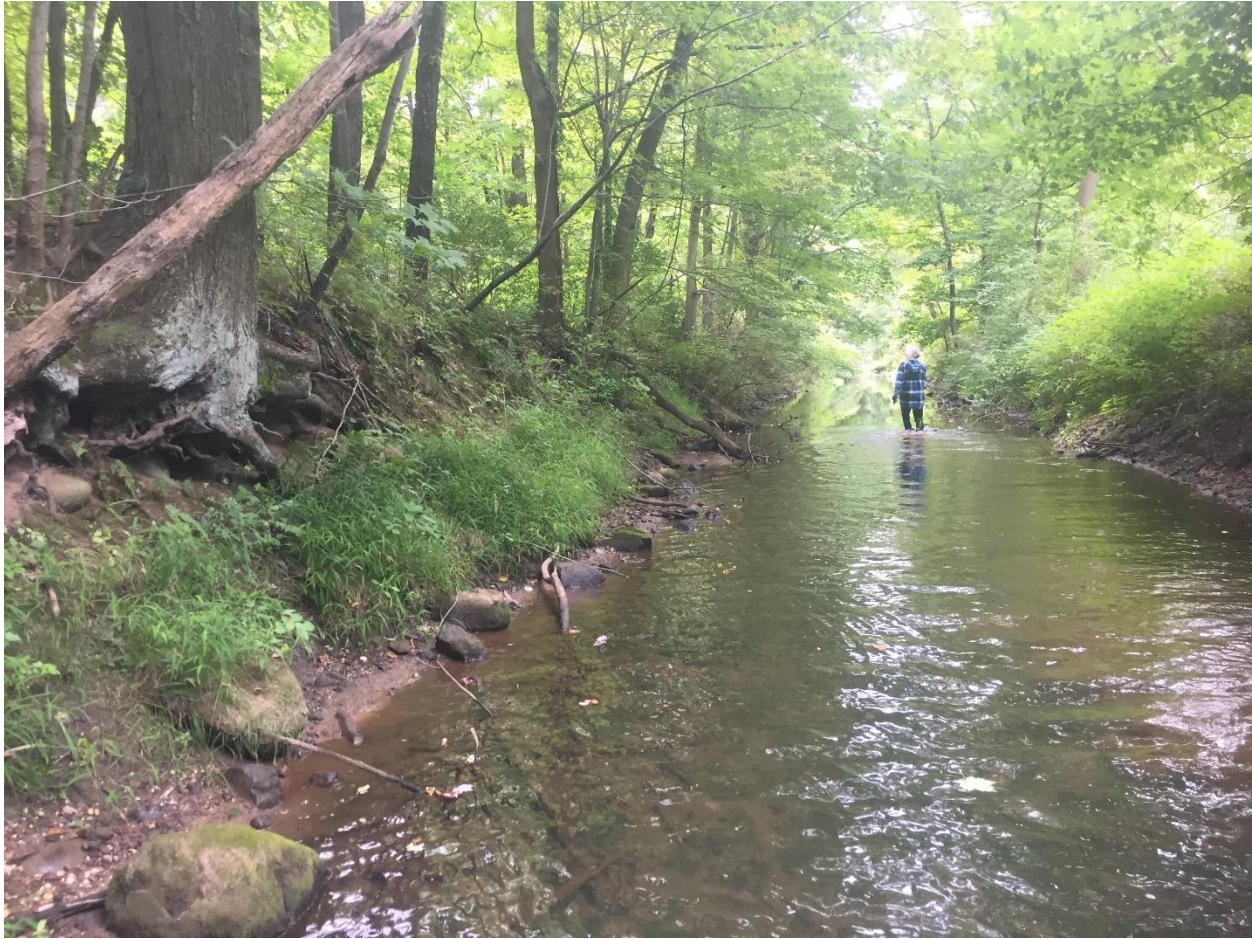
Figure 23: Channelized reach of Black Brook downstream south of Winchell Road. Photo taken August 17, 2017 by Alicia Beattie.
