Martin's Run Ecological Restoration Project

Feasibility Report

Project Number 003-021

December 2018

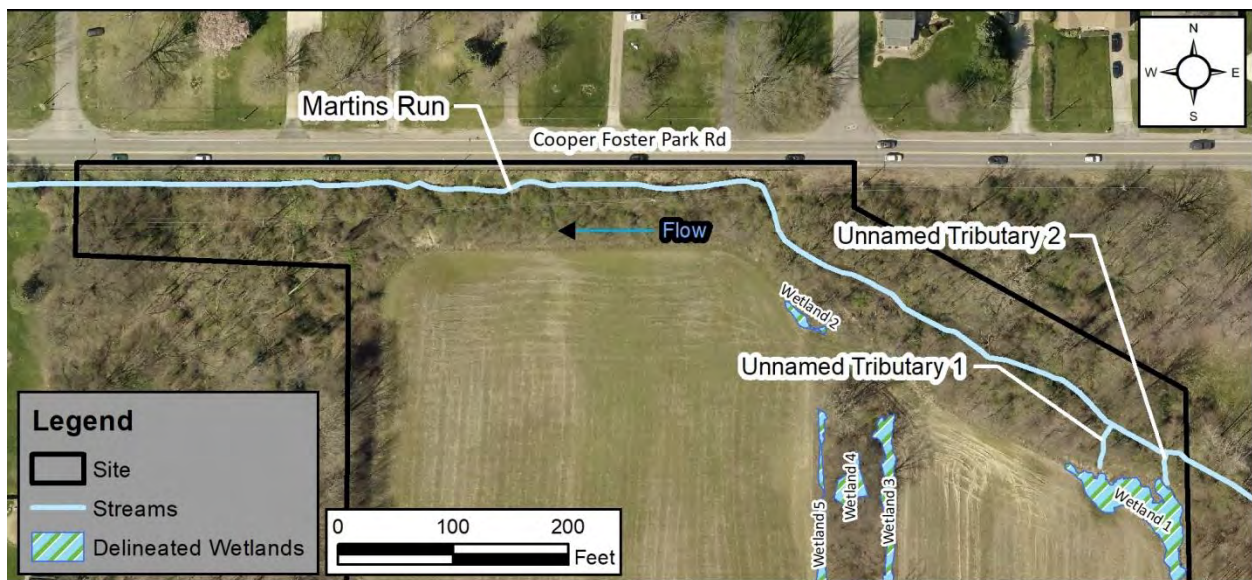
Figure 4: Martin's Run and Unnamed Tributaries

Martin's Run and two unnamed tributaries of Martin's Run occur on the Site, as shown below in Figure 4. Approximately 1,060 linear feet of Martin's Run is contained within the northern forested area on-Site. This area is dominated by pin oaks (*Quercus palustris*), black locust (*Robinia pseudoacacia*), elm (*Ulmus spp.*), sassafras (*Sassafras albidum*), and cottonwood (*Populus deltoides*). In-stream cover includes marginal overhanging vegetation as well as small amounts of rootmats, boulders, woody debris, and aquatic macrophytes. The stream has fair quality riffle/pool development. The stream is moderately entrenched with the streambanks being approximately 3 to 4 feet in height. Water depths at baseflow are 0.25 to 2 feet with moderate to fast velocities. The bankfull stage of the stream is approximately 1.3 feet. According to Ohio EPA, the designated aquatic life use for Martin's Run as warm water habitat (WWH) and monitoring data from 2015 at Tower Boulevard (approximately 1.5 miles downstream of the Site) indicates that the stream is in non-attainment of the WWH aquatic life use¹. Further discussion into stream geomorphology and classification can be found in Section 2.6.

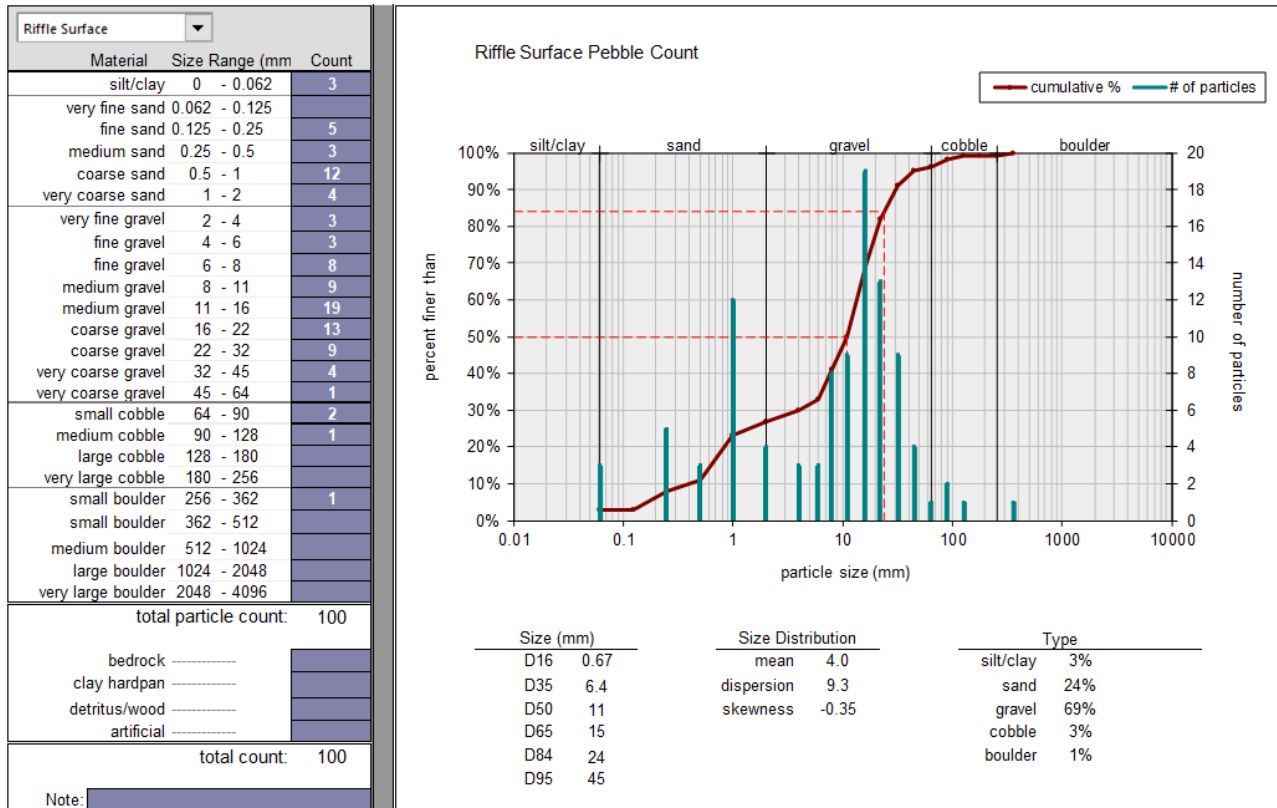
Figure 7: Pebble Count Data

Bed material in the channelized reach includes higher percentages of cobbles and boulders due to material that has been placed along road to help protect against erosion. The larger substrate is predominantly artificially-placed materials as opposed to an indication of what is being transported by the stream. The channel has cut down deep enough in places to reach the shallow sandstone bedrock. Sand and silt, as well as some gravel compose the majority of the channel bed substrate.

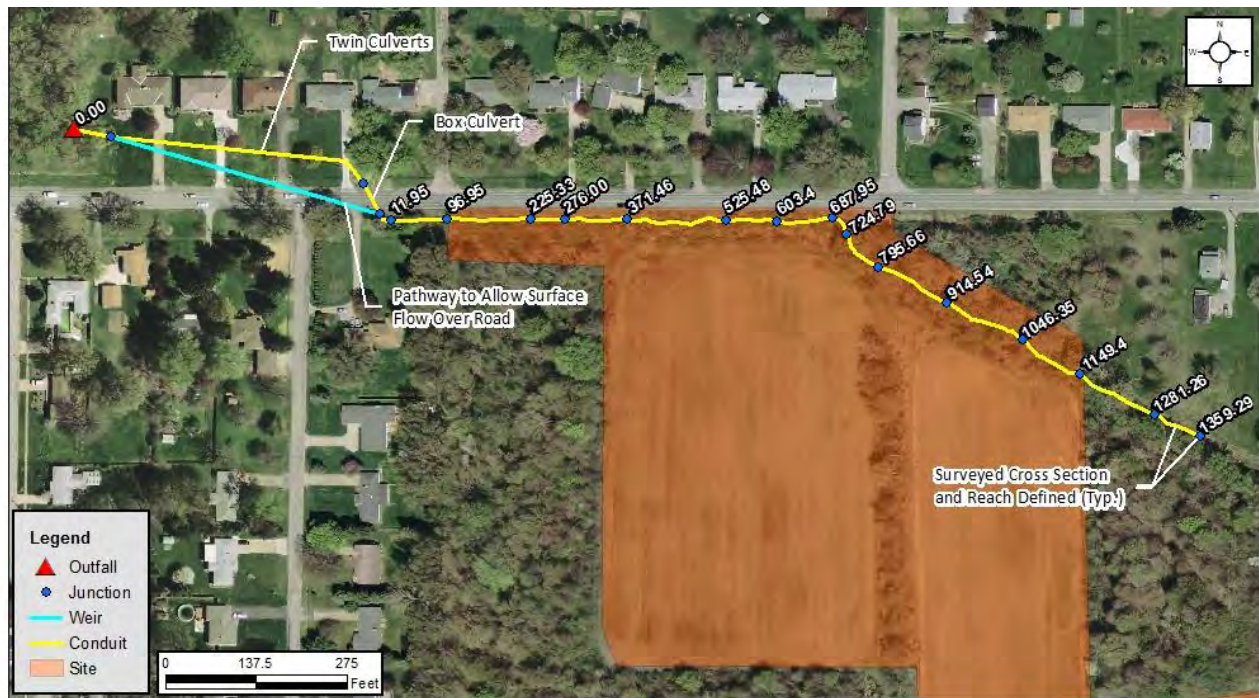
Figure 10. Plan View of PCSWMM Geometry – Existing Conditions

The geometry of the existing conditions model consists of conduits and junctions, modeled to represent 15 individual cross sections within the project area, through a series of open irregular natural channels defined by transect coordinates obtained from the 2018 survey. Additionally, the existing conditions model consists of two (2) culverts crossing Cooper Foster Park Road, with one additional cross section taken downstream of the culverts, outside of the project area. Cross-sections were located to pick up changes in channel geometry, in addition to the upstream face of the upstream-most culvert. Field measurements were collected to further define the culverts extending beyond the limits of the survey. Figure 10 illustrates the existing conditions model geometry.

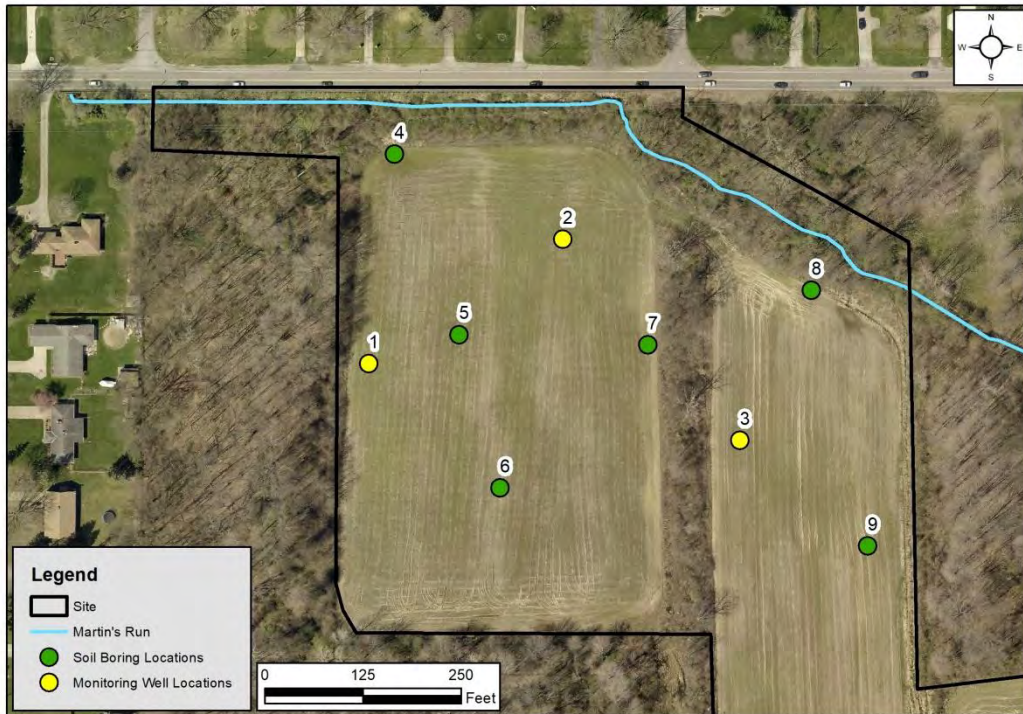
Figure 13: Boring and Monitoring Well Locations

Boring depths ranged from 18.7 to 20 feet below existing grade. Bedrock elevations are higher near borings 1, 2, 3, 6, and 7. Based on a historic 1903 USGS map (see Figure 14 below), a tributary once ran through this area. It is possible that the higher bedrock ridges extend further south and east, with lower bedrock elevations at the former channel location east of boring 6. The locations of borings are shown on Figure 13 and boring results are shown on Table 7.

GeoSci, Inc. completed soil borings at nine locations on the Site. Topsoil depth within borings averaged 12 inches. Subsurface soils consisted primarily of silty clay, sandy silty clay, and clayey silt with varying amounts of gravel and sandstone fragments. Bedrock was encountered at six of the nine borings and consisted of very soft to medium hard shale, sandstone, and siltstone. Samples were collected at all nine test boring locations and the team noted where bedrock and water were first encountered. Samples were sent to GeoSci’s laboratory for further analysis. Specific soil classification and engineering parameters are documented in the report by GeoSci (Appendix H).

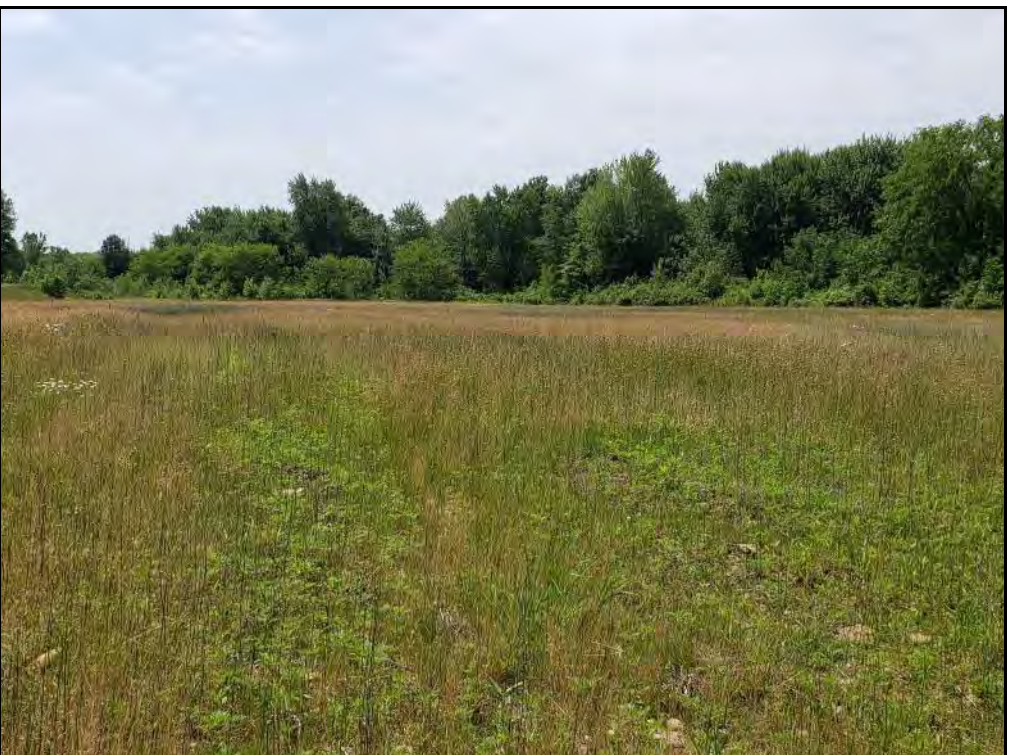
Photo No. 2	Date: 6/7/2018

Direction Photo Taken: South		
Description: Representative view of open field areas on the Site. The fields have been under cultivation for an extended period of time and were planted with soybean the previous growing season (2017).

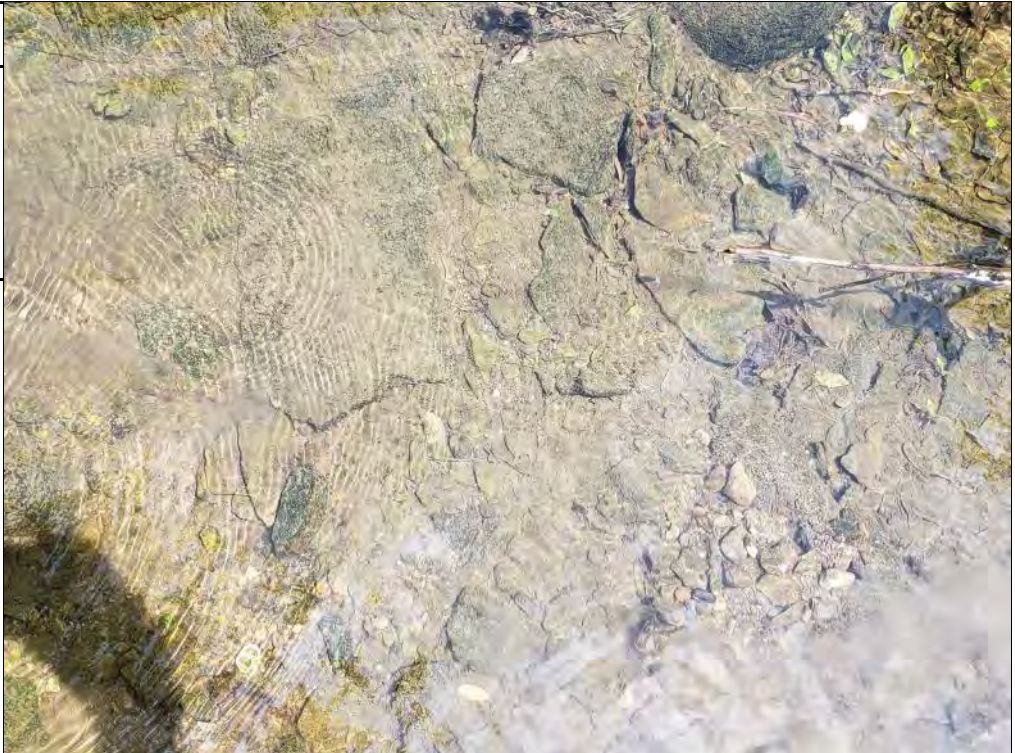
Photo No. 5	Date: 6/7/2018

Direction Photo Taken: Down		
Description: View of Martin's Run substrate.

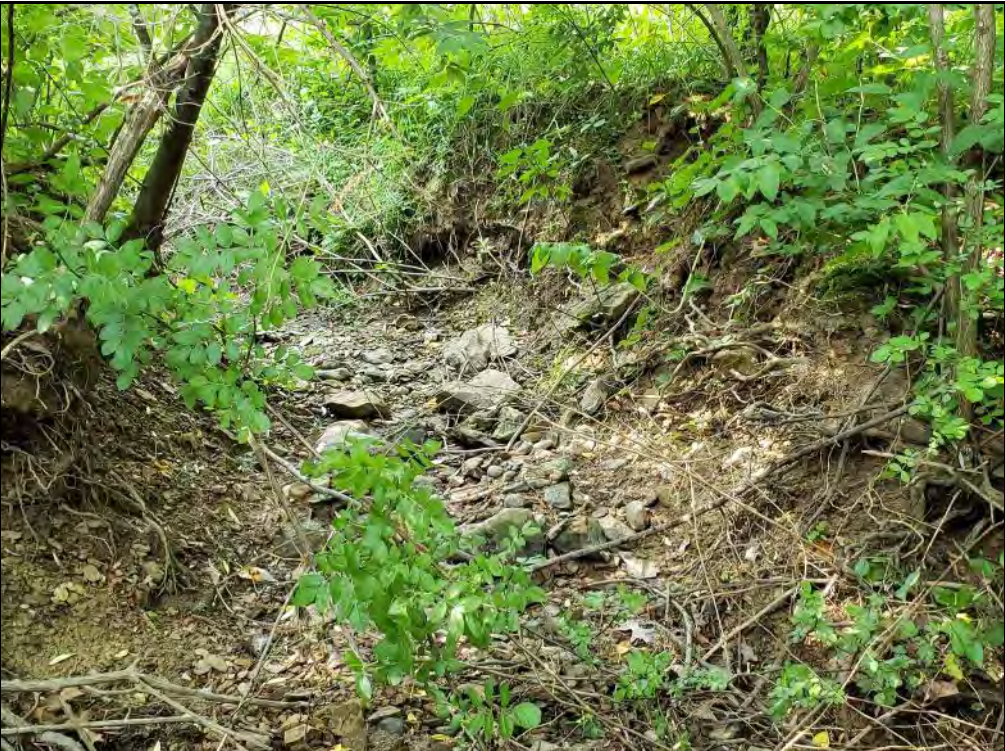
Photo No. 7	Date: 6/7/2018

Direction Photo Taken: South/Upstream		
Description: View of small ephemeral tributary (Unnamed Tributary 1) to Martin's Run. The channel originates at a tile at the edge of the cultivated field.

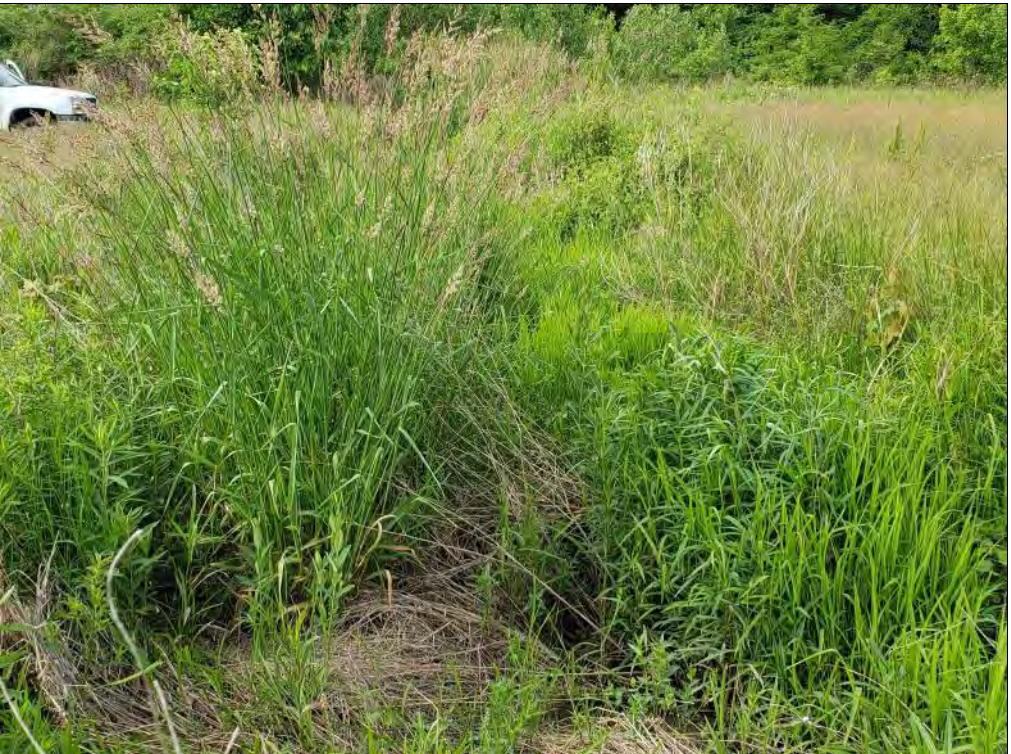
Photo No. 10	Date: 6/7/2018

Direction Photo Taken: South		
Description: View of Wetland 1, linear wetland.

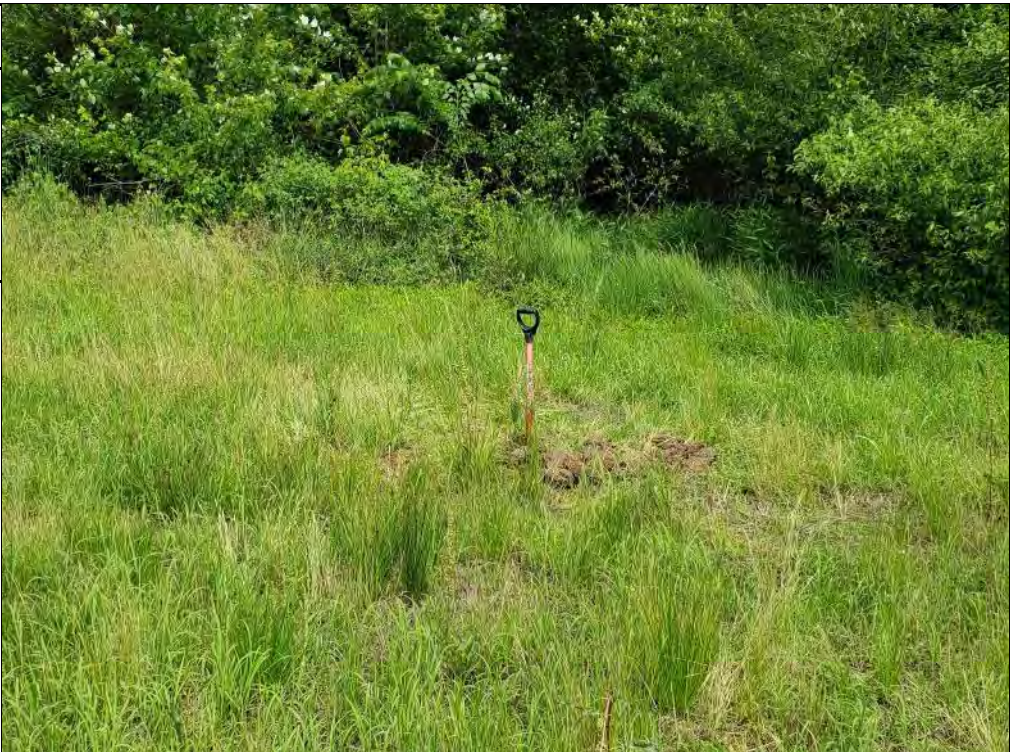
Photo No. 20	Date: 6/7/2018

Direction Photo Taken: North		
Description: Plot 6: Non-wetland plot in the northwestern portion of the site.

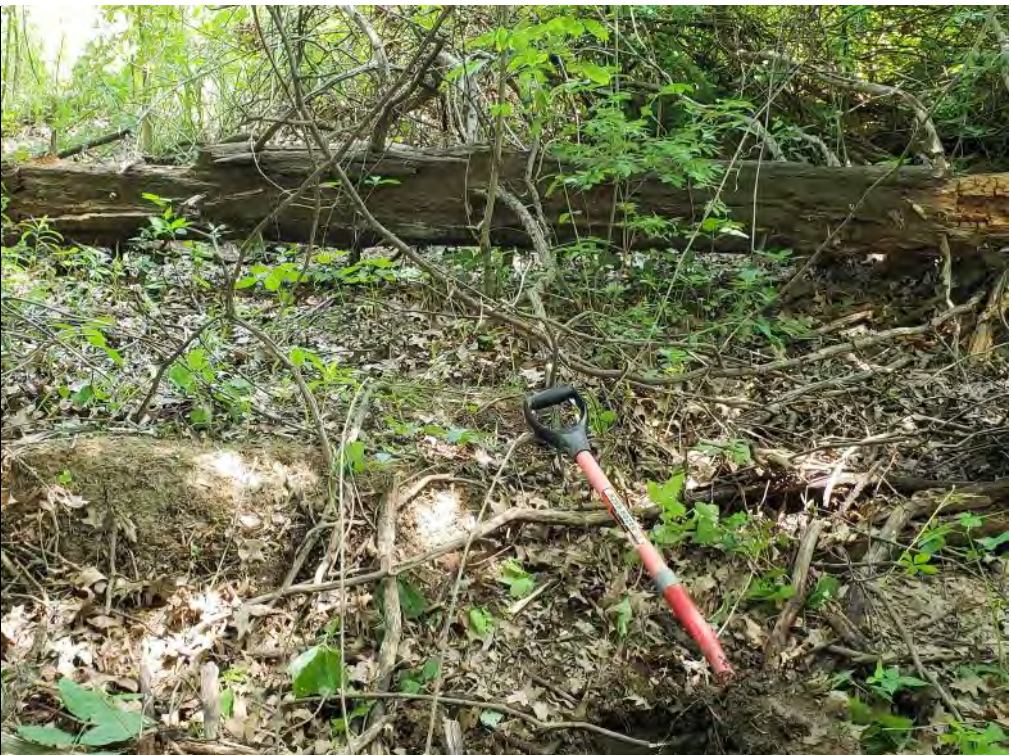
Photo No. 26	Date: 6/7/2018

Direction Photo Taken: East		
Description: Plot 10: Non-wetland plot located south of Wetland 4.

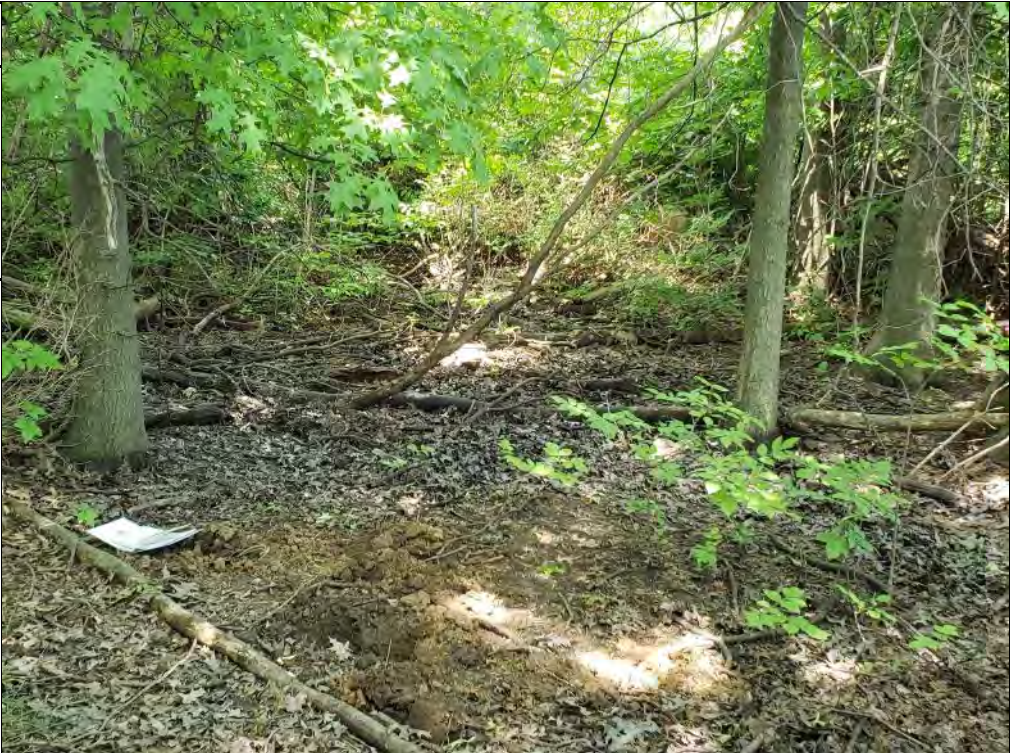
Photo No. 27	Date: 6/7/2018

Direction Photo Taken: North		
Description: View of Wetland 4 (Plot 9). This is a small forested wetland (PFO) located within a linear wooded corridor.

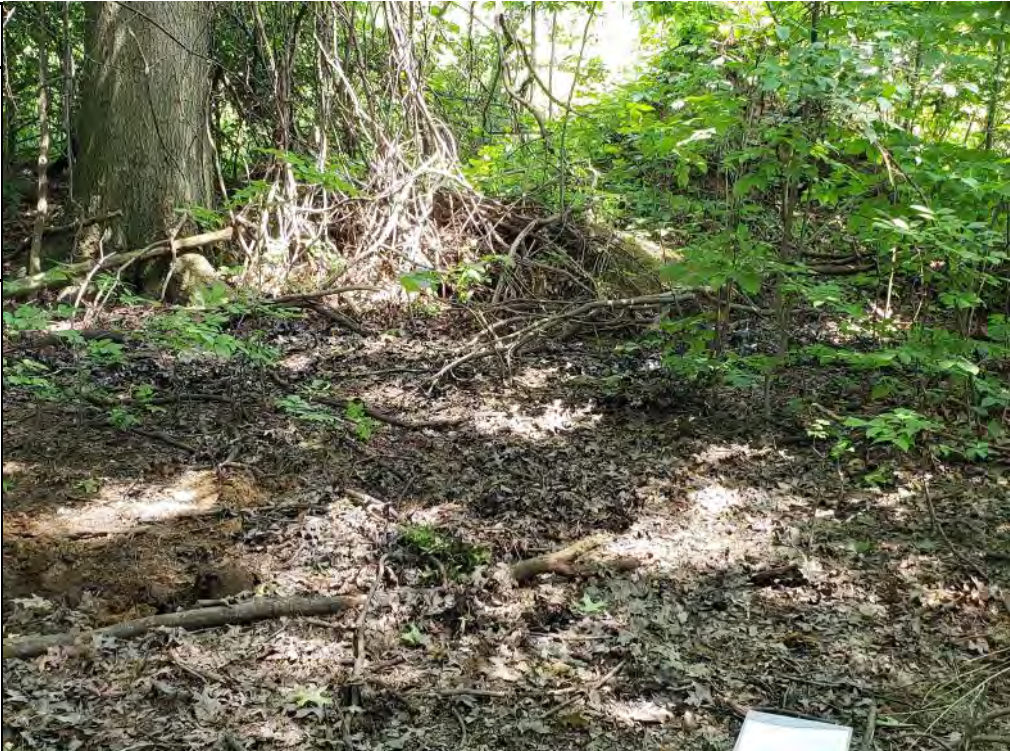
Photo No. 30	Date: 6/7/2018

Direction Photo Taken: East		
Description: Wetland 4

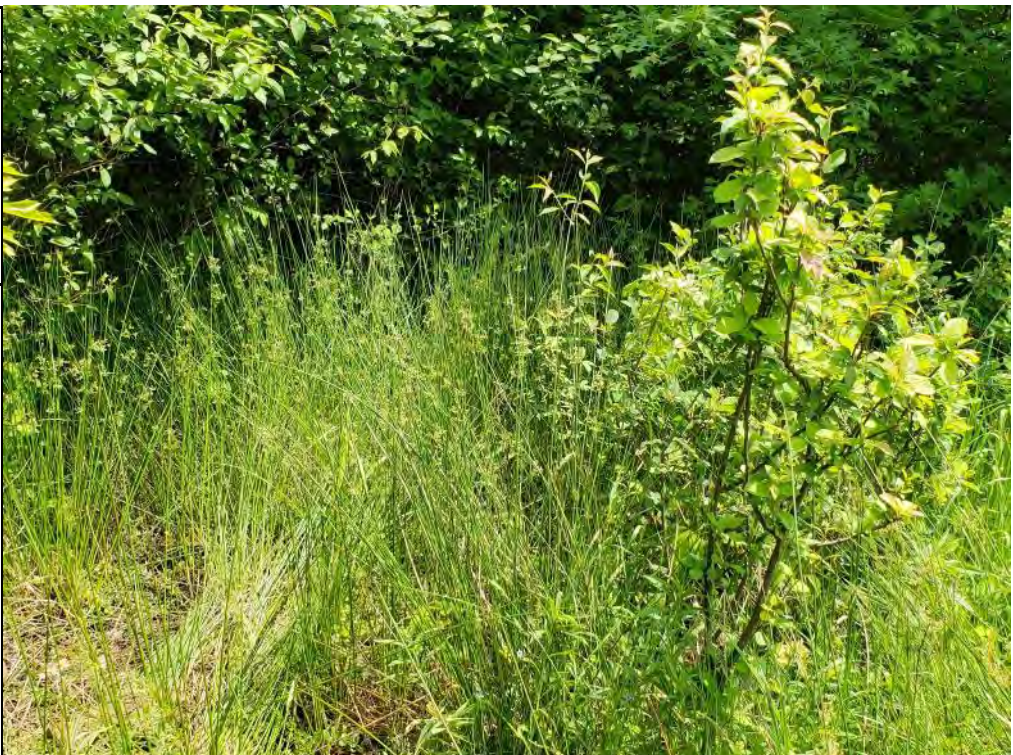
Photo No. 32	Date: 6/7/2018

Direction Photo Taken: South		
Description: Wetland 5

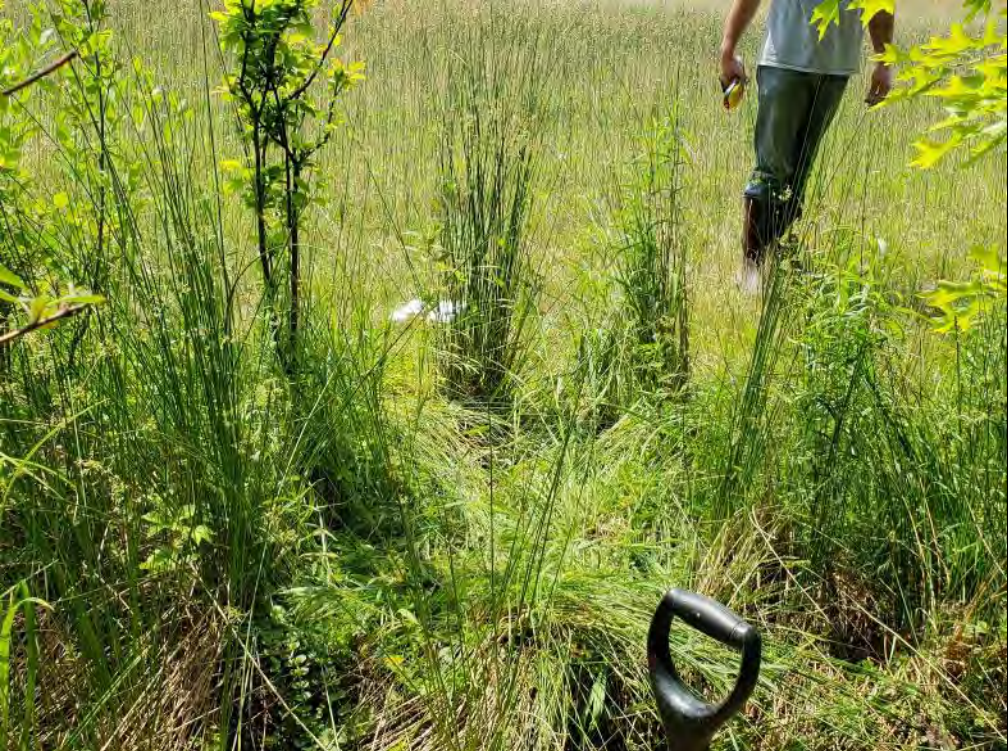
Photo No. 33	Date: 6/7/2018

Direction Photo Taken: West		
Description: View of Wetland 5

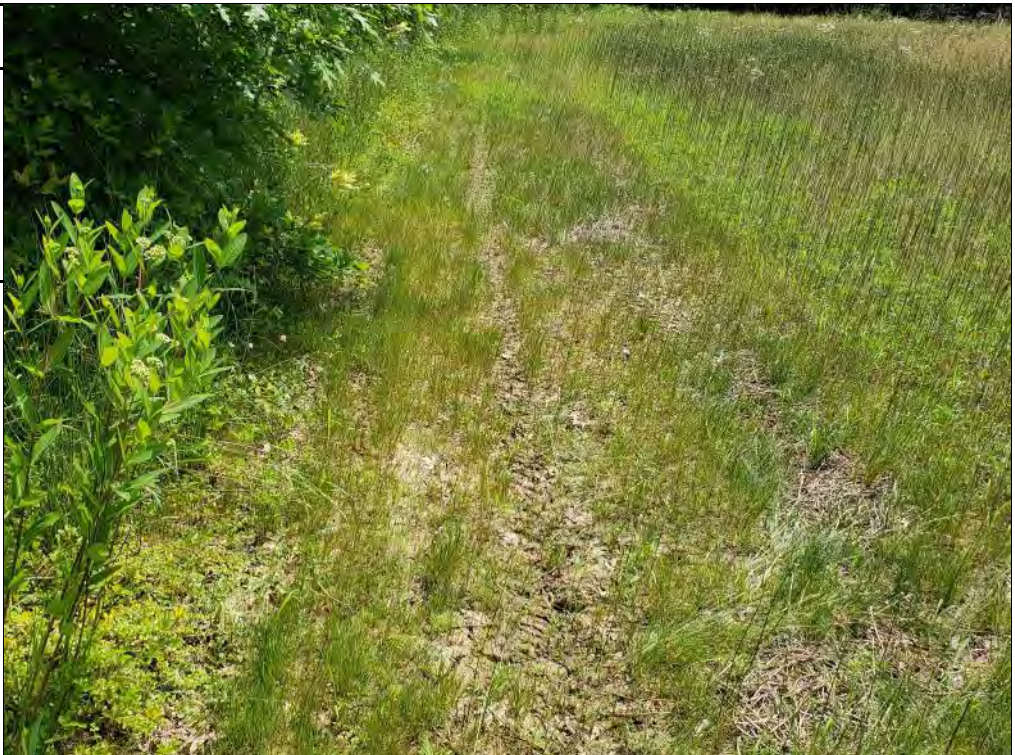
Photo No. 35	Date: 6/7/2018

Direction Photo Taken: South		
Description: Plot 12: Non-wetland plot west of Wetland 5

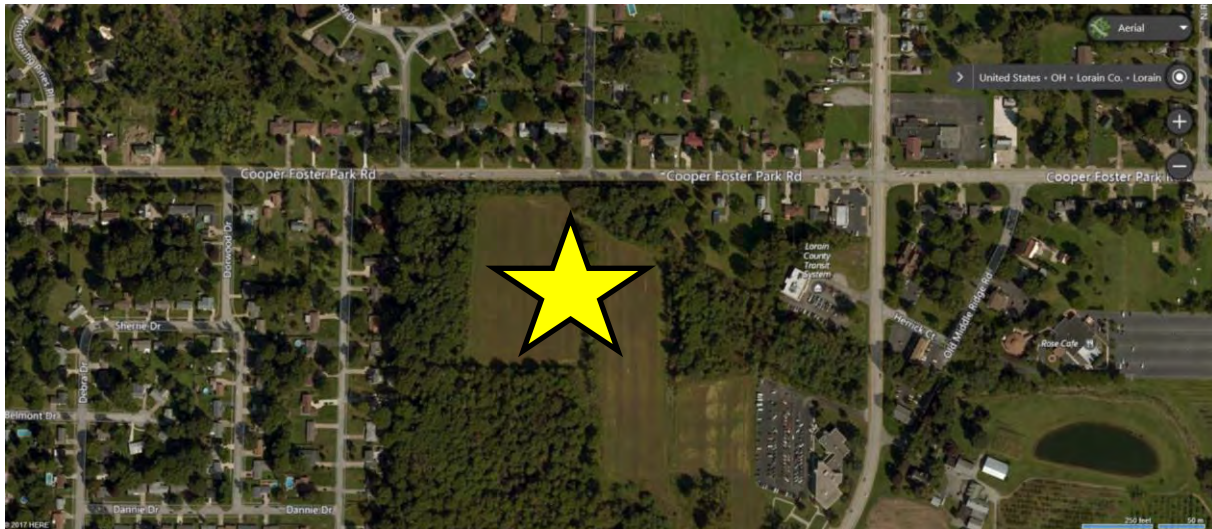
Figure 1. Aerial Photograph

Based upon the information provided, the project involves ecological restoration activities located adjacent (west) to 205 Cooper Foster Park Road in Lorain, Lorain County, Ohio, as depicted in the Figure 1 below:

Note that the site is relatively flat and is currently used for agriculture purposes.
