Karst of Northern Portions of the Peebles and Jaybird 7.5-Minute Quadrangles, Ohio

by
Douglas J. Aden and Brittany D. Parrick

Open-File Report 2018-3
Columbus 2018

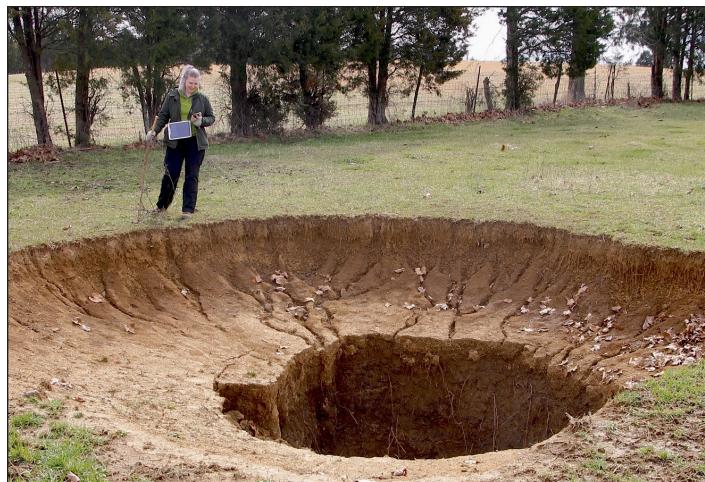
FIGURE 1. An active, 12-ft-deep and 22-ft-wide sinkhole in Adams County, Franklin Township off of Frog Hollow Road. Based on historical imagery, the outer portion of this sink is estimated to have begun forming between 2006 and 2009, with the inner collapse opening in 2017.

areas are at risk of subsidence, collapse, or other damage. Cattle and other livestock are also at risk in fields with deep pit sinkholes (fig. 1).
