# Indian Lake 2023 Annual Progress Report Logan County, Ohio

Provided for: The Ohio Department of Natural Resources (ODNR)

Prepared by: Restorative Lake Sciences  
Jennifer L. Jermalowicz-Jones, PhD, CLP  
Water Resources Director  
18406 West Spring Lake Road  
Spring Lake, Michigan 49456  
[www.restorativelakesciences.com](http://www.restorativelakesciences.com)

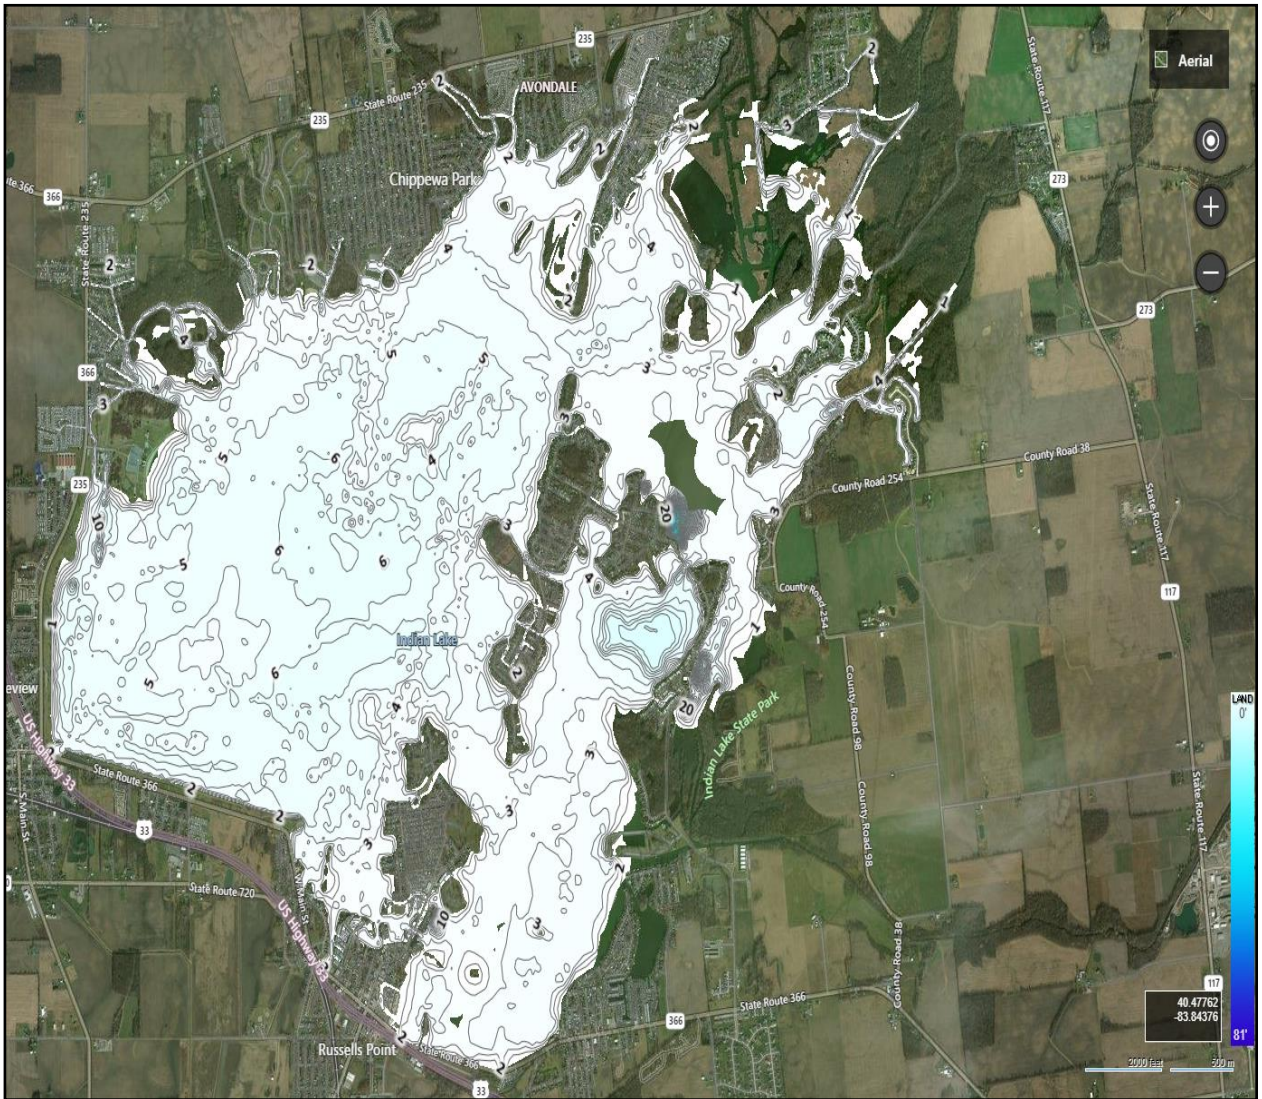
**Figure 1. Indian Lake Depth Contour Map, Logan County, Ohio (August 15-20, 2022).**

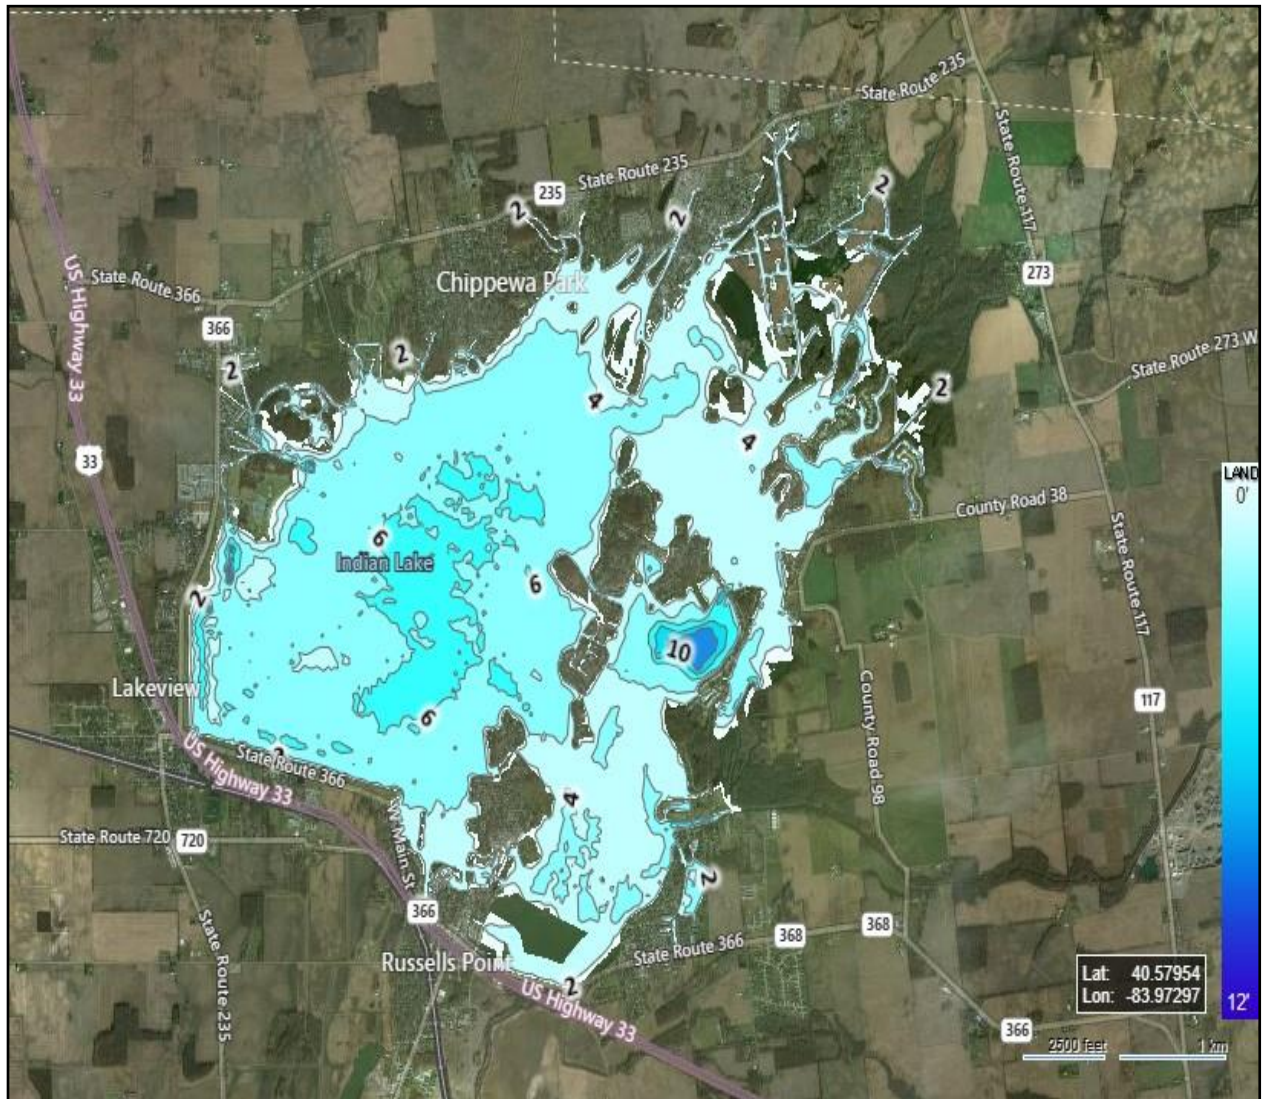
Figure 2. Indian Lake Depth Contour Map, Logan County, Ohio (July 17-20, 2023).

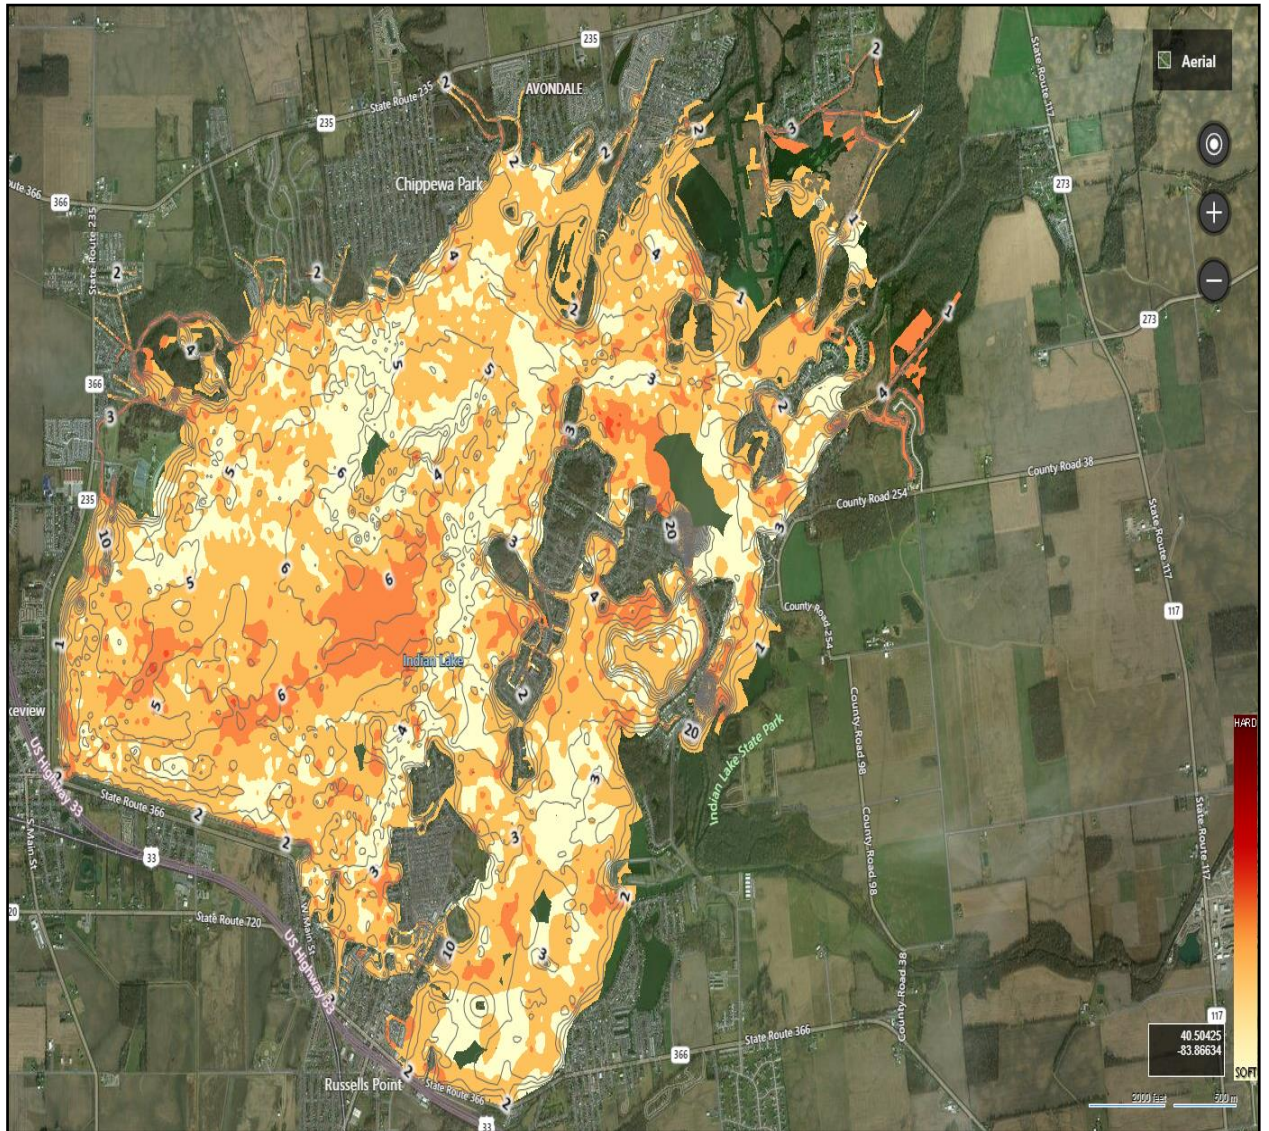
**Figure 3. Indian Lake Relative Sediment Hardness Map, Logan County, Ohio (August 15-20, 2022).**

<b>Lake Bottom Relative Hardness Category</b>	<b># GPS Points in Each Category (Total =55,368)</b>	<b>% Relative Cover of Bottom by Category</b>
<b>0.0-0.1</b>	156	0.3
<b>0.1-0.2</b>	12,718	23.0
<b>0.2-0.3</b>	37,754	68.1
<b>0.3-0.4</b>	4,711	8.5
<b>&gt;0.4</b>	29	0.1

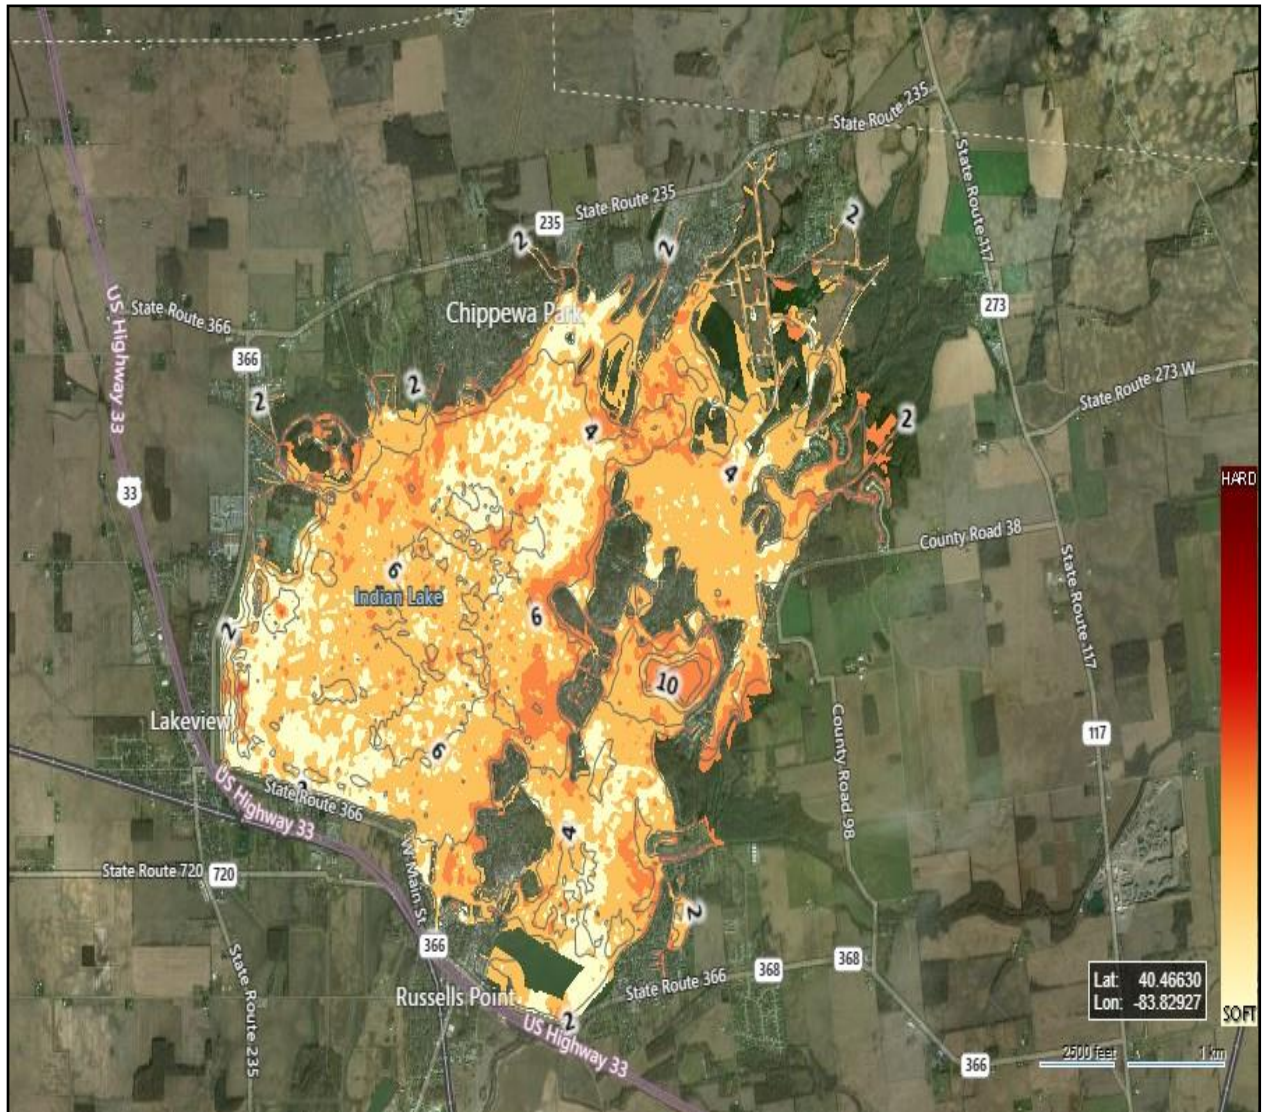
**Figure 4. Indian Lake Relative Sediment Hardness Map, Logan County, Ohio (July 15-20, 2023).**

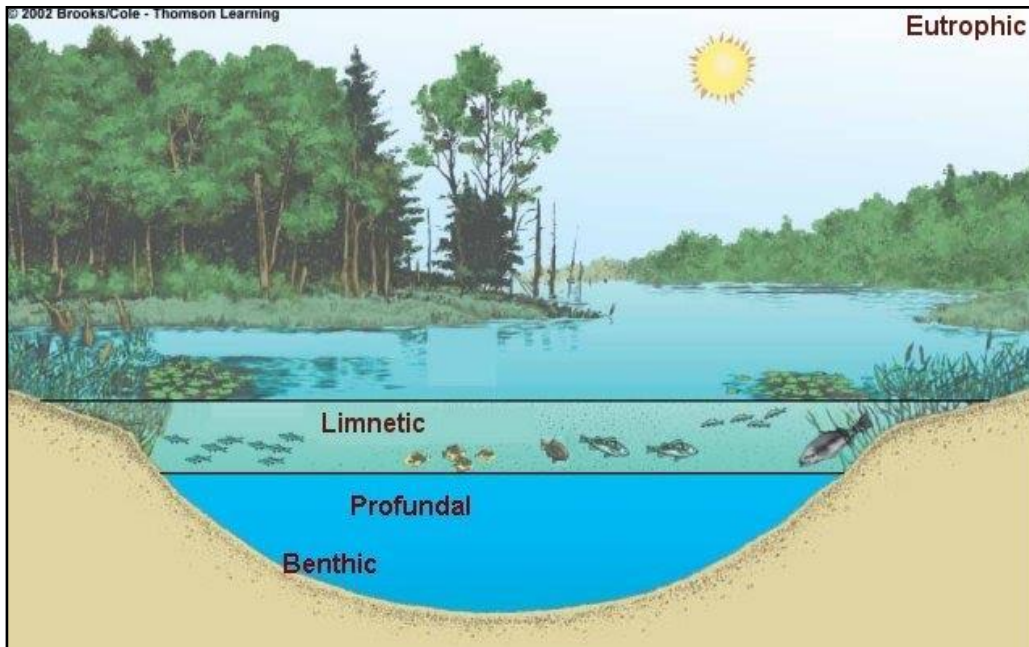
**Figure 5. Diagram showing a eutrophic or nutrient-enriched lake ecosystem (photo adapted from Brooks/Cole Thomson learning online).**

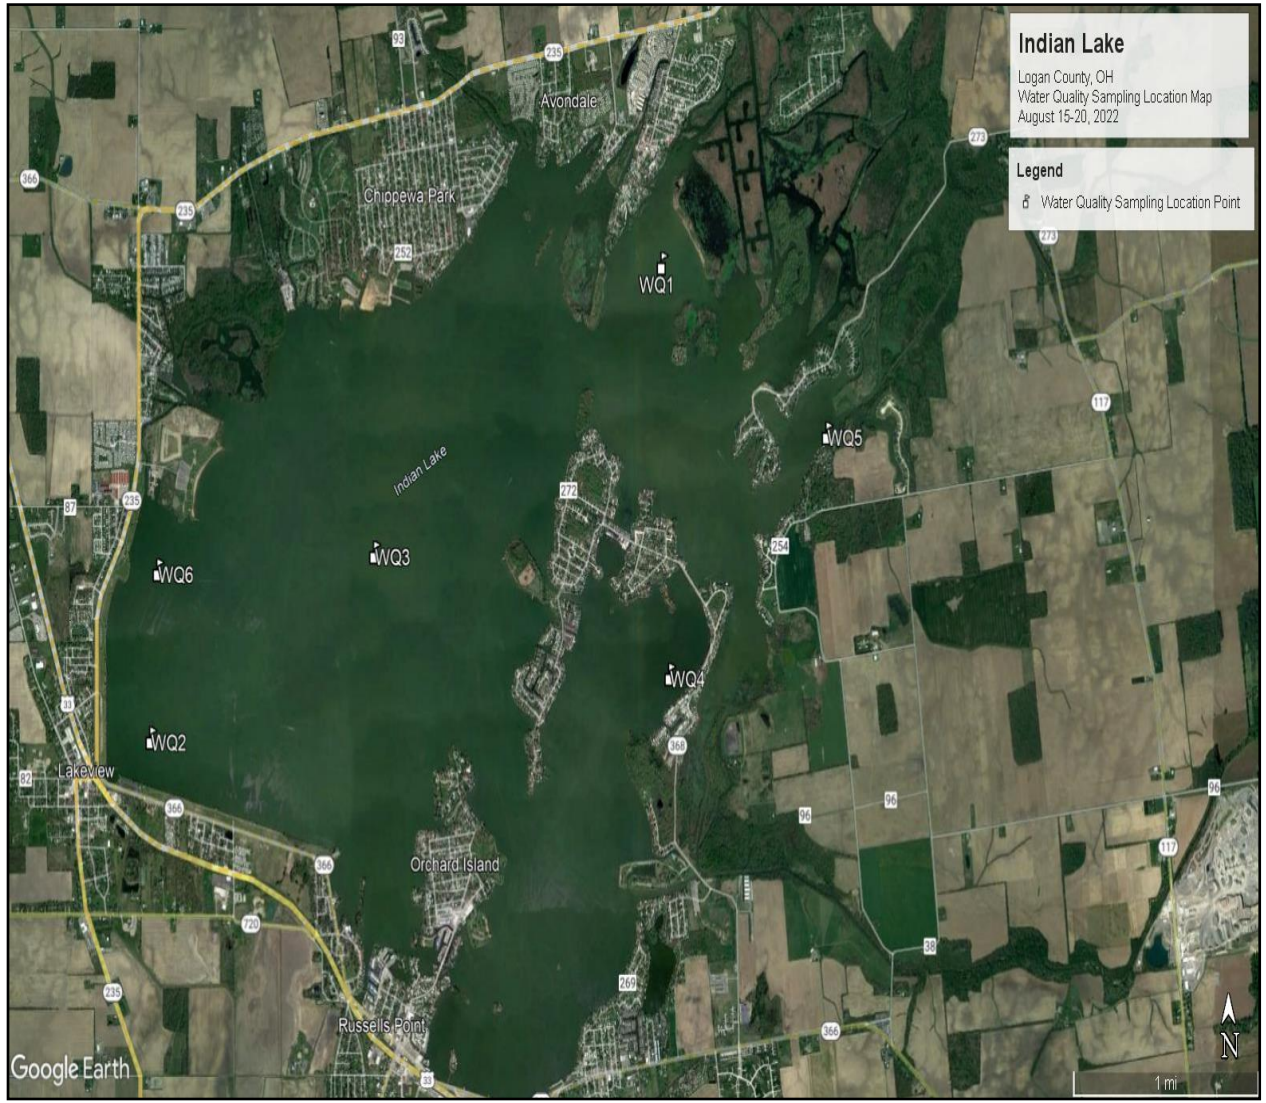
**Figure 6. Locations for water quality basin sampling in Indian Lake, Logan County, Ohio (August 19, 2022, April 22, 2023, and July 21, 2023).**

Water quality parameters measured during this evaluation included the following parameters at N=6 water quality sampling stations: 1.) Physical water quality parameters such as dissolved oxygen (in  $\text{mg L}^{-1}$ ), water temperature (in  $^{\circ}\text{C}$ ), conductivity ( $\text{mS cm}^{-1}$ ), total dissolved solids ( $\text{mg L}^{-1}$ ), and pH (S.U), and 2.) Chemical water quality parameters such as total phosphorus and ortho-phosphorus (also known as soluble reactive phosphorus or SRP measured in  $\text{mg L}^{-1}$ ), total Kjeldahl nitrogen and total inorganic nitrogen (in  $\text{mg L}^{-1}$ ), total suspended solids (measured in  $\text{mg L}^{-1}$ ), and chlorophyll-*a* (in  $\mu\text{g L}^{-1}$ ). In addition, Secchi transparency (measured in feet) was collected at each of the N=6 sampling stations. All of these parameters respond to changes in water quality and consequently serve as indicators of change over time. Mean 2022-2023 physical and chemical water quality data for the Indian Lake basin are displayed below and are presented in Tables 6-17. A map showing the sampling locations for all water quality samples is shown below in Figure 6. In addition to water samples, a total of N=20 lake sediment samples were collected with an Ekman hand dredge and analyzed for sediment percentage of organic carbon (Table 18). A map showing the sediment sampling locations is displayed as Figure 7. All water samples and readings were collected at the N=6 locations on August 19, 2022, April 22, 2023, and July 21, 2023 with the use of a Van Dorn horizontal water sampler and calibrated Eureka Manta II® multi-meter probe with parameter electrodes, respectively. All samples were taken to a NELAP (EPA)-certified laboratory for analysis. Whenever possible, historical data comparisons were made for certain parameters that utilized similar sampling locations and methods as those used in this study.

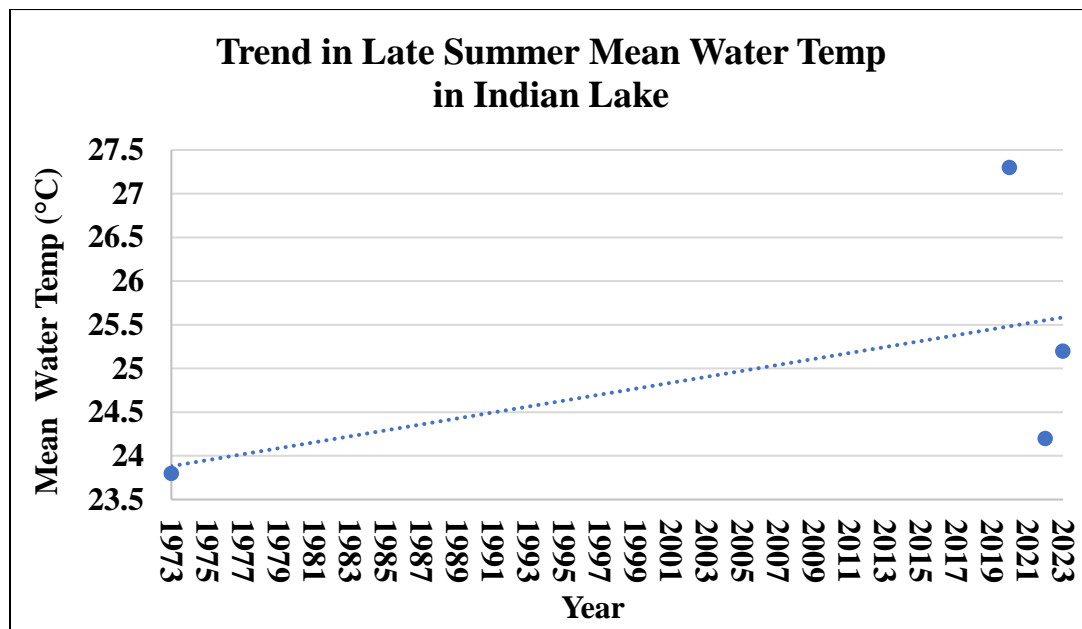
**Figure 8. Trend in August mean water temperatures in Indian Lake over time. NOTE: Due to scarce data collected at the same time with similar methods, more precise trends could not be produced and thus continued data collection is recommended (EPA and RLS data).**

A lake's water temperature varies within and among seasons, and is nearly uniform with depth under the winter ice cover because lake mixing is reduced when waters are not exposed to the wind. When the upper layers of water begin to warm in the spring after ice-off, the colder, dense layers remain at the bottom. This process results in a "thermocline" that acts as a transition layer between warmer and colder water layers. During the fall season, the upper layers begin to cool and become denser than the warmer layers, causing an inversion known as "fall turnover". In general, shallow lakes will not stratify and deeper lakes may experience single or multiple turnover cycles. Indian Lake water temperatures were measured in degrees Celsius (°C) with the use of a calibrated Eureka Manta II® submersible thermometer. All water temperatures of Indian Lake demonstrated weak thermoclines due to overall shallow depths. The 1973 EPA evaluation noted a mean August water temperature of 23.8°C. These water temperatures are warm but can support a warm-water fishery. Figure 8 displays the change in late summer water temperatures over time. Due to the significant data gaps in between the EPA study and current evaluation, an accurate trend cannot be developed but the mean water temperatures do appear to be increasing. The collection of more data in future years will help solidify this observation. Table 7 below shows the mean water temperatures during 2022-2023 for all basins sampled. Summer water temperatures in 2023 were slightly higher than in 2022 due to higher overall air temperatures.

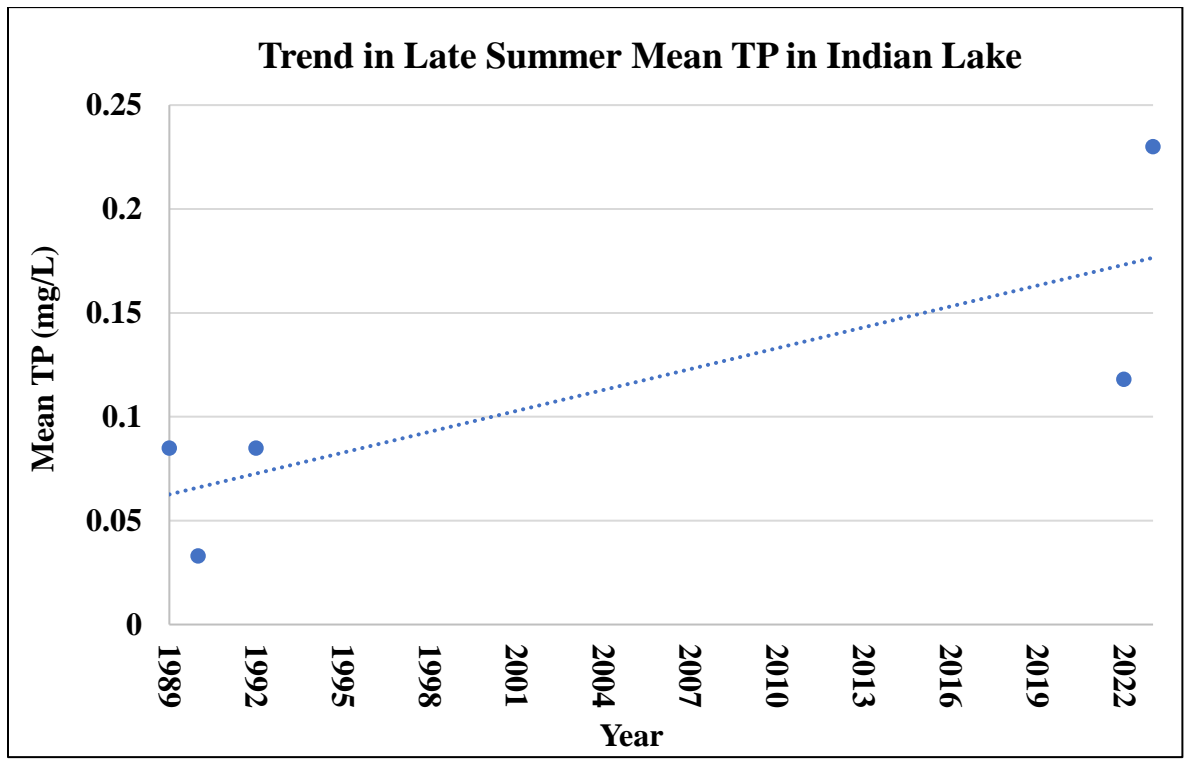
**Figure 9.** Trend in late summer mean total phosphorus concentrations (TP) in Indian Lake over time. NOTE: Due to scarce data collected at the same time with similar methods, more precise trends could not be produced (CLIP, OLMS, RLS data).

Total phosphorus (TP) is a measure of the amount of phosphorus (P) present in the water column. Phosphorus is the primary nutrient necessary for abundant algae and aquatic plant growth. Lakes that contain greater than 0.020-0.025 mg L<sup>-1</sup> of TP are defined as eutrophic or nutrient-enriched. TP concentrations are usually higher at increased depths due to the higher release rates of P from lake sediments under low oxygen (anoxic) conditions. Phosphorus may also be released from sediments as pH increases. Total phosphorus was measured in milligrams per liter (mg L<sup>-1</sup>) with the use of Method EPA 200.7 (Rev. 4.4). The 1973 EPA study noted that the mean August TP concentration was 0.128 mg L<sup>-1</sup>. TP concentrations have thus declined since 1973 likely due to immediate watershed improvements (Figure 9). The mean TP in late-July, 2023 was much higher (Table 12) and could be attributed to the decay of submersed aquatic vegetation which likely released nitrogen and phosphorus upon decay. This will take time for the water in the lake to be replaced and the concentrations to return to normal. These concentrations are still much higher than desired however, and efforts should continue to decrease them over time.

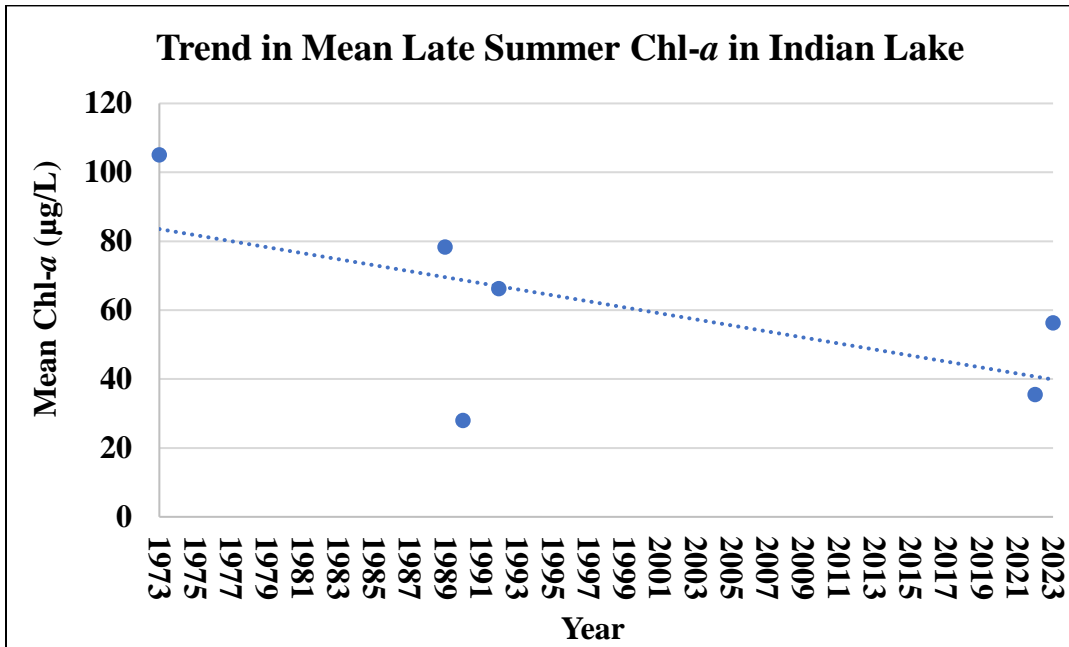
**Figure 10. Trend in August mean chlorophyll-a in Indian Lake over time. NOTE: Due to scarce data collected at the same time with similar methods, more precise trends could not be produced (EPA, CLIP, OLMS, RLS data).**

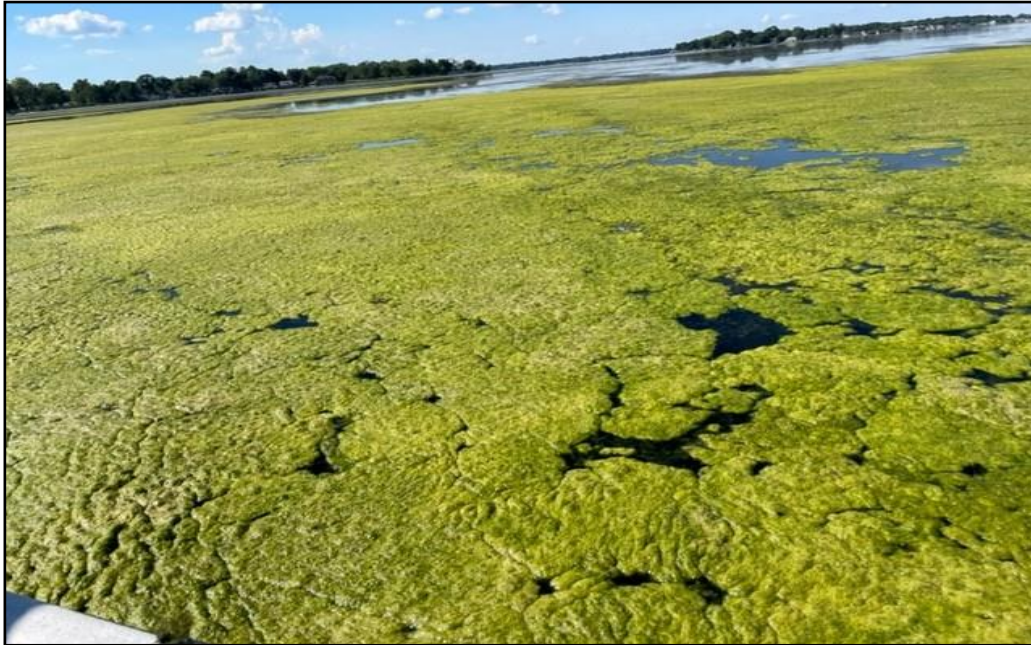
**Figure 11. Dense filamentous *Pithophora* algae on the surface of Indian Lake (August 19, 2022).**

In addition to the planktonic algal forms present in Indian Lake, there were also dense filamentous algae noted on the lake in the form of mats referred to as *Pithophora* (Figure 11). *Pithophora* is a filamentous green algae that thrives in shallow and low flowing waters. It has irregularly branched filaments with swollen reproductive akinetes. The alga produces gas bubbles and thus remains buoyant on the surface but may sink to the lake bottom during intense wave activity and then float back to the surface. This alga is representative of highly nutrient-enriched waters and is difficult to control but was harvested in 2023 with only small areas in the canals remaining (Figure 12).

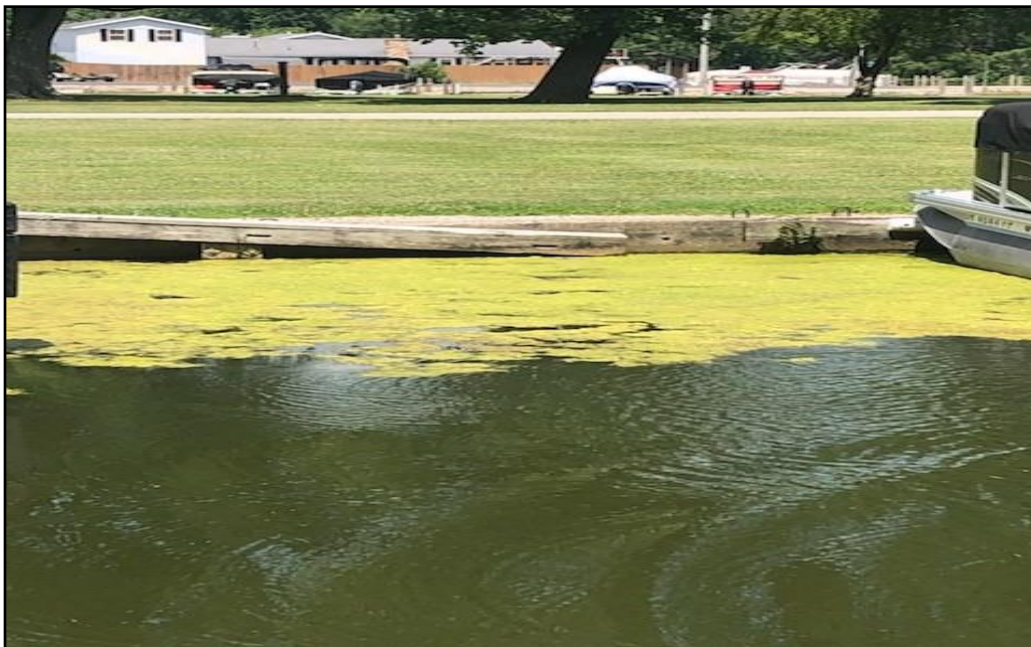
**Figure 12. Photo showing Indian Lake *Pithophora* remnants with some dissolved blue-green algae in the water column (July 21, 2023).**

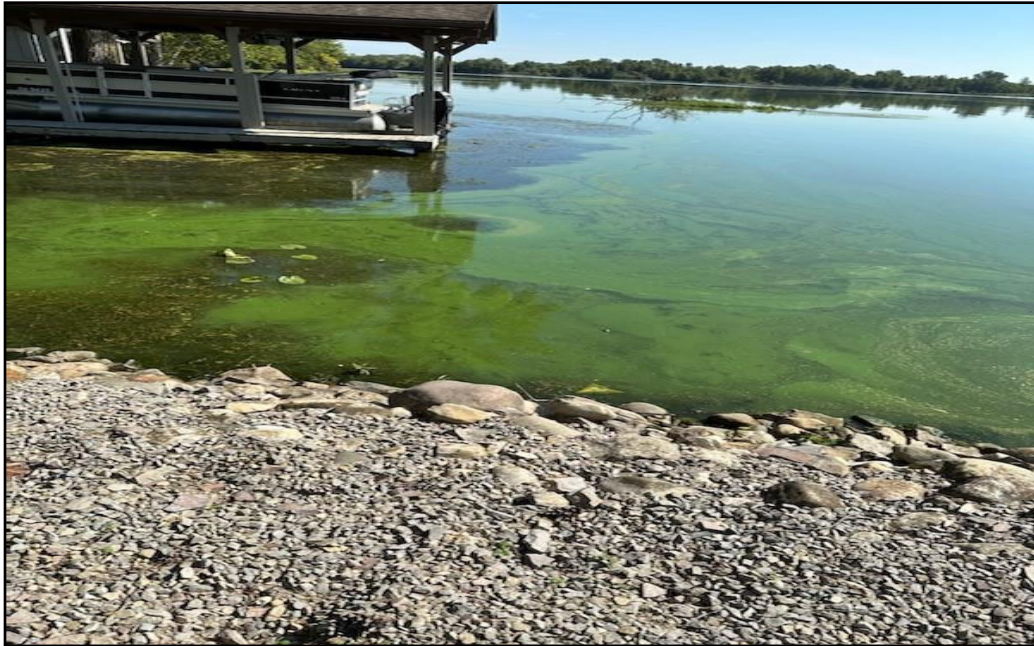
**Figure 13.** A prominent blue-green algae bloom at the north shore of Indian Lake (September, 2022; photo courtesy of Dustin Wickersham).

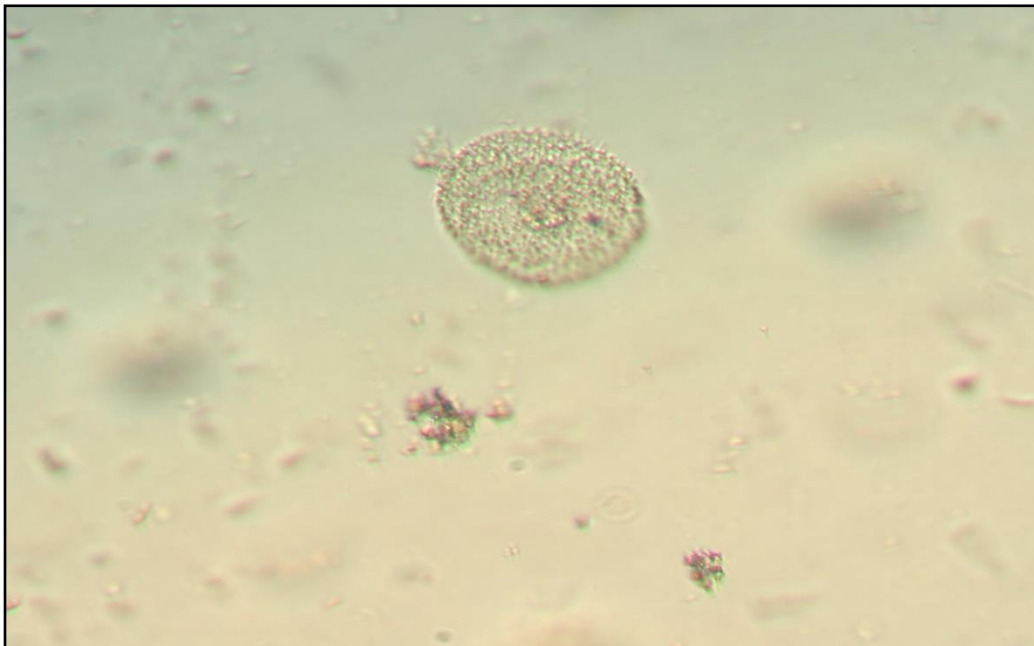
**Figure 14.** Microscopic image of the blue-green alga *Microcystis* in a July 21, 2023 water sample analyzed by RLS.

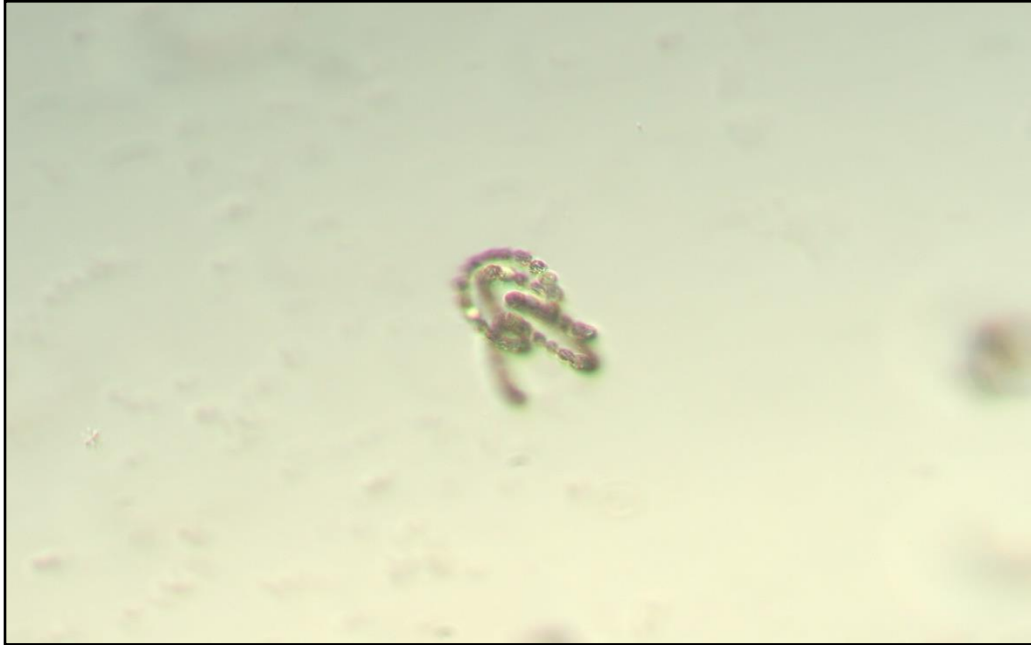
**Figure 15. Microscopic image of the blue-green alga *Anabaenopsis* sp. in a July, 2023 water sample analyzed by RLS.**

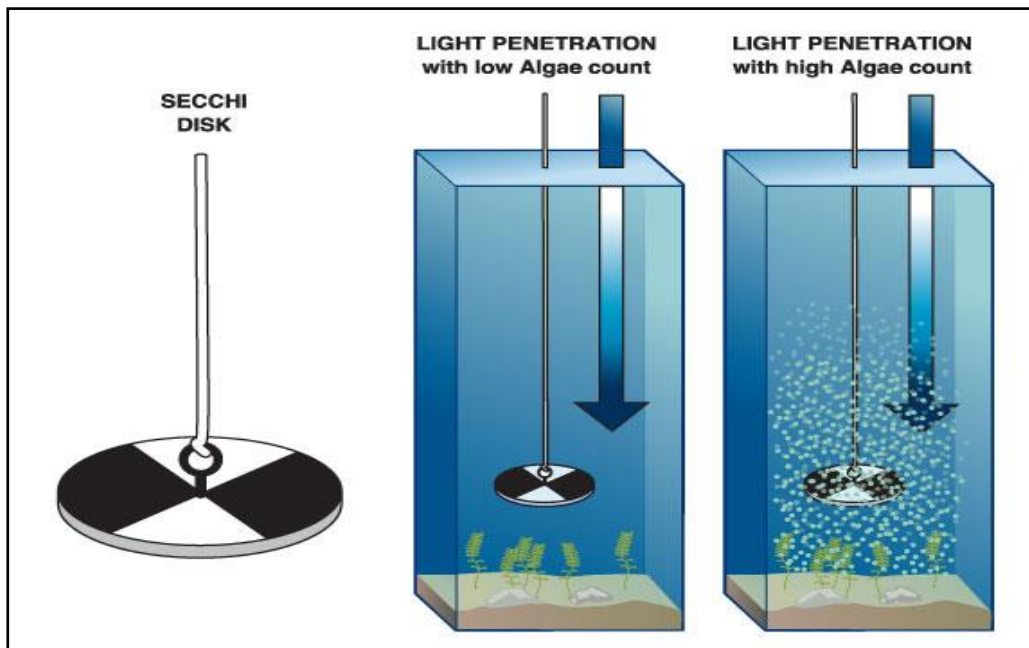
**Figure 16. Measurement of water transparency with a Secchi disk.**

Secchi transparency is a measure of the clarity or transparency of lake water and was measured with the use of an 8-inch diameter standardized Secchi disk. Secchi disk transparency is measured in feet (ft.) or meters (m) by lowering the disk over the shaded side of a boat around noon and taking the mean of the measurements of disappearance and reappearance of the disk (Figure 16). Elevated Secchi transparency readings allow for more aquatic plant and algae growth. Eutrophic systems generally have Secchi disk transparency measurements less than 7.5 feet due to turbidity caused by excessive planktonic algae growth. A historical mean measured by the EPA in 1973 was 1.3 feet and thus water clarity has improved since 1973. These measurements are indicative of low water clarity. Measurements were collected during calm conditions. This transparency indicates a high quantity of suspended particles and algae throughout the water column which would result in lower water clarity. Secchi transparency is variable and depends on the amount of suspended particles in the water (often due to windy conditions of lake water mixing) and the amount of sunlight present at the time of measurement. A hedonic study conducted by Michael *et al.*, (1996) determined that a 1.0 meter improvement in water clarity increased average lakefront property values from \$11-\$200 per square foot. Table 18 displays the mean Secchi transparency in 2022-2023 with stable values in 2022 and spring of 2023 but a reduction by July of 2023 due to the observed increase in planktonic algae. Figure 17 shows the change in Secchi transparency over time.

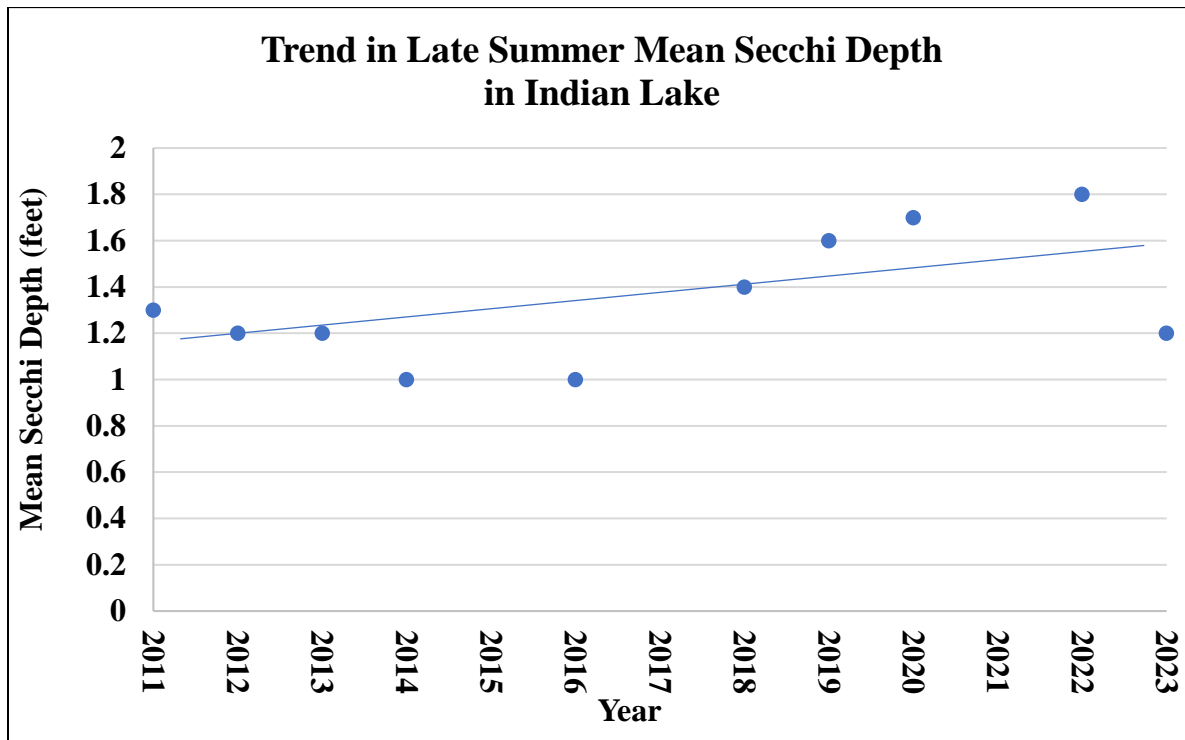
Figure 17. Trend in summer mean Secchi depth (transparency) in Indian Lake over time. NOTE: Due to scarce data collected between 2011-2022, more definitive long-term trends prior to 2011 could not be created (CLIP, OLMS, RLS data).

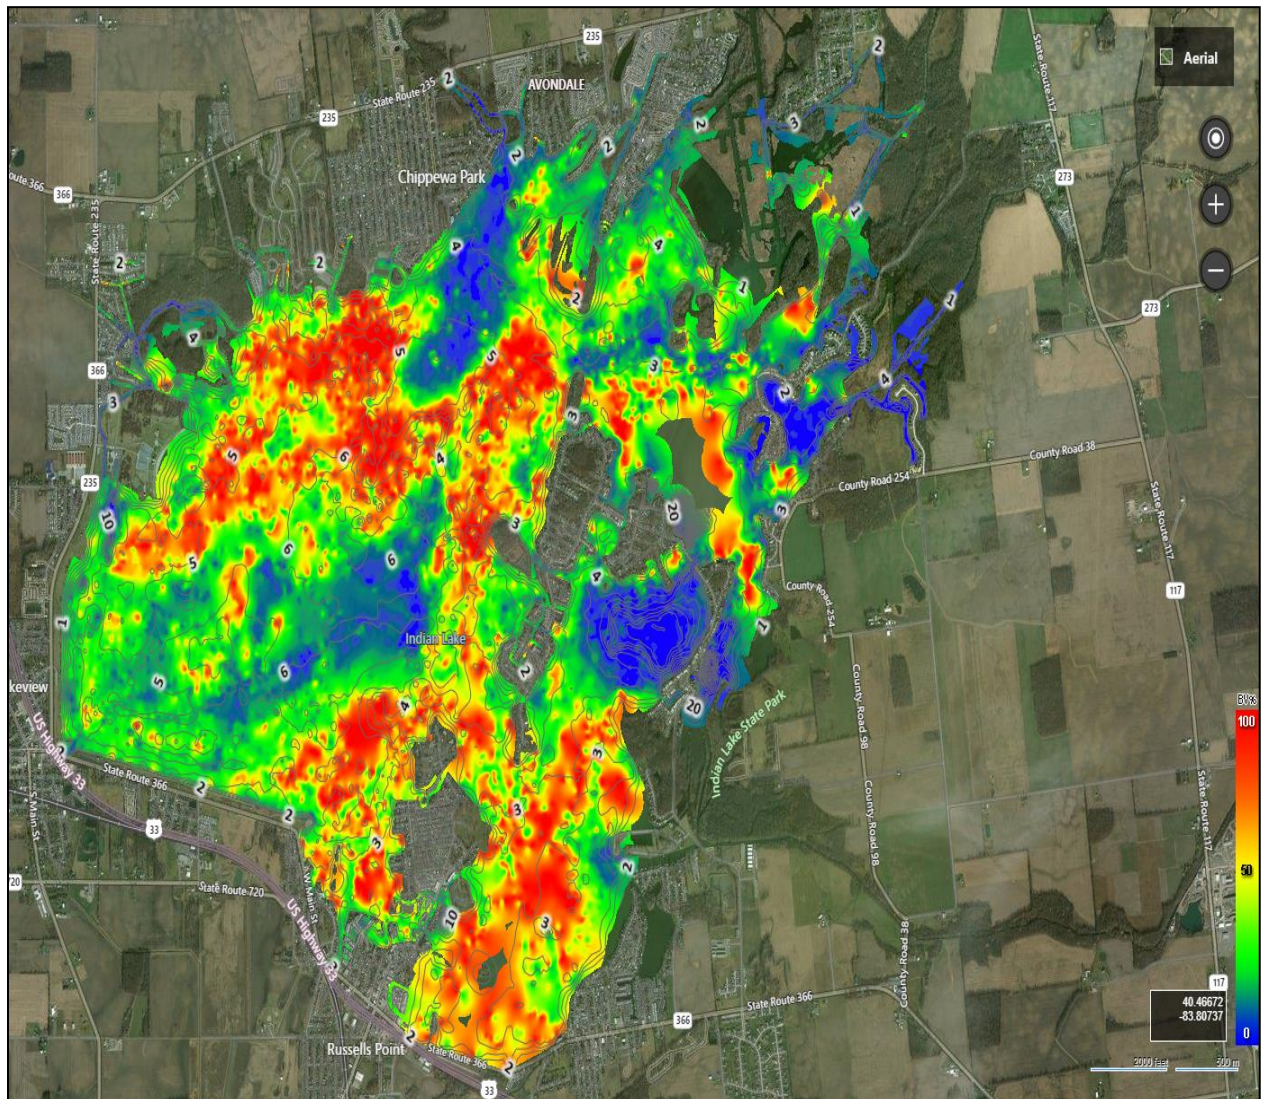
**Figure 18. Aquatic plant biovolume of all aquatic plants in Indian Lake, Logan County, Ohio (August 15-20, 2022). Note: Red color denotes high-growing aquatic plants, green color denotes low-growing aquatic plants, and blue color represents a lack of aquatic vegetation.**

<b>Biovolume Cover Category</b>	<b>August 15-20, 2022</b>	<b>April 16-20, 2023</b>	<b>July 17-20, 2023</b>
<b>0-20%</b>	58.2	67.1	81.5
<b>20-40%</b>	17.8	19.5	10.6
<b>40-60%</b>	7.9	7.5	3.3
<b>60-80%</b>	1.5	0.5	0.4
<b>80-100%</b>	14.6	5.4	4.3

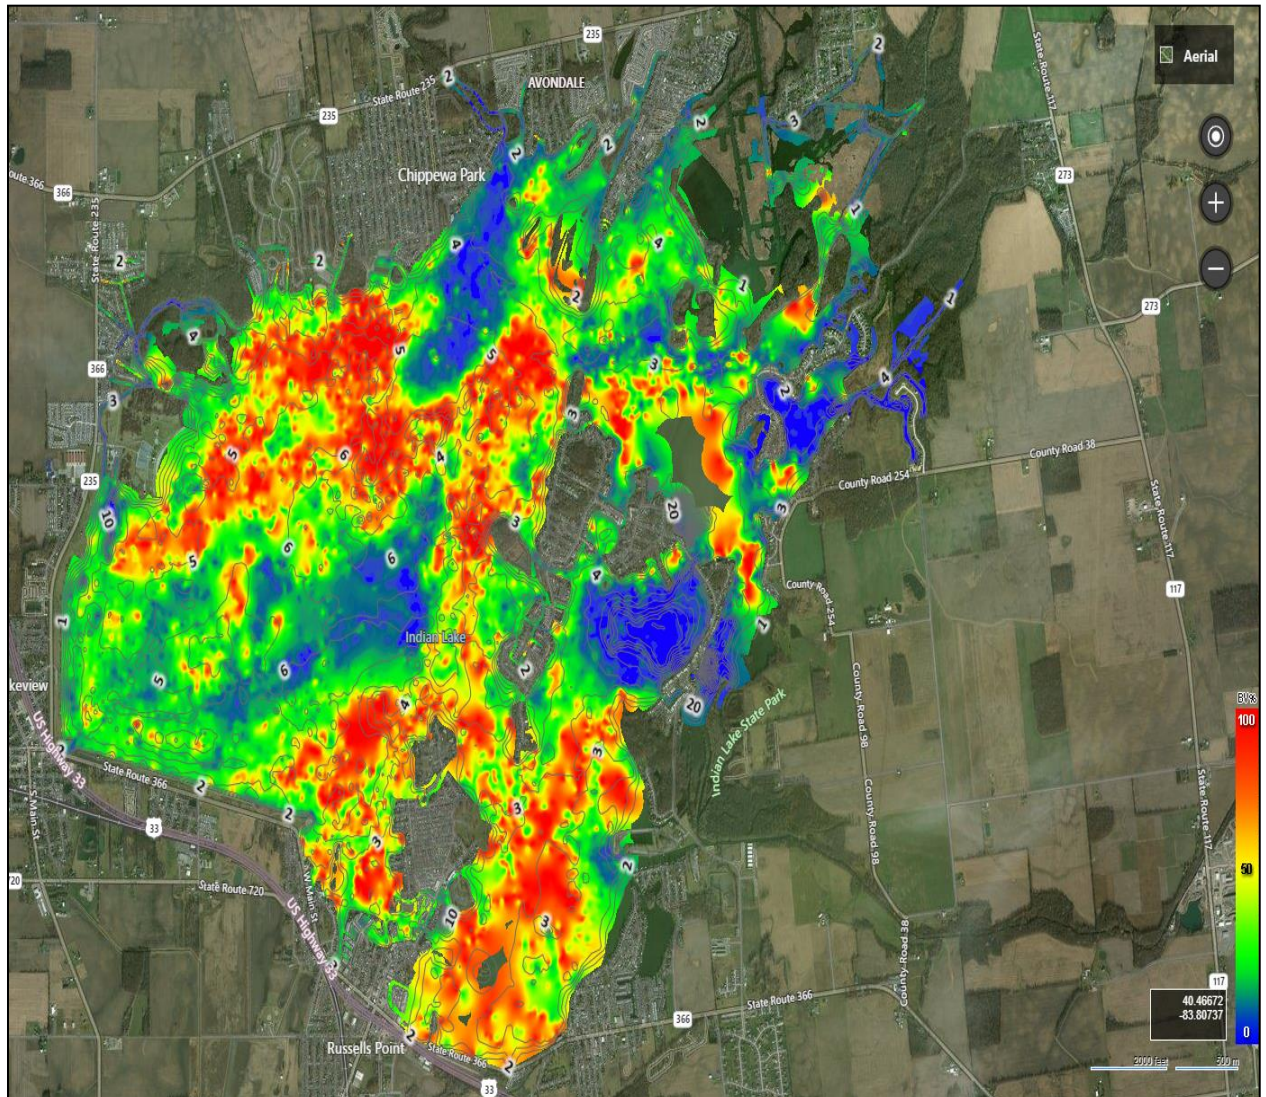
**Figure 19. Aquatic plant biovolume of all aquatic plants in Indian Lake, Logan County, Ohio (April 16-20, 2023). Note: Red color denotes high-growing aquatic plants, green color denotes low-growing aquatic plants, and blue color represents a lack of aquatic vegetation.**

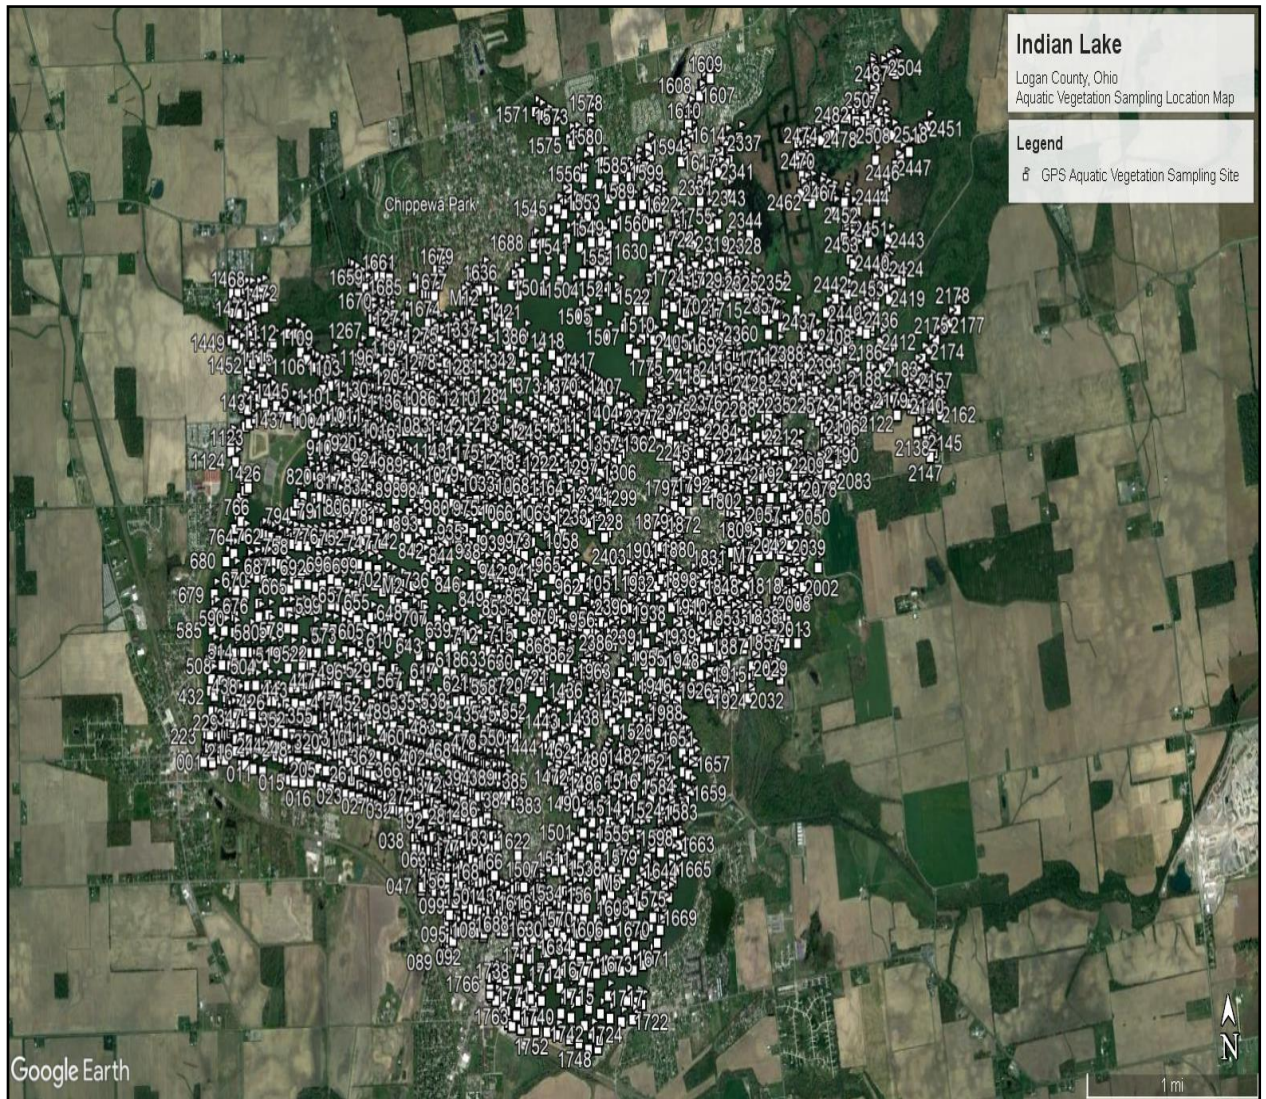
**Figure 21. Aquatic vegetation sampling locations in Indian Lake (August 15-20, 2022, April 16-20, 2023 and July 17-20, 2023).**

The GPS Point-Intercept/AVAS survey of Indian Lake was conducted on August 15-20, 2022, April 16-20, 2023 and July 17-20, 2023, and consisted of 2,934 sampling locations around the littoral zone (Figure 21). Data were placed in a table showing the relative abundance of each aquatic plant species found and a resultant calculation showing the frequency of each plant and cumulative cover.
