# Indian Lake 2023 Annual Progress Report Logan County, Ohio

Provided for: The Ohio Department of Natural Resources (ODNR)

Prepared by: Restorative Lake Sciences  
Jennifer L. Jermalowicz-Jones, PhD, CLP  
Water Resources Director  
18406 West Spring Lake Road  
Spring Lake, Michigan 49456  
[www.restorativelakesciences.com](http://www.restorativelakesciences.com)

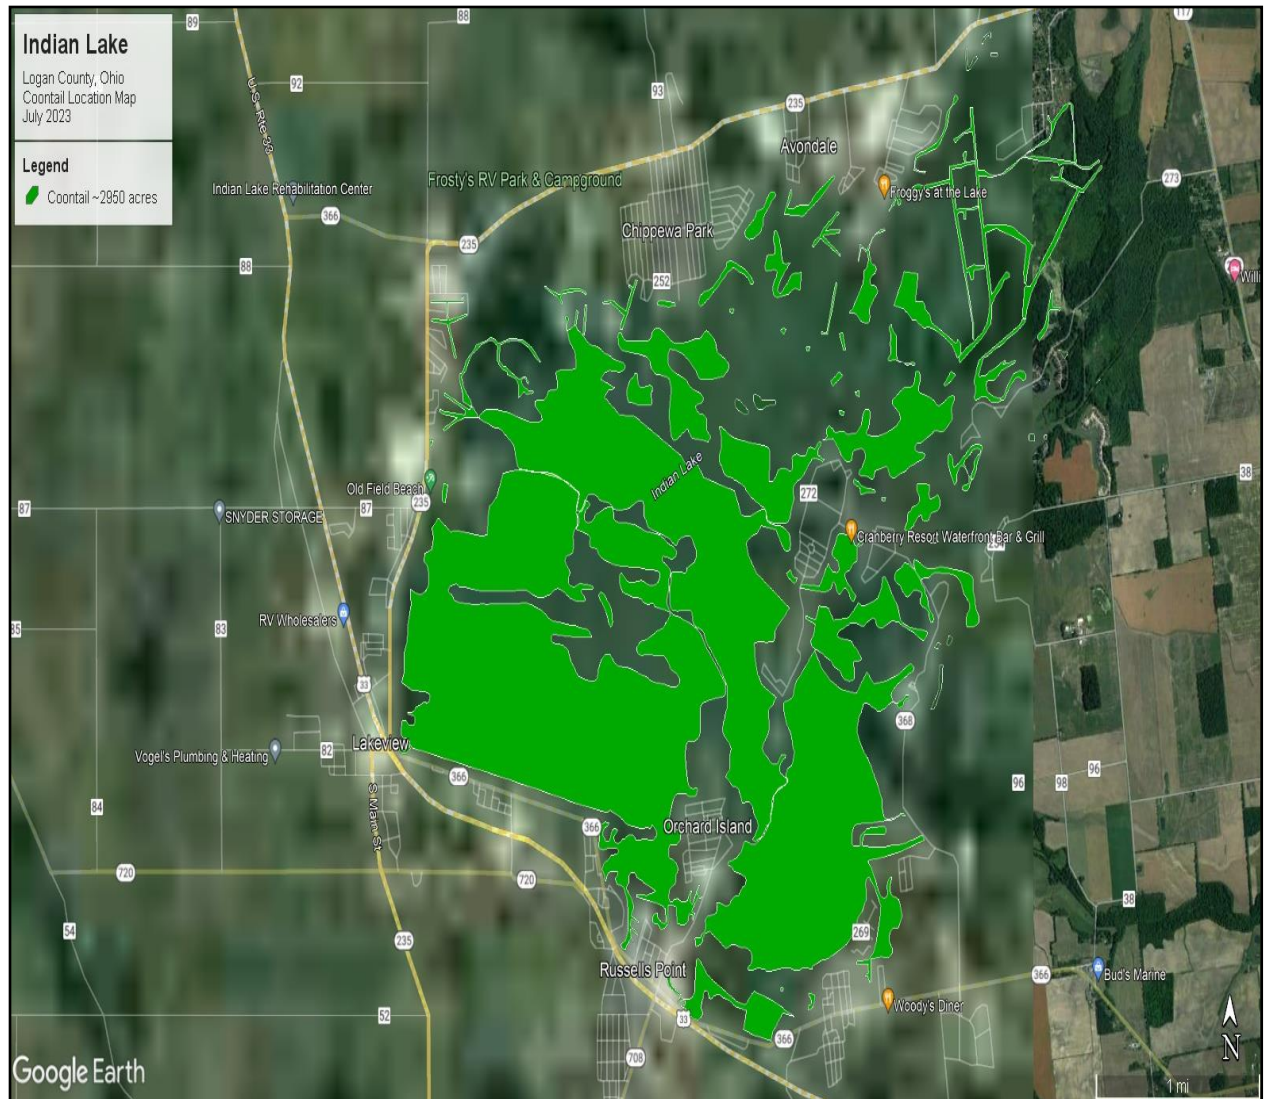
**Figure 25. Distribution of all areas of the native aquatic plant, Coontail, throughout Indian Lake (July 17-20, 2023). NOTE: Only dense areas should be prioritized for removal through mechanical harvesting in 2024 and these maps will be created by RLS after a spring, 2024 survey.**

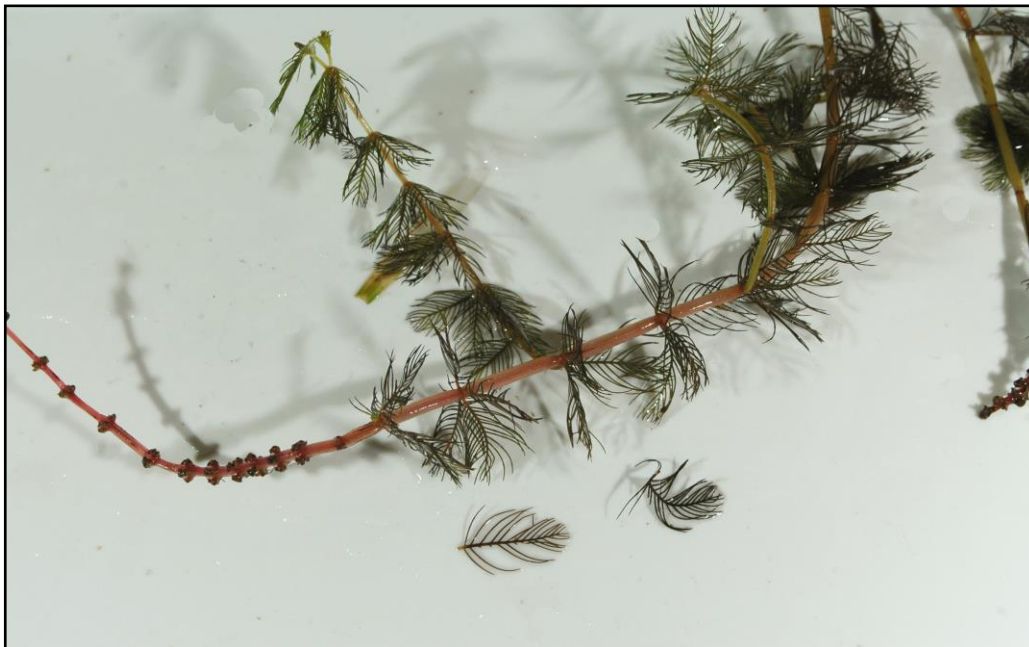
**Figure 49. Eurasian Watermilfoil plant with seed head and lateral branches (©RLS).**

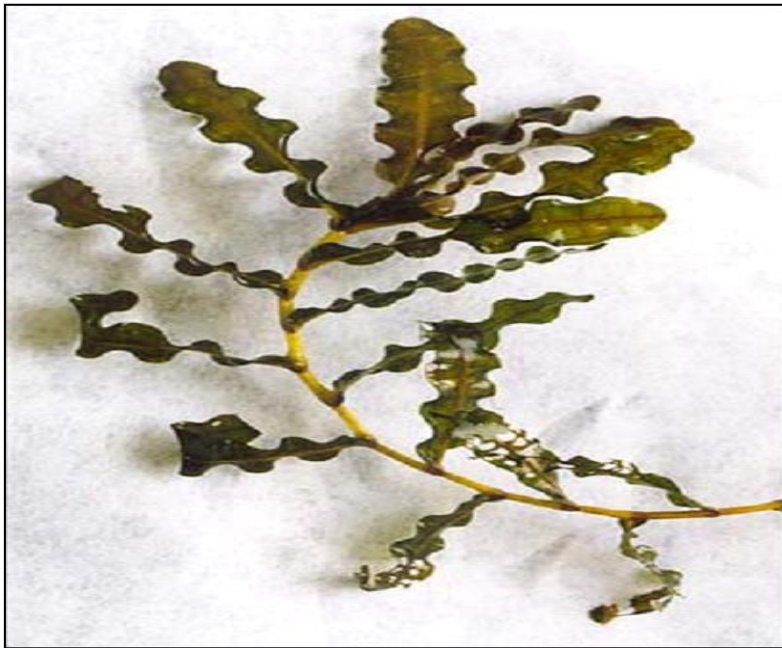
**Figure 53. Curly-leaf Pondweed (*Potamogeton crispus* L.).**

Curly-leaf Pondweed (*Potamogeton crispus*; Figure 53) is an exotic, submersed, rooted aquatic plant that was introduced into the United States in 1807 but was abundant by the early 1900's. It is easily distinguished from other native pondweeds by its wavy leaf margins. It grows early in the spring and as a result may prevent other favorable native aquatic species from germinating. The plant reproduces by the formation of fruiting structures called turions (Figure 54). The plant does not reproduce by fragmentation as milfoil does; however, the turions may be deposited in the lake sediment and germinate in following seasons. Fortunately, the plant naturally declines around mid-July in most lakes and thus is not likely to be prolific throughout an entire growing season. Curly-leaf Pondweed is a pioneering aquatic plant species and specializes in colonizing disturbed habitats. It is highly invasive in aquatic ecosystems with low biodiversity and unique sediment characteristics. It was present in Indian Lake but was not abundant at the time of the August 2022 survey. The April 2023 survey determined that approximately 1,821 acres of Curly-leaf Pondweed were present (Figure 55). Since it is also invasive, it was harvested due to its heavy presence during the spring and summer of 2023. Management for future invasions could include mechanical harvesting to remove the turion seed pods. The July, 2023 survey determined that the only significant remaining quantities of the pondweed were present in the canals and occupied less than 1 acre overall.

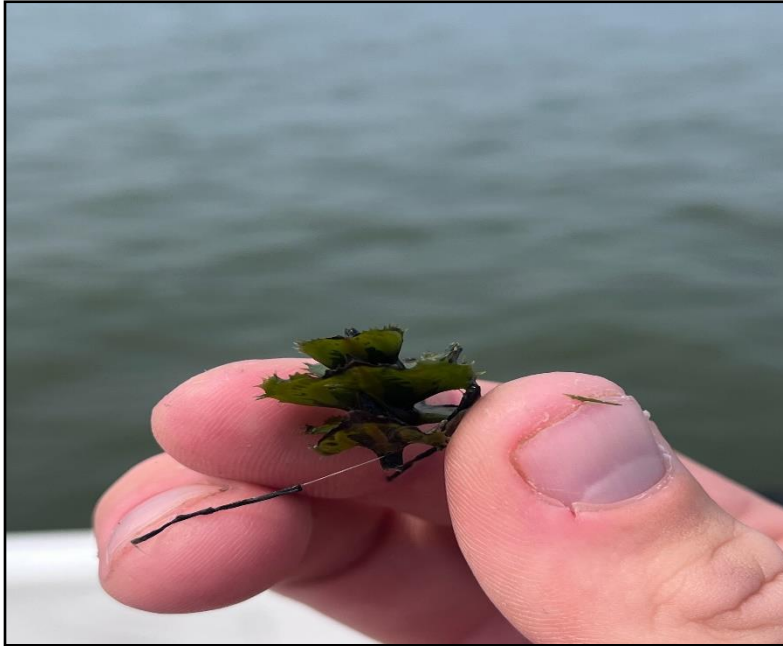
**Figure 54.** A turion (seed pod) from Curly-leaf Pondweed in Indian Lake (RLS, April, 2023).

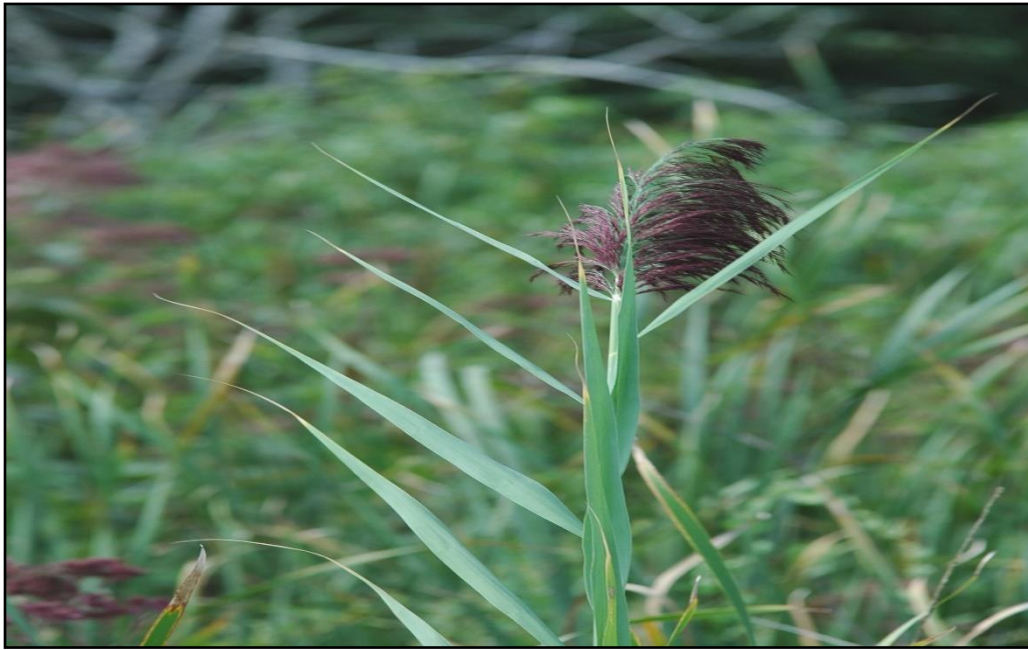
**Figure 56. Common Reed (*Phragmites australis*).**

The Common Reed (*Phragmites australis*; Figure 56) is an imminent threat to the surface area and shallows of the lake since it may grow submersed in water depths of  $\geq$  two meters (Herrick and Wolf, 2005), thereby drying up wetland habitat and reducing lake surface area. In addition, large, dense stands of *Phragmites* accumulate sediments, reduce habitat variability, and impede natural water flow (Wang et al., 2006). This plant was found in three locations around Indian Lake and should be manually removed.

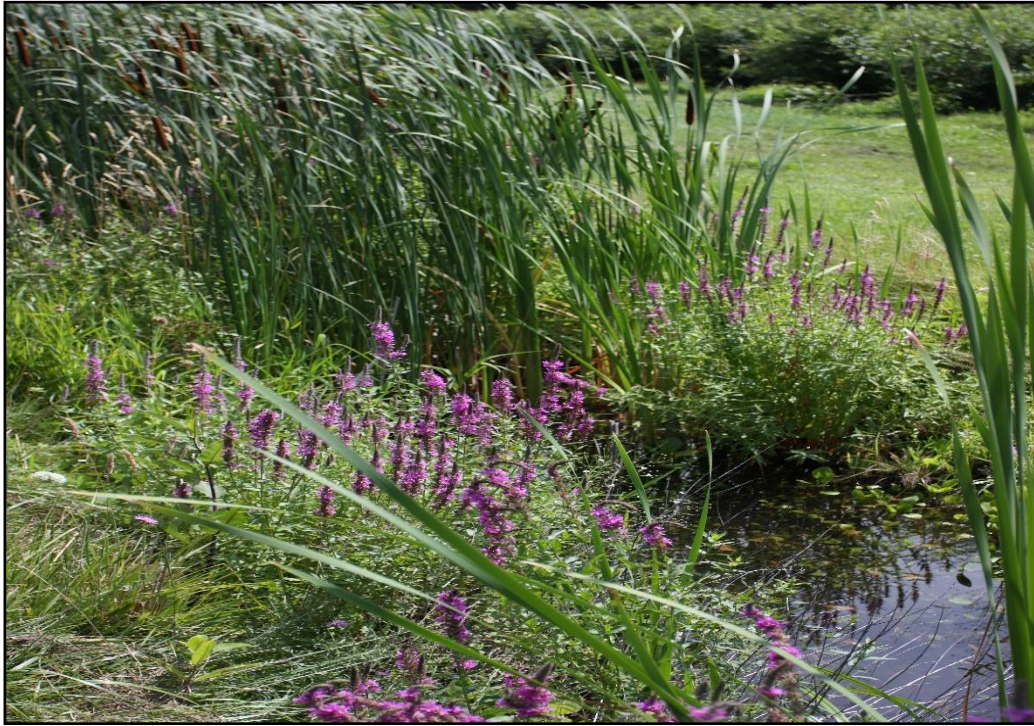
**Figure 57. Purple Loosestrife (*Lythrum salicaria* L.).**

Purple Loosestrife (*Lythrum salicaria*; Figure 57) is an invasive (exotic) emergent aquatic plant that inhabits wetlands and shoreline areas and was found in thirty locations around the shoreline of Indian Lake. *L. salicaria* has showy magenta-colored flowers that bloom in mid-July and terminate in late September. The seeds are highly resistant to tough environmental conditions and may reside in the ground for extended periods of time. It exhibits rigorous growth and may out-compete other favorable native emergents such as Cattails (*Typha latifolia*) or native Swamp Loosestrife (*Decodon verticillatus*) and thus reduce the biological diversity of localized ecosystems. The plant is spreading rapidly across the United States and is converting diverse wetland habitats to monocultures with substantially lower biological diversity. Lake residents should be educated about its invasiveness and threat to the health of the Indian Lake ecosystem. This plant may be removed by hand pulling or using a shovel to remove the roots and then discarding the plant into the garbage if it is discovered to avoid further infestation. If the plant is not promptly removed by hand, it could dominate in wetland areas and require larger-scale systemic herbicide treatments. Figure 58 shows the distribution of *Phragmites* and Purple Loosestrife, the two invasive emergent aquatic plants found along the shoreline Indian Lake.

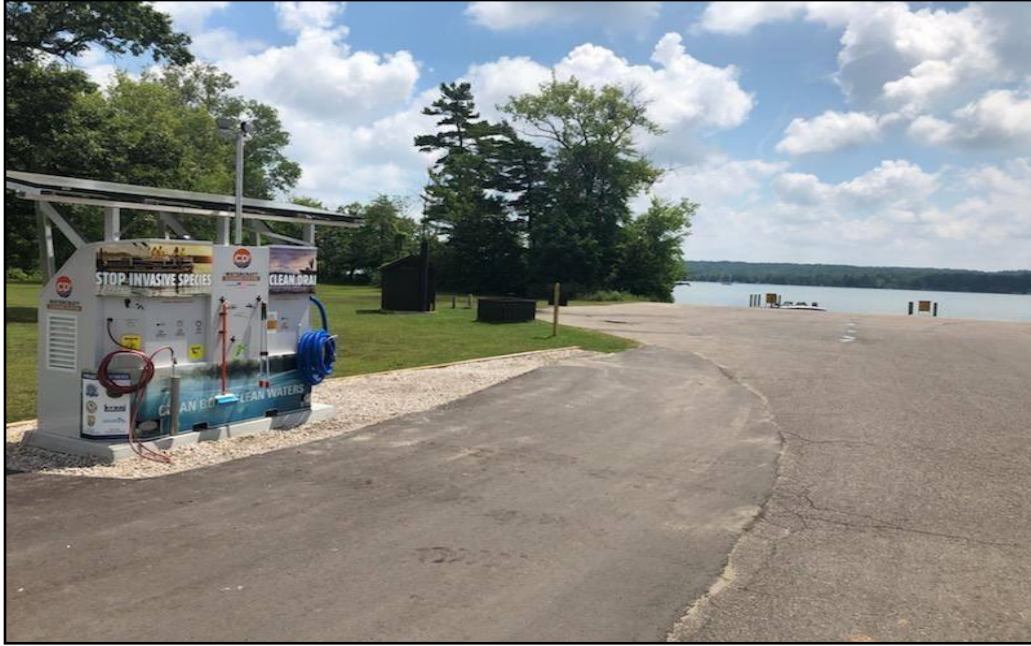
**Figure 59.** A public boat washing station for boat access sites.

The first ingredient to successful prevention of unwanted transfers of exotic species to Indian Lake is awareness and education. The majority of the exotic species of concern have been listed in this report. Other exotic species on the move could be introduced to the riparians around Indian Lake through a local community educational workshop or other educational events and should be included in an EDRR document. RLS noted the abundance of AIS signage at local public access sites and still recommends a boat washing station if permitted (Figure 59). Ideally, AIS signs should be placed at all access sites listed in Figure 60 below.

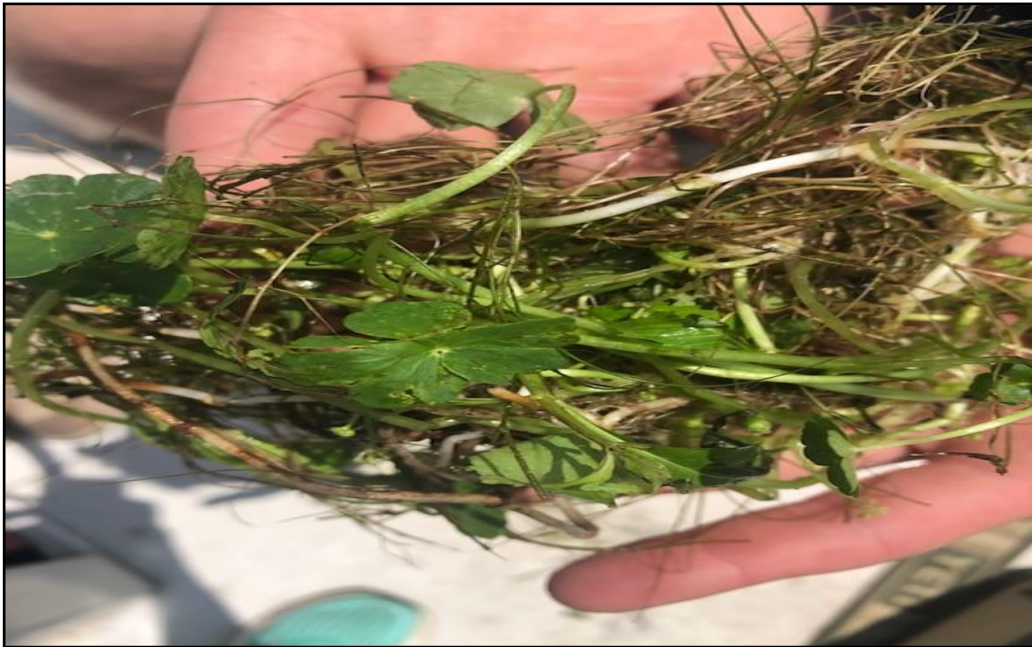
**Figure 61. Invasive *Hydrocotyle* from Indian Lake (©RLS, 2023).**

During the July 16-20, 2023 whole-lake survey, RLS found one location in the center of the lake that contained the invasive species *Hydrocotyle* sp., or Water Pennywort (Figure 61). This plant is capable of spreading throughout the lake with particular suitability for the canals. RLS immediately discarded this plant specimen (Figure 62) and did not find any other specimens during the entire lake survey. Vigilance is needed however and supports the need for whole-lake inventories each season to prepare for an EDRR protocol if a new invasive species is found. If this or any other rare invasive species is found in the lake, a GPS coordinate should be taken, and the plant should be discarded and not placed back into the lake.

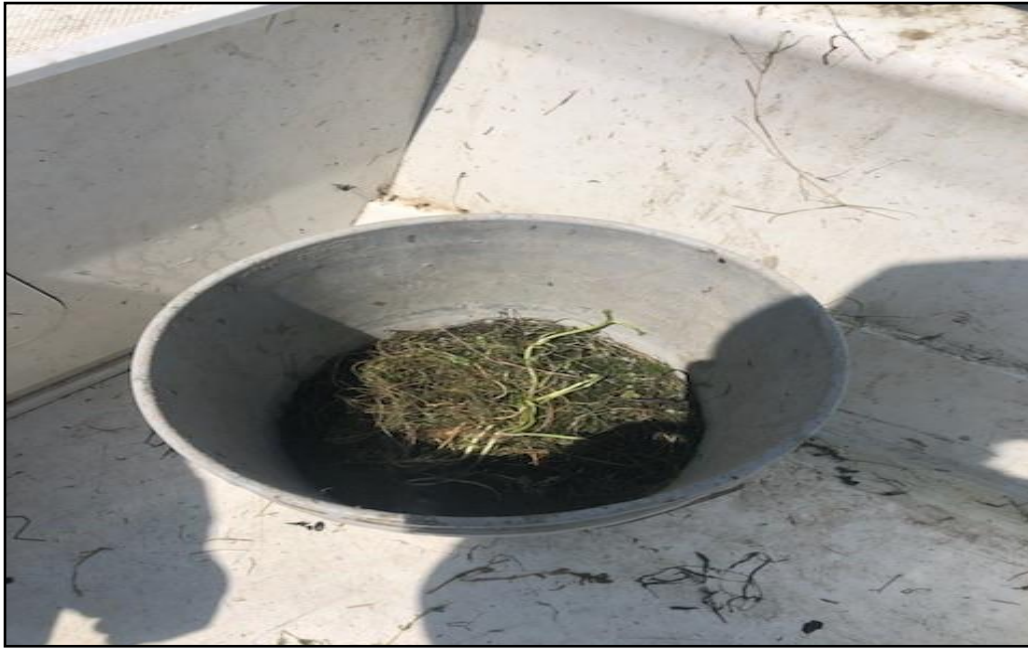
**Figure 62. Discarded *Hydrocotyle* in Indian Lake (RLS, 2023).**

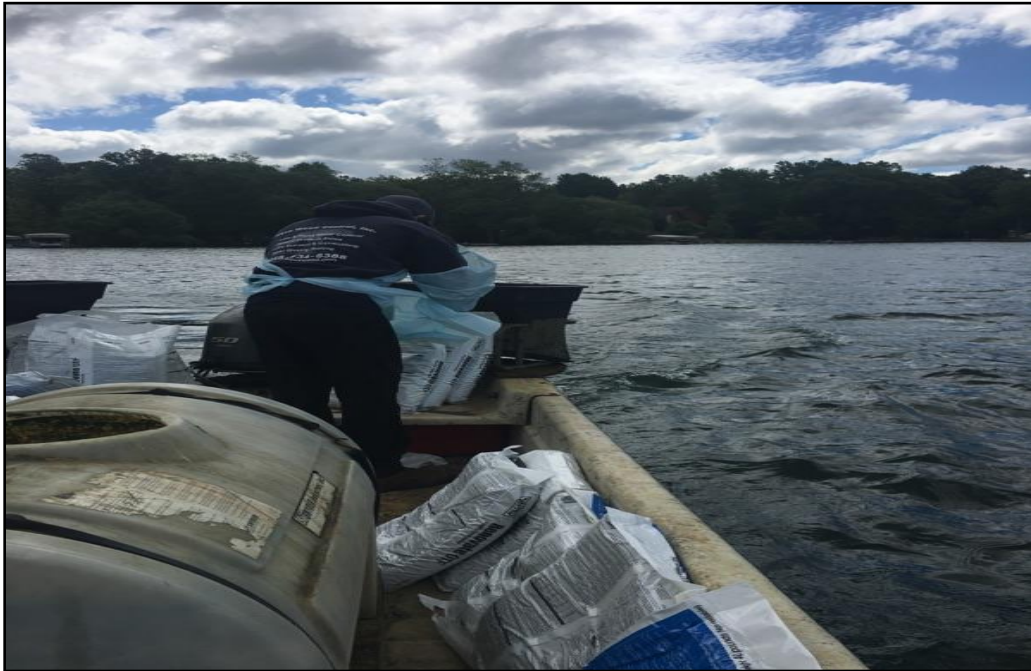
**Figure 63. A boat used to apply aquatic herbicides in inland lakes (©RLS).**

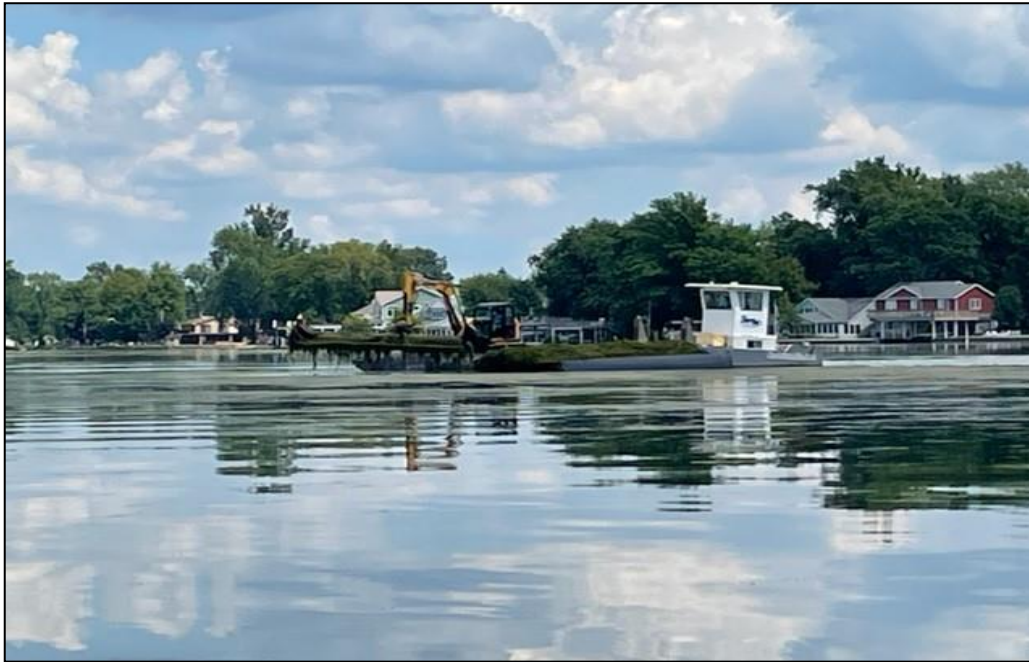
**Figure 65. A mechanical harvester used to remove aquatic plants in Indian Lake (©RLS).**

Mechanical harvesting is usually not recommended for the removal of Eurasian Watermilfoil since the plant may fragment when cut and re-grow on the lake bottom. Additionally, it is often not practical for very large lakes, given the long transfer times to offload harvested vegetation. Fortunately, Indian Lake utilizes a few offload/transfer sites with multiple harvesting machines to reduce this transfer time and increase removal efficacy. Mechanical harvesting should be a long-term method of managing both surface *Pithophora* mats and dense areas of Coontail.

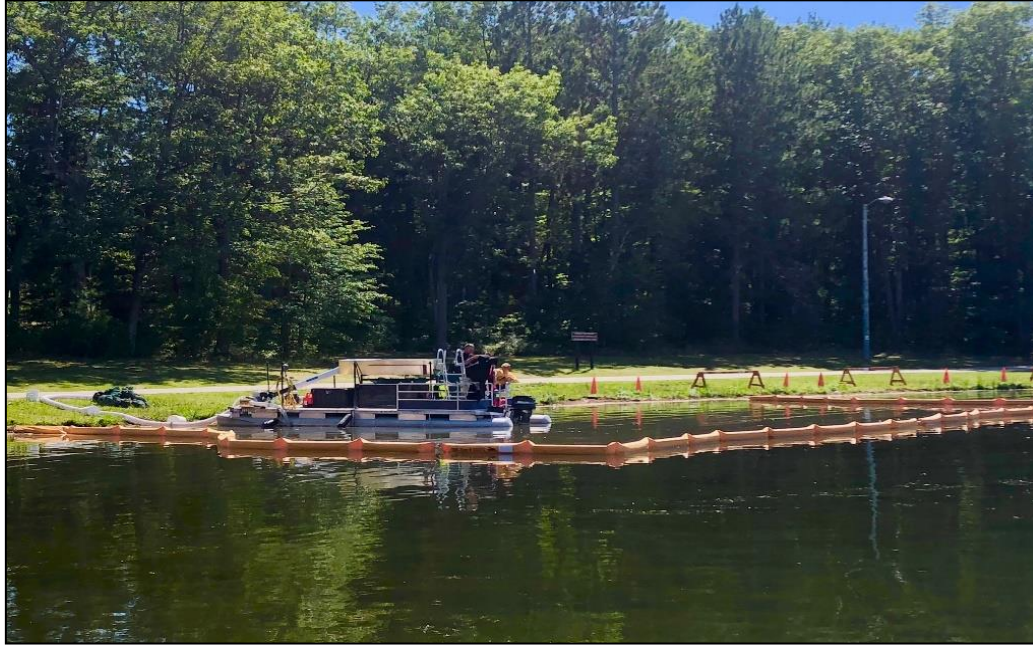
**Figure 66. A DASH boat used for aquatic plant removal (©RLS).**

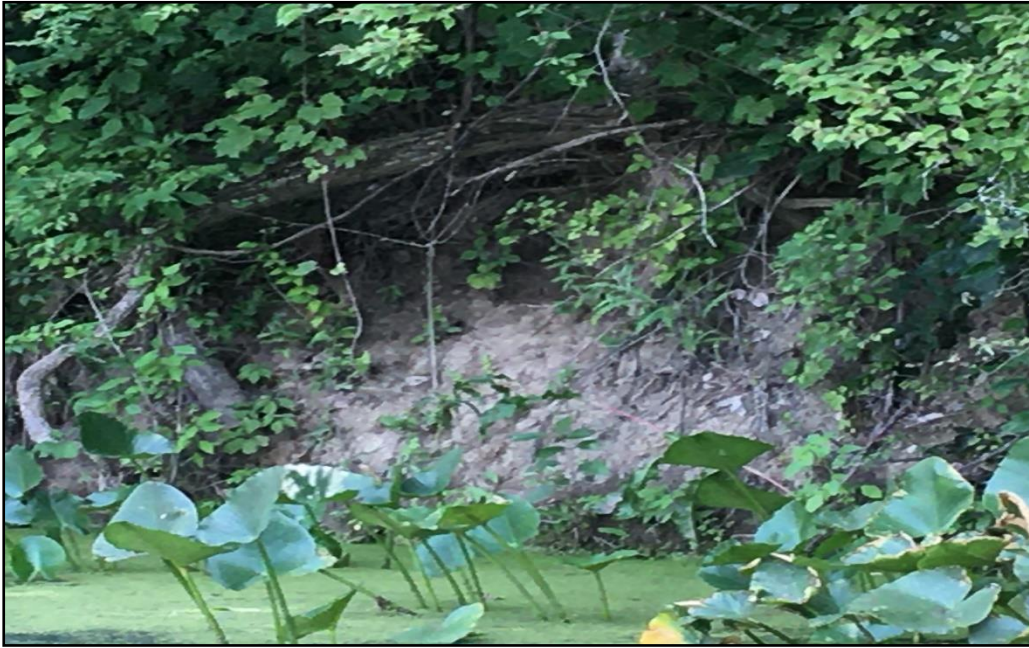
**Figure 67. Shoreline erosion on an Indian Lake canal (July, 2023).**

- 9) A detailed shoreline erosion survey is recommended to determine all possible sources of soil transport to Indian Lake during heavy rainfall events.
