# WETLAND DETERMINATION DATA SHEETS AND SITE PHOTO DOCUMENTATION

Project/Site: Buckeye Partners F-0005785 City/County: Mantua/Portage Sampling Date: 7/22/2026  
Applicant/Owner: Buckeye Partners LP State: OH Sampling Point: S1  
Investigator(s): BC Dickson Section, Township, Range: S42 T5N R8W  
Landform (hillside, terrace, etc.): Stream Floodplain Local relief (concave, convex, none): None Slope %: 0 - 1  
Subregion (LRR or MLRA): 192 (Lake Erie Glaciated Plateau) Lat: 41.281817 Long: -81.196729 Datum: UTM83  
Soil Map Unit Name: Holly silt loam, 0 to 2 % NWI classification: PEM1F  
Are climatic / hydrologic conditions on the site typical for this time of year? Yes X No      (If no, explain in Remarks.)  
Are Vegetation No, Soil No, or Hydrology No significantly disturbed? Are "Normal Circumstances" present? Yes X No       
Are Vegetation No, Soil No, or Hydrology No naturally problematic? (If needed, explain any answers in Remarks.)

| DATE 7/30/2026 | | <b>Buckeye Partners Line 521 F-0005785</b><br><b>Mantua, OH</b> |
| JOB NO. | | <b>Wetland Sample Point: 41.281817 -81.196729</b> |

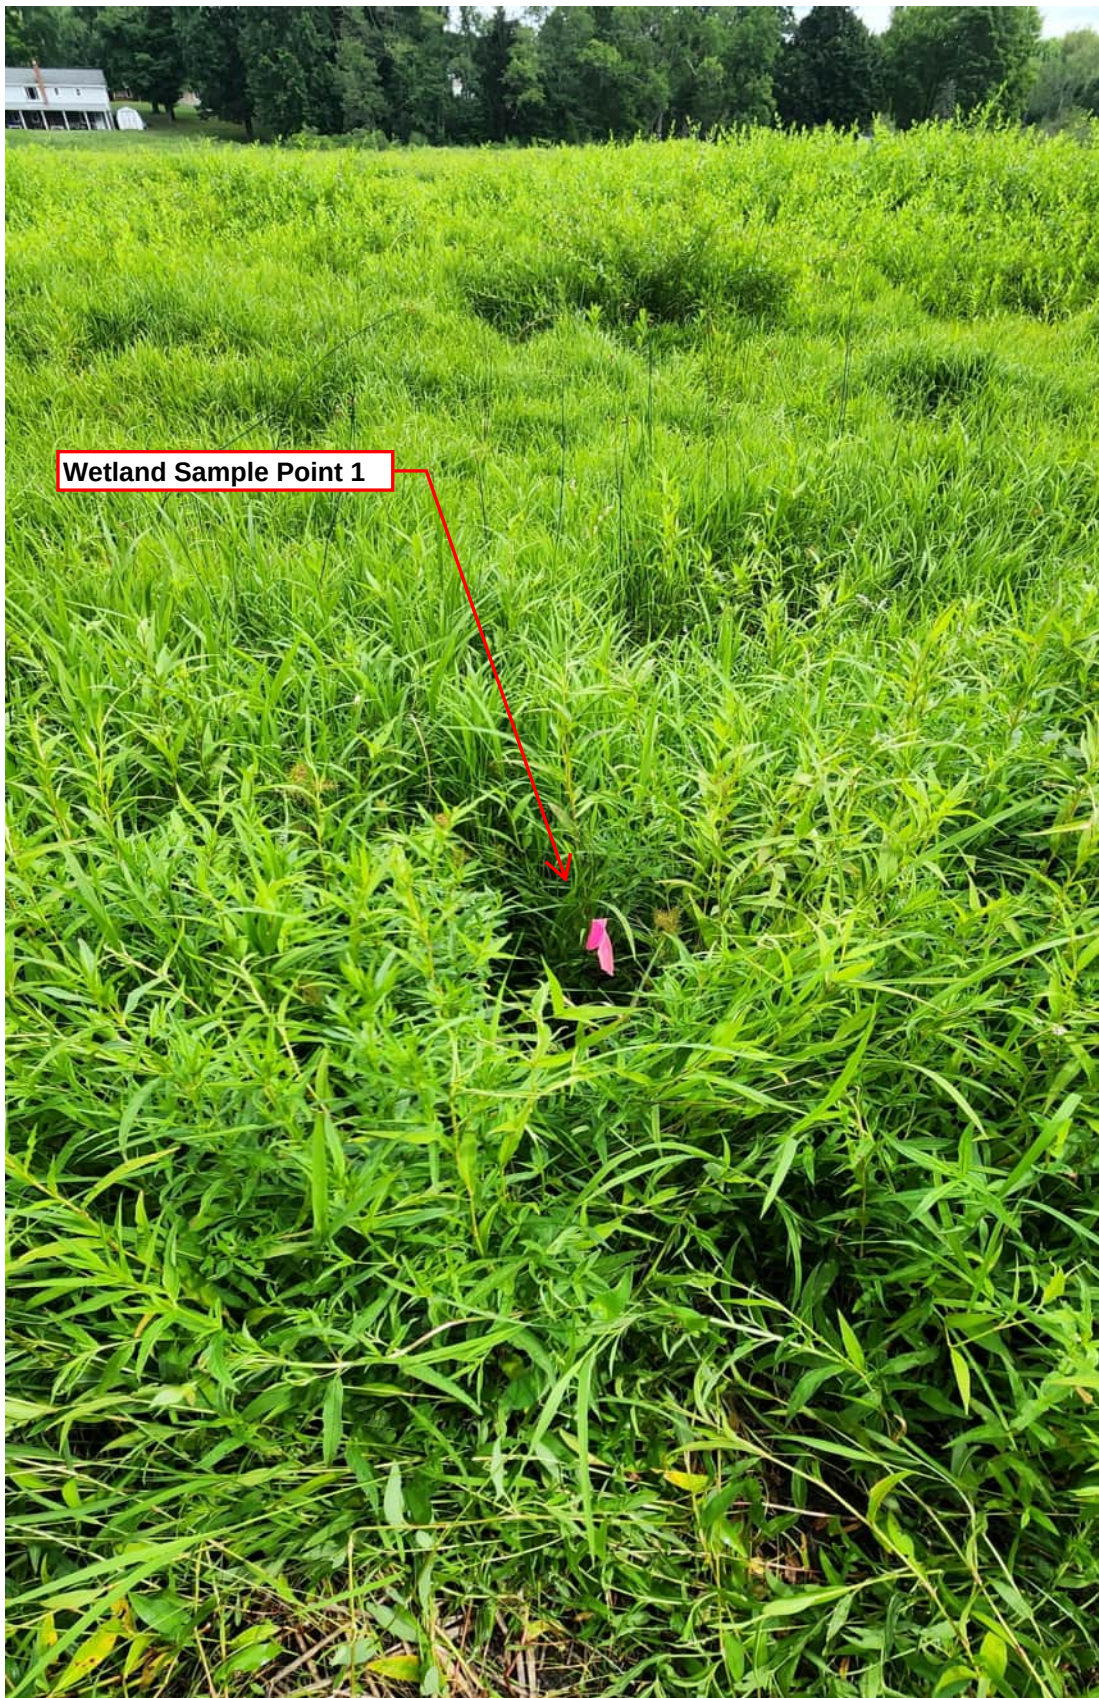
Figure 1. View looking north on ROW at wetland sample point 1.  
(41.281817 -81.196729)

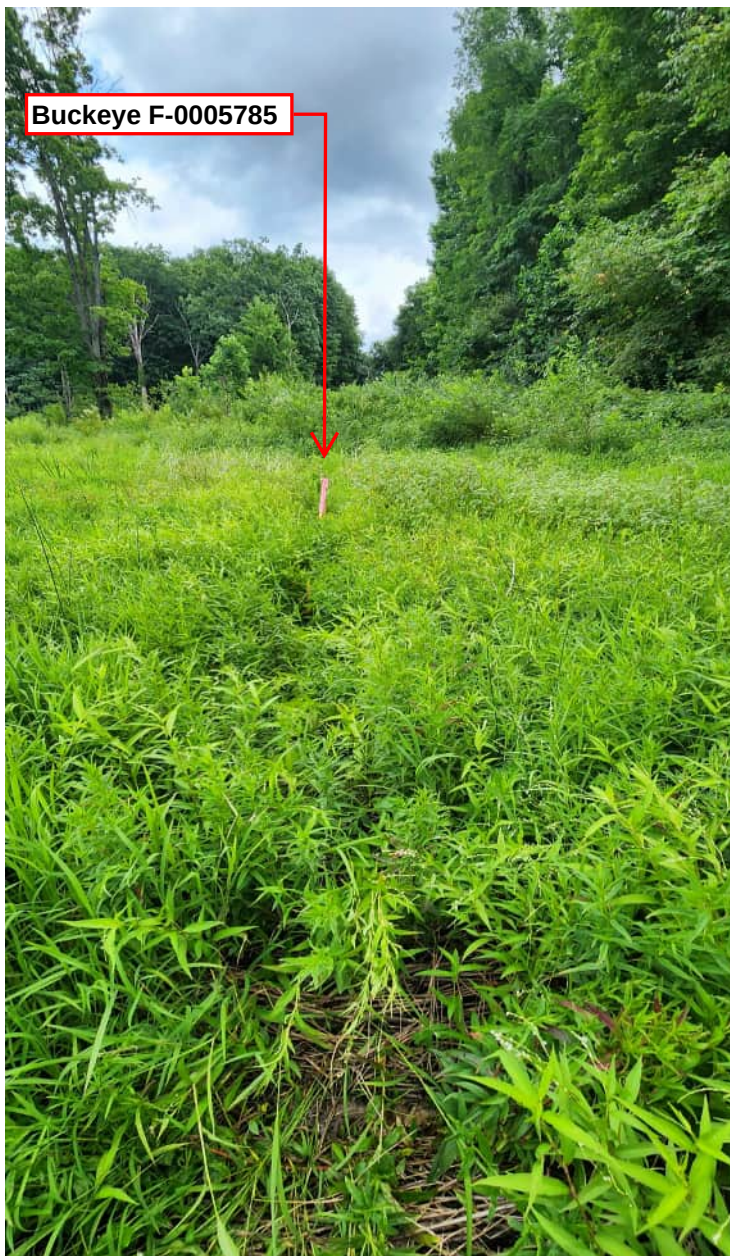
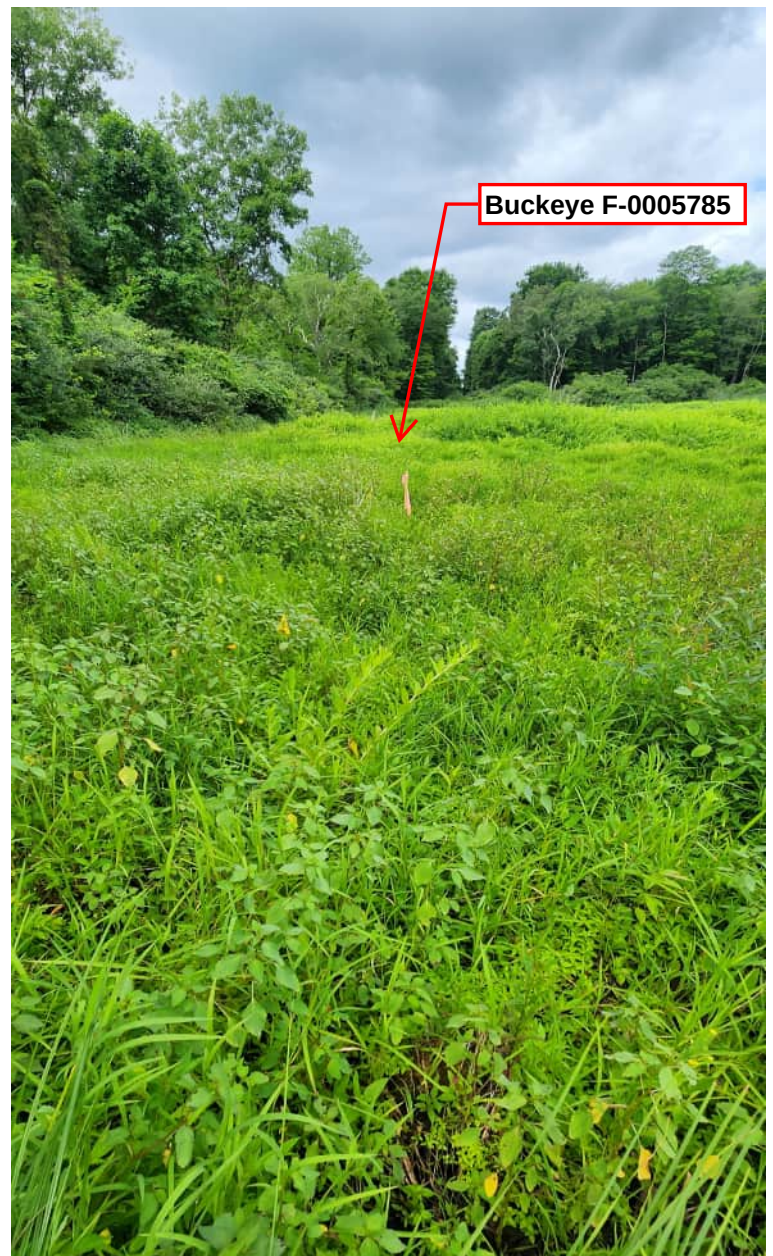
Figure 2. View of project area on pipeline ROW looking east (photo left) and west (photo right) of wetland south of Mennonite Road and north of Headwaters Trail.

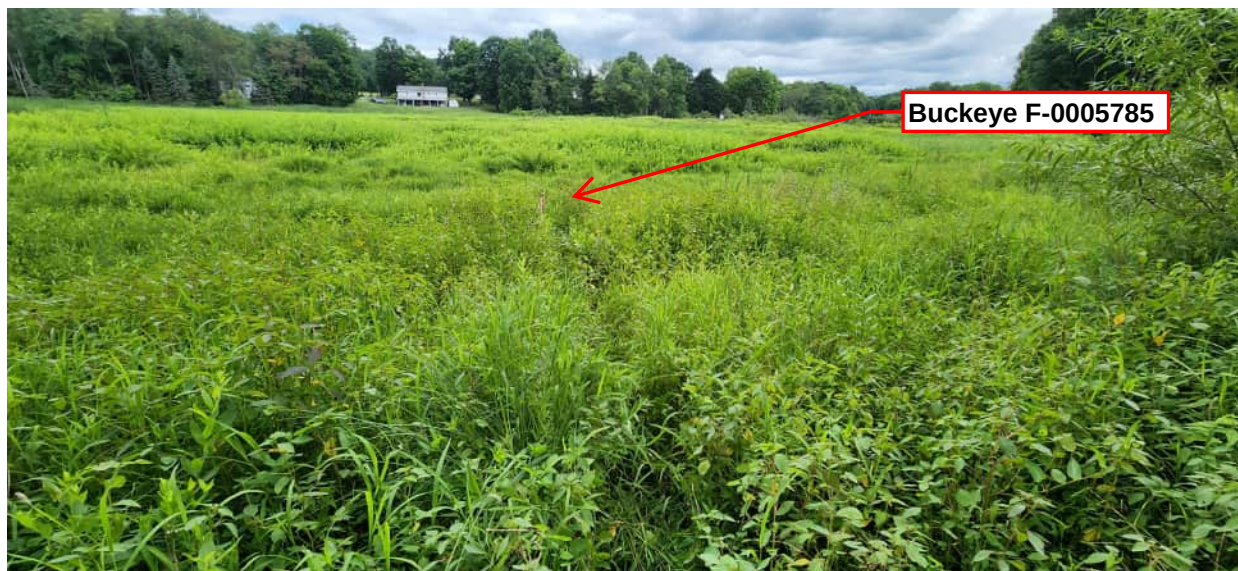
Figure 3. View looking north across ROW at project area toward Mennonite Road

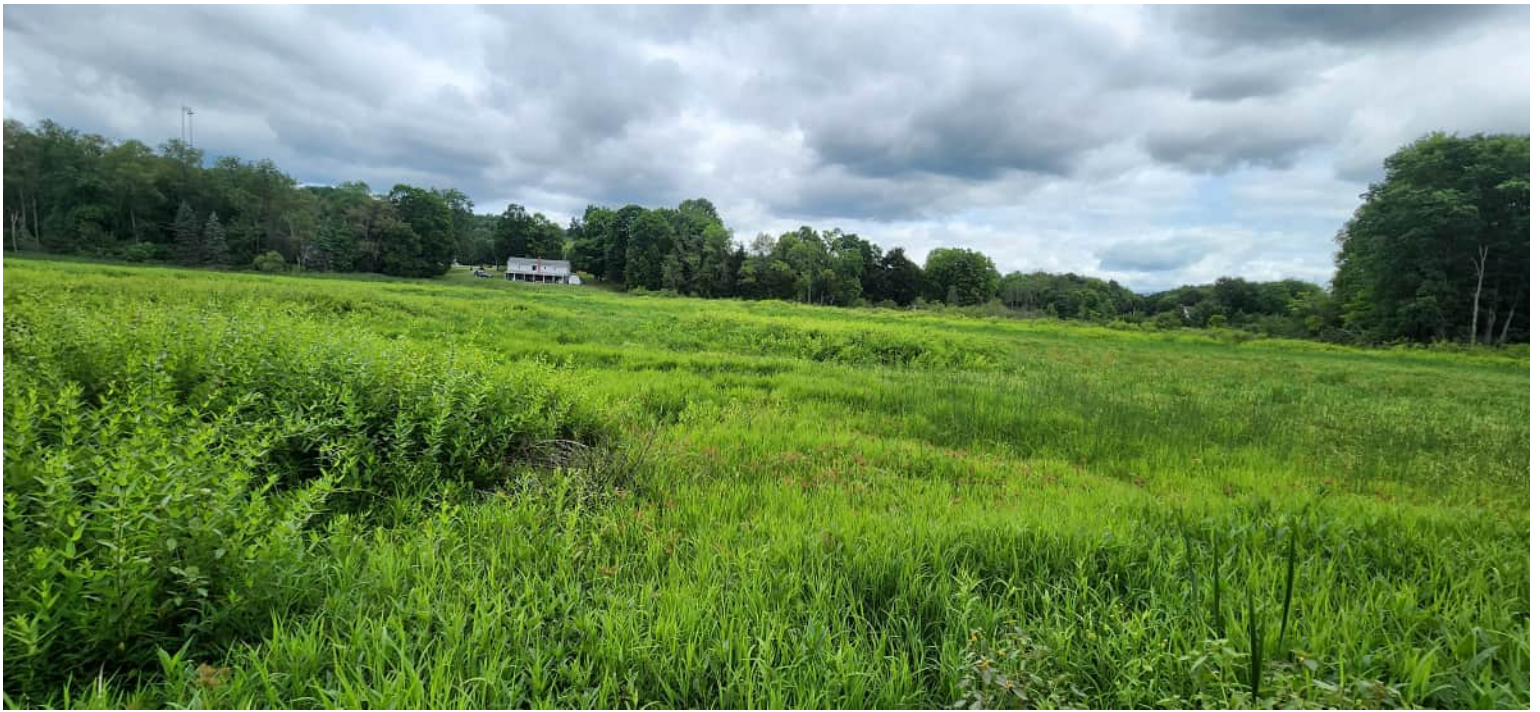
Figure 4. View looking northeast across greater wetland toward Mennonite Road

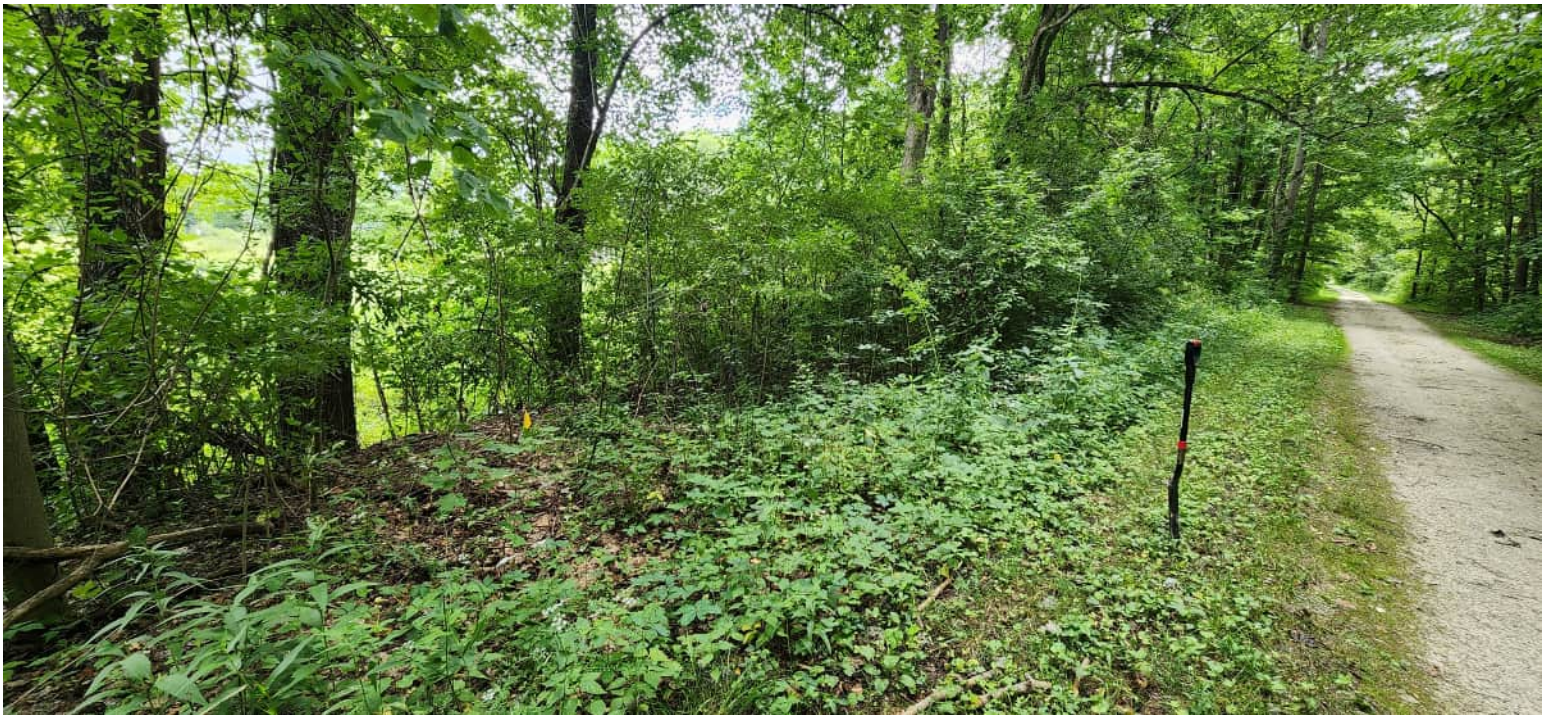
Figure 5. View looking east along Headwaters Trail of bank descending into wetland.  
Base of bank is an abrupt wetland boundary.

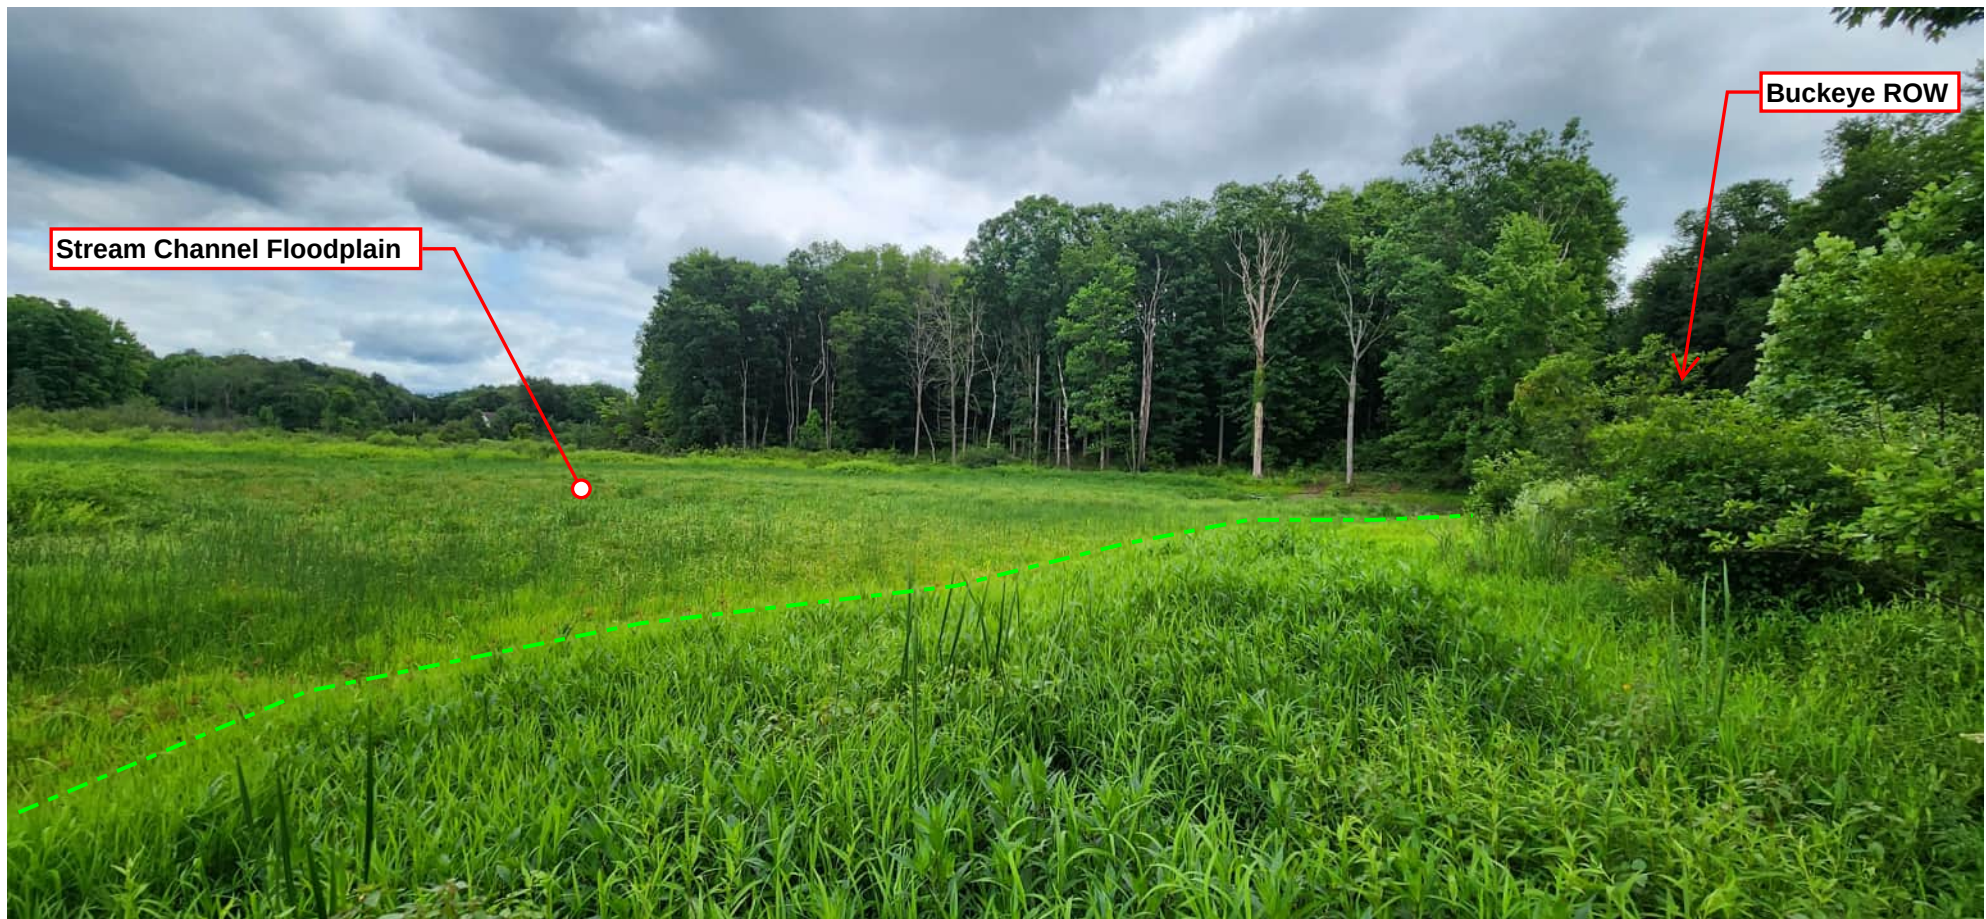
NOTE: The greater vegetation community composition shifts at the floodplain boundary of the trib to the Cuyahoga River.

Figure 7. View looking east across greater wetland where the vegetation community changes along the active floodplain of the tributary to the Cuyahoga River. This area is north on the Buckeye ROW.
