REPORT OF INVESTIGATIONS No. 53

EFFECTS OF LARGE STRUCTURES
on the
OHIO SHORE OF LAKE ERIE

By
Robert P. Hartley

COLUMBUS
1964

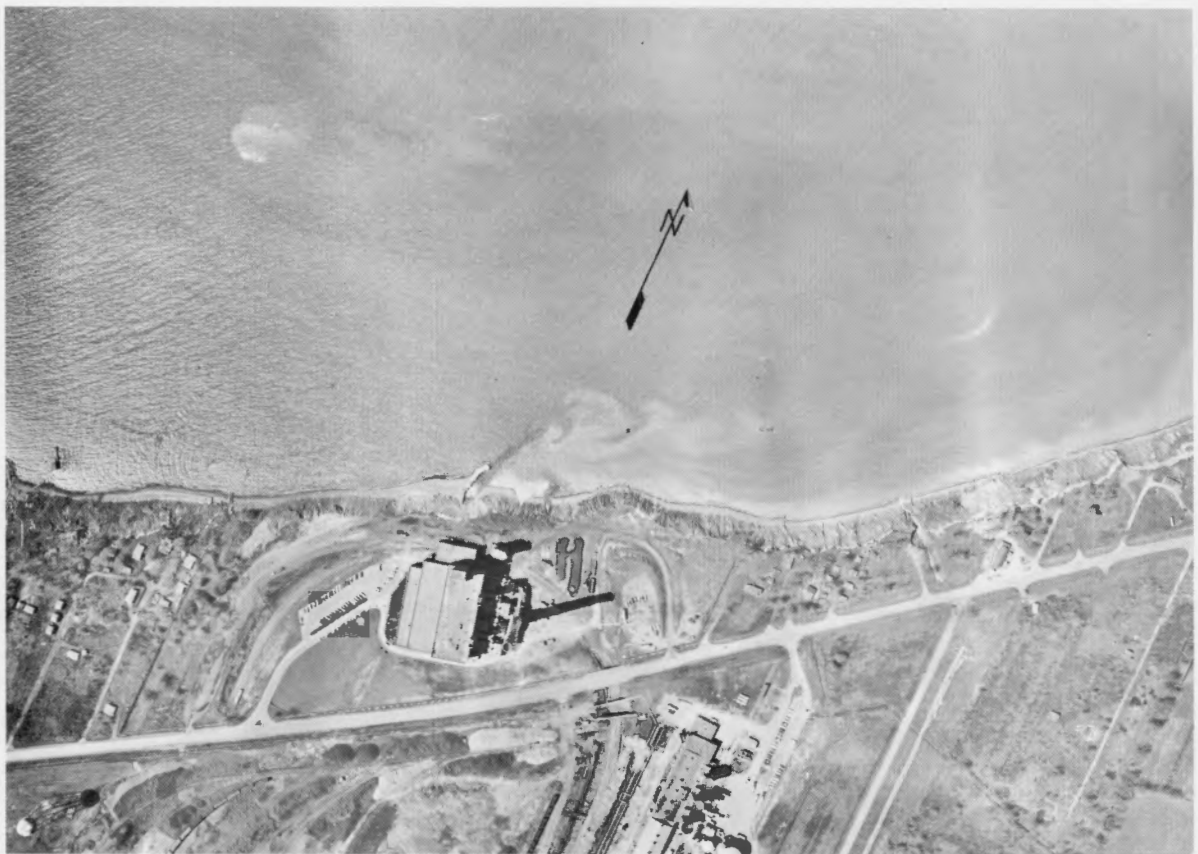
- Figure 30.- Walnut Beach at Ashtabula, Ohio. West harbor breakwater in upper right center. Note shore arm nearly covered by sand. Large sand deposit east of breakwater built from sand moving over and through wall. Photo taken 5/1/58. Water level 571.5.
- Figure 31.- Vicinity of metallurgical plant three miles east of Ashtabula River. Compare with fig. 30 and note absence of beaches and eroding character of shore banks. Bank east of plant rises to more than 60 feet above lake level. Photo taken 5/1/58. Water level 571.5.

The west breakwater has trapped a beach about 3,500 feet long, tapering westward from a width of nearly 900 feet near the breakwall (fig. 30). The beach continues eastward across the breakwater and a huge amount of sand has accumulated on the east side of the breakwater. This sand is permanently trapped, out of the reach of strong waves and currents. The large beach build-up is the result of strong easterly longshore drift and a fair sand supply to the west.

The west breakwater completely cuts off the movement of sand past Ashtabula, thereby starving the beaches to the east (fig. 31). Probably more volume is lost annually in this stretch than in any other comparable distance along the Ohio shore. All of the beach materials must originate within this stretch from bank erosion, since the nearshore bottom is bedrock. Much of the bank material is too fine for beaches and is moved offshore.

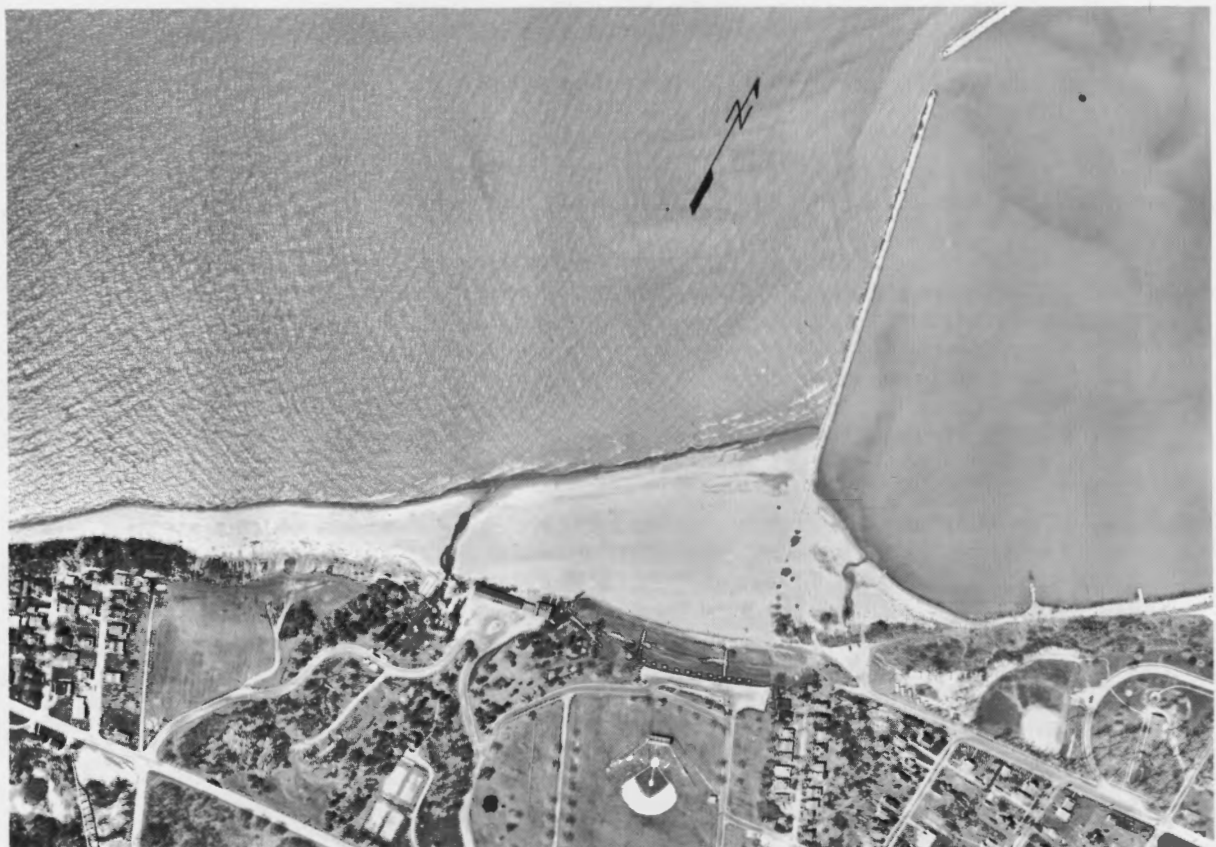
The west breakwater has trapped a great deal of sand and gravel, creating a beach more than 2,000 feet long (fig. 33). It is about 700 feet wide near the wall and tapers westward to about 50 feet at the west end. A considerable amount of sand has passed over the west breakwater to form a protected beach inside the harbor with shoal water off the beach.

→ Figure 33.- Conneaut Township Park at Conneaut, Ohio. West harbor breakwater in right half of photo. Note accumulation of sand east of breakwater which has passed over breakwater. Water very shallow east of breakwater, partly a result of sand passing through breakwater opening. Photo taken 5/1/58. Water level 571.5.
