About the Program

In an on-going effort to assist property owners along Ohio's Lake Erie coast by providing free technical assistance, the *Lake Erie Shore Erosion Management Plan (LESEMP)* is being developed by the Ohio Department of Natural Resources through a partnership between the Office of Coastal Management, Division of Wildlife and Division of Geological Survey.

Description

The *LESEMP* Vermilion to Cleveland Harbor Region includes the Lake Erie shoreline from the mouth of the Vermilion River to the east end of the sand beach at Edgewater Park in Cleveland. The region includes the eastern end of Erie County, the entire Lake Erie shore in Lorain County and the western end of Cuyahoga County.

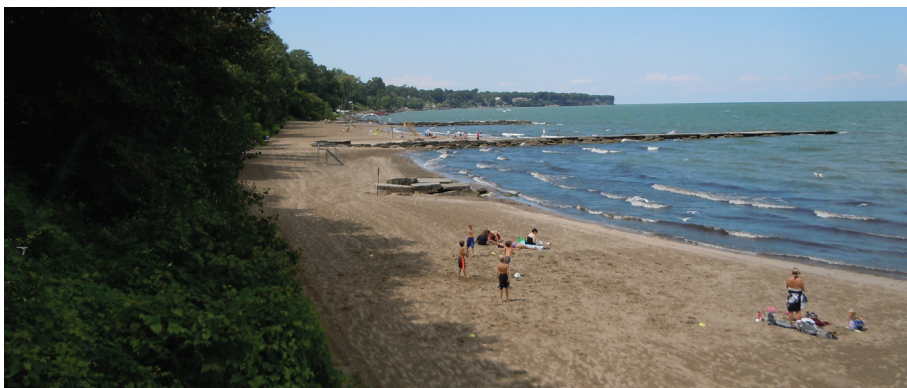
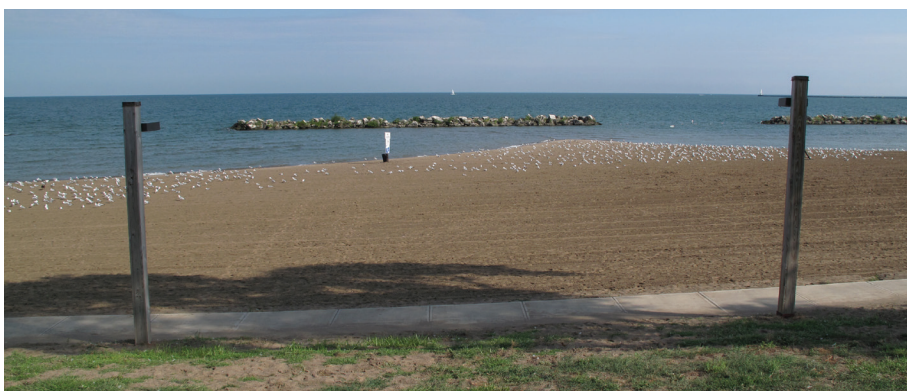
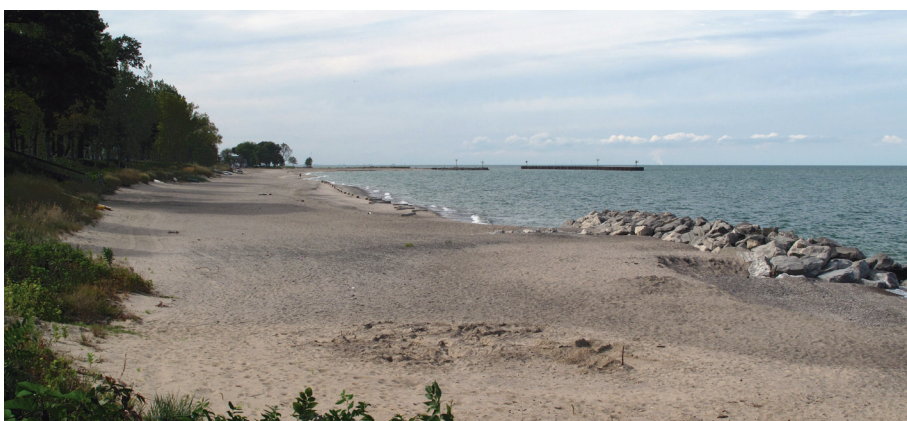
The largest beaches in Vermilion to Cleveland Harbor Region are in areas where sand accumulation is supported by significant shore structures such as the groins at Huntington Reservation in Bay Village (top) or the detached breakwaters at Lakeview Park in Lorain (middle) and east of the jetties at the mouth of the Vermilion River (bottom).

Approximately 1,200 feet west of the Lorain Harbor Breakwaters, a series of detached breakwaters stabilize about 1,500-foot long beach of considerable width at the east end of Lakeview Park. The breakwaters at Lakeview Park, constructed in 1977 by the U.S. Army Corps of Engineers, were the first detached breakwaters constructed for the purpose of beach stabilization in Ohio. The breakwaters were constructed approximately 450 feet lakeward of the toe of the bluff and help support a wide salient beach at the park. A narrow beach extends along the shore between Lakeview Park and Lorain Harbor. The beach gradually widens as sand accumulates near the landward end of the harbor breakwaters.

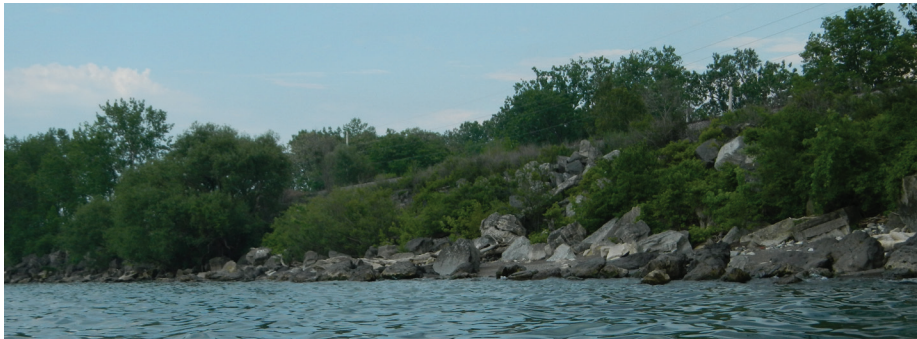
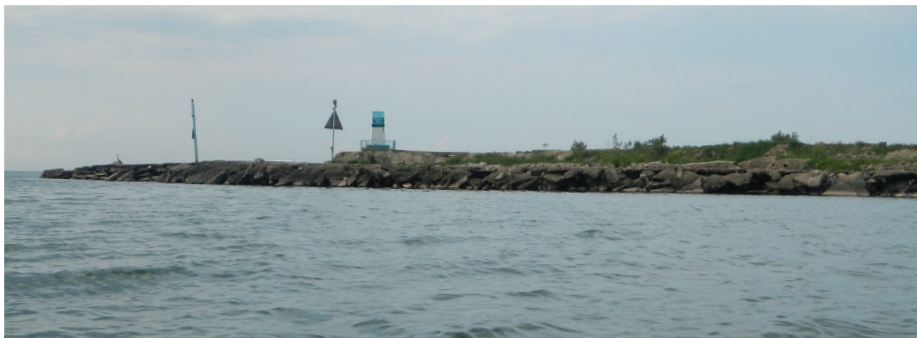
A nearly continuous armor stone revetment protects almost 4 miles of shore lakeward of the Norfolk Southern Railway at the east end of the City of Vermilion and the west end of the City of Lorain (top). The revetment is split near the center by the jetties at the mouth of Beaver Creek (bottom).

The next 3.8 miles of shore to the east is protected by a long, nearly continuous armor stone revetment lakeward of the Norfolk Southern Railway. The revetment is split near the midpoint by the jetties at the mouth of Beaver Creek. The remains of several submerged wood-pile groins can also be seen in the nearshore lakeward of the revetment. East of the Norfolk Southern Railway revetment, the shore leading up to Lorain Harbor is

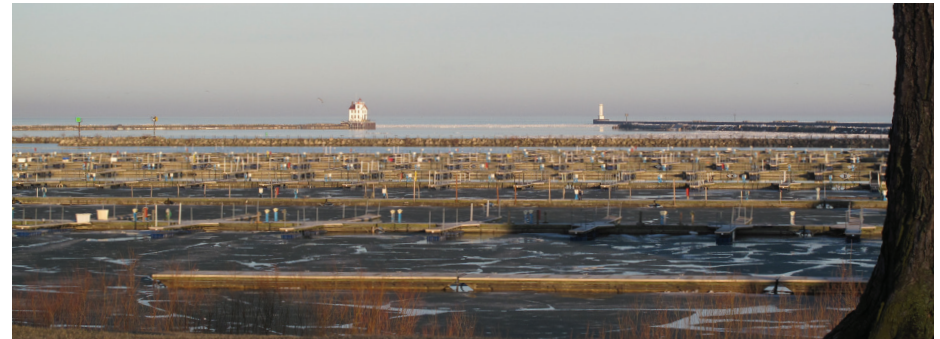
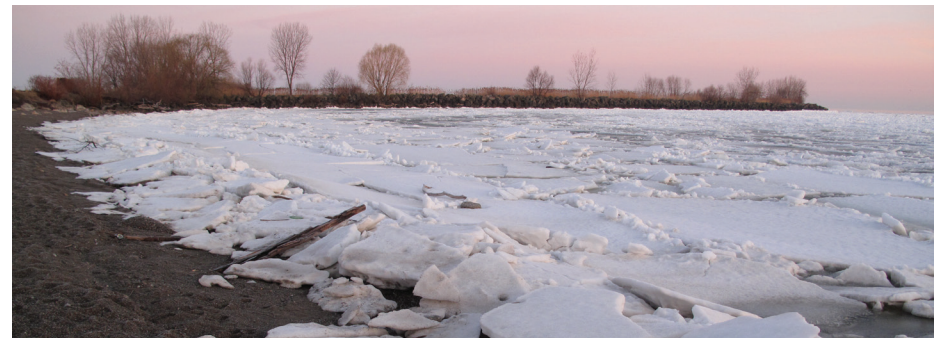
Lorain Harbor is protected by a series of breakwaters and a confined disposal facility for storing material dredged from the harbor channels. The Lorain Harbor Lighthouse is located at the lakeward end of the western breakwater (top). The CDF is located at the east end of the harbor (bottom).

approximately 4,000 feet (0.75 miles) to the Lorain Harbor lighthouse at the lakeward end. Two breakwaters, one 2,200-foot long and one 2,000-foot long, protect the harbor basin from waves from the north and northeast. The east end of the harbor is bounded by a 2,300-foot long breakwater. A 58-acre D-shaped confined disposal facility was constructed along the northeast side of the east breakwater to store sediments dredged from the harbor's shipping channels. The harbor houses the city of Lorain's public boat ramp, public fishing pier, water treatment facility, the mouth of the Black River, the city of Lorain's wastewater treatment plant, the U.S. Coast Guard Station Lorain (www.uscg.mil/d9/sectdetroit/lorain.asp) and the marina at Lakeside Landing

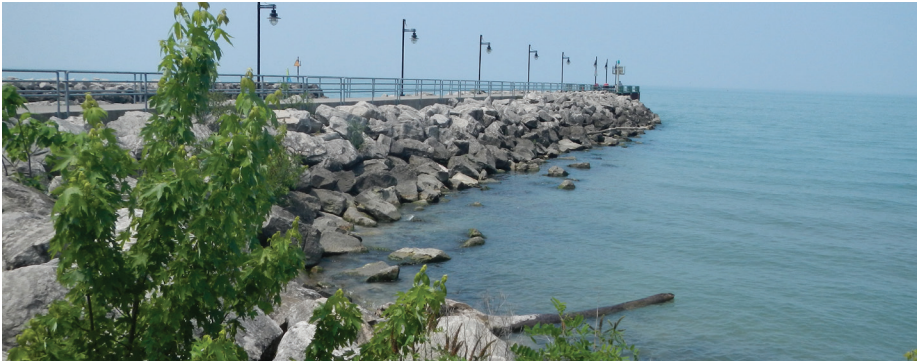
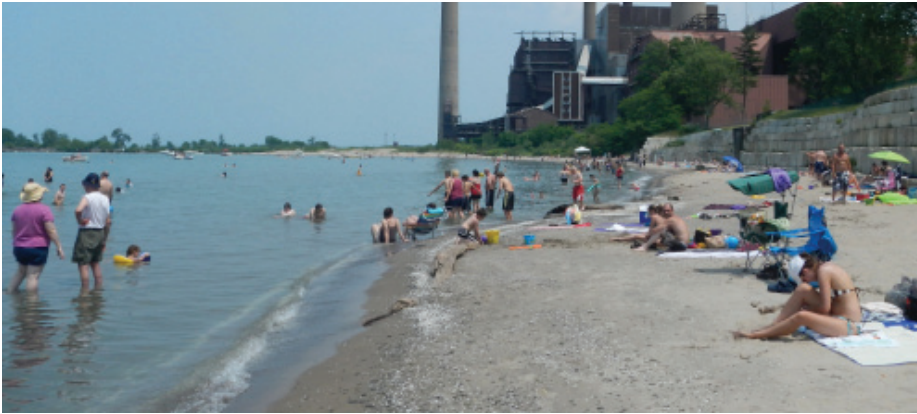
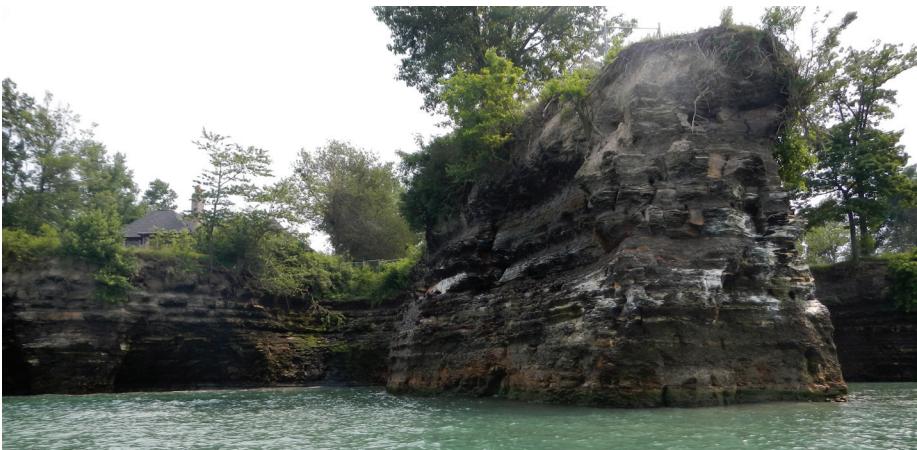
The breakwaters at Miller Road Park and the Avon Lake power plant help stabilize the beach along the shore between the structures (top and middle). The shore of Avon Point consists of shale bluffs along several small headlands separated by narrow embayments (bottom).

Miller Road Park's shore includes a boat ramp protected by two shore-connected breakwaters. East of Miller Road Park the shore of the GenOn Avon Lake Generating Station (Avon Lake power plant) includes a series of shore-perpendicular breakwaters protecting the power plant water intake and outlets. The breakwaters at Miller Road Park and the Avon Lake power plant help stabilize approximately 1,500 feet of beach between the structures.

East of the Avon Lake power plant the shale bluffs along the shore continue to the northeast before gradually turning to the southeast along the shore of Avon Point. Because Avon Point is a gradual headland made up of several small headlands and embayments, the point of diverging currents is highly dependent on constantly changing wind and wave directions. Localized currents can converge or diverge along the shore of the individual landforms, contributing to the formation of the irregular shoreline at Avon Point. As a result, this area experiences frequent cross currents and littoral currents that are highly variable and difficult to predict. Much of the shale bluffs in this area are unarmored; however, shore protection, such as armor stone revetments or concrete block seawalls, are common in several of the narrow embayments in the shale bluff.

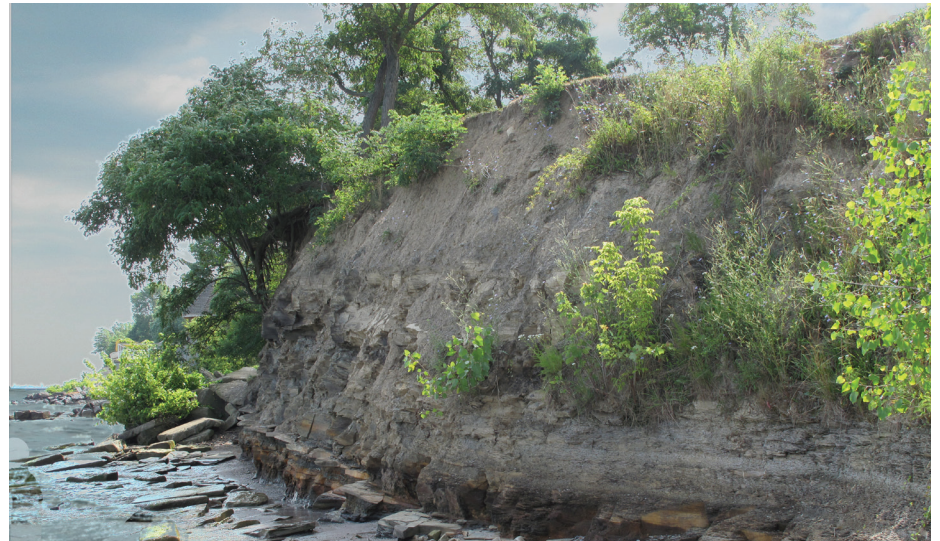
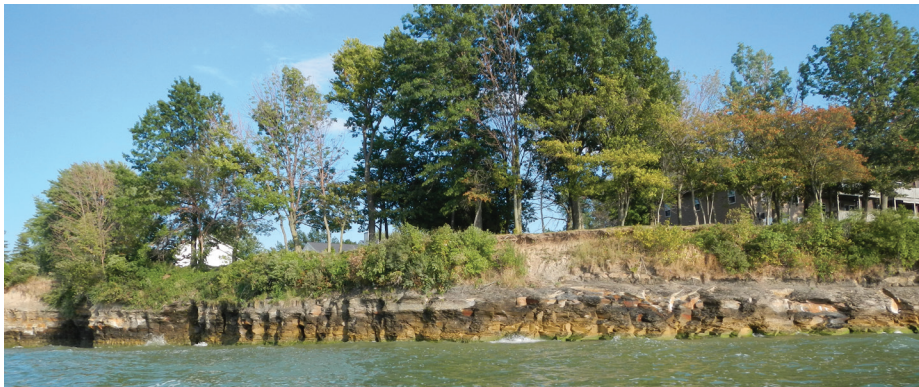
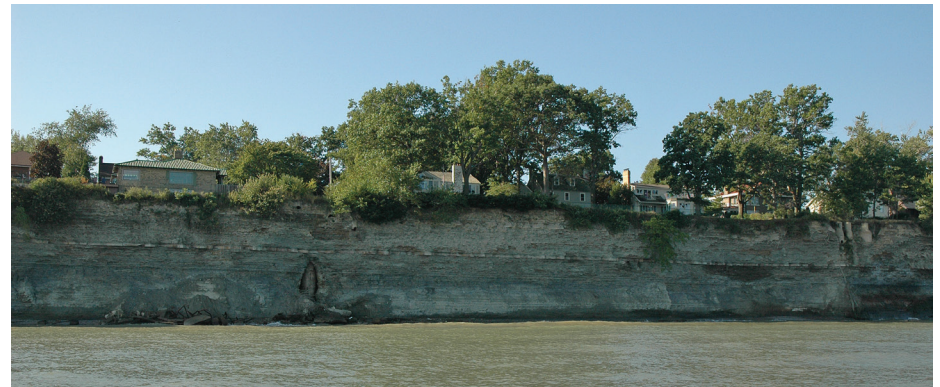
Much of the shore from Vermilion to Cleveland Harbor is fronted by fairly erosion resistant shale bluffs. The 15 to 20-foot high bluffs near the west end of the region are composed of shale covered with a layer of till of varying thickness (left and top right). The layer of shale at the base of the bluff gradually increases in elevation along the shore of Sheffield Lake. The bluffs are primarily shale by the west end of Avon Lake. The eastern portion of the region includes long stretches of unarmored bluffs.

East of Lorain Harbor the shore is characterized by 15 to 25-foot bluffs containing two layers of till separated by a layer of glaciolacustrine deposits. Shale begins to be exposed at the base of the bluff near the west end of Sheffield Lake. To the east the bluff transitions to primarily shale at the west end of Avon Lake. Bluff heights gradually increase to nearly 50 feet as the bluffs become entirely shale near the tip of Avon Point. Due to the shale bluffs and diverging littoral currents near Avon Point, sand deposits in this area are thin and discontinuous. Narrow, transient beaches occasionally

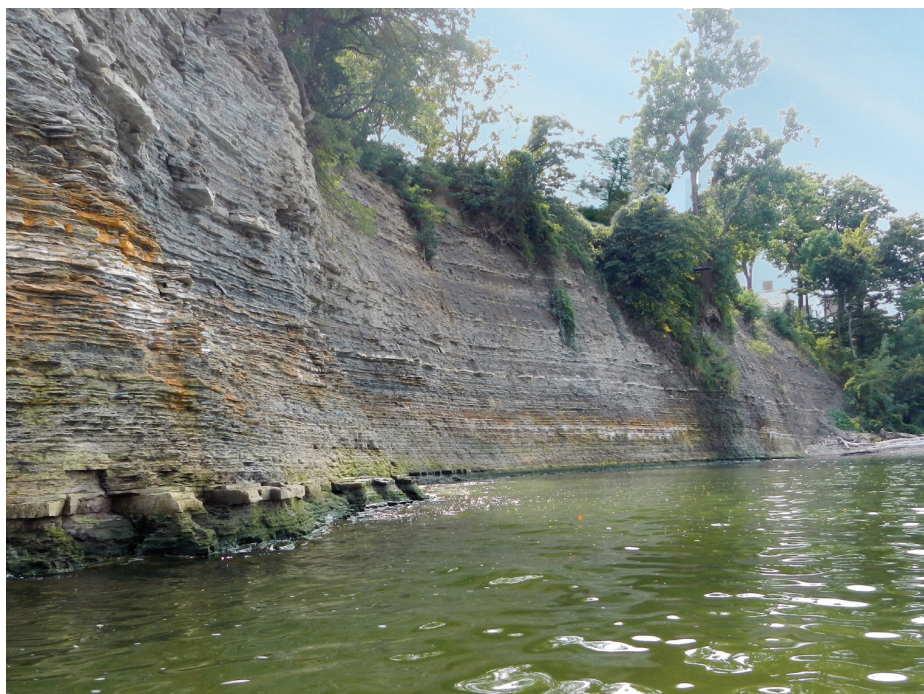
The shore transitions from bluffs composed silt clay and sand to shale bluffs at the mouth of Porter Creek at the east end of Huntington Reservation (top right). The eastern portion of the region is generally characterized by 40 to 60-foot shale bluffs (right). The shale bluffs just west of the Rocky River mouth are shown above.

East of Avon Point the 40 to 50-foot bluffs transition from shale to glaciolacustrine silts and clays capped in sand. The transition occurs near the Lorain/Cuyahoga county line with several shale headlands separated by broad embayments where the bluffs are composed of glaciolacustrine deposits. The silt, clay and sand bluffs extend along the shore at the west end of Bay Village until the mouth of Porter Creek. Shale bluffs front the shore from Porter Creek to Sperry Creek (near the east end of Bay Village) where the bluff composition transitions back to till and glaciolacustrine silts and clays capped in sand. Shale extends into the nearshore throughout most of the area from Avon Point to the mouth of the Rocky River; but the

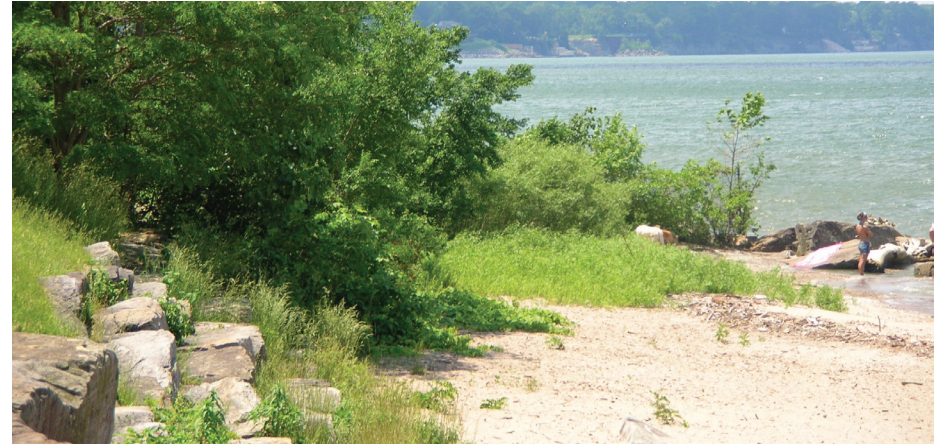
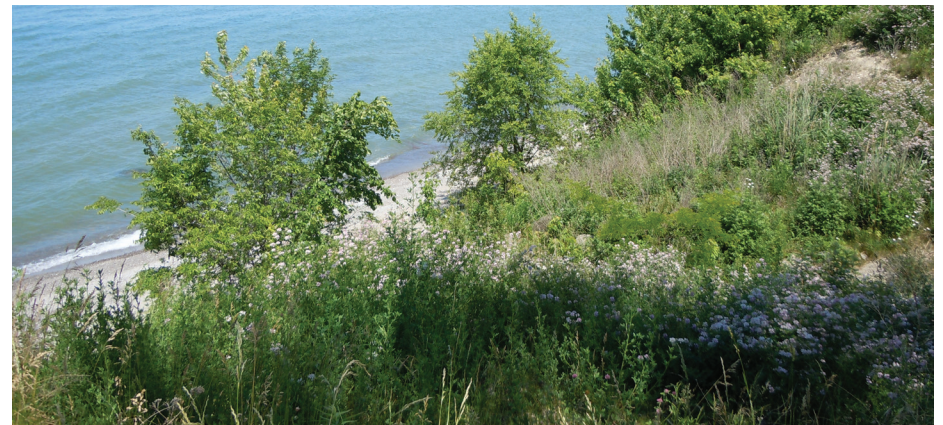
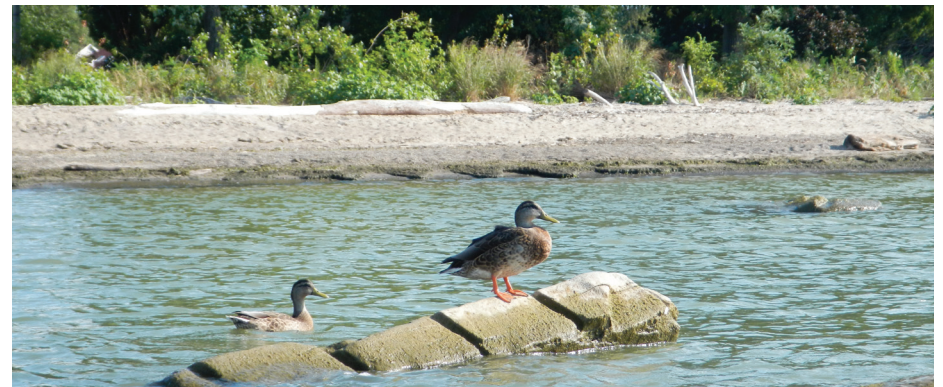
Planting native vegetation along the beach helps stabilize the beach by encouraging sand accumulation and dune formation and provides important habitat for resident and migratory bird populations.

Beaches along the Vermilion to Cleveland Harbor Region provide important yet fragile habitat. Beaches wide enough to support vegetation are generally limited to areas where they are supported by shore structures. Supplementing existing beach flora with additional native vegetation is recommended throughout this region both to improve habitat and for erosion management to help stabilize the beach.

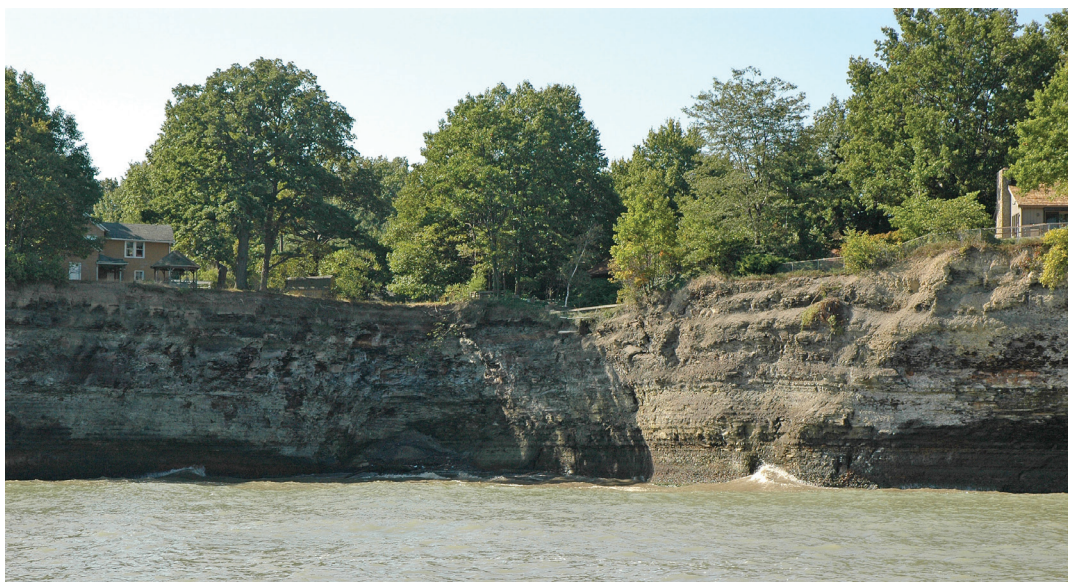
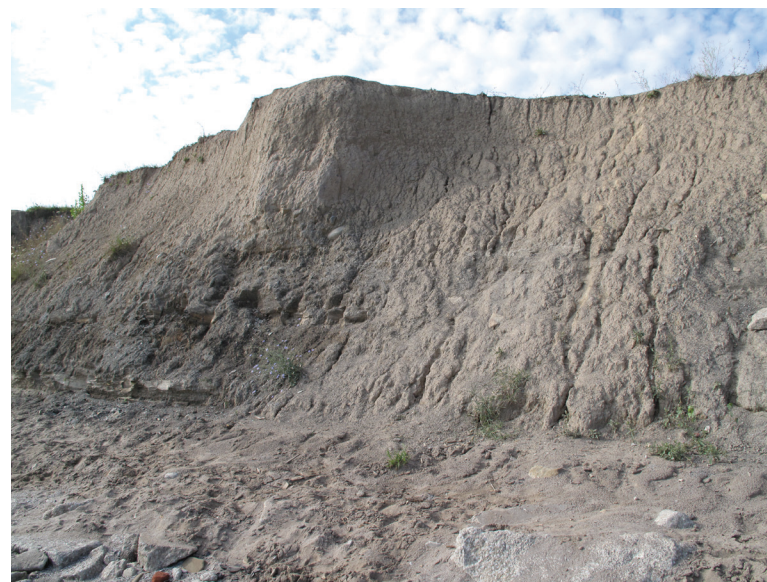
The vertical shale bluffs fronting most of the reach are fairly erosion resistant but are susceptible to wave based erosion at their base. If the bluff is undercut the upper portion of the bluff may collapse (left). Surface water run-off can cause rills to erode along the face of bluffs composed of till or glaciolacustrine deposits (right).

The vertical shale bluffs fronting most of the Vermilion to Cleveland Harbor Region generally erode in episodes of collapsing, rather than by the gradual removal of soil. This means a shale bluff may appear stable for many years before suddenly experiencing a loss of several feet. This is generally the result of wave action at the base of the bluff. Erosion of the shale bluffs by wave action is due both to the significant forces as waves impact the bluff

and by the motion or water or suspended sand and gravel scouring the base of the bluff. The waves breaking on the shore also releases energy that dislodges material from the shore and forces water into existing voids, widening the voids and forcing materials apart. The shale bluffs can also be damaged by ice forces both from ice floes in the lake and from freeze/thaw processes due to ground water in the bluff face. These factors eventually cause cracks in the shale and can lead to rockfalls, particularly in undercut areas.

Areas with bluffs composed of till, and glaciolacustrine deposits will generally erode from a combination of wave action, surface water run-off, ground water seepage and mass wasting. Waves impacting the bluff can cause scour at the toe of the bluff and displacement of loose materials. This leads to slumping of unsupported material higher on the bluff face. Erosion between layers within the bluff due to groundwater seepage can also result in mass wasting (slumping and collapsing). Surface water run-off and weathering, including wind and freeze-thaw processes, are also important factors contributing to erosion of the bluffs in this region.

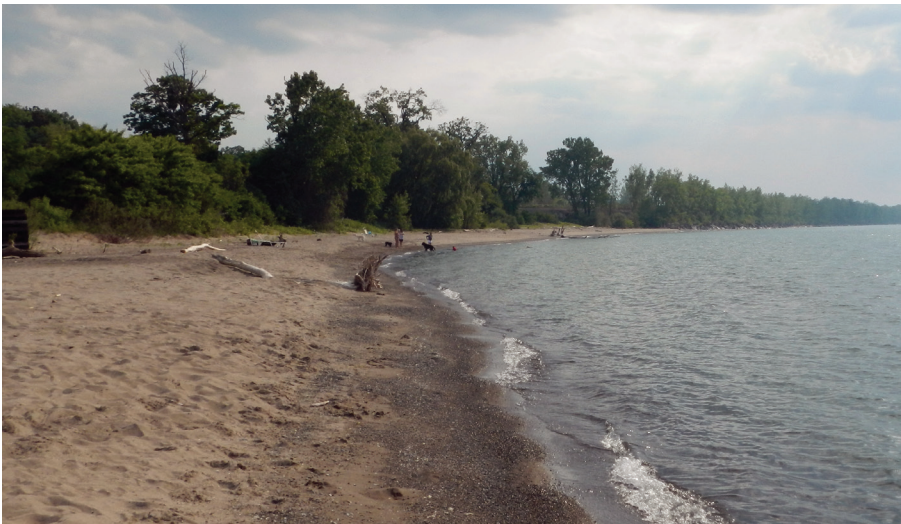
From 1990 to 2004 average recession rates were greatest along the unarmored beach downdrift (west) of the jetties at the mouth of Beaver Creek.

As stretches of this region with bluffs composed of unconsolidated materials continued to be armored, average recession rates continued to decrease from 1990 to 2004. Average recession rates ranged from 0 to 2.5 feet per year throughout the region. Recession was greatest along the unarmored beach near the Beaver Creek jetties. Future erosion along most of the Vermilion to Cleveland Harbor Region will likely be limited as most areas with till, clay or glaciolacustrine deposits near the toe of the bluff are heavily armored with protective structures. Future erosion will likely be limited to small unprotected areas or gaps between structures or the slow recession of the long stretches with fairly erosion resistant shale bluffs. With adequate maintenance of the existing shore structures in this reach, future recession rates should be low along most of the region.
