Common Problems for Small Dams with Conduits as the Principal Spillway

A dam safely passes a flood event by a combination of storing water in the lake and passing water through its spillways. Earthen embankments are not designed to have floodwaters overtop them. An emergency spillway should not pass over the crest of the dam; it should be located in the abutment area.

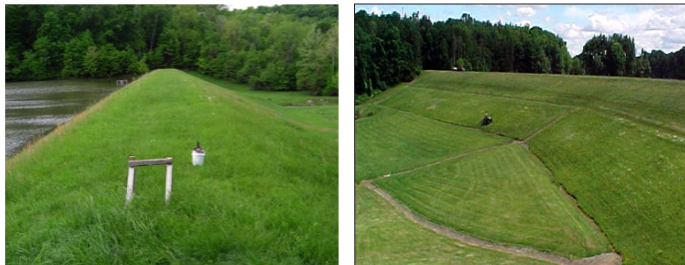
An excellent grass cover will reduce erosion and is easily maintained.

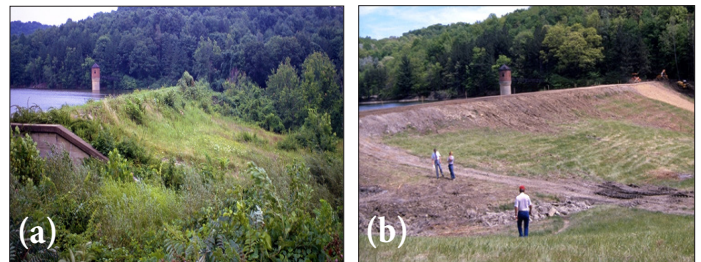
(a) Embankments covered with trees and brush makes inspection difficult. (b) Cleared of trees and brush, this embankment is much easier to inspect, but needs a good vegetal cover.

Trees and brush must not be permitted on embankment surfaces or in vegetated earth spillways. Extensive root systems can provide seepage paths for water. Trees that blow down or fall over can leave large holes in the embankment. Brush hinders visual inspection, provides a haven for burrowing animals, and retards growth of grass vegetation.

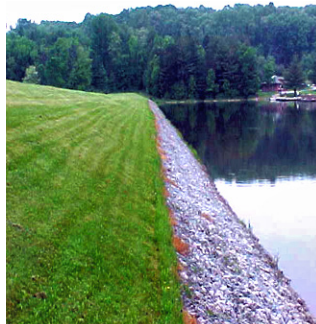
This slope is well maintained with rock riprap along the shoreline.

Muskrats and groundhogs can also damage the slope. The upstream face of a dam is commonly protected against wave erosion by placement of a layer of rock riprap over a layer of bedding and a filter material.

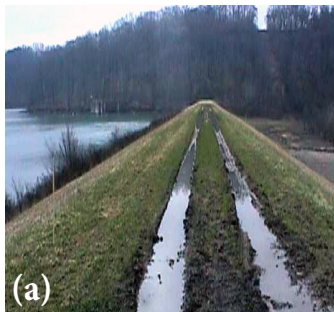
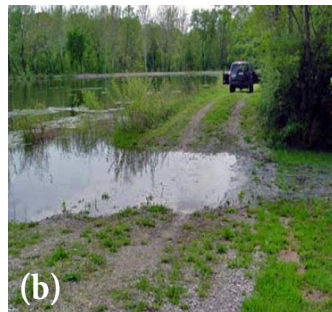
(a) Embankment crests with vehicle ruts will collect water and weaken the embankment. (b) Crest beginning to overtop in low area. This could lead to erosion and failure of the dam.

Vehicular traffic should be discouraged, especially during wet conditions, to avoid ruts. Water collected in ruts may cause localized saturation, thereby weakening the embankment. Ruts can develop into low areas. Low areas on the crest

increase the likelihood that a dam will be overtopped during severe floods. Earthen embankments are not designed to be overtopped. Should the dam overtop, floodwaters will concentrate in the low area, increasing the likelihood of erosion of the crest and downstream slope. Severe erosion can lead to failure of the embankment. A well-vegetated earth embankment

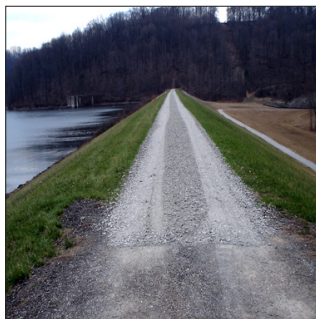
Crest with a good cover that will reduce the effects of vehicular traffic.

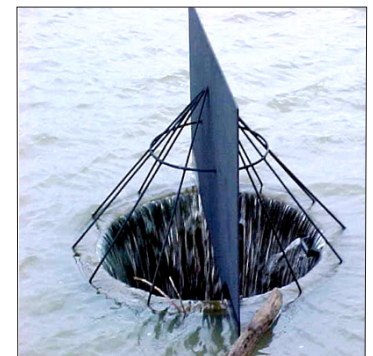
Trashracks with properly sized openings will pass smaller debris and stop larger items.

A spillway must remain free from obstructions to maintain its flow capacity. Trashracks are designed to keep trash and other debris from entering the spillway and restricting flow. Trashracks should be designed to allow small debris such as leaves to pass through the spillway while stopping larger debris from entering the spillway where they might become lodged. Trashracks usually become plugged if the openings are too small or the trashrack is flat across the opening. Small openings will collect debris such as twigs and leaves, which in turn cause a progression of larger items to build up, eventually blocking the entire inlet. Vegetation around the inlet also can reduce flow through the spillway.

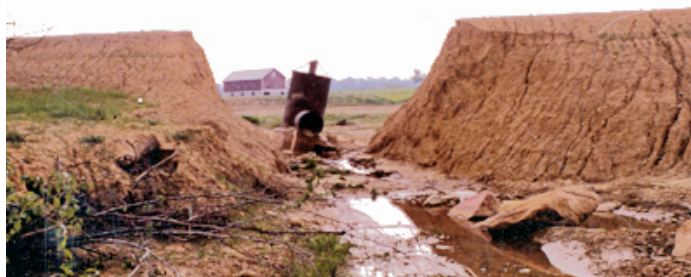
This Dam failed from seepage along the principal spillway.

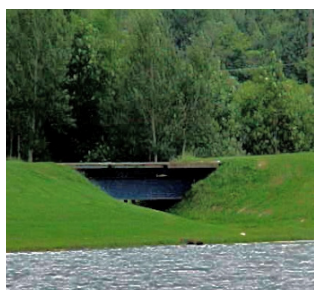
This bridge blocks much of the spillway, reducing its ability to convey water.

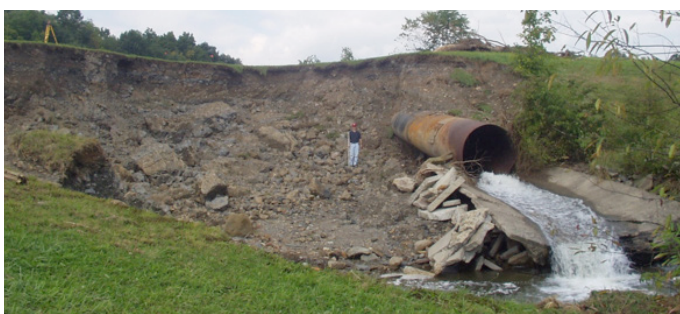
Severe erosion and near failure of the dam (2004) resulted after the principal spillway plugged during a storm. The dam did not have an emergency spillway. The dam was removed one week later.

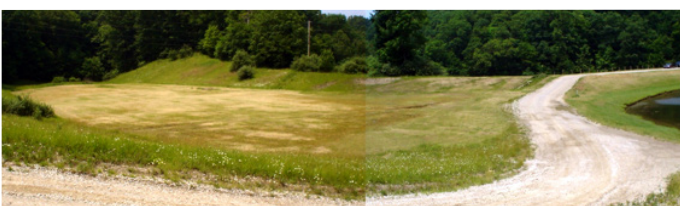
This open-channel emergency spillway is clear of trees, brush and other obstructions. Also note the good grass cover.

The emergency spillway is the second spillway to experience flow during a flood event. For most dams in Ohio, the emergency spillway consists of a grass-lined, earthen open channel. An open channel can convey much more flow than a pipe spillway, so it is important to keep the spillway free of obstructions. Obstructions reduce the flow capacity and could cause the dam to overtop and fail. Permanent structures including buildings, fences, and roadway embankments for access across the spillway should not be constructed in the spillway. Earthen channels should be protected by a good grass cover, an appropriately designed rock cover, concrete, or other various types of erosion control matting. Grass-lined channels should be mowed at least twice per year to maintain a good grass cover and to prevent trees, brush, and weeds from becoming established. Poor vegetal cover can result in extensive and rapid erosion when the spillway flows.
