Ohio Department of Natural Resources Division of Water Resources Fact Sheet

Fact Sheet 99-51

Dam Safety: Outlet Erosion Control Structures (Stilling Basins)

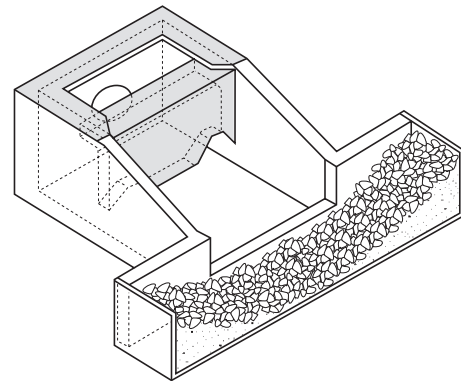
Impact Basin

A concrete impact basin is an energy dissipating device located at the outlet of the spillway in which flow from the discharge conduit strikes a vertical hanging baffle.

Discharge is directed upstream in vertical eddies by the horizontal portion of the baffle and by the floor before flowing over the endsill. Energy dissipation occurs as the discharge strikes the baffle, thus, performance is not dependent on tailwater. Most impact basins were designed by the United States Department of Agriculture, Natural Resources Conservation Service and the United States Department of Interior, Bureau of Reclamation. If any of the severe defects that are referenced in the opening paragraphs are observed, a registered professional engineer should be contacted to evaluate the stability of the outlet.

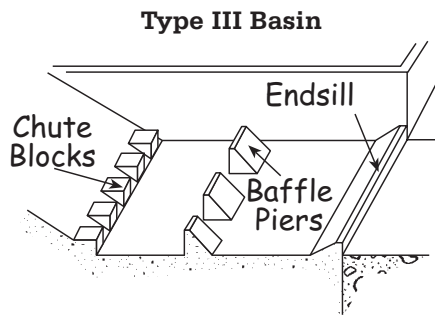
Type II and Type III basins reduce the energy of the flow discharging from the outlet of a spillway and allow the water to exit into the outlet channel at a reduced velocity. Type II energy dissipators contain chute blocks at the upstream end of the basin and a dentated (tooth-like) endsill. Baffle piers are not used in a Type II basin because of the high velocity water entering the basin.

Type III energy dissipators can be used if the entrance velocity of the water is not high. They contain baffle piers which are located on the stilling basin apron downstream of the chute blocks. Located at the end of both the Type II and Type III basins is an endsill. The endsill may be level or sloped, and its purpose is to create the tailwater which reduces the outflow velocity. If any of the severe defects associated with concrete structures are observed, a registered professional engineer should be contacted to evaluate the stability of the basin.

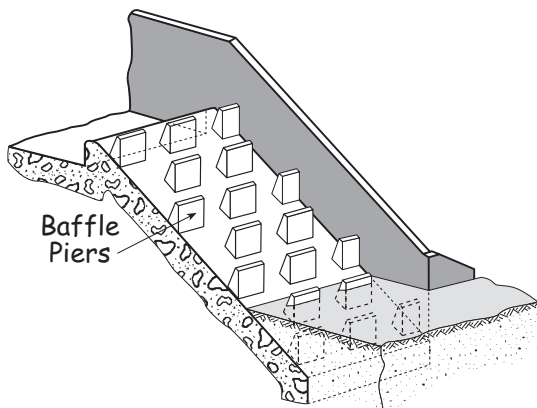
Baffled Chute Basin

Baffled chutes require no initial tailwater to be effective and are located downstream of the control section. Multiple rows of baffle piers on the chute prevent excessive acceleration of the flow and prevent the damage that occurs from a high discharge velocity. A portion of the baffled chute usually extends below the streambed elevation to prevent undermining of the chute. If any of the severe problems associated with concrete that are referenced in the opening paragraphs are observed, a registered professional engineer should be contacted to evaluate the stability of the outlet.

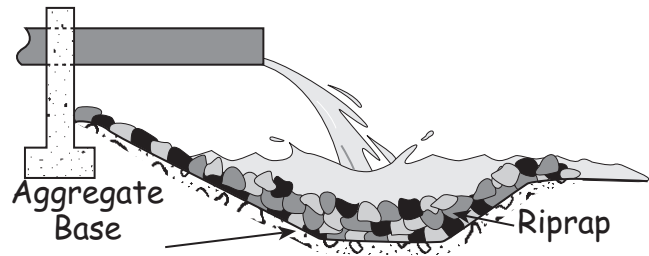
Plunge Pool

A plunge pool is an energy dissipating device located at the outlet of a spillway. Energy is dissipated as the discharge flows into the plunge pool. Plunge pools are commonly lined with rock riprap or other material to prevent excessive erosion of the pool area. Discharge from the plunge pool should be at the natural streambed elevation. Typical problems may include movement of the riprap, loss of fines from the bedding material and scour beyond the riprap and lining. If scour beneath the outlet conduit develops,

the conduit will be left unsupported and separation of the conduit joints and undermining may occur. Separation of the conduit joints and undermining may lead to failure of the spillway and ultimately the dam. A registered professional engineer should be contacted to ensure that the plunge pool is designed properly.
