Nine-Element Nonpoint Source Implementation Strategy

Lower Swan Creek: Heilman Ditch-Swan Creek HUC-12 (04100009 08 04)

Version 1.3 February, 2021

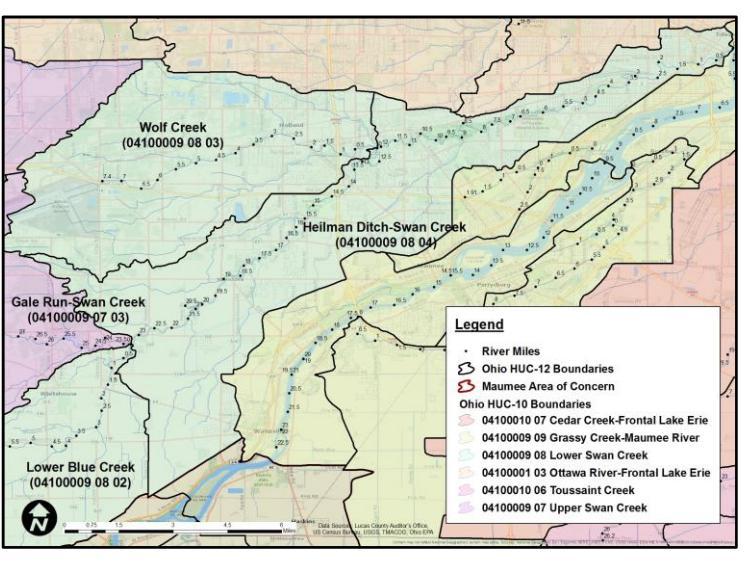
FIGURE 2: **RIVER MILE MAP OF HEILMAN DITCH-SWAN CREEK HUC-**12.

¹It should be noted that the river mile maps used in this document were created using data digitized by TMACOG (made available from the PCS DMDS online system) utilizing 2004 aerial photography and may not represent current stream lengths or correlate to other river mile data sets, notably they do not precisely align with Ohio EPA river mile delineations.

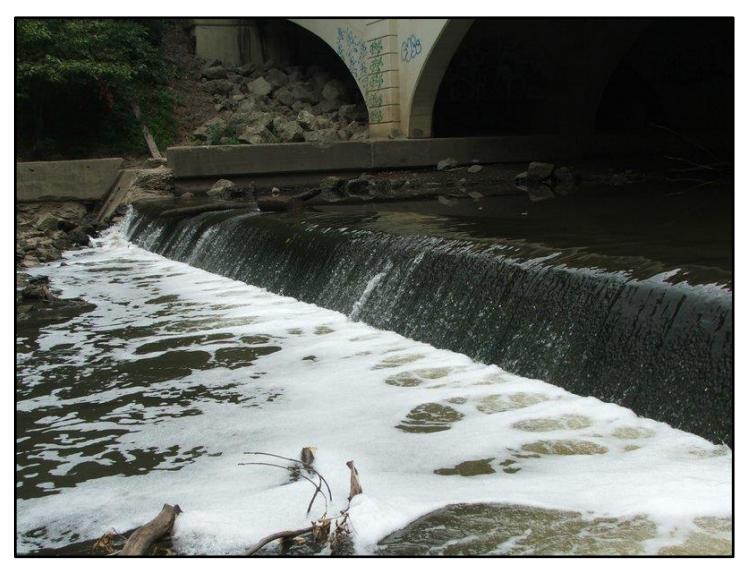
FIGURE 8: HIGHLAND PARK DAM (~RM 4.3).

A low-head dam is located at approximately RM 4.2. Constructed in 1926, the dam encases a 36inch sewer main and is believed to be protecting the 3-lane roadway bridge immediately upstream (JFNew, 2009). A 2009 dam mitigation project attempted to address the barrier to fish passage created by the dam's height and its associated large scour hole, with an additional objective to restore flow integrity to the lower 11 miles of Swan Creek. Two large engineered rocked riffles were installed and meandering fish bypass low flow channels were integrated into the design (Figure 8). Improvements to aquatic habitat and communities in nearby sampling locations may be shown in the next Ohio EPA sampling event in Swan Creek, scheduled to occur in summer 2017.

The impoundment existing at RM 4.4 has an impact on the habitat score at this location. The low-head dam located at RM 4.2 exhibited silt-settling properties; thus, the habitat score at this site was fairly high (QHEI=74.5). However, those effects were not far-reaching, as moderate silt amounts were found at the downstream end of this site. The worst habitat throughout all of Swan Creek was found at RM 1.58, lacking in all six QHEI habitat categories.

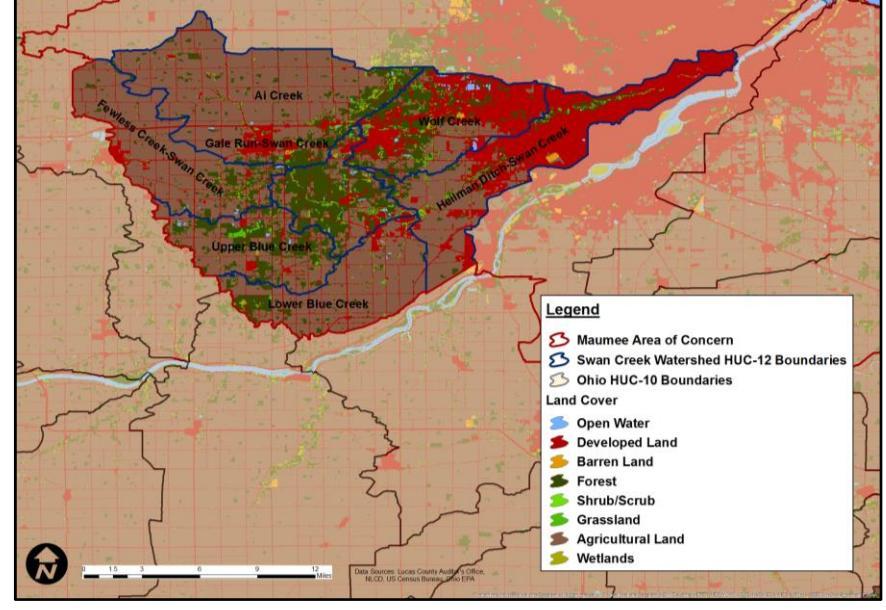
FIGURE 9: LAND USE IN THE SWAN CREEK WATERSHED: UPPER SWAN CREEK (HUC-10: 04100009 07) AND LOWER SWAN CREEK (HUC-10: 04100009 08).

Land use within the Heilman Ditch-Swan Creek HUC-12 is varied between upstream and downstream segments (Figure 9). Cropland dominates onethird of the HUC-12 (31%), primarily in the upstream segment of the watershed (Table 1). From approximately RM 15, the landscape progressively becomes more urbanized, accounting for the majority of land use within the HUC-12 (57%). A wooded riparian corridor and protected parklands (Swan Creek Metropark) account for an additional 7.5% of land use in the HUC-12. In all, stream habitat quality mirrors the surrounding land use. In the agricultural reach (RM 23-19), channel substrates consist primarily of sand and silt, and banks are unstable. Swan

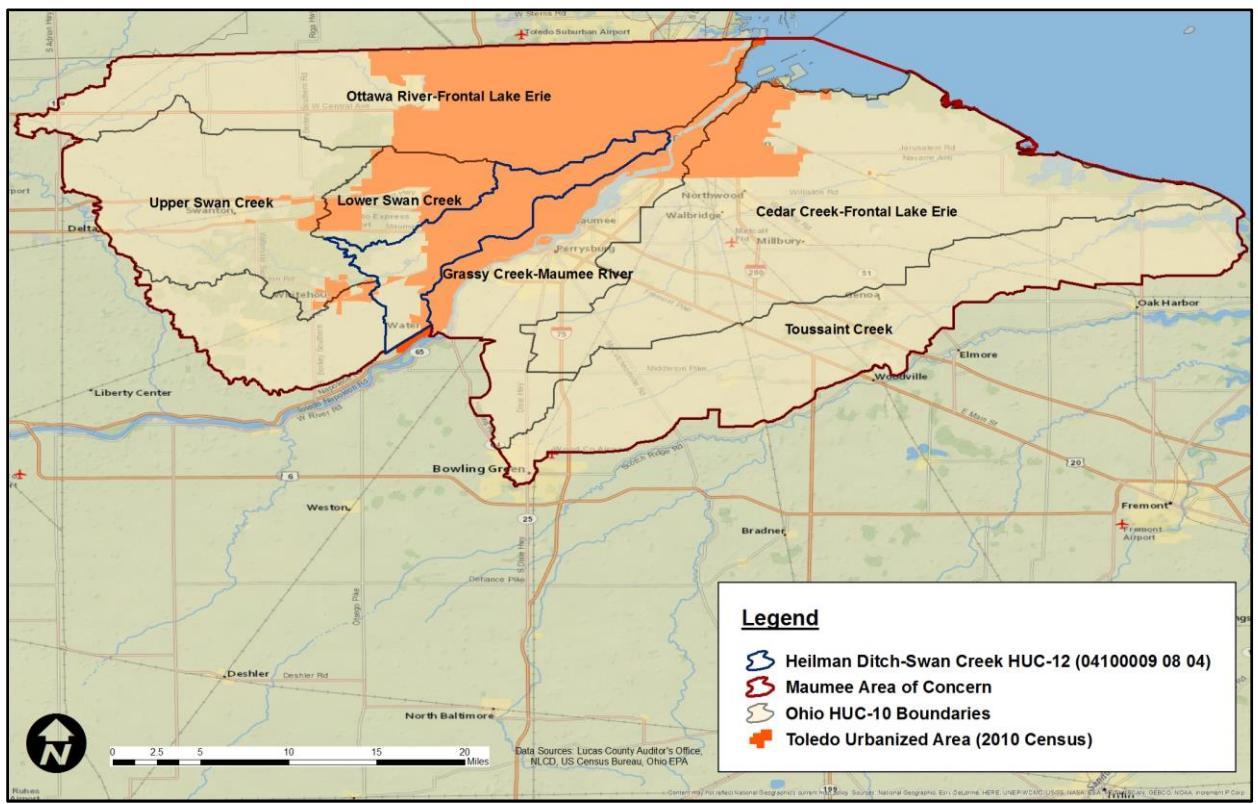
FIGURE 10: TOLEDO URBANIZED AREA AS DEFINED BY THE 2010 CENSUS.

Approximately 68% of the **Heilman Ditch-Swan Creek HUC-12** is located within the NPDES regulated Municipal Separate Storm Sewer System (Figure 10). One Phase I MS4 permit (City of Toledo) exists throughout this watershed, along with several Phase II municipalities and agencies, including Monclova Township, the City of Maumee, the Village of Holland, the Village of Waterville, the Ohio Department of Transportation and the Ohio Turnpike Commission. These storm water systems do not connect with water treatment systems; therefore, oil, grease, pesticides, herbicides, dirt and grit are carried directly to waterways and have a high potential to negatively impact water quality (Ohio EPA, 2009b). In addition, the City of Toledo operates eight combined sewer overflow (CSO) outfalls on Swan Creek, which can be sources of elevated suspended solids, bacteria and nutrient levels that negatively impact stream health and aquatic communities. The Toledo Waterways Initiative implemented a long-term, 18-year project in 2002 to reduce CSOs and eliminate water pollution in Swan Creek, the Ottawa River and the Maumee River (Toledo Waterways Initiative, 2017). Upon completion, this project is expected to reduce overflow volume to the Swan Creek watershed by 25%, or approximately 16 million gallons/year (Cousino, 2017).

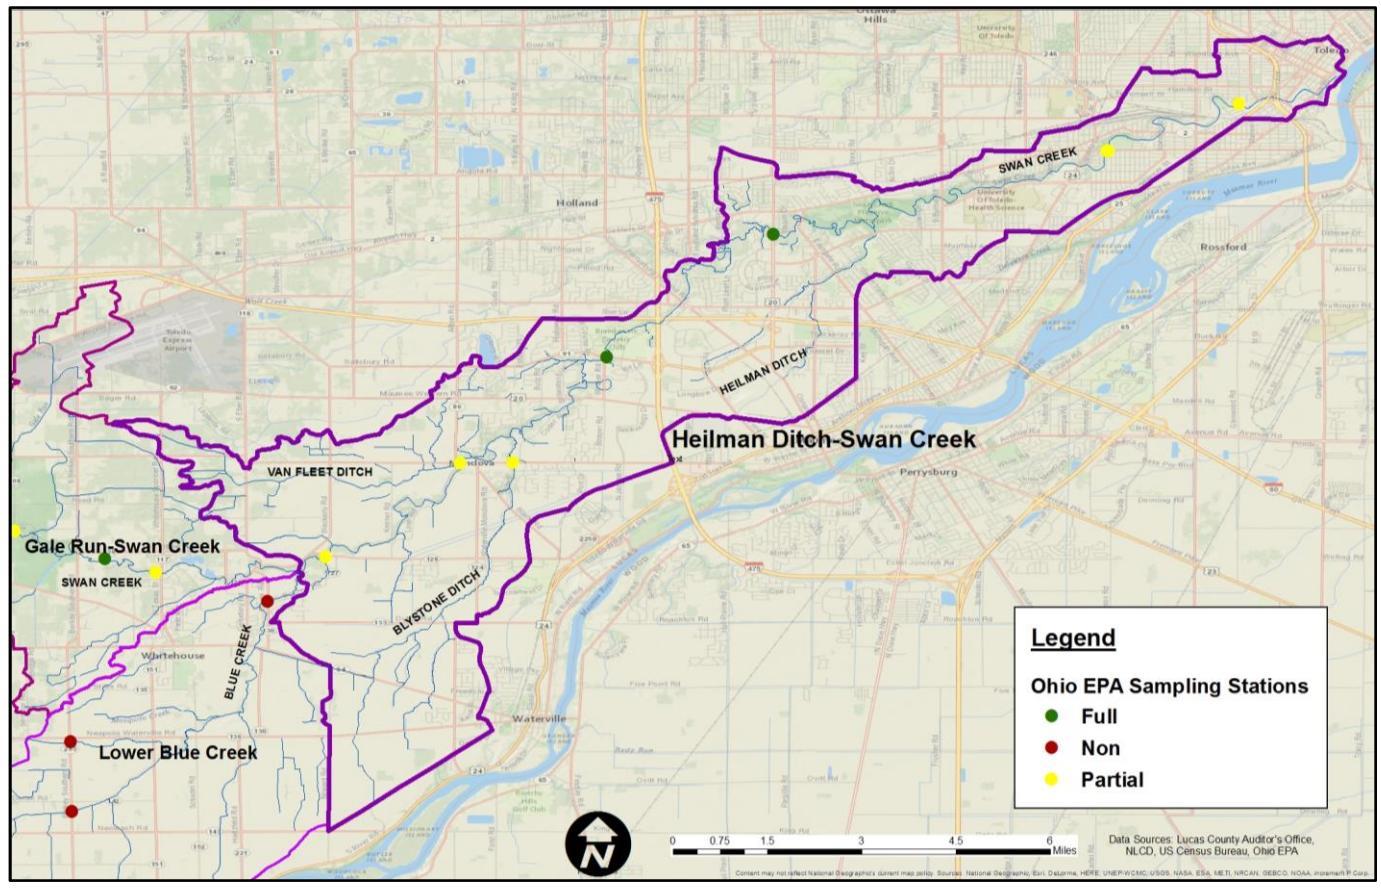
FIGURE 11: SAMPLING LOCATIONS AND ATTAINMENT STATUS IN SELECTED LOCATIONS IN THE HEILMAN DITCH-SWAN CREEK WATERSHED AND UPSTREAM WATERSHEDS.

A summary of the sample locations and their biological status in the Heilman Ditch-Swan Creek HUC-12 are provided in Table 2. For reference, sample locations and biological status from sampling sites immediately upstream from the HUC-12 are included as well. Figure 11 details sampling points and attainment status. The quality of habitat, affected by land use, in Swan Creek is a critical factor in attainment scores for fish and macroinvertebrate communities. Overall, silty substrates, high embeddedness, and low sinuosity related to tiled fields, channelized ditches and urbanization have contributed to degradation caused by flashy storm water and torrent flows, scoured substrates and the filling of interstitial spaces with silt (Ohio EPA, 2009a). In the uppermost sampling locations in the **Heilman Ditch-Swan Creek HUC-12**, the stream lacked sufficient habitat to support diverse fish communities, while silt substrates, impoundment and channel morphology in the lower reaches inhibited macroinvertebrate densities.

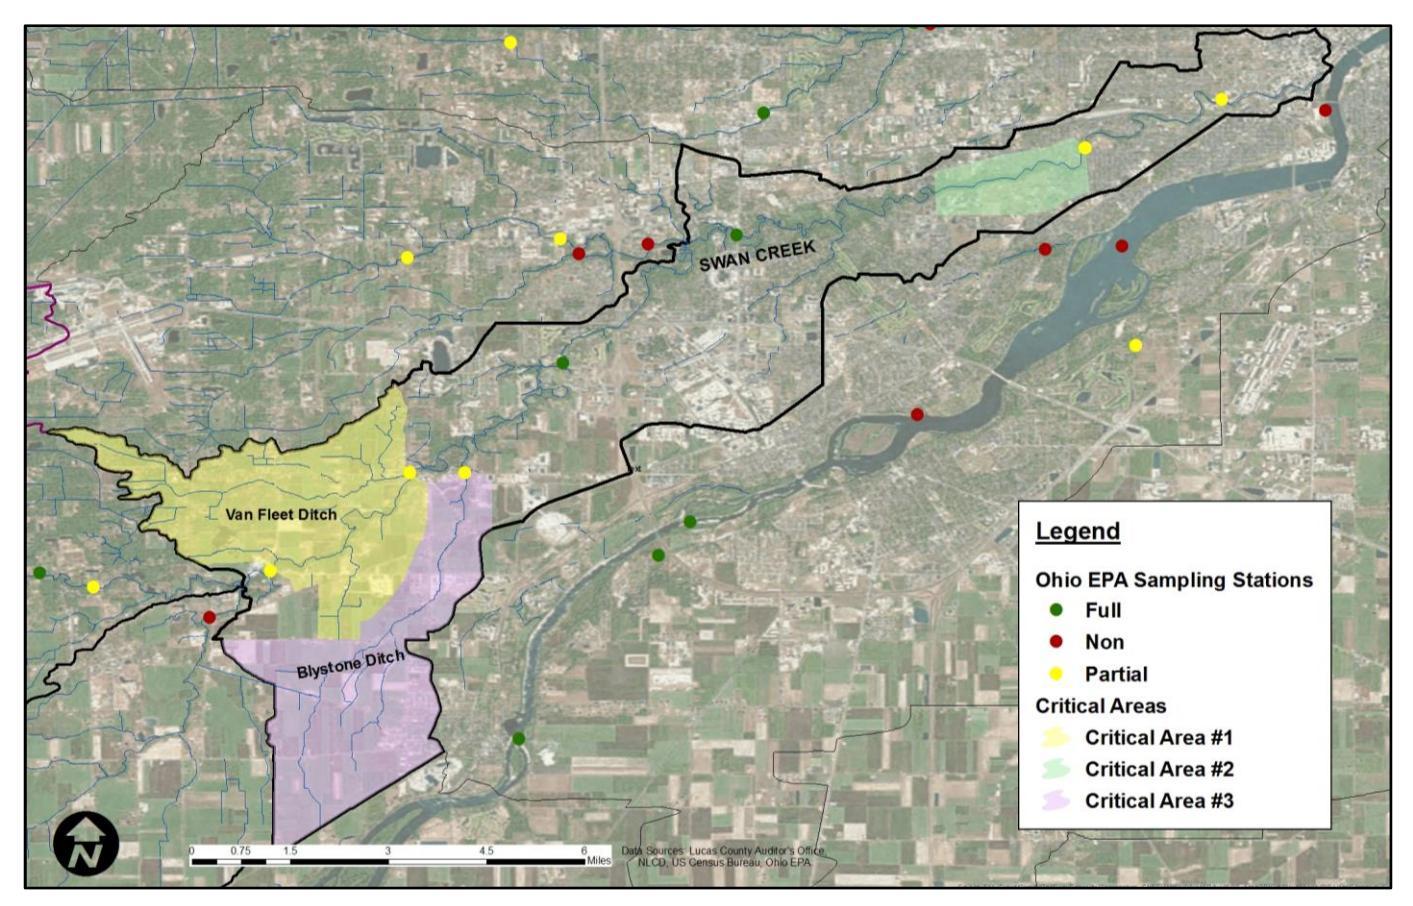
FIGURE 12: HEILMAN DITCH-SWAN CREEK HUC-12 CRITICAL AREAS.

Overall, nine sampling sites are located in the **Heilman Ditch-Swan Creek HUC-12** (Figure 12). Seven are located in Swan Creek, one is located in Blystone Ditch near the confluence with the Swan Creek main stem, and one is located in the headwaters of Heilman Ditch. Five of the seven sampling locations in Swan Creek are in *Partial Attainment*. The sampling location in Blystone Ditch is in *Partial Attainment*, and the sampling location in Heilman Ditch does not meet expectations for LRWs. With the exception of the sampling locations at RM 4.4 and 4.2, the remainder of the partial attainment points are remote enough from each other and their respective sources of impairment are so varied, that it is likely that each point and its requisite segment has its own associated critical area (Table 5). At this time, specific restoration strategies and projects have been identified for three critical areas to address the nonpoint source pollution issues that are believed to be causing the impaired state in the **Heilman Ditch-Swan Creek HUC-12.** Additional critical areas will be developed in subsequent versions of this NPS-IS plan.

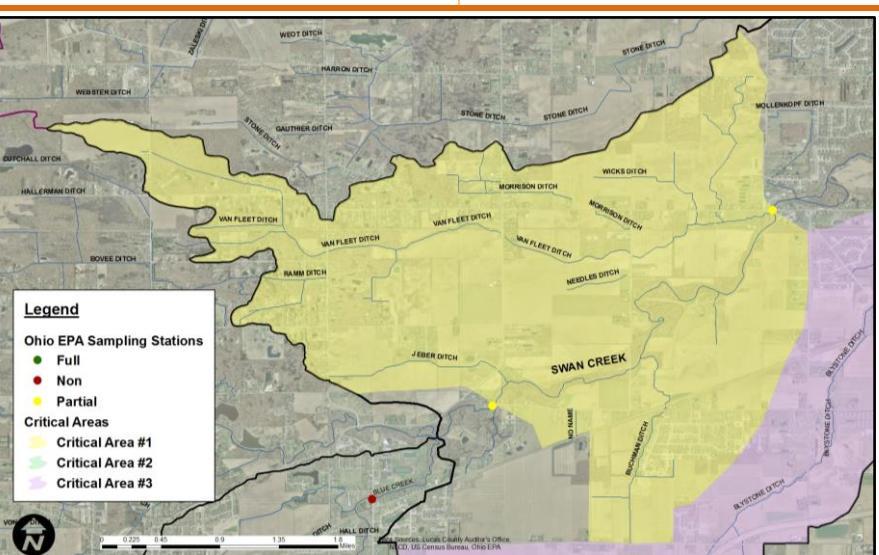
FIGURE 13: HEILMAN DITCH-SWAN CREEK HUC-12 CRITICAL AREA 1.

The Swan Creek sampling site located at RM 18.5 (Albon Rd.) is located within a transition zone from relatively high agricultural land use density to an area of rapidly developing residential and urban land uses in the **Heilman Ditch-Swan Creek HUC-12**. Tributaries through this section still flow through relatively dense agricultural land. The sampling location is listed in *Partial Attainment* of the Warmwater Habitat aquatic life use designation, caused by excessive nitrate/nitrite levels sourced from crop production with subsurface drainage. Due to its centralized location within the HUC-12, impairment in this segment is likely attributed to land use characteristics of the watershed of Swan Creek and its contributing waterways between Stitt Rd. and Albon Rd. (Table 6). None of these tributaries are currently included in the Lucas County Ditch Maintenance Program, and maintenance to date has been handled privately. Van Fleet Ditch is undergoing the petition process, as of April 2020, and will be improved and maintained by Lucas County with two-stage ditch design. Upstream segments beyond RM 21.6 that are in *Partial Attainment* are likely also contributing to the *Partial Attainment* status at Albon Rd.

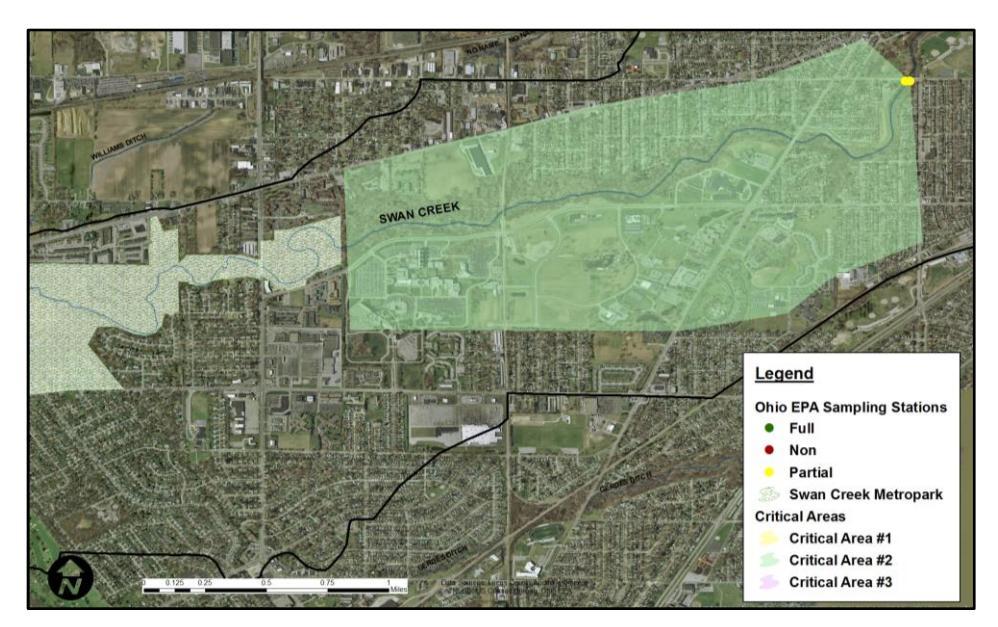
FIGURE 15: HEILMAN DITCH-SWAN CREEK HUC-12 CRITICAL AREA 2.

Using the rationale described in the Handbook for Developing Watershed Plans to Restore and Protect Our Waters (U.S. Environmental Protection Agency, 2008) (Section 10.3.4): "In general, <u>management practices are</u> <u>implemented immediately adjacent to the waterbody or upland</u> to address the sources of pollutant loads."— *Critical Area 2* includes the sub-watershed area of Swan Creek that contributes runoff or drainage waters to this reach, between RM 6.75 and RM 3.75 (Figure 15).

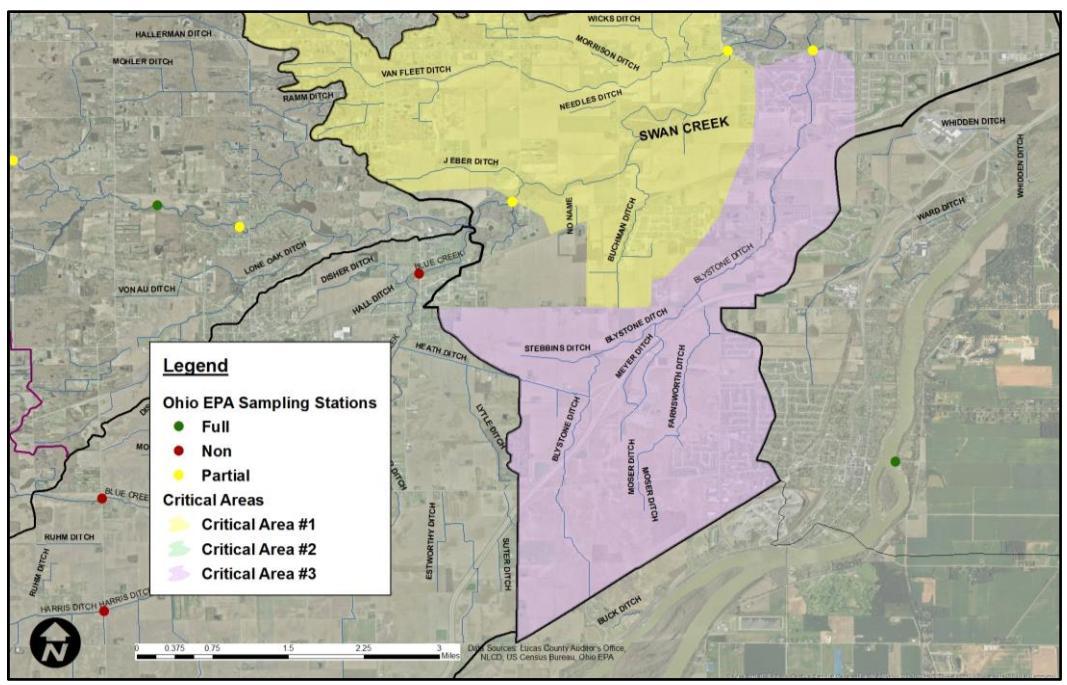
FIGURE 16: HEILMAN DITCH-SWAN CREEK HUC-12 CRITICAL AREA 3.

Using the rationale described in the Handbook for Developing Watershed Plans to Restore and Protect Our Waters (U.S. Environmental Protection Agency, 2008) (Section 10.3.4): "In general, <u>management practices are</u> <u>implemented immediately adjacent to the waterbody or upland</u> to address the sources of pollutant loads." — *Critical Area 3* (Figure 16) includes the watershed and riparian areas of Blystone Ditch and its tributaries that contribute runoff or drainage waters to Blystone Ditch from the headwaters to RM 0.54 (Table 13).
