3.6 DAM/LEVEE FAILURE

3.6.1 HAZARD IDENTIFICATION

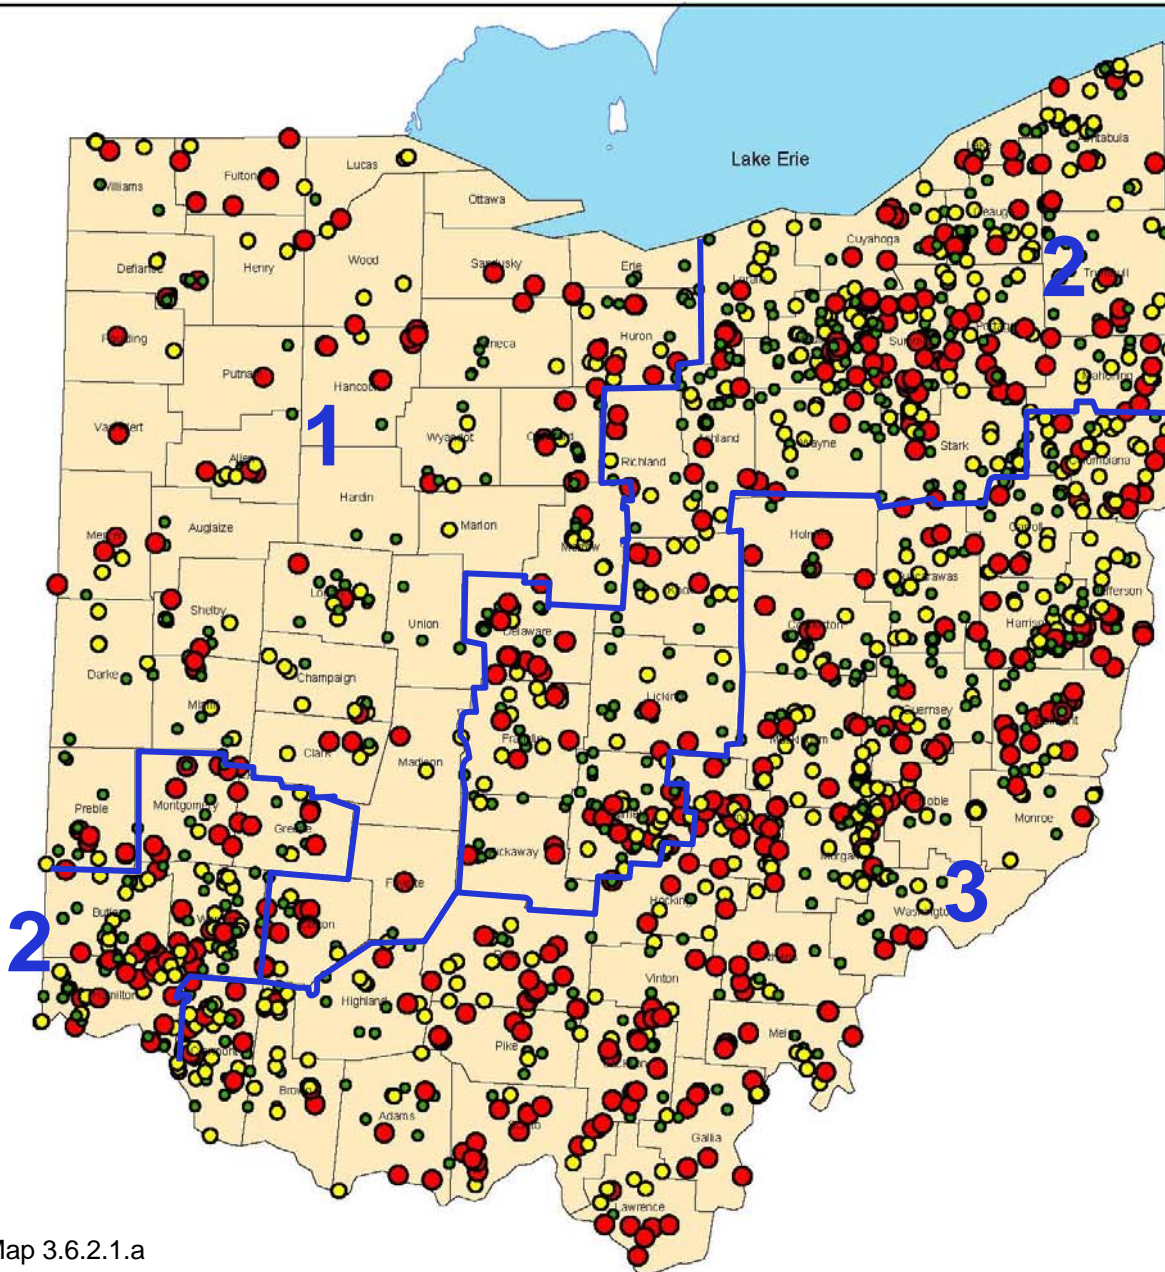
In Ohio, there are 498 high, 541 significant, and 639 low hazard potential dams (see Table 3.6.2.1.b). Map 3.6.2.1.a provides general location of all dams located in Ohio. This assessment will primarily focus on the top ten dams in Ohio whose failure could have catastrophic consequences (see Map 3.6.2.1.b):

**State of Ohio
Regulated Dams
Hazard Classification
2003**

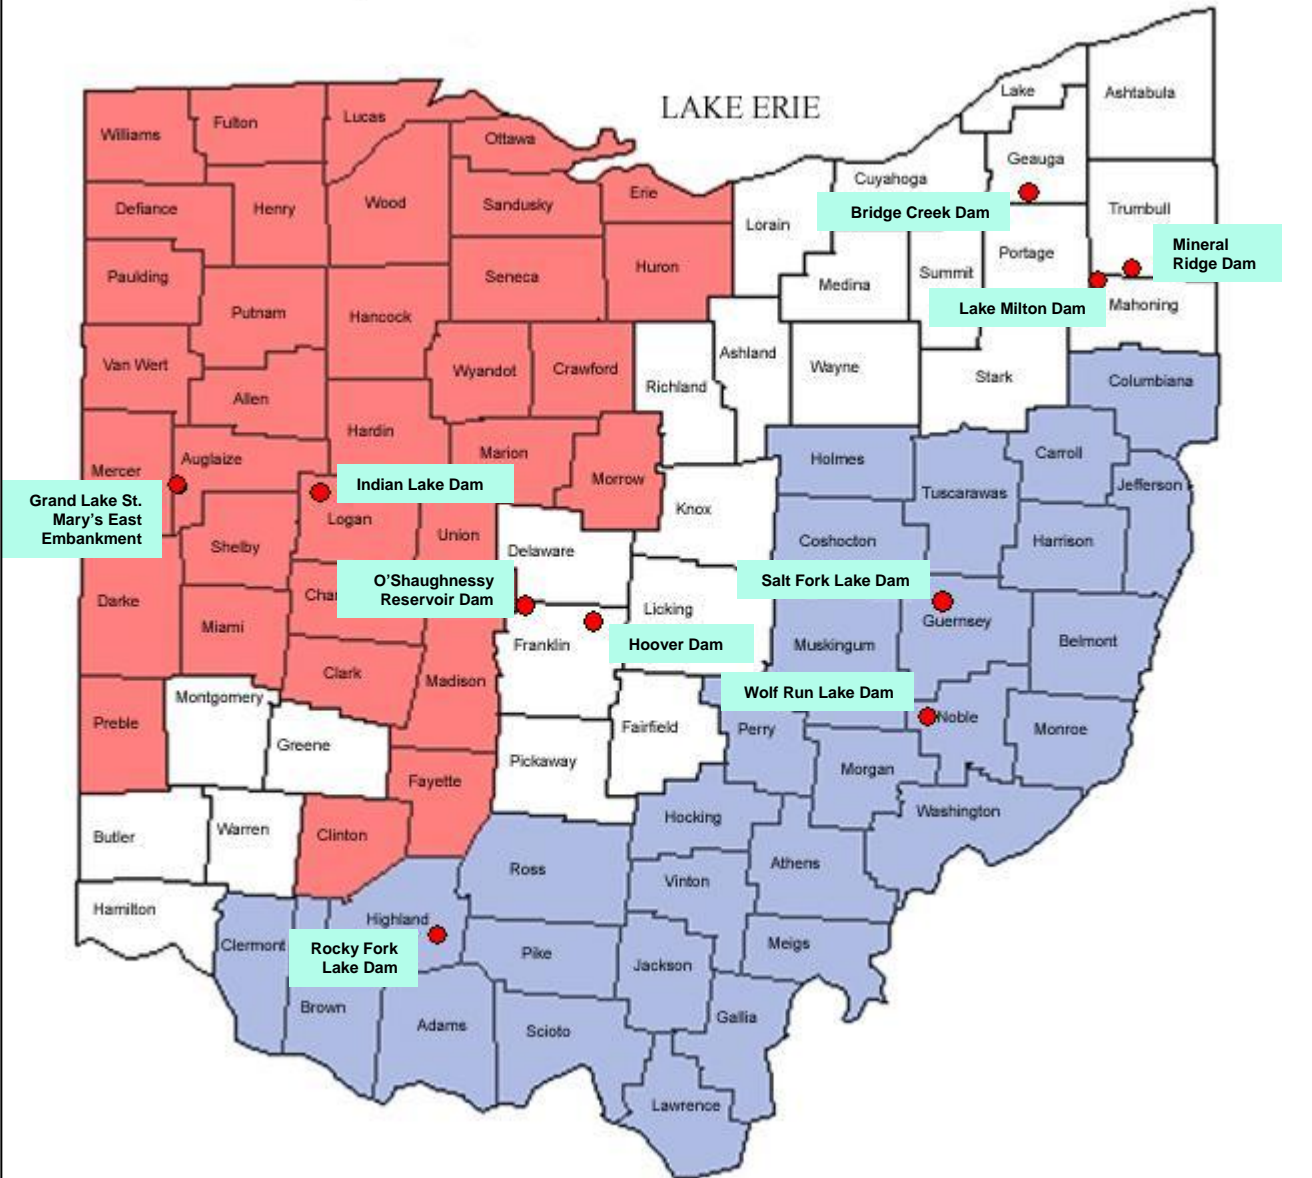
Top Ten High Hazard Dams in Ohio

For this particular vulnerability study the top 10 high hazard dams discussed (see Map 3.6.2.1.b).

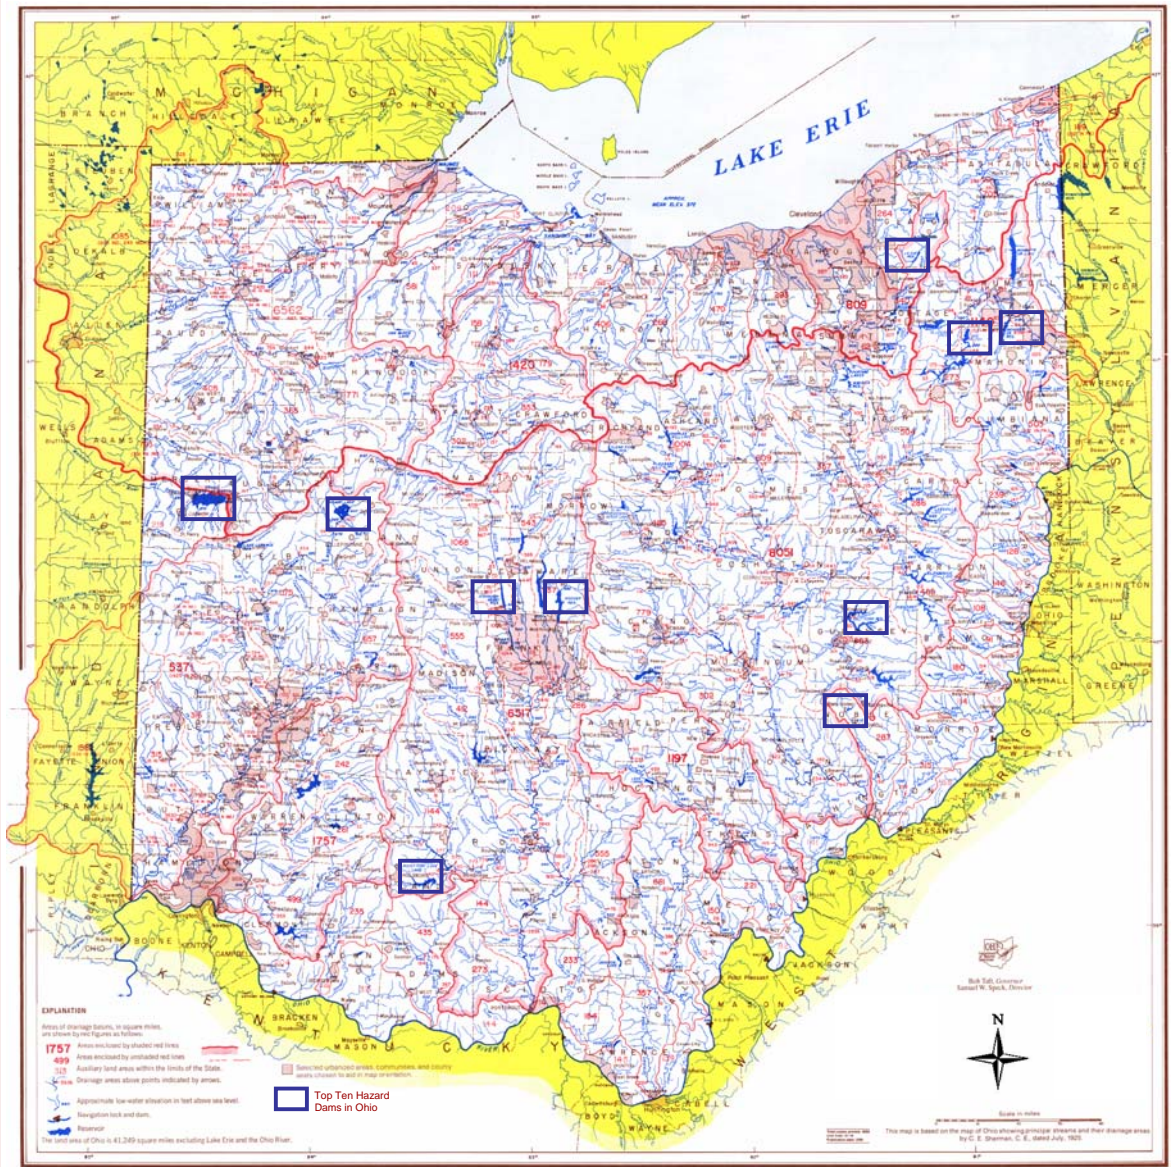
Division of Water
**PRINCIPAL STREAMS
 AND THEIR
 DRAINAGE AREAS**
 1996

Produced by ODNR
 Disclaimer: The information presented on this map has been compiled through various sources, the Ohio EMA does not guarantee its accuracy.
 Source: ODNR, OEMA
