2.6 DAM/LEVEE FAILURE

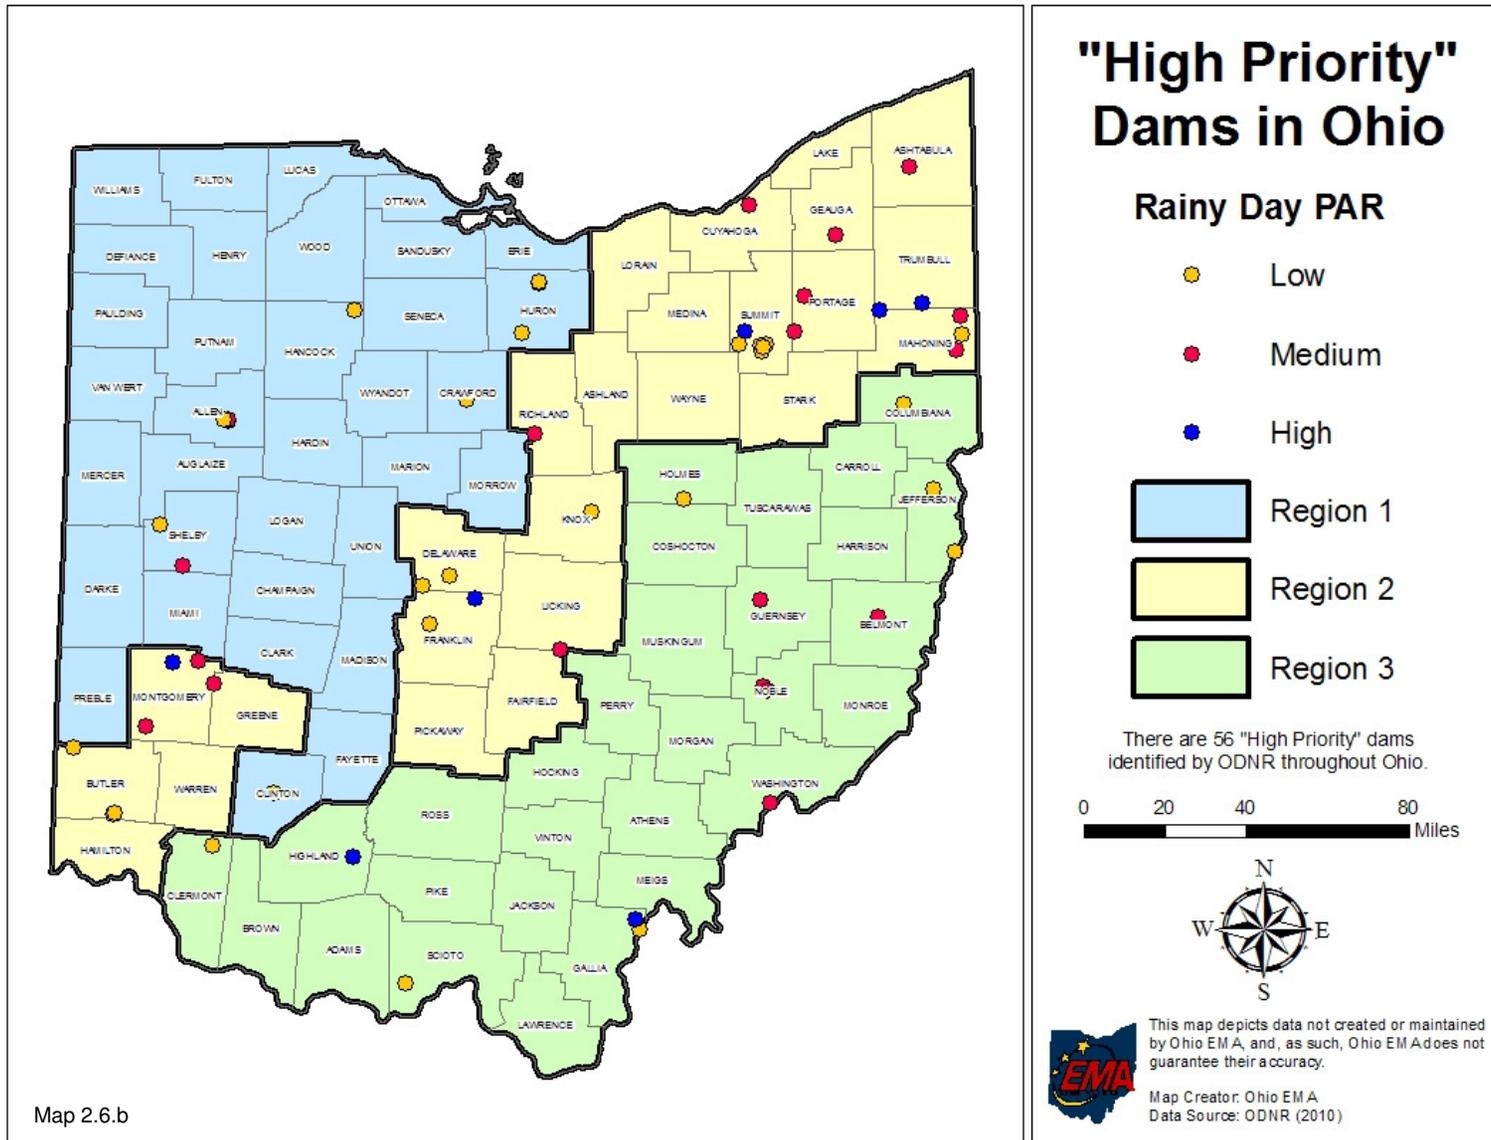
These results focus on the High Hazard potential dams, and they are considered by ODNR as “high priority,” as failure of any one would presumably result in a loss of at least 50 human lives. Table 2.6.f lists the High Hazard dams with this characteristic by region, and Map 2.6.b displays the *Rainy Day* PAR.

Of the 56 “high priority” dams, 41 are categorized as *large* since they have more than 5,000 acre-feet of storage, or they have more than 100 acres of surface area at the dams’ normal pools. The remaining 15 dams have less storage, but still represent a real risk to more than 50 people per dam.

Region 1 includes 12 “high priority” dams, seven of which reside in Allen (3) and Huron (4) Counties combined. Even though no dams in this Region have a *High* PAR level, three of the dams exhibit a *Medium* PAR level. Two of the dams in Allen County (Ferguson Upground Reservoir and Metzger Upground Reservoir) do not have approved EAPs. A failure of these structures could prove to be even more catastrophic than represented in Table 2.6.f since the proper preparedness has not been accomplished. However, both have draft inundation mapping, which could aid local officials in outreach initiatives for the public.

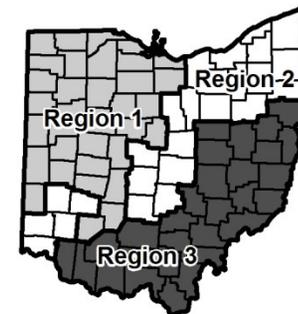
State of Ohio Wildfire Hazard Assessment

These data were compiled by the ODNR Division of Forestry in conjunction with this planning effort. Wildfire risk is assigned at the township level because rural fire departments are typically organized at this level. Evaluating wildfire hazard at the township level better illustrates the areas that need to increase fire prevention and awareness programs.

The product of this project, the Ohio wildfire hazard assessment map, accurately indicates wildfire hazard level for all townships in Ohio (see map 2.7.c). Communities at risk to wildfire in Ohio are those townships that were attributed with a calculated wildfire hazard value equal to *High* or *Very High*.

Region 1 and Region 2 are assessed as having generally low wildfire hazard, with several pockets of moderate risk of wildfire. Region 3 is assessed as having generally moderate risk of wildfire, with a sizeable section of southern Ohio having high or very high wildfire risk (Gallia, Lawrence, Scioto, Adams, Pike, and southern Ross Counties). Southeastern and eastern Ohio were assessed as having an additional 29 communities rated as having high wildfire hazard. Particular high-risk groups in southeastern and eastern Ohio occur in southern Athens and Meigs Counties, as well as in Belmont and southern Jefferson Counties.

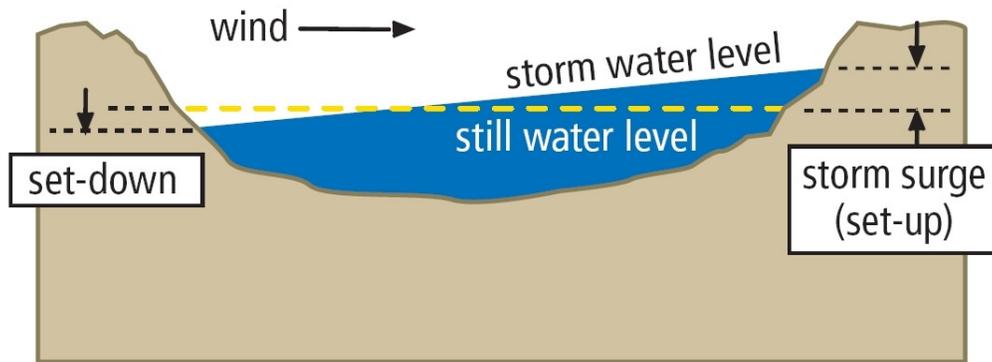
The United States Army Corps of Engineers office in Detroit Michigan developed a profile of seiche as part of a larger work analyzing water levels for the Great Lakes. Figure 2.8.a displays the static impact seiche has on a body of water with water levels rising on the downwind shore and falling along the upwind shore.

Lake Profile Showing Wind Set-Up

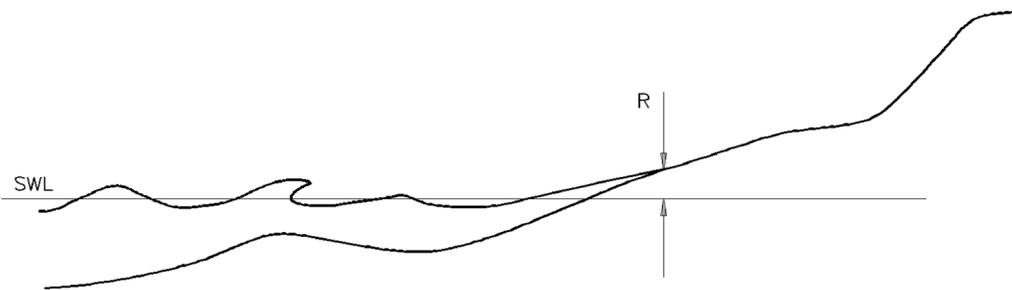
Figure 2.8.b provides a detailed description of the combined effect of wind and wave actions. The base water level for the lake is marked as the SWL, or still water level. The position marked R represents the new increased water level at the shoreline. When winds are generated by severe storms the potential for wave action increases greatly.

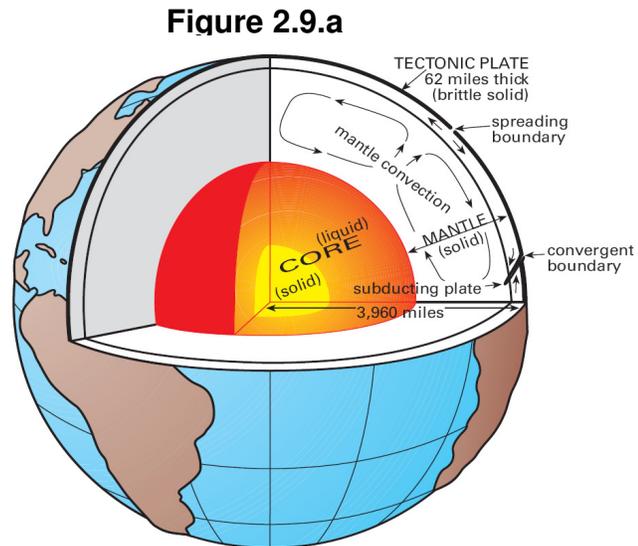
Interior zones of the Earth (figure modified from Washington Division of Geology and Earth Resources, Information Circular No. 85, 1988). The Earth's crust consists of great plates that slowly move across the surface of the Earth in response to convection cells in the mantle. Most earthquakes occur where plates meet, such as at spreading or convergent boundaries.

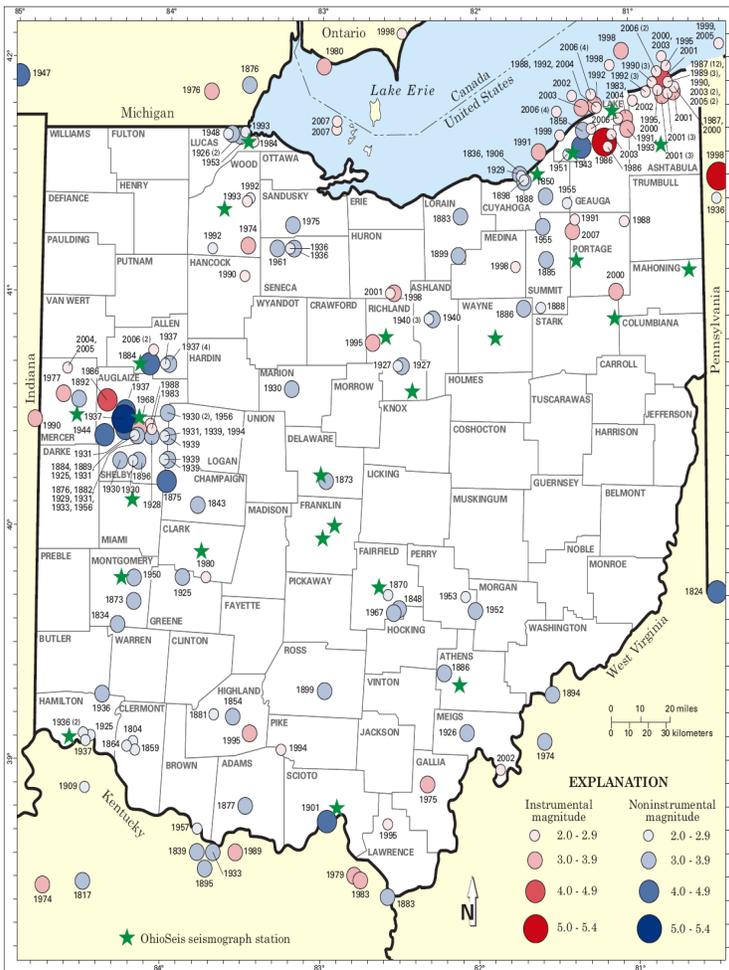
Locations of felt earthquakes or those with magnitudes of 2.0 or greater in Ohio and its border area. Locations and magnitudes of historical earthquakes are represented by symbols corresponding to felt area or maximum epicentral Modified Mercalli intensities. Noninstrumental locations may be in error by a considerable distance, especially for early events.

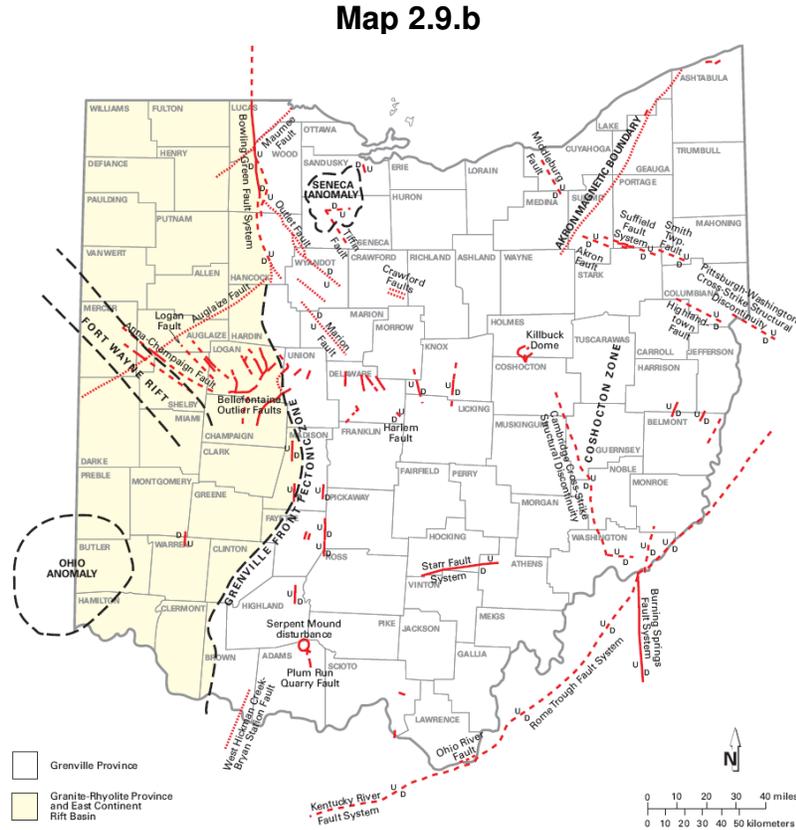
Basement structures in Ohio (modified from Division of Geological Survey Map PG-23, 2002). This map portrays a number of deep faults and other structures that have been identified by a variety of geologic studies. Some faults are well known, whereas others are speculative. Very few of them are visible at the surface. The Fort Wayne (Anna) rift in western Ohio is the site of numerous historic earthquakes.

The Division of Geological Survey has developed a map of geologic features, referred to as basement structures, which lie far below the earth's surface (see Map 2.9.b). The Region 1 active zone corresponds to the structure called the Akron Magnetic Boundary. Several geologists have speculated the boundary is a fracture zone in crystalline rocks lying more than 6,000 feet below the surface. The active area of Region 2 matches to better understood features. The Fort Wayne Rift along with the Anna-Champaign, Logan and Auglaize faults, though still poorly understood, can be evaluated using the existing understanding of how these structures behave.

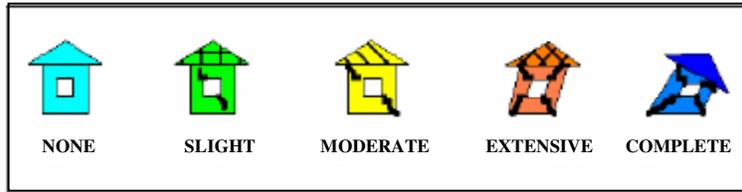
Figure 2.9.d

Impacts are reported in terms of damage degree, income losses and property damage. The HAZUS-MH MR4 User’s Manual provides a basic diagram to depict the degrees of damage, (see Figure 2.9.d).
