# Nature-Based Shoreline OPTIONS FOR THE GREAT LAKES COASTS

Briana Shea, Adam Bechle, Gene Clark

September 2021, Funded by the Wisconsin Coastal Management Program and the National Oceanic and Atmospheric Administration, Office for Coastal Management, Grant # NA17NOS4730144

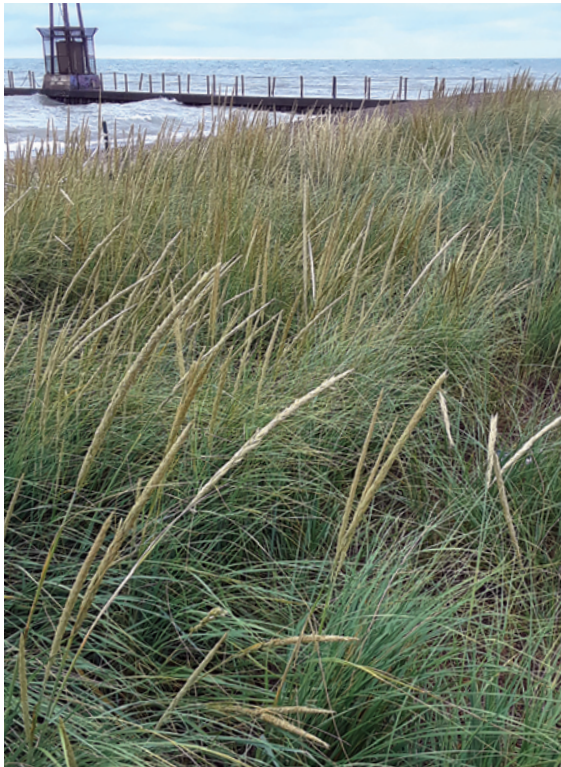
American beachgrass (*Ammophila breviligulata*) planted at Loyola Park in Chicago by the Loyola Dunes Restoration volunteer group in collaboration with the Chicago Parks District. The vegetation holds beach sand against wind erosion and has also been effective at reducing upland flooding from wave action. *Ann Whelan*

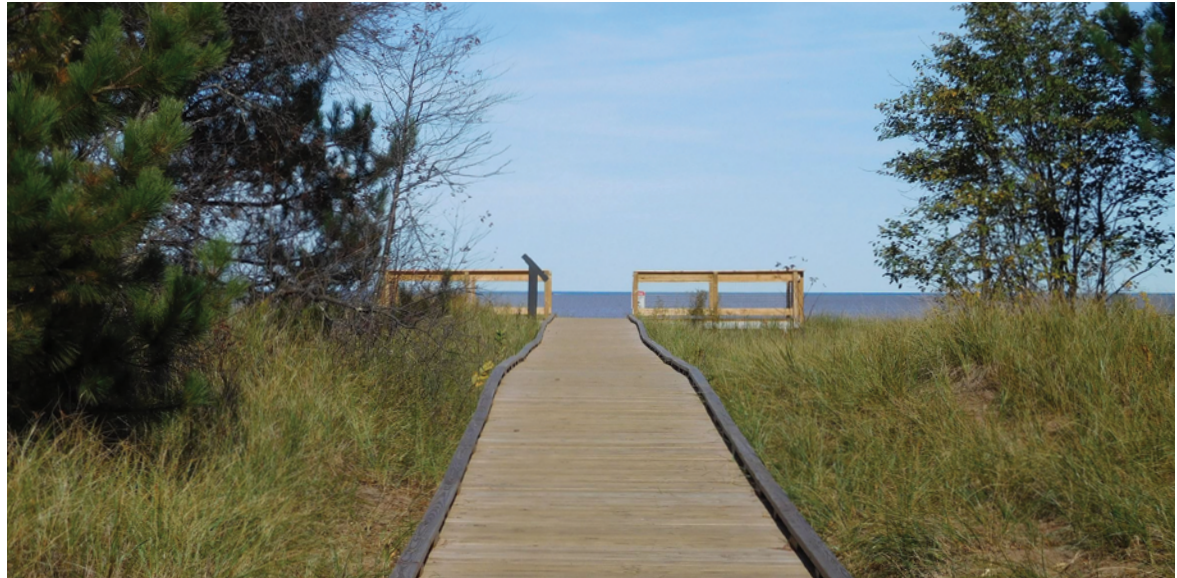
A restoration project at Wisconsin Point included revegetating the dunes, which limits wind erosion. Boardwalks reduce foot traffic over the restored vegetation. *City of Superior*

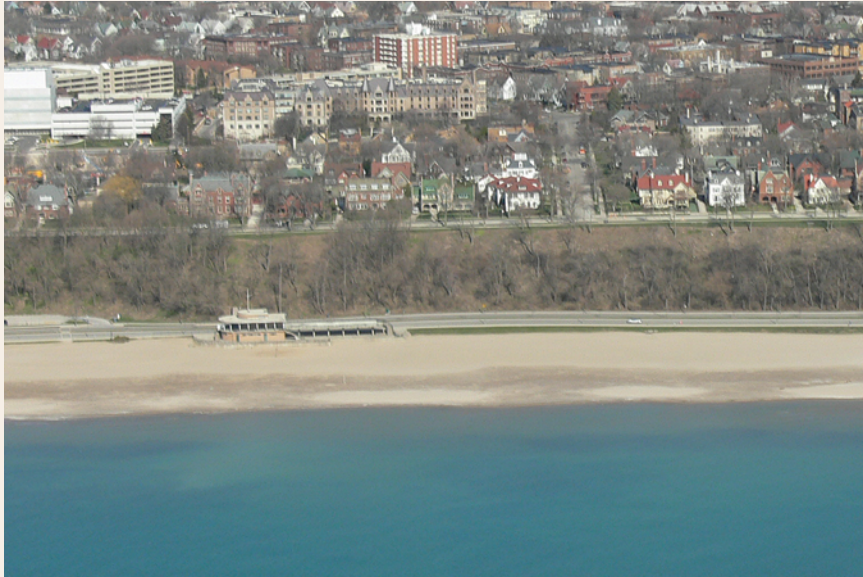
**Before Vegetating (2007)** This aerial image of the beach before the project shows areas of ponded stagnant water and wet sand. The beach lacks much vegetation except for a narrow buffer of turfgrass by the adjacent roadway. *David Mickelson*

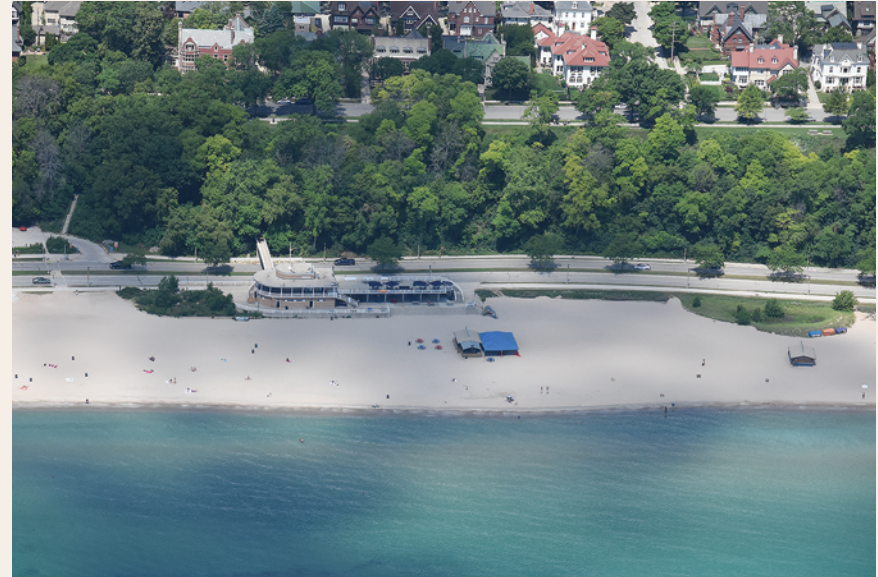
**After Vegetating (2019)** Two of the six vegetated swales, which have improved water quality and added native plant species to the beach. *Capt. Dennis Carr*

The bioswales were placed around storm sewer discharge pipes and a parking lot at the beach. The bioswales were designed to infiltrate 90% of the stormwater into the ground. The native vegetation planted in the bioswales was selected for root structures that anchor the sand, filter pollutants from the water and allow water to infiltrate into the sand. Dune grass was also planted on the slope of the bioswales to prevent erosion. The wide beach provides the bioswales some protection from the high wave energy of the open coast. A gull deterrent program was also used to reduce gull populations to further combat beach bacteria.

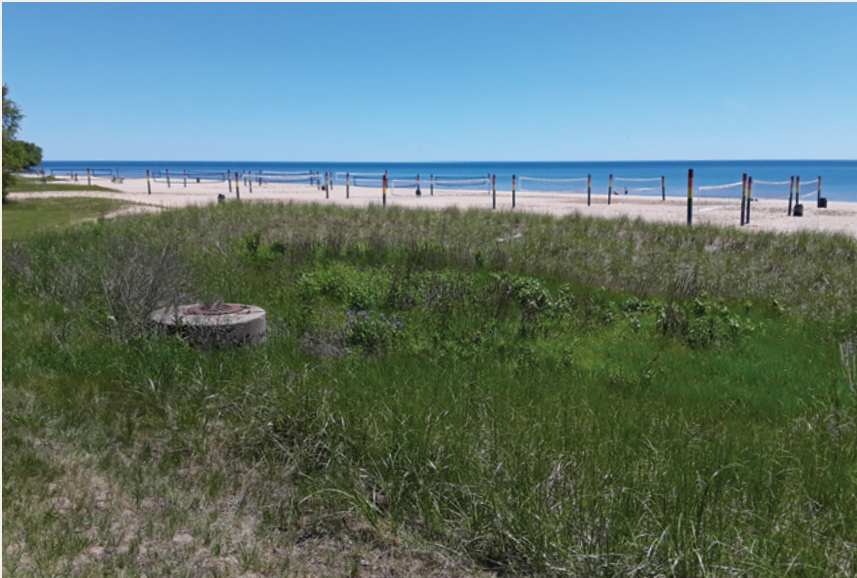
Bioswale along the beach with well-established native vegetation. *Stevan Keith*

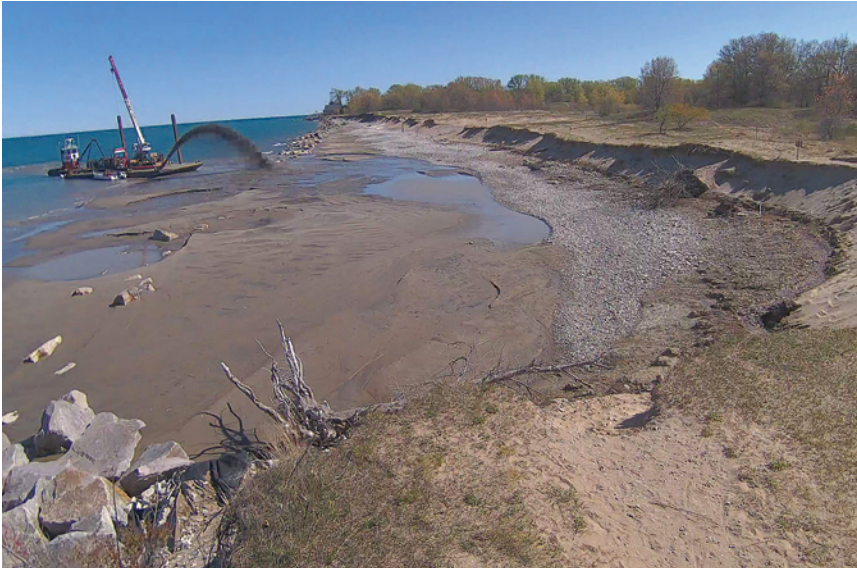
Clean sand dredged from Kenosha Harbor in Wisconsin is pumped to a beach placement site.  
*Chin Wu*

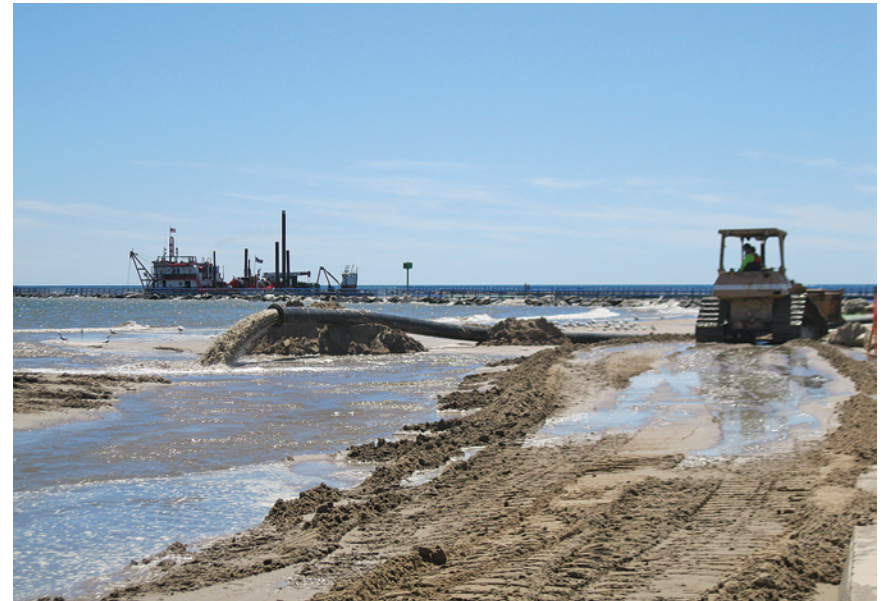
Clean, coarse-grained sediment dredged from the Two Rivers Harbor in Wisconsin is pumped to the placement site and spread across the beach with heavy machinery. *Jim Killian*

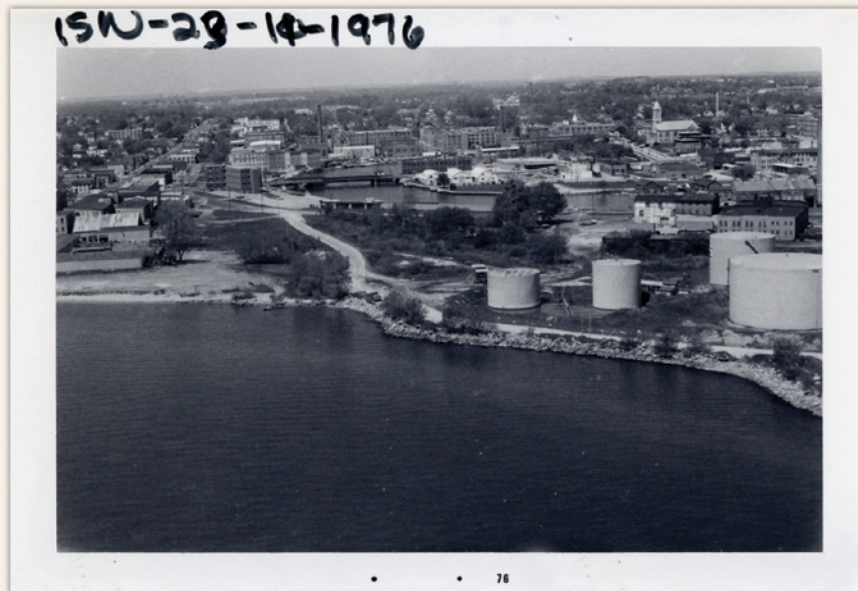
**Before Nourishment (1976)** Concrete rubble on the shoreline provided erosion protection for oil storage tanks. *Dave Mickelson*

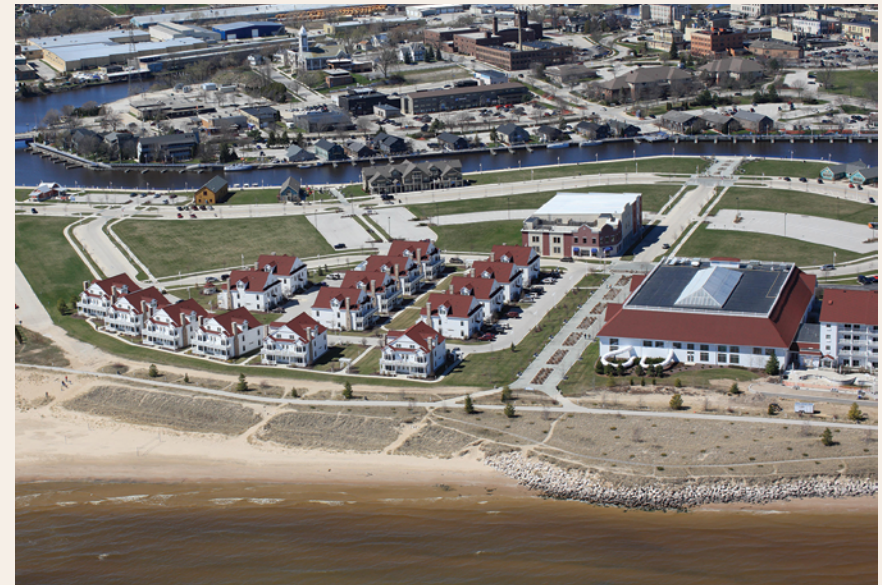
**After Nourishment – Low Lake Levels (2012)** The beach and buried revetment (left half of shoreline in image) several years after the nourishment project. *USACE*

provide protection for the large investment as well as create recreational and aesthetic amenities. The revetment was constructed back from the intended shoreline and then covered in sand planted with native dune grass and trees to act like a dune. Sand was placed in front of the buried revetment to create a nourished beach and dune system. Historic erosion rates and wave energy records were used to design the beach profile and revetment. Under low lake levels, sand deposited by the waves builds up the beach in front of the revetment, functioning much like a natural dune and beach system. Under high water levels, waves erode the sand, but the revetment, which may become exposed, prevents more severe erosion of the shore. As lower water returns, the sand will build back up to re-establish the dune and beach system, although re-nourishment may be required to supplement the natural processes.

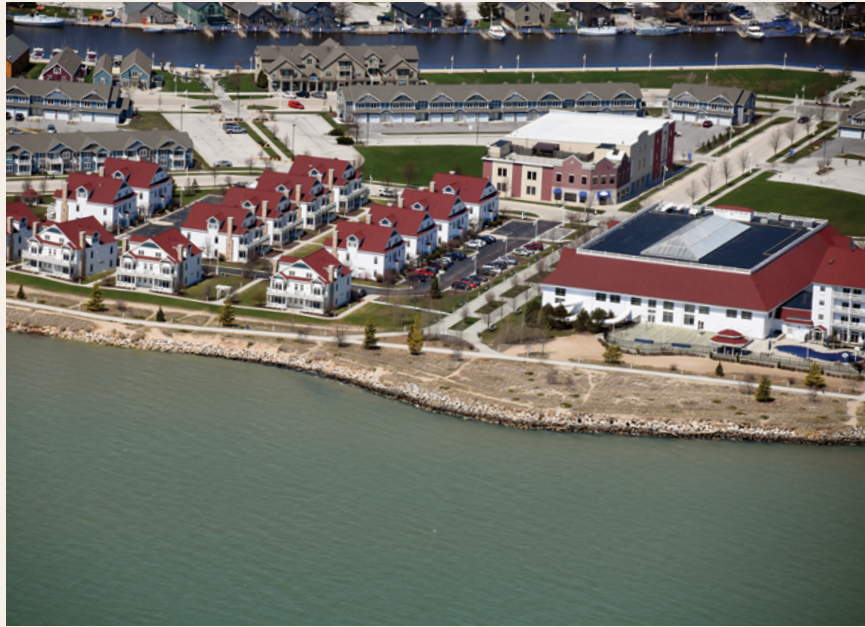
**After Nourishment – High Lake Levels (2019)** Beach has been inundated by high water levels. Sand that had buried the revetment has been eroded but the now-exposed revetment is preventing further erosion. *Capt. Dennis Carr*

Nourishment was used in a high wave energy environment as part of a buried revetment, which has prevented large-scale erosion in extreme events.

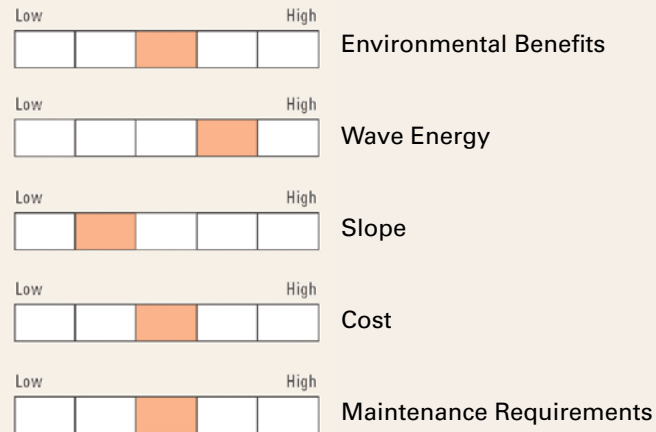
The nourished dune and beach system created an aesthetically pleasing shoreline that re-established natural coastal processes and habitat. Monitoring has revealed that the beach has been decreasing in size since construction. This is likely due to a large harbor jetty to the north, which blocks sediment transported along the shore by waves that would normally replenish the beach. High water levels on Lake Michigan have also inundated the beach and allowed waves to erode away the sand that had buried the revetment. The now-exposed revetment is preventing further erosion as designed. Future re-nourishment has been recommended to replenish lost sand and raise the grade of the beach to reduce bacterial contamination.

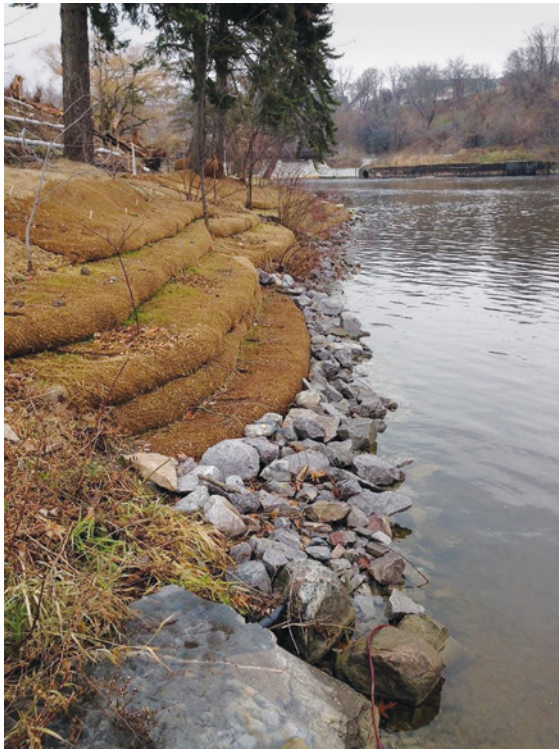
A slope stabilization project in the Milwaukee River estuary that features grading, biodegradable matting and vegetation. Some toe protection was also used. *Marek Landscaping*

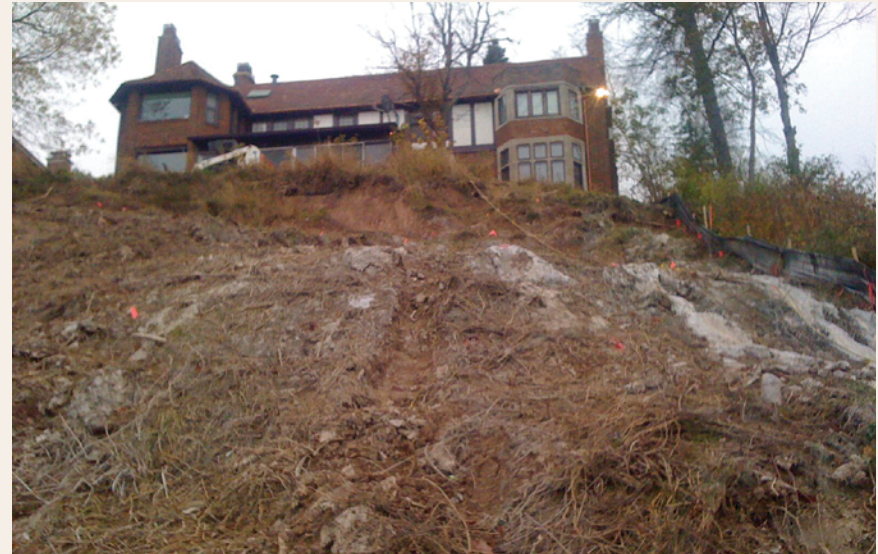
**Before** Before stabilization, the bluff was failing very close the residence, indicated by the steep unvegetated slope close to the home. *Marek Landscaping*

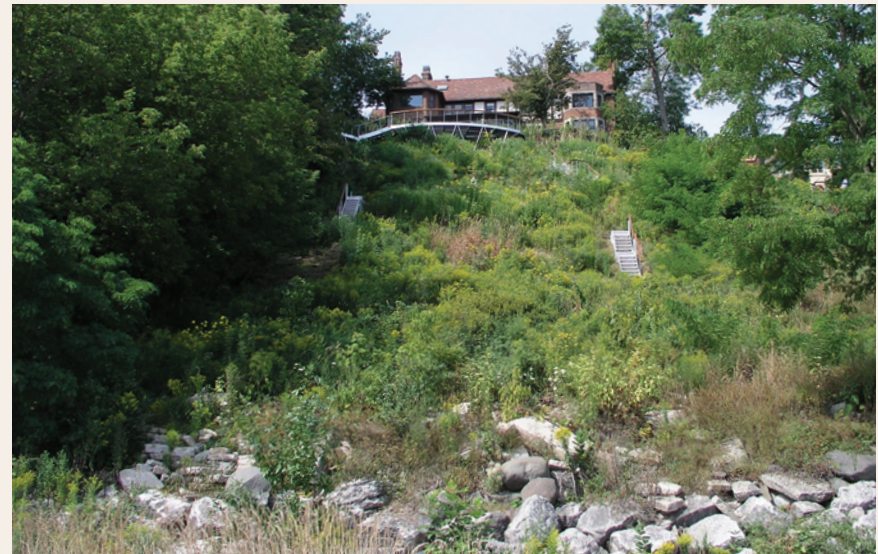
**After** Stabilization of the upper slope incorporated native vegetation, improving the aesthetic and recreational value of the property. *Marek Landscaping*

The LivingWall system has stabilized the upper bluff slope near the residence, and the establishment of vegetation creates a nice appearance for the slope. General maintenance and cleanup are done routinely. Invasive species have to be treated on occasion. This project received a 2015 Award of Merit from the Wisconsin Chapter of the American Association of Landscape Architects in the Residential Category.

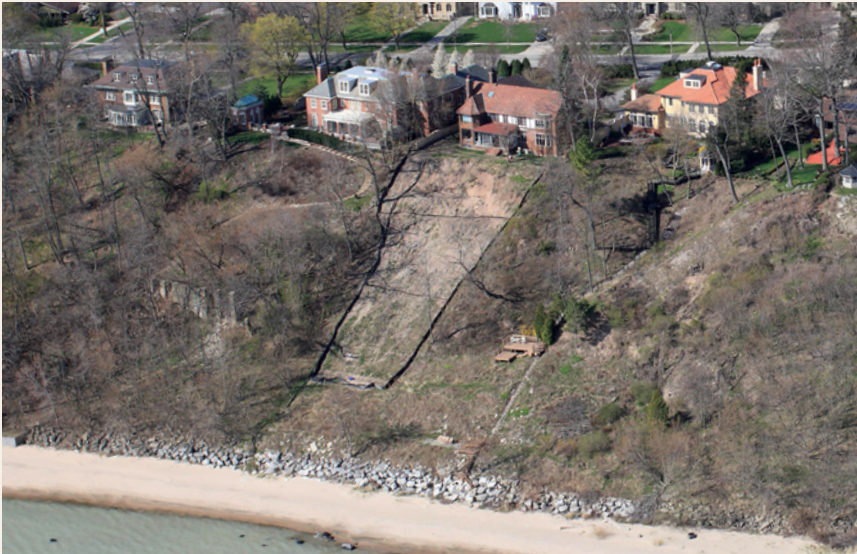
**Before** Oblique aerial image (2012) of the site before stabilization with a relatively unvegetated upper bluff slope, especially the particularly steep section just feet from the residence. *USACE*

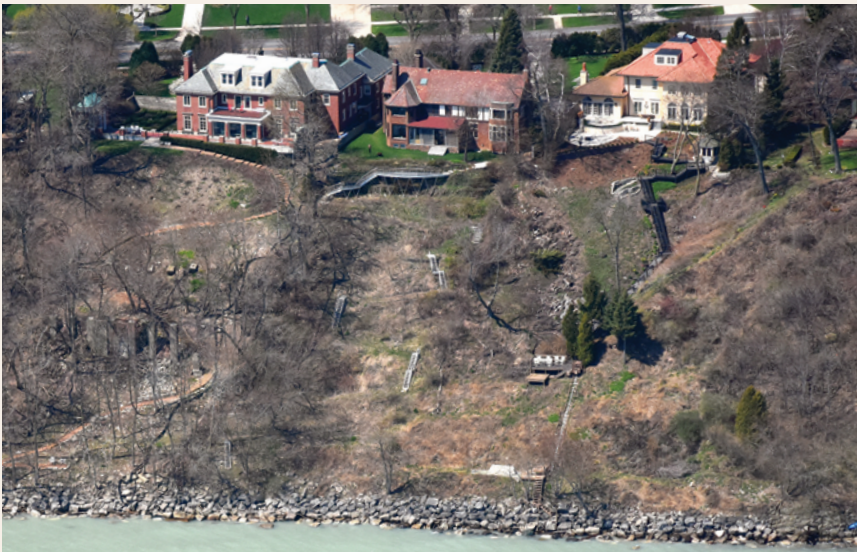
**After** Oblique aerial image (2019) of the stabilization project with the vegetated terrace wall and new staircase near the residence, as well as a revegetated bluff face. *Capt. Dennis Carr*

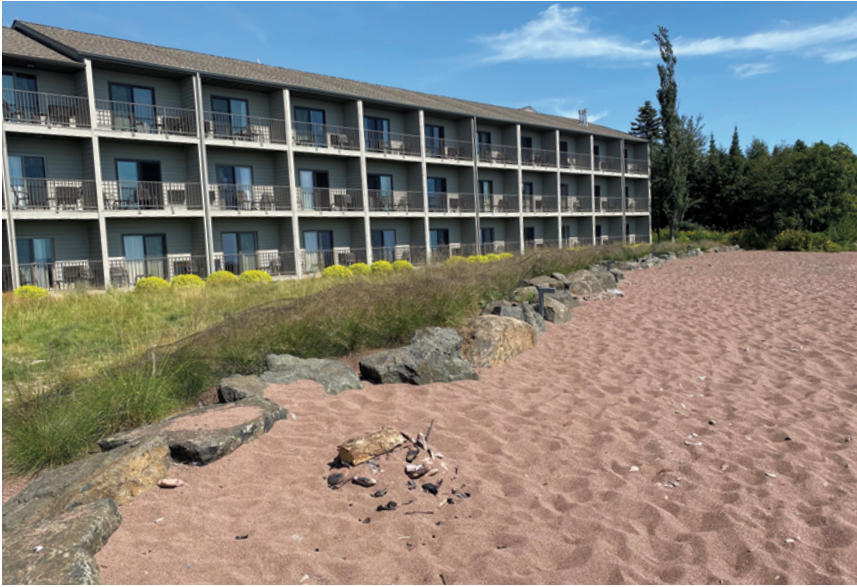
Rock edging used to protect upland vegetation from waves and the overwash of beach sand into the vegetation on Lake Superior in Grand Marais, Minn. *Melanie Perello*

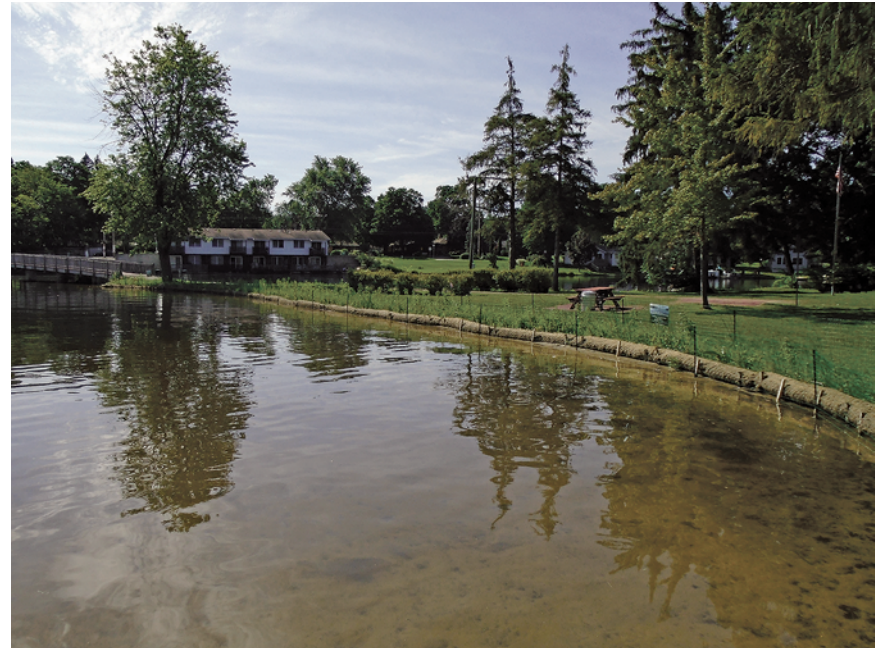
Coir log edging on Maple Lake, Mich., an inland lake with low wave energy. *Brian Majka*

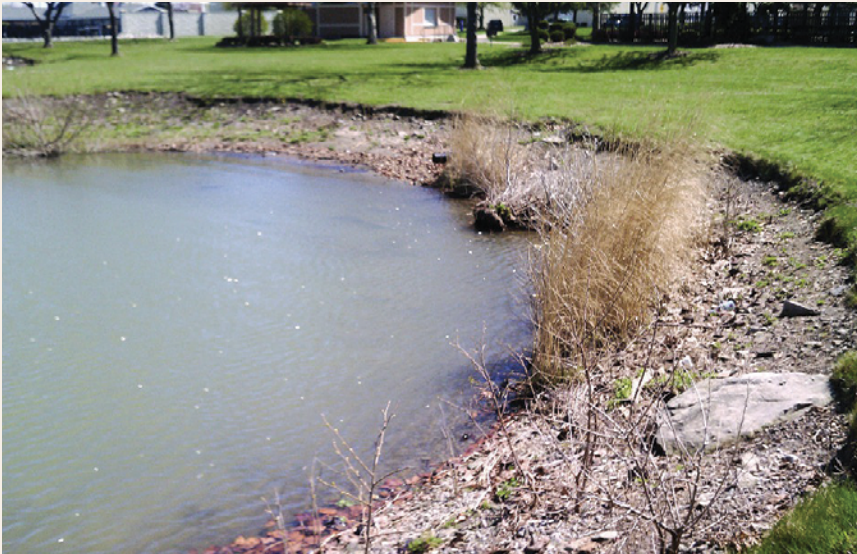
**Before** A turfgrass shoreline was eroding and visually unappealing.  
*Erie Soil and Water Conservation District*

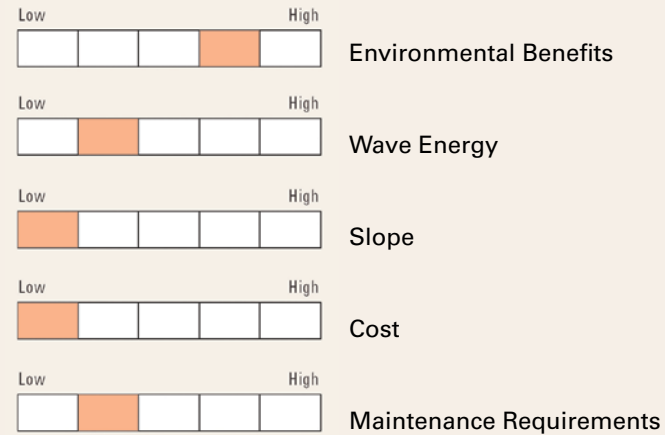
**After** Edging helped native vegetation establish to stabilize the shoreline. Visual appeal has also improved. *Erie Soil and Water Conservation District*

Edging and native vegetation were installed at Shoreline Park in Sandusky Bay, which was both losing land to erosion and turning foul due to goose droppings. Coir log edging was used to slow erosion at the toe of the shoreline as an alternative to adding a stone revetment in this sheltered, low wave energy bay on Lake Erie. The existing turf grass slope was replaced with erosion-control matting planted with native vegetation to secure the soil and deter geese from the area. The project was organized by the city of Sandusky and the Erie Soil and Water Conservation District staff and completed by staff and volunteers.

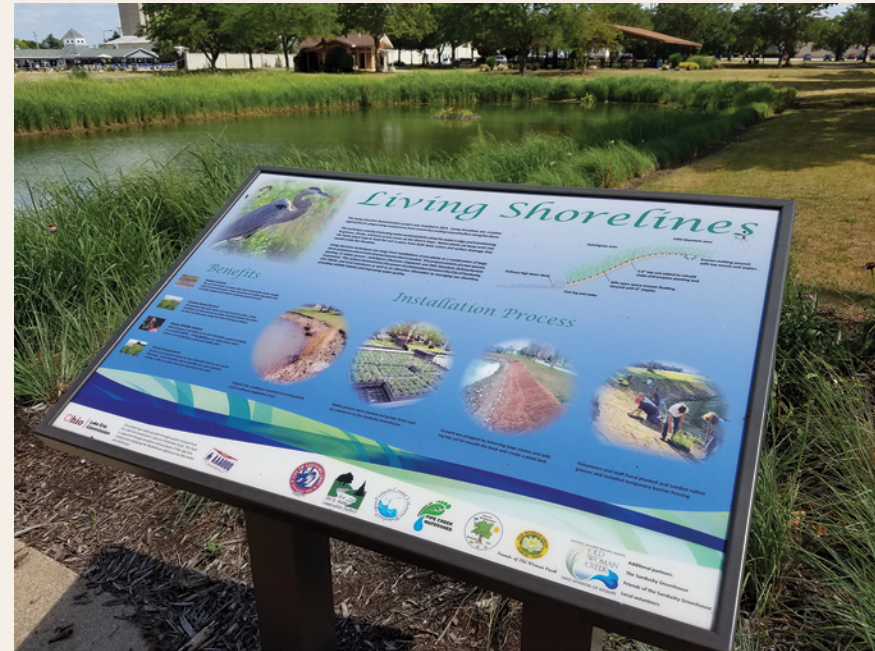
Educational signage informing visitors of the benefits of the edging project.  
*Erie Soil and Water Conservation District*

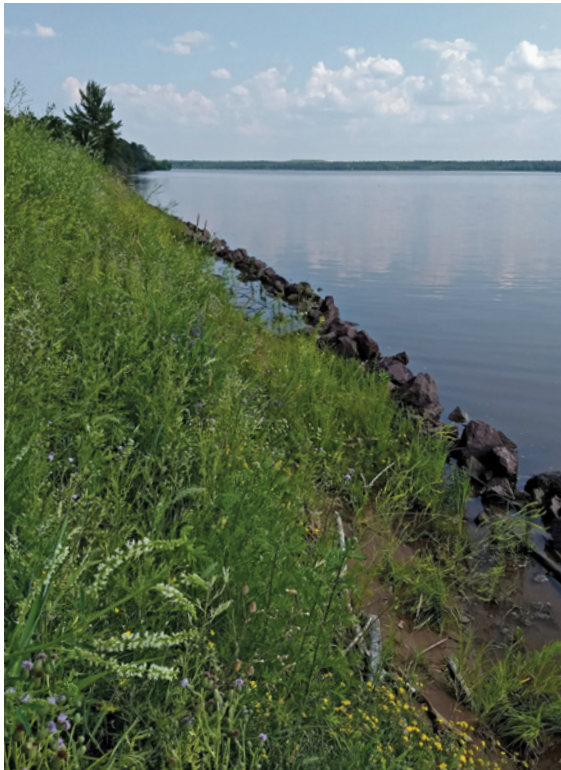
A rock sill in Allouez Bay in Superior, Wis. *Adam Bechle*

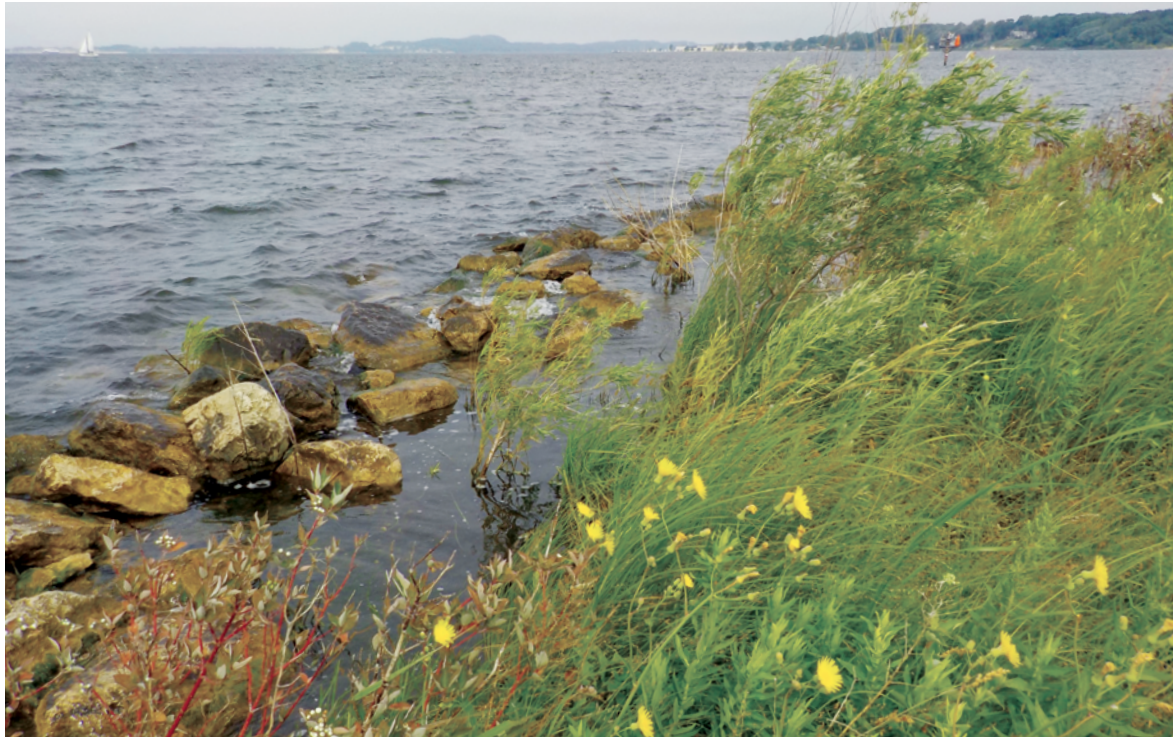
A rock sill built near the Center Point Bay Marina in Muskegon Lake, Mich. *Brian Majka*

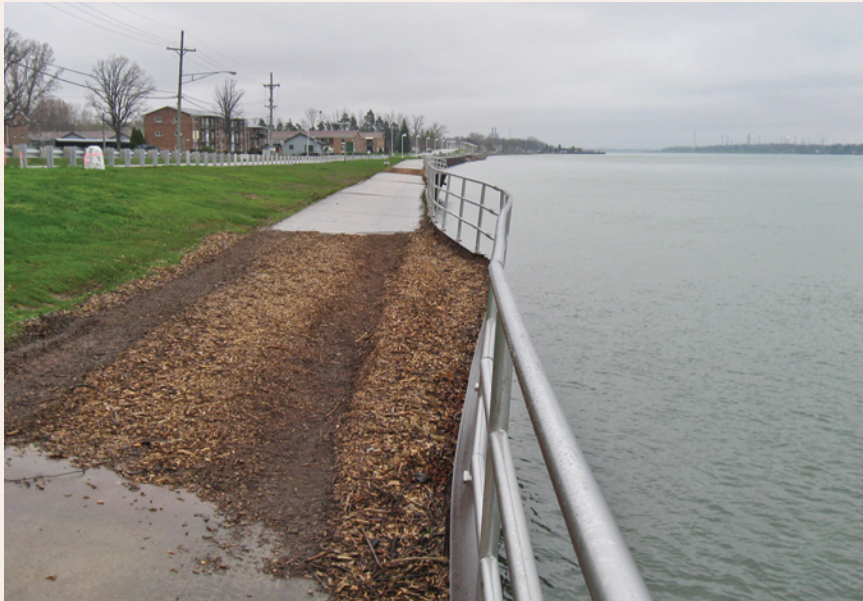
**Before** The area was protected with a steel sheet pile seawall that had become unstable and provided limited environmental benefits. *Barry Kreiner*

The city of Marysville replaced 1,885 feet of seawall on the St. Clair River with a marsh sill to combat the loss of fish and wildlife habitat in the river. Prior to construction, the shoreline consisted of a failing seawall of steel sheet pile and rock with a mowed turf grass lawn at the top. The shoreline experiences moderate wave energy from large ship wakes due to its location on the shipping lane between Lake Erie and Lake Huron. The project was funded by the Great Lakes Restoration Initiative and the city of Marysville in association with the St. Clair River Area of Concern. The project cost was \$1.8 million (2012 cost), which included removing the existing seawall, constructing the marsh sill and making boardwalk improvements.

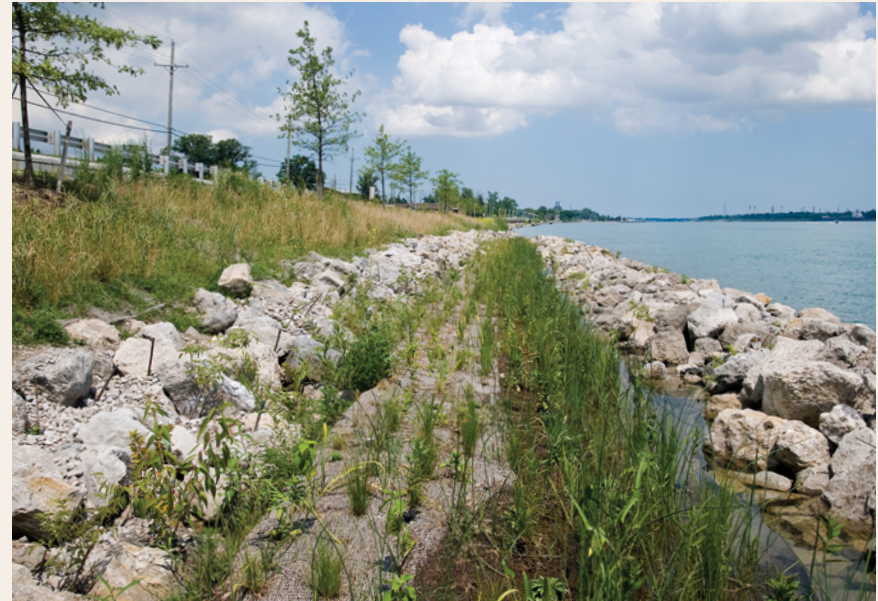
**After – Low Water** The area was protected by a sill with marsh vegetation. New vegetation was also planted along the shore. At low water levels, the marsh may be above the water line and the sill is emergent. *Michigan Department of Environment, Great Lakes, and Energy*

The living shoreline consists of a rock sill, native vegetation and rock toe edging at the shore. The top of the sill is 2 to 3 feet below the ordinary high water mark. The stone edging is located on the shore at the ordinary high water mark. The sill reduces wave energy at the shore while the marsh vegetation and stone edging protects the shore from the remaining wave energy. At low water levels, the marsh may be above the water line and the sill is emergent. At high water levels, the sill and marsh may be completely submerged. Another part of the shoreline consists of a rock revetment where vegetation and shallow water habitats were also restored. Gravel, cobble and root wads, which are dead tree trunks with their roots attached, were placed offshore to provide shallow water habitat and spawning ground. Planting was done with seed, plant plugs and live stakes, which are cuttings from tree branches.

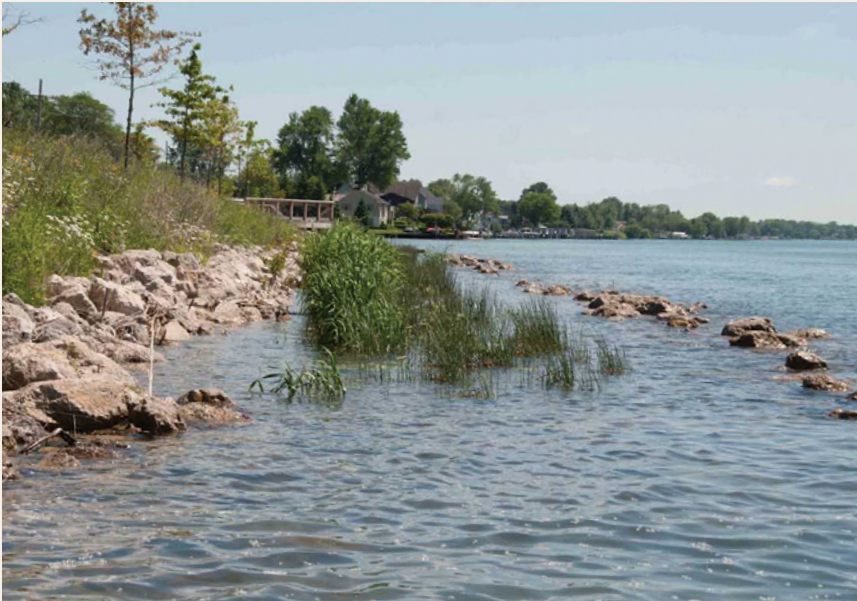
**After – High Water** At high water levels the marsh may be completely submerged. In this case the sill will dissipate some wave energy and stone edging will provide protection to the shoreline. *Michigan Department of Environment, Great Lakes, and Energy*

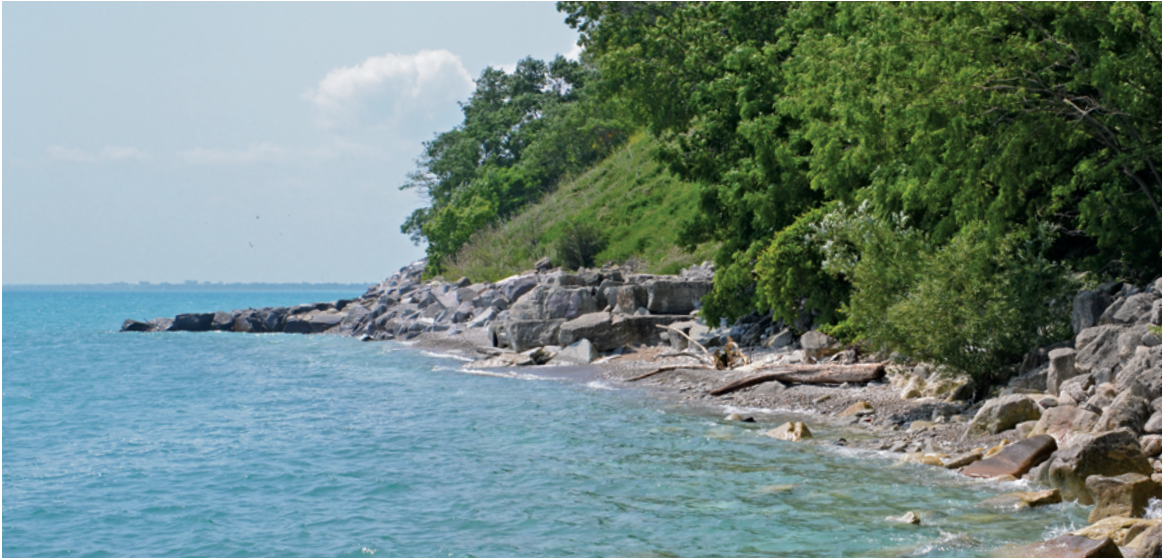
Terrestrial vegetation growing adjacent to revetments. At armored coasts in Lake Erie, fish species richness was observed to be higher at sites with terrestrial vegetation than at non-vegetated sites (Simonson, 2017). *Adam Bechle*

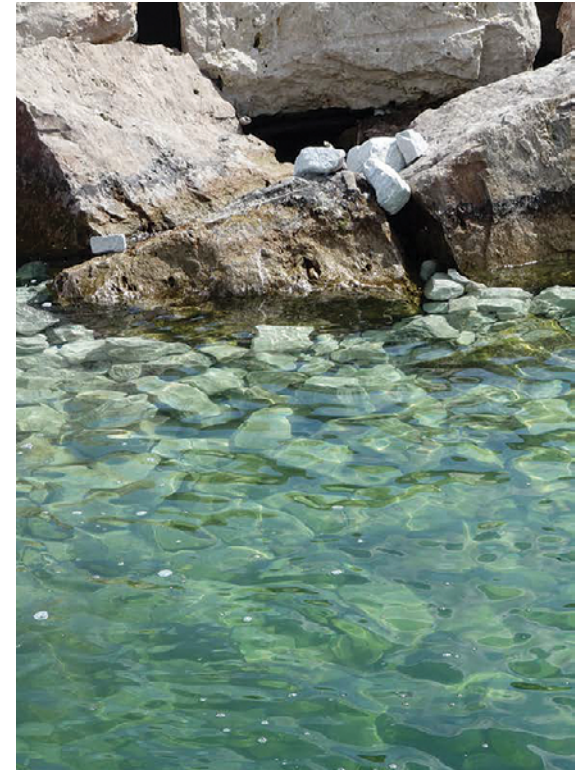
The USACE modified a section of the Milwaukee Harbor breakwater with a shallow slope of cobblestones to increase availability of fish habitat. *Burton Suedel*

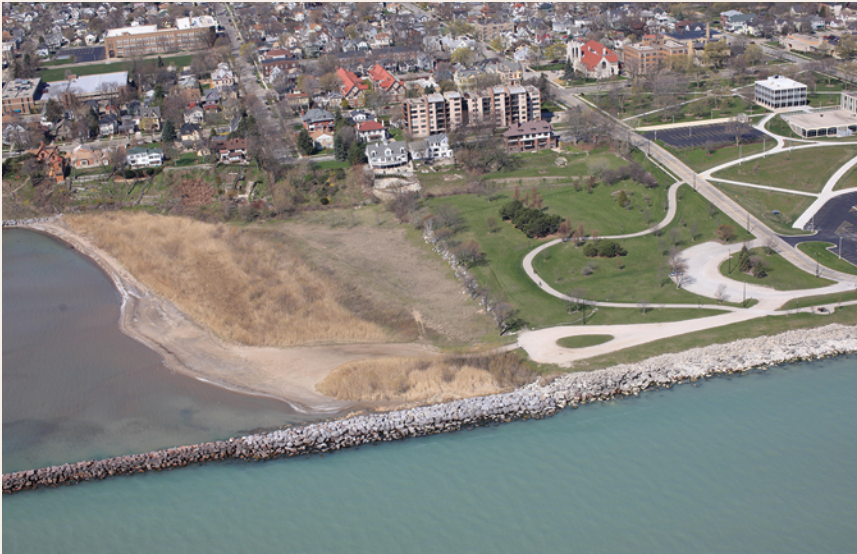
**Before** Prior to the project, the area adjacent to the breakwater was eroded due to overtopping and the rest of the park was dominated by invasive Phragmites. *USACE*

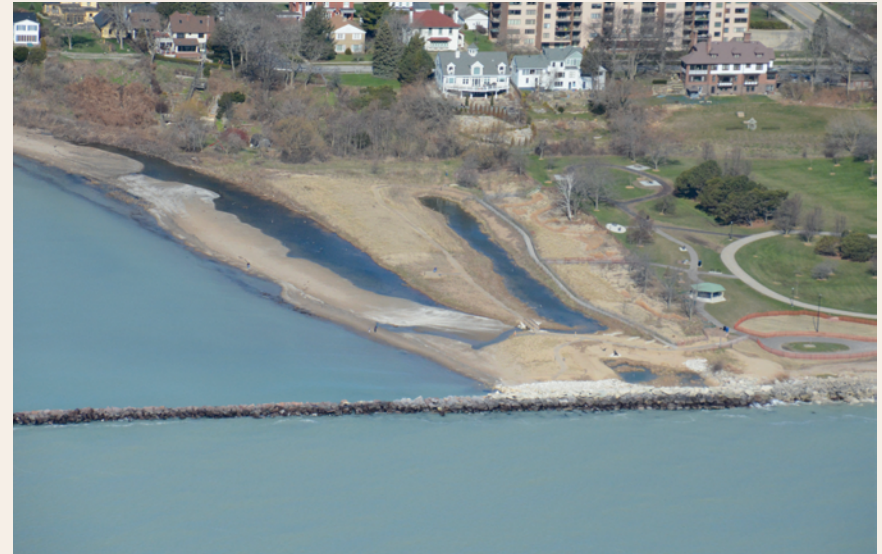
**After** The raised breakwater facilitated construction of connected wetland areas. Invasive species were replaced with diverse native vegetation. An overflow channel was built adjacent to the breakwater to handle extreme storm surge and precipitation events. *Capt. Dennis Carr*

The breakwater was raised by 3 to 4 feet to prevent overtopping from waves. This reduced erosion of the adjacent shore, allowing the existing wetland area to be protected and incorporated into a larger constructed wetland. Invasive species were removed and the constructed wetland and wetland fringe area were revegetated with native species. Dunes were also built to help capture runoff. In the upland area of the park, a rain garden and bioswale were built to help capture runoff and increase infiltration. Native vegetation was planted throughout the park, creating a diversity of habitat types including sand prairie, dune and wetland. The design has been adapted over time to help control large storm surges and excess runoff from significant precipitation events. This has included connecting the constructed wetlands with a drainage system, installing flow dissipaters to reduce runoff intensity and building an overflow drainage channel along the breakwater.

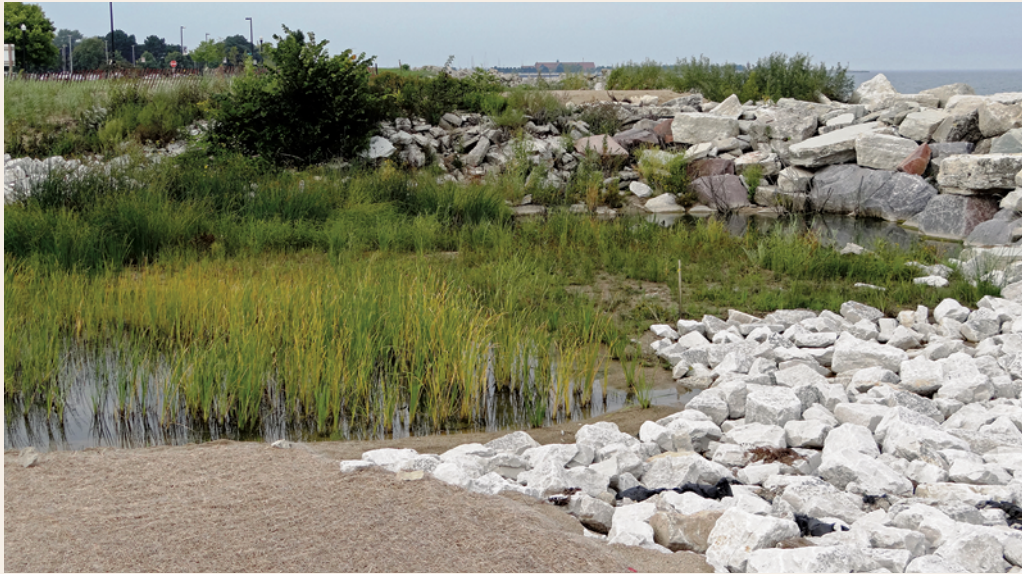
An area of established wetland near the breakwater. *Julie Kinzelman*
