GEOLOGICAL SURVEY OF OHIO

FOURTH SERIES, BULLETIN 18

BUILDING STONES OF OHIO

By J. A. BOWNOCKER

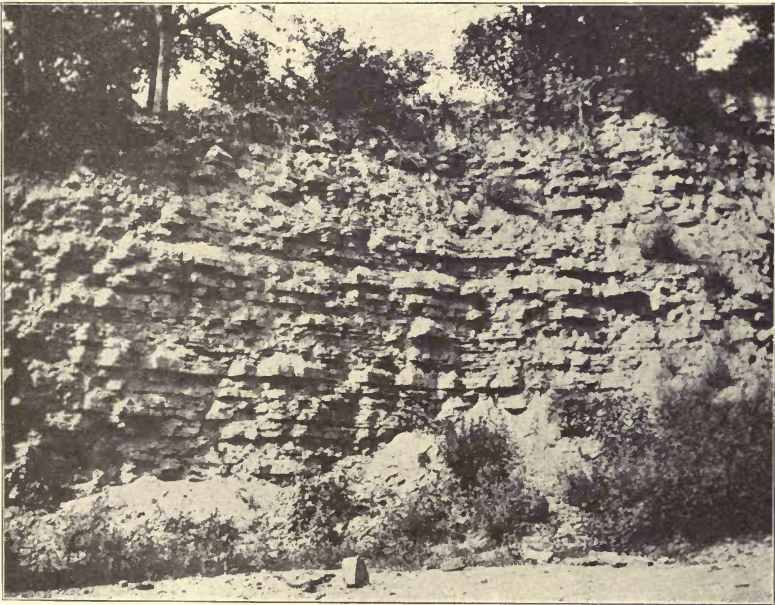
B.—View of Cincinnati limestone and shales (Lorraine formation), Cincinnati.
Note the large proportion of shales.

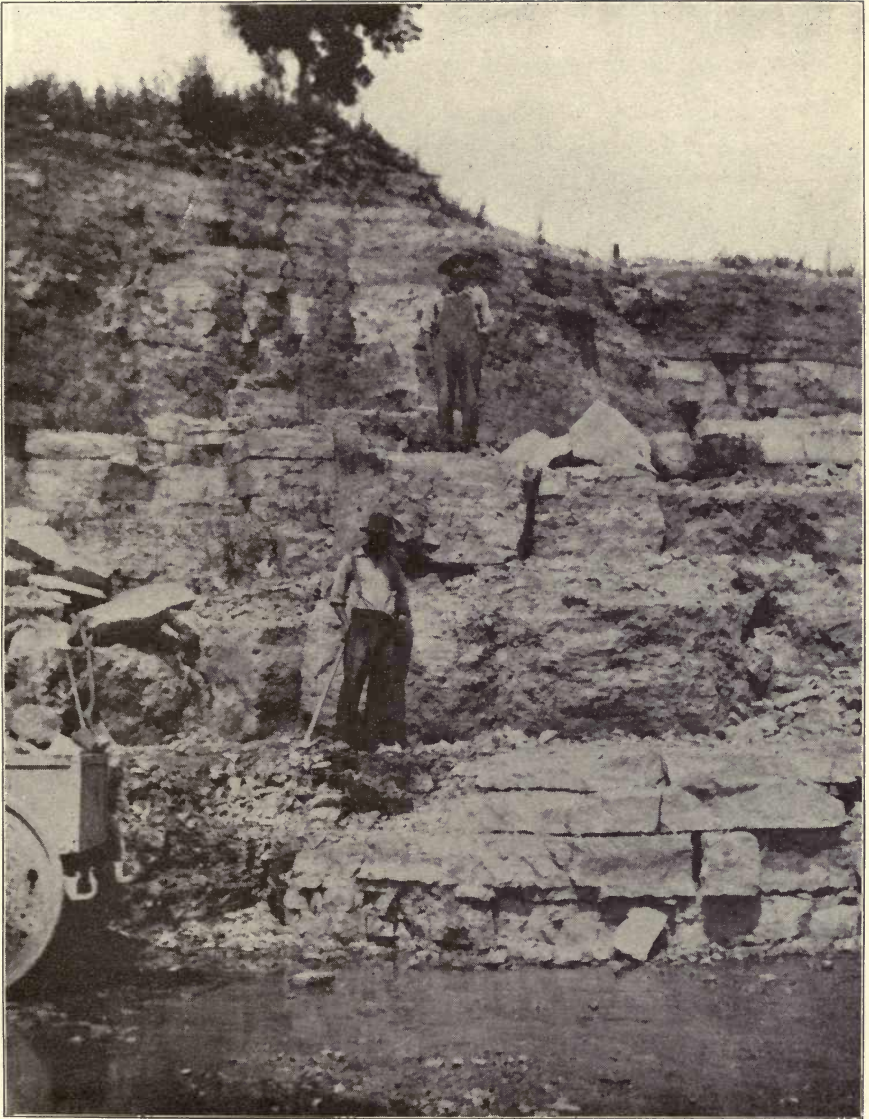
PLATE III.

Niagara limestone in the Robinson quarry, two miles south of Covington, Miami County. The lower man stands on top of the Osgood beds and to his back is the massive West Union limestone. The upper man stands on top of the West Union and to his back are the Springfield beds, the layers of which are not well shown. The broken rock under the tree forms the base of the Cedarville division of the Niagara.

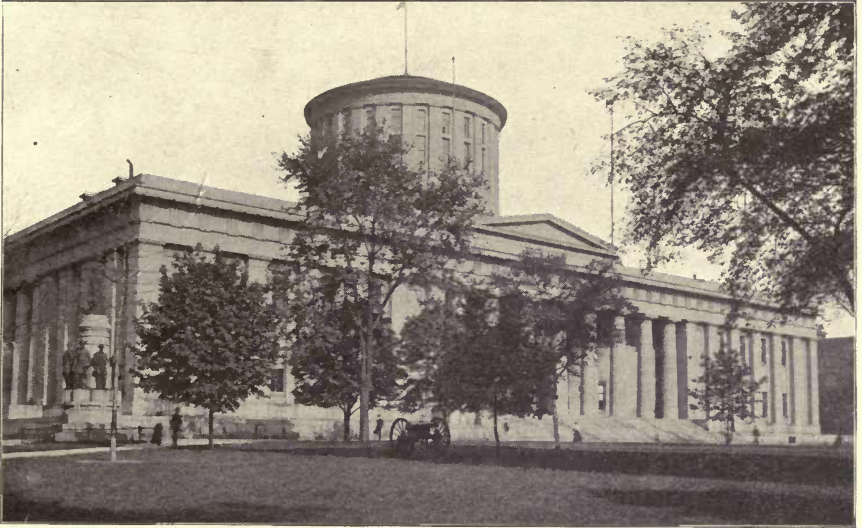
PLATE V.

A.—State House, built of Columbus limestone. Photograph by J. E. Hyde.

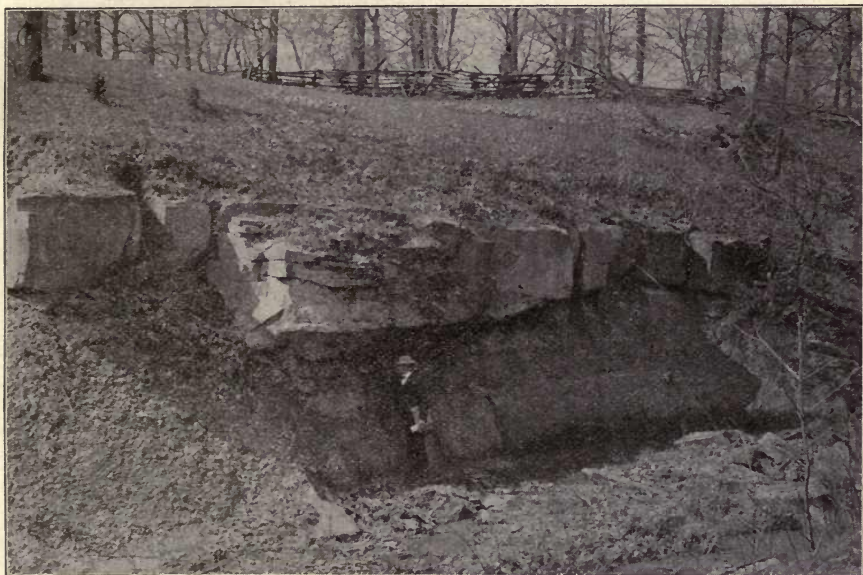
Fig. 4.—Entire section of Berea sandstone near Lithopolis. Note unconformity between sandstone and underlying Bedford shale. Photograph by H. A. Gleason.

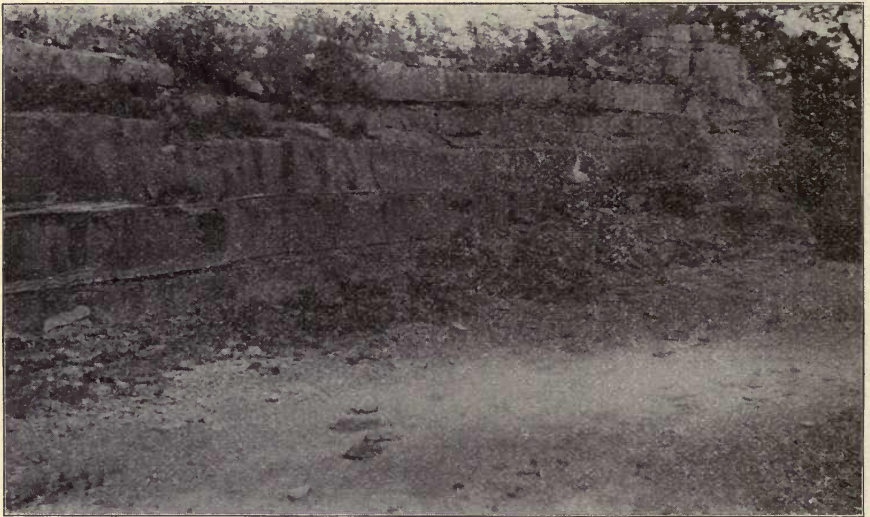
Fig. 5.—Partial view of Berea sandstone in old Peck quarry near Waverly.

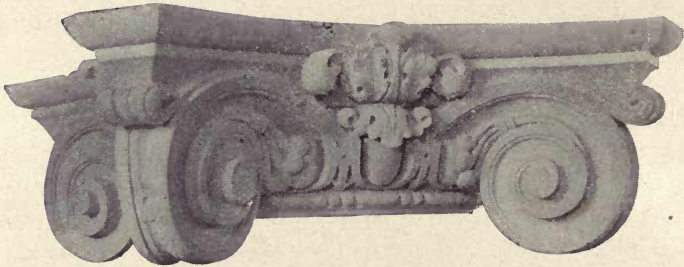
Fig. 10.—A carved block of Berea sandstone.
Courtesy of Ohio Quarries Co.

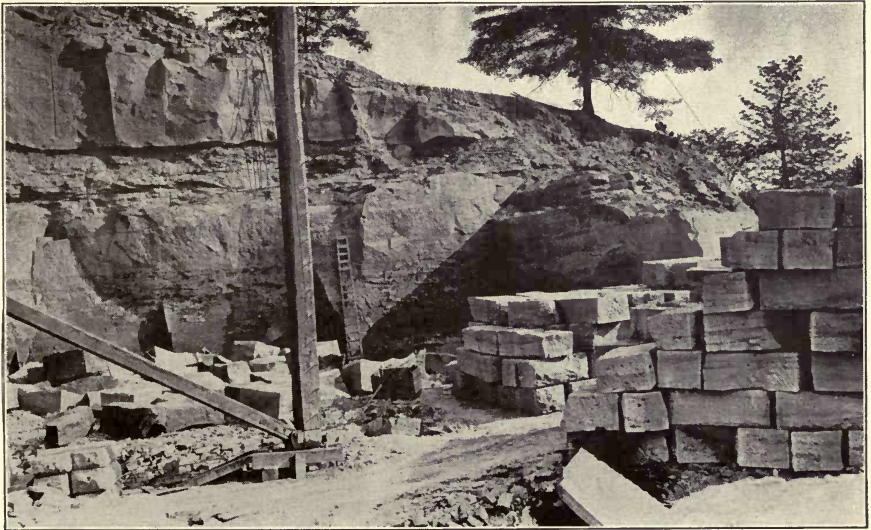
B.—Quarry in Mahoning sandstone at Corning, Perry County. The rock is used for bridges, foundations and viaducts. Photograph by D. D. Condit.

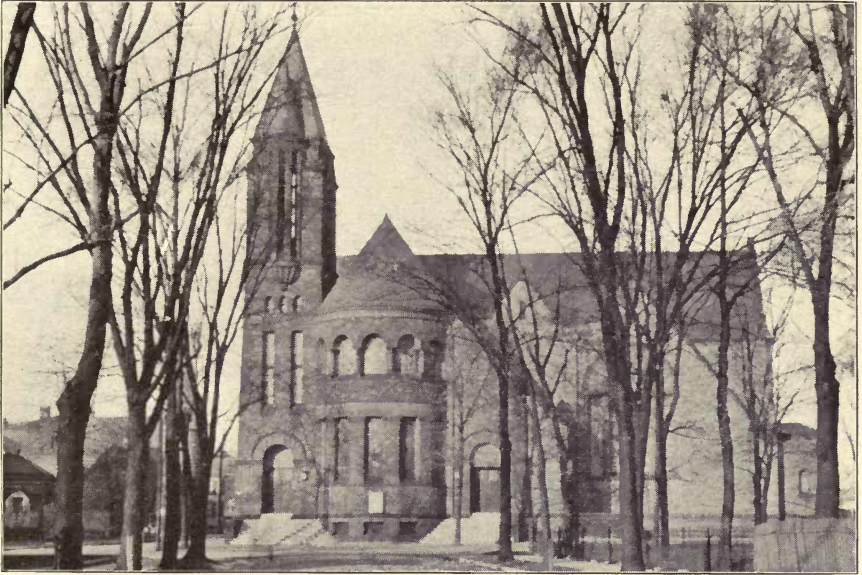
A.—Broad Street Presbyterian Church, Columbus. Built of Conemaugh sandstone from Tippecanoe, Harrison County and Sherrodsville, Carroll County. The brown sandstone trimming is from Holmes County, Ohio, and the south shore of Lake Superior. Photograph by T. M. Hills.
