# **Karst of the Bellevue Quadrangle and portions of the Clyde and Castalia Quadrangles, Ohio**

by  
**Douglas J. Aden**

Open-File Report 2013-1  
Columbus 2013

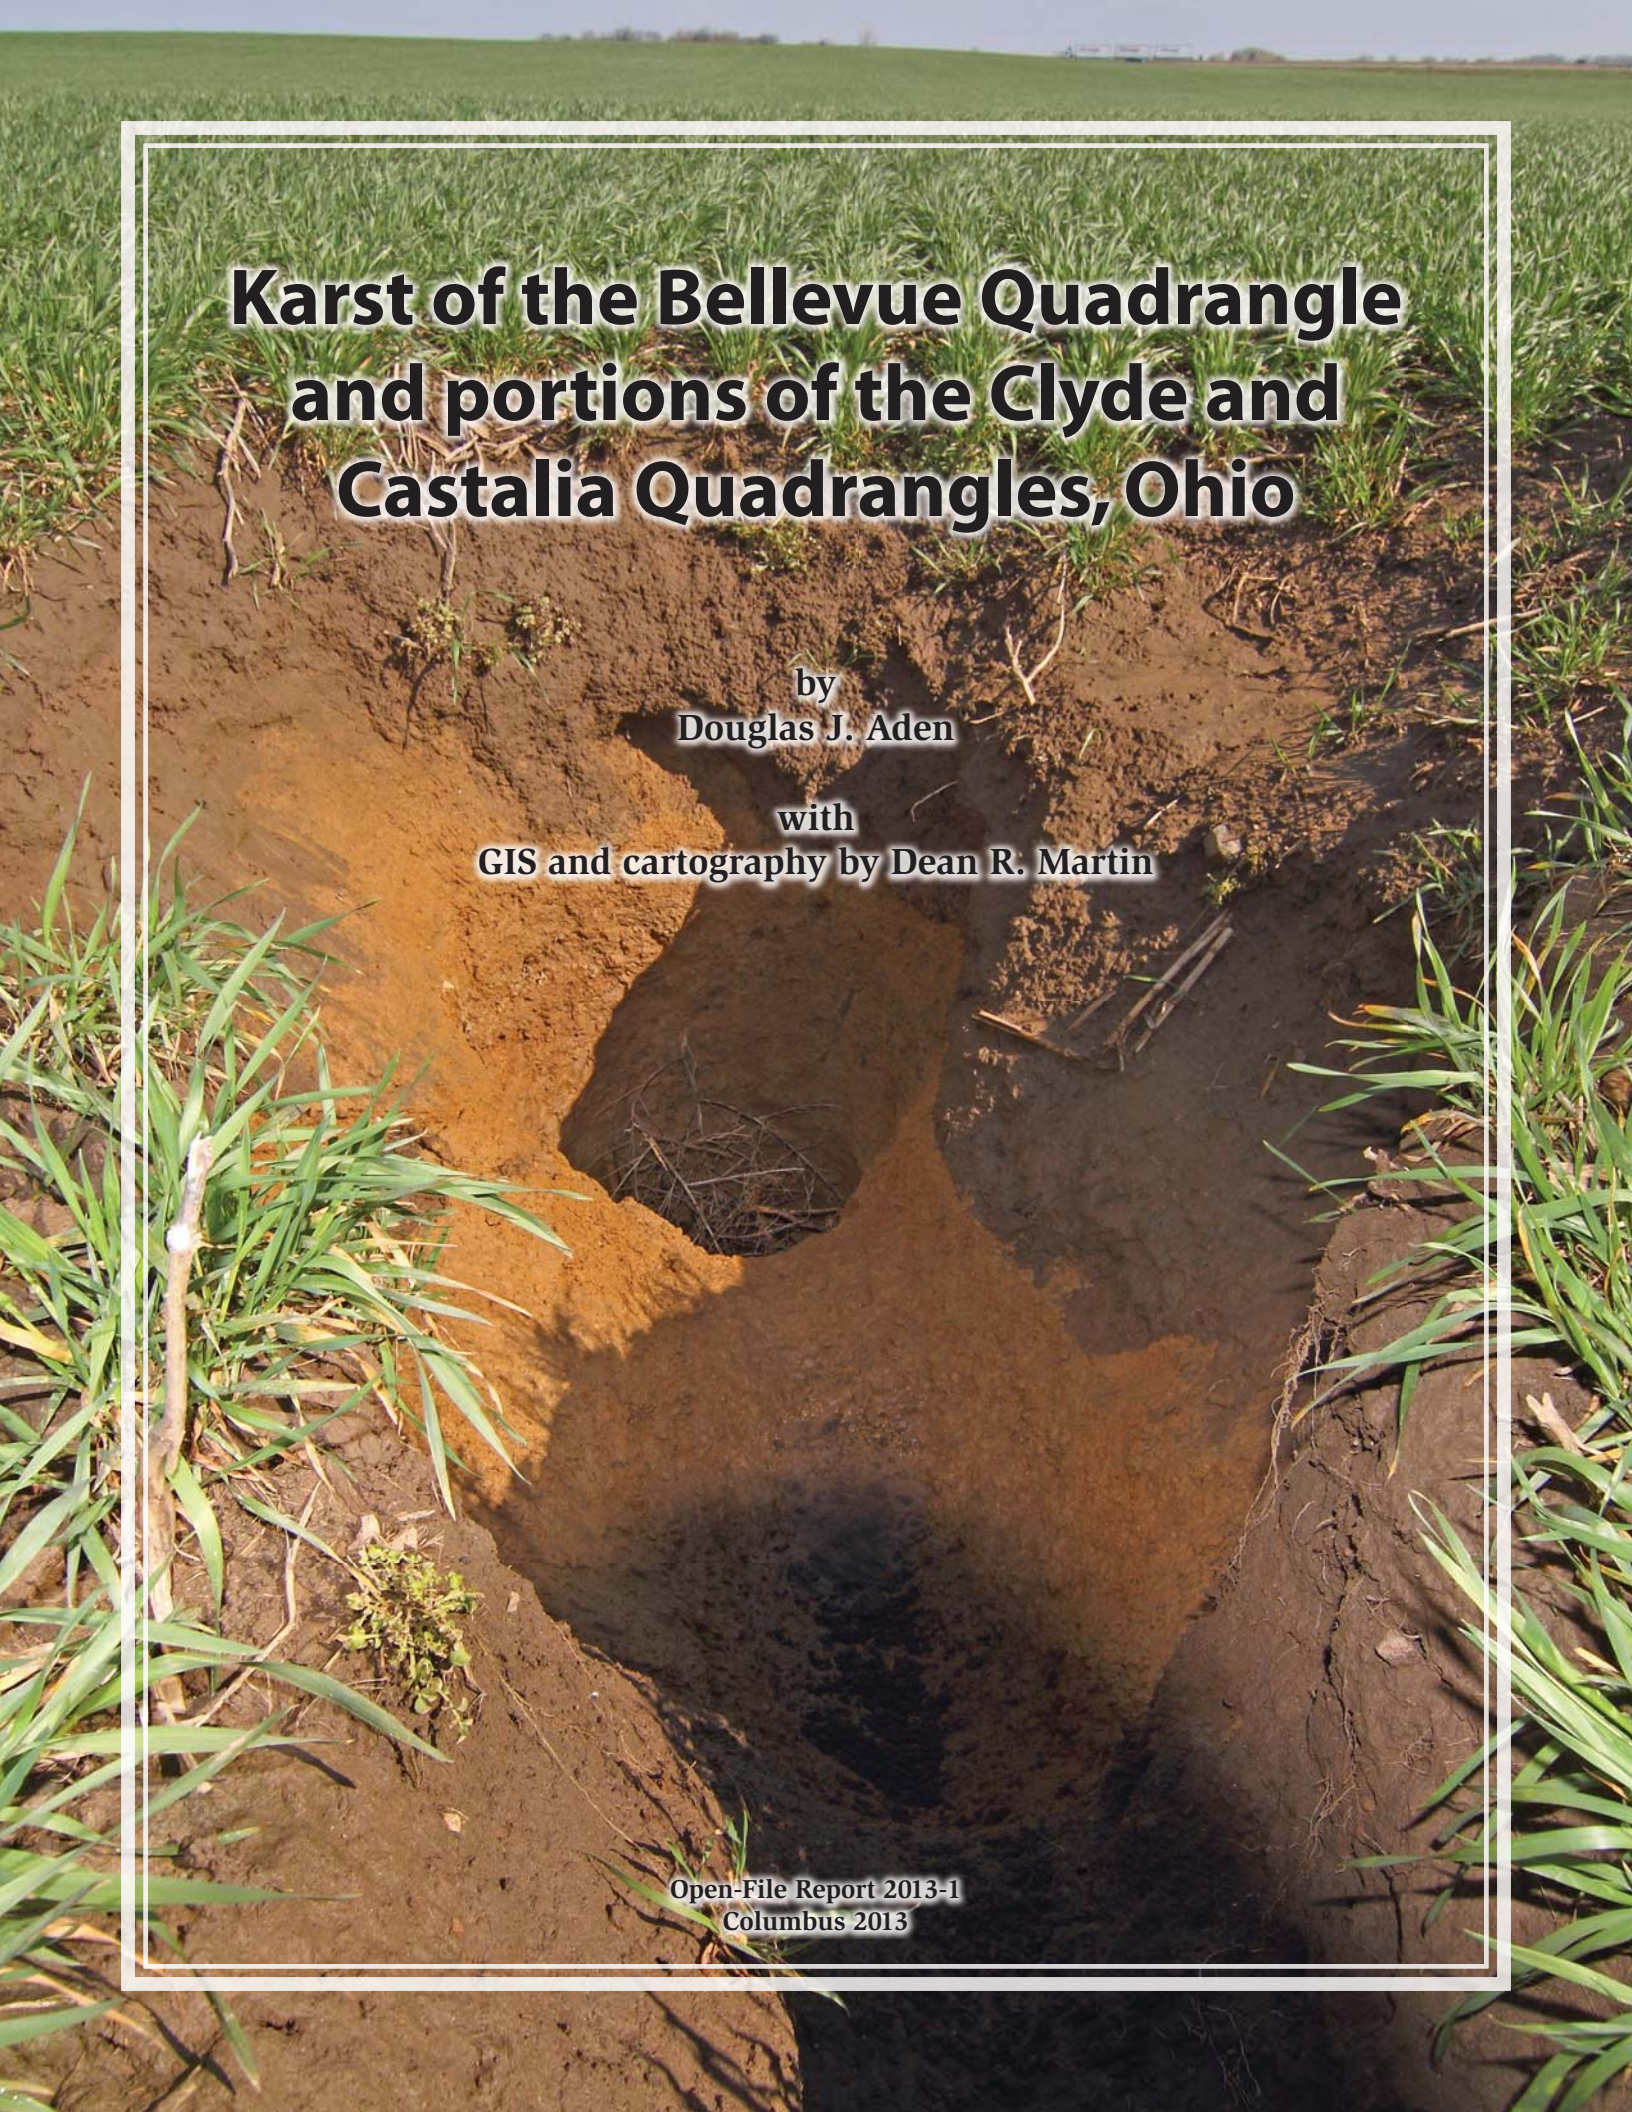
*Cover image:* At about 6 ft deep, this sink has formed since the winter wheat was planted eight months prior. Brown top soil is visible above the orange till and plant material has been washed in by rain and fills the sink throat. Photo faces north and a truck can be seen on Interstate 80 on the horizon. Eighty-five feet SW of this sink is an intermittent disappearing stream that aligns with the trend of the much larger depression containing these features. The overall depression is 10 ft deep (with the pictured sink another 6 ft deeper) about 1.25 mi long, 1000 ft wide, and bisected by the Interstate.
