# OHIO SCHOOL BUS STANDARDS AND INSPECTION MANUAL

2025

## OHIO STATE HIGHWAY PATROL LICENSING AND COMMERCIAL STANDARDS

Revision Date: July 2025

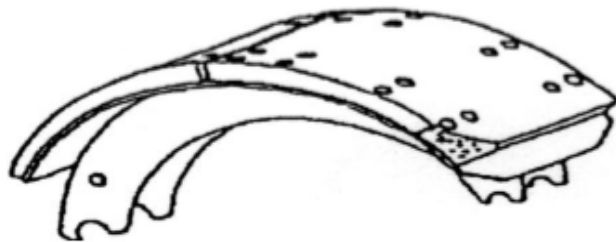
Out-of-Service  
Portion of lining missing that exposes a fastening device.

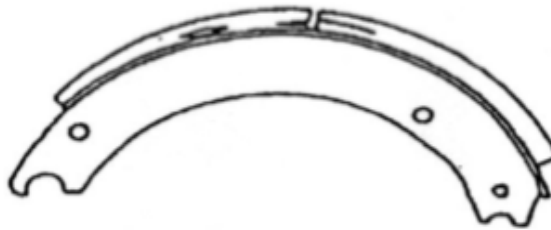
Out-of-Service  
Cracks or voids that exceed 1/16" in width.  
Cracks that exceed 1-1/2" in length.
