PAVEMENT CONDITION RATING SYSTEM

The Ohio Department of Transportation
Office of Pavement Engineering
1980 West Broad Street
Columbus, OH 43223

April 2006

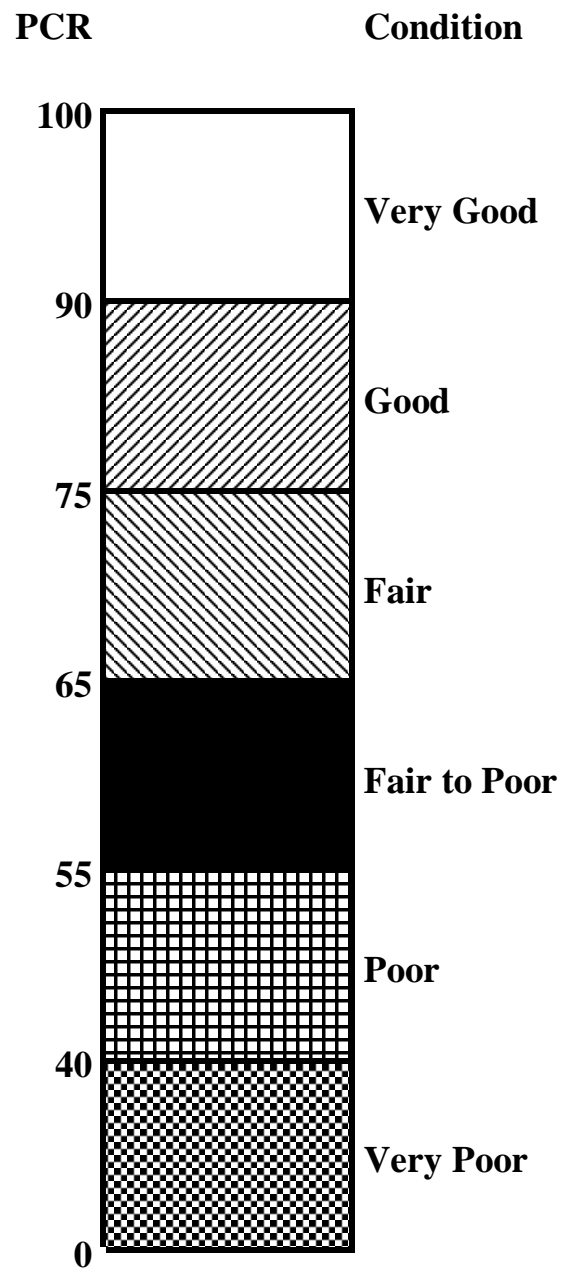
A Pavement Condition Rating (PCR) Scale was developed to describe the pavement condition using the PCR numbers calculated from Equation (1). This scale has a range from 0 to 100; a PCR of 100 represents a perfect pavement with no observable distress and a PCR of 0 represents a pavement with all distress present at their “High” levels of severity and “Extensive” levels of extent. Figure 1 illustrates the PCR Scale and the descriptive condition of a pavement associated with the various ranges of the PCR values.

Figure 1. Pavement Condition Rating (PCR) Scale

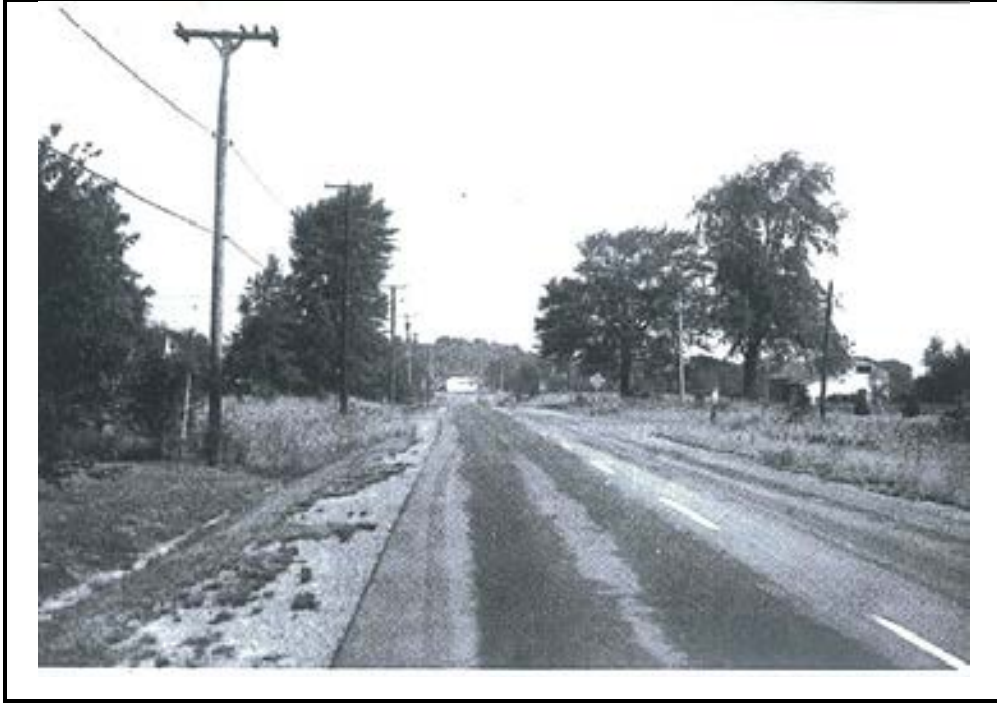
Distress Type:	Bleeding
Description:	Bleeding or flushing is the presence of free asphalt binder on the pavement surface. Bleeding is caused by an excess amount of bituminous binder in the mixture and/or low air void content.
Severity Level:	Only 2 severity levels are defined. Medium-- both coarse aggregate and free bitumen are noticeable at the pavement surface. High-- surface appears black with very little aggregate noticeable.
Extent Level:	Occasional-- less than 10 percent of the length exhibits bleeding. Frequent-- between 10 and 30 percent of the length is bleeding. Extensive-- bleeding occurs in more than 30 percent of the length.

Photo A-3. Bleeding in Flexible Pavement, High Severity

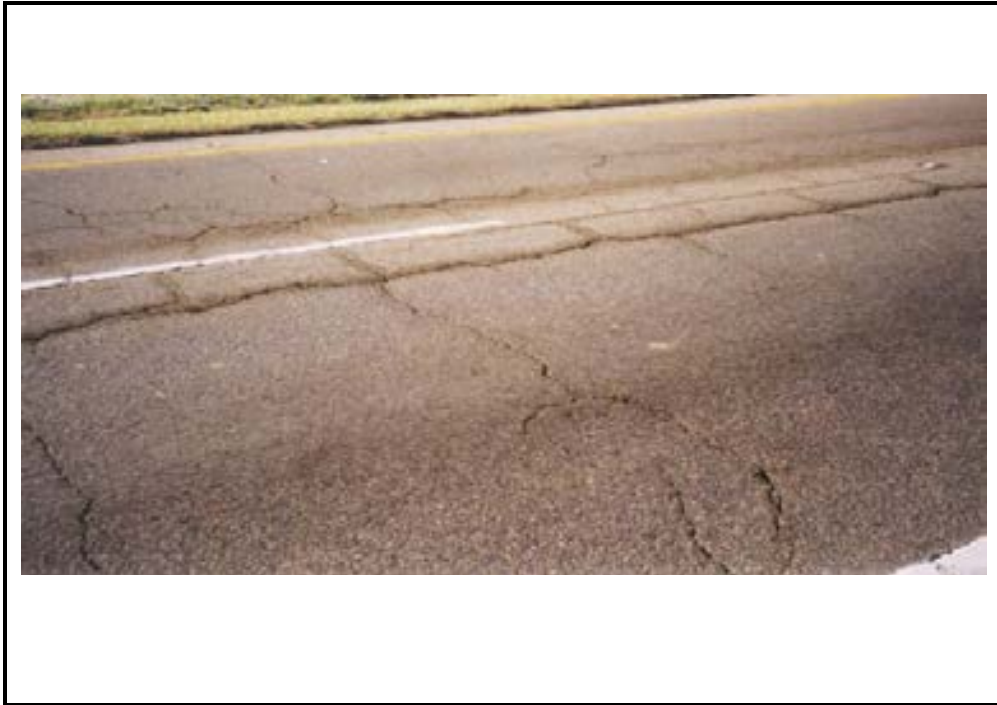
Extensive— None of the existing cracks have been sealed, there is no sealant on the roadway.

Photo A-8. Crack Sealing Deficiency in Flexible Pavement, Unsealed Cracks

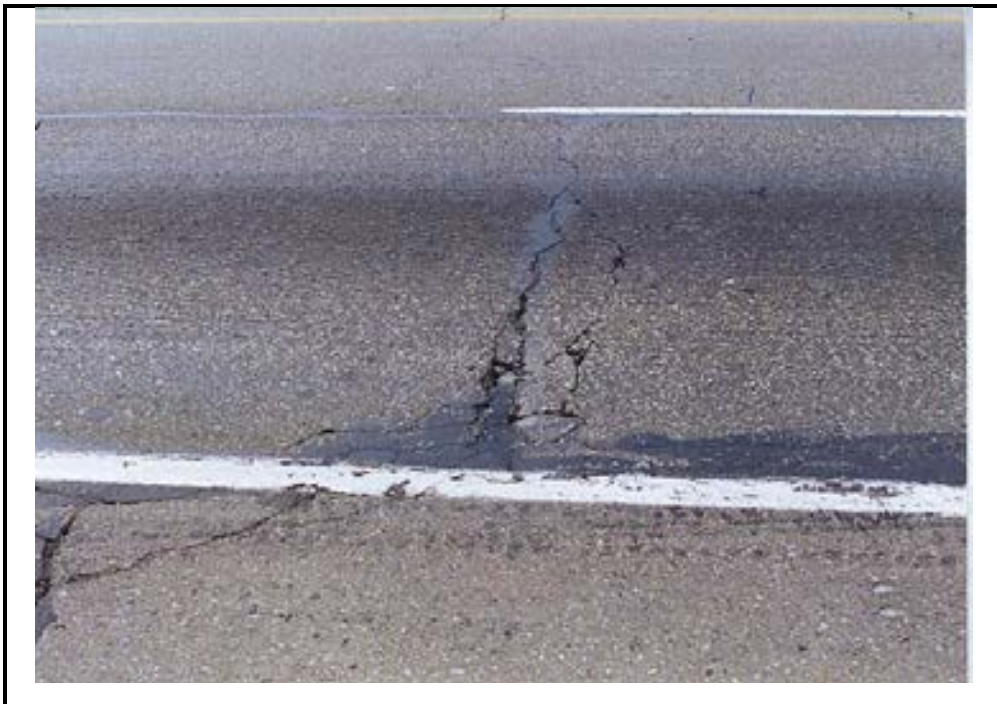
Photo A-9. Crack sealing Deficiency in Flexible Pavement, Cracks not sealed properly

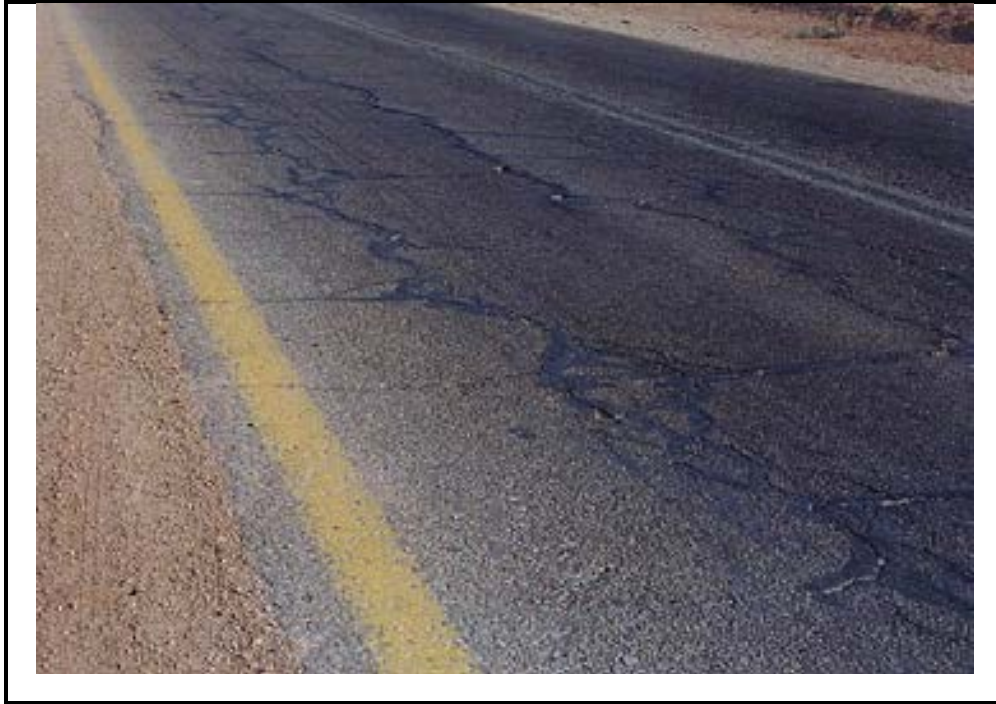
Photo A-15. Wheel Track Cracking in Flexible Pavement, Med. Severity

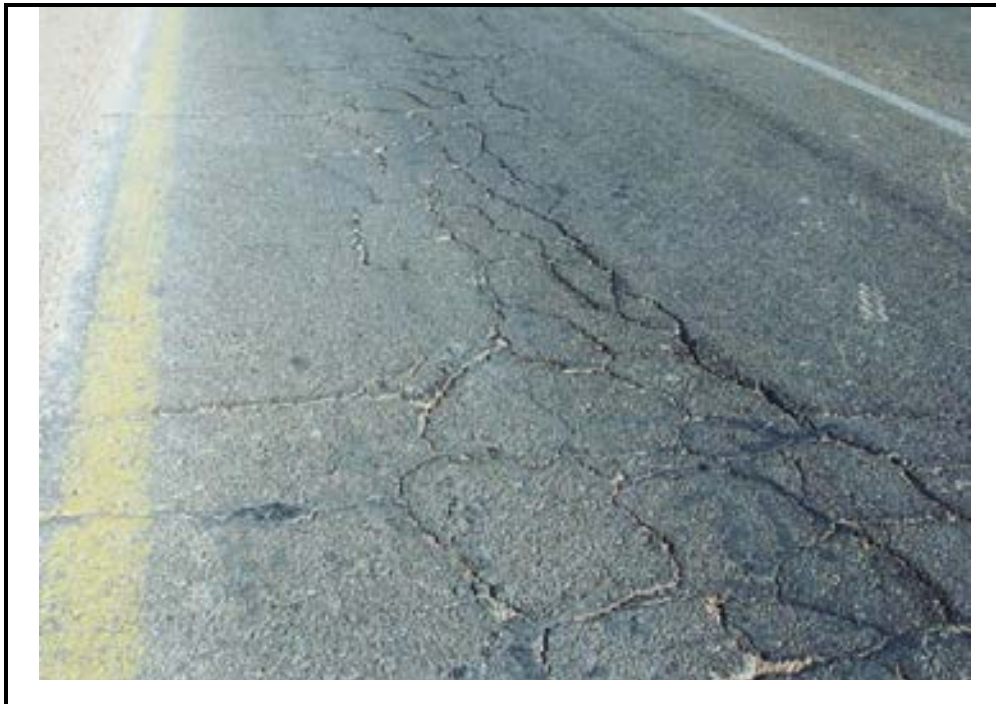
Photo A-16. Wheel Track Cracking in Flexible Pavement, High Severity

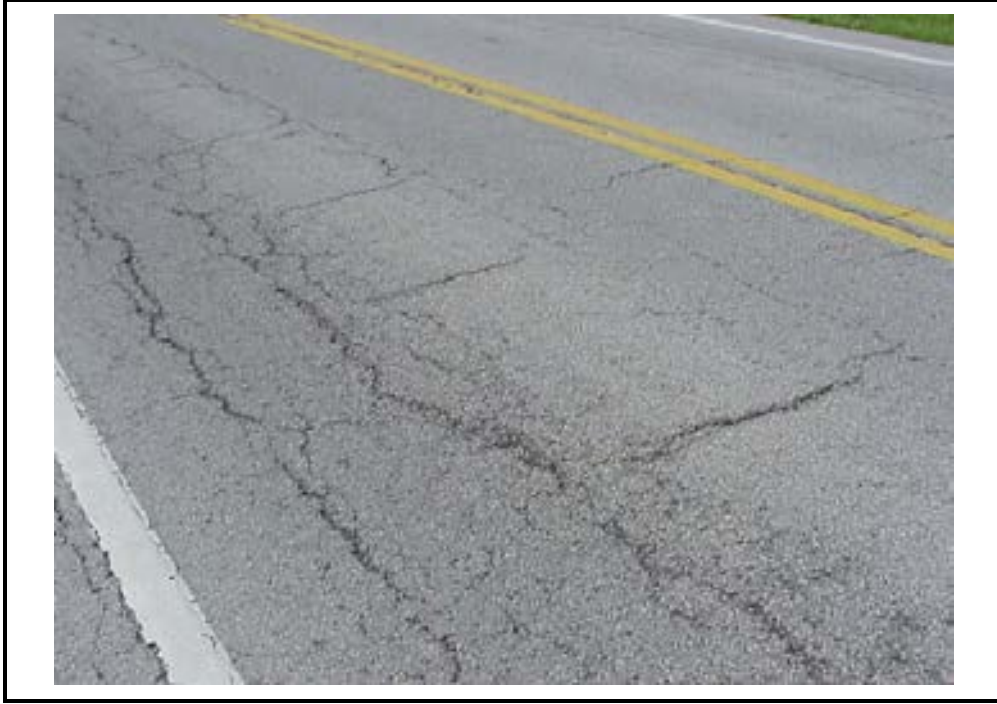
Severity Level:	Low--	Average size of block formed is greater than or equal to 6' x 6' or an occasional transverse crack that is not a thermal crack.
	Medium--	Average size of block formed is greater than 3' x 3' but less than 6' x 6'.
	High--	Average size of block formed is less than 3' x 3'.
Extent Level:	Occasional--	Less than 20 percent of the section length is affected by this distress.
	Frequent--	Between 20 and 50 percent of this section length is affected by this distress.
	Extensive--	Greater than 50 percent of the section length is affected by this distress.

Photo A-17. Block and Transverse Cracking in Flexible Pavement, Medium Severity

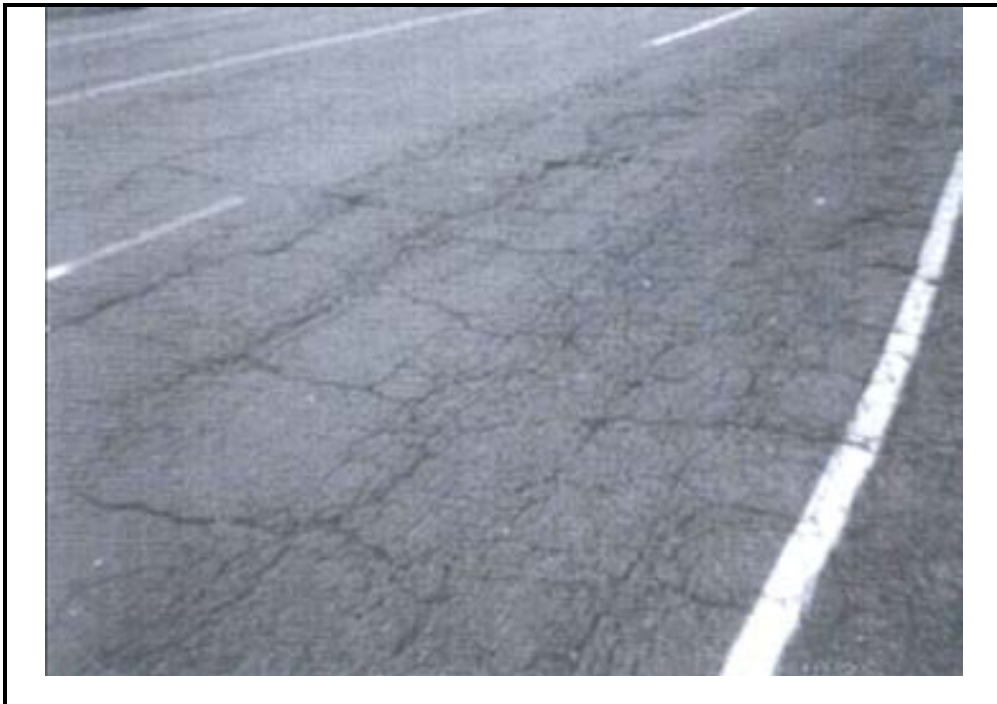
Photo A-18. Block and Transverse Cracking in Flexible Pavement, High Severity

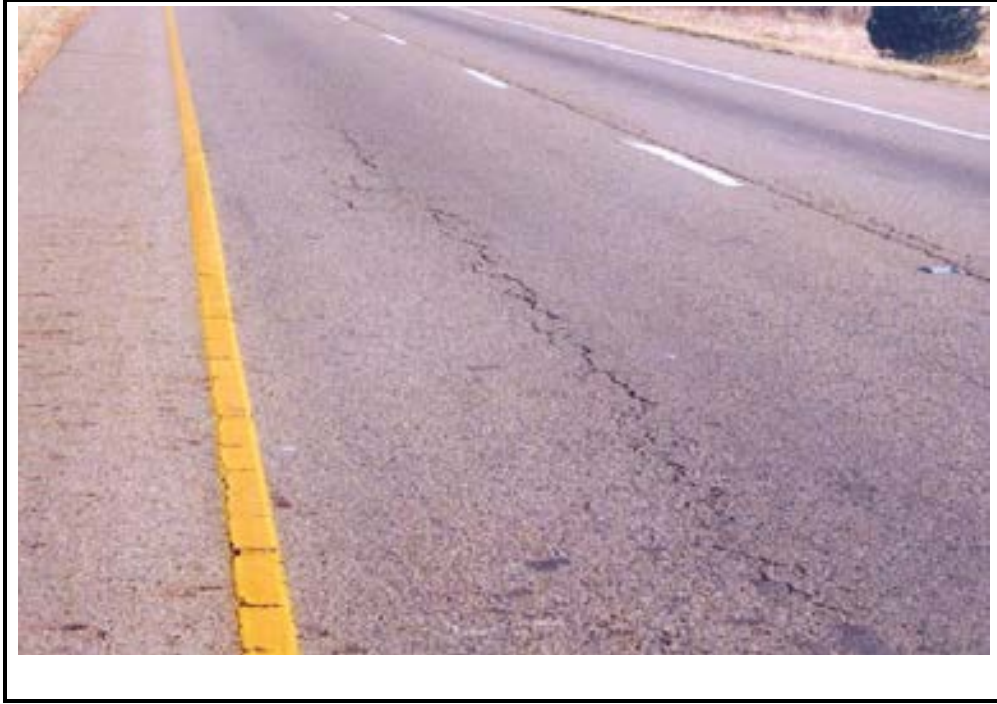
Occasional--	Less than 50 feet per station (15 m / 30 m)
Frequent--	Between 50 and 150 feet per station (15 and 45 m/30 m).
Extensive--	More than 150 feet per station (45 m/30 m). Complete reflective longitudinal cracking along the pavement centerline and edge [200 linear feet per station (60 m/ 30 m)] is termed extensive.

Photo A-19. Longitudinal Joint Cracking in Flexible Pavement, Medium Severity

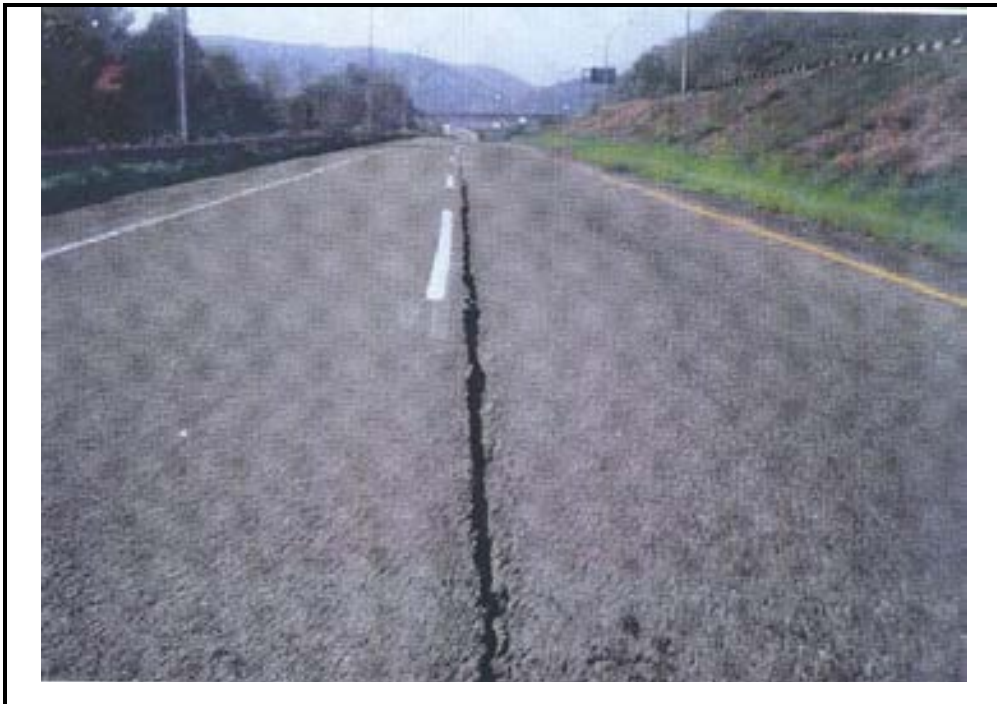
Photo A-20. Longitudinal Joint Cracking in Flexible Pavement, High Severity

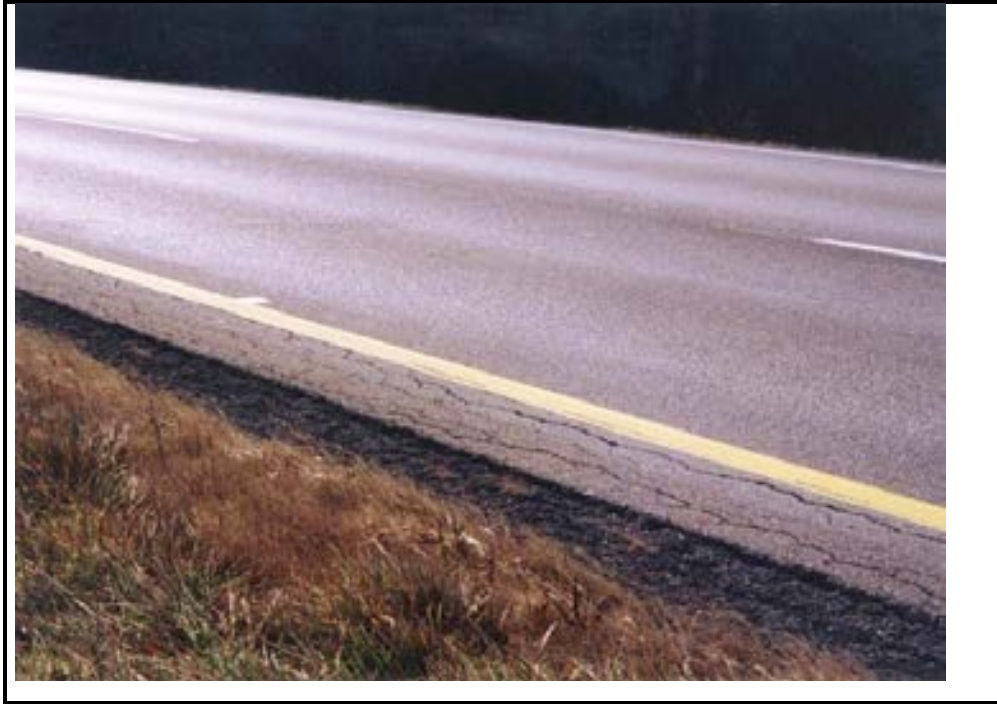
Extensive-- Cracking occurs along more than 50 percent of the pavement edge within the section.

Photo A-21. Edge Cracking in Flexible Pavement, Medium Severity

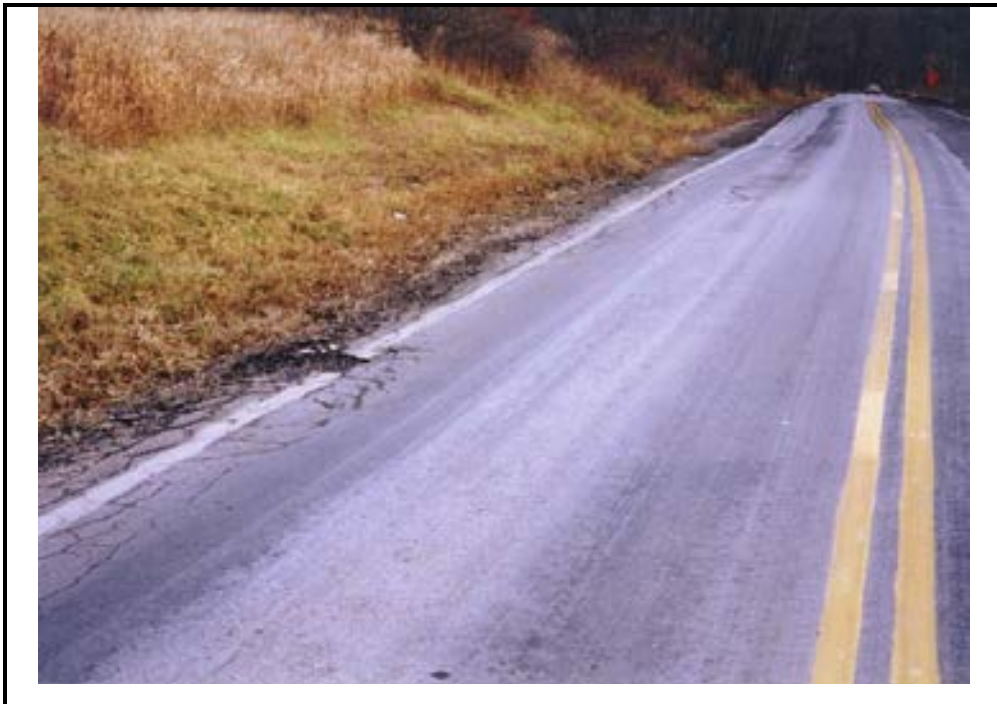
Photo A-22. Edge Cracking in Flexible Pavement, High Severity

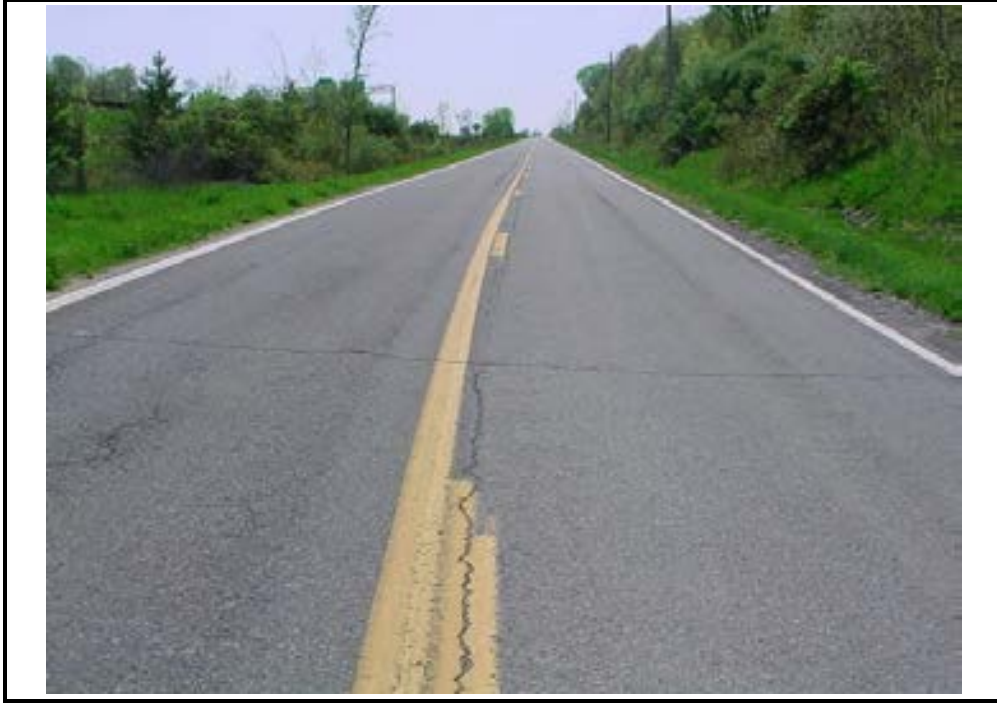
Severity Level:	Low--	Average crack width less than 1/4 inch (6 mm), no spalling.
	Medium--	Average crack opened or spalled to a width between 1/4 to 1 inch (6 mm to 25 mm) along at least half of its length.
	High--	Average crack opened or spalled to a width greater than 1 inch (25mm) along at least half of its length.
Extent Level:	Occasional--	Average crack spacing (CS) is greater than 200 ft.
	Frequent--	Average crack spacing (CS) is between 75 ft and 200 ft.
	Extensive--	Average crack spacing (CS) is less than 75 ft.

Photo A-23. Thermal Cracking in Flexible Pavement, High Severity

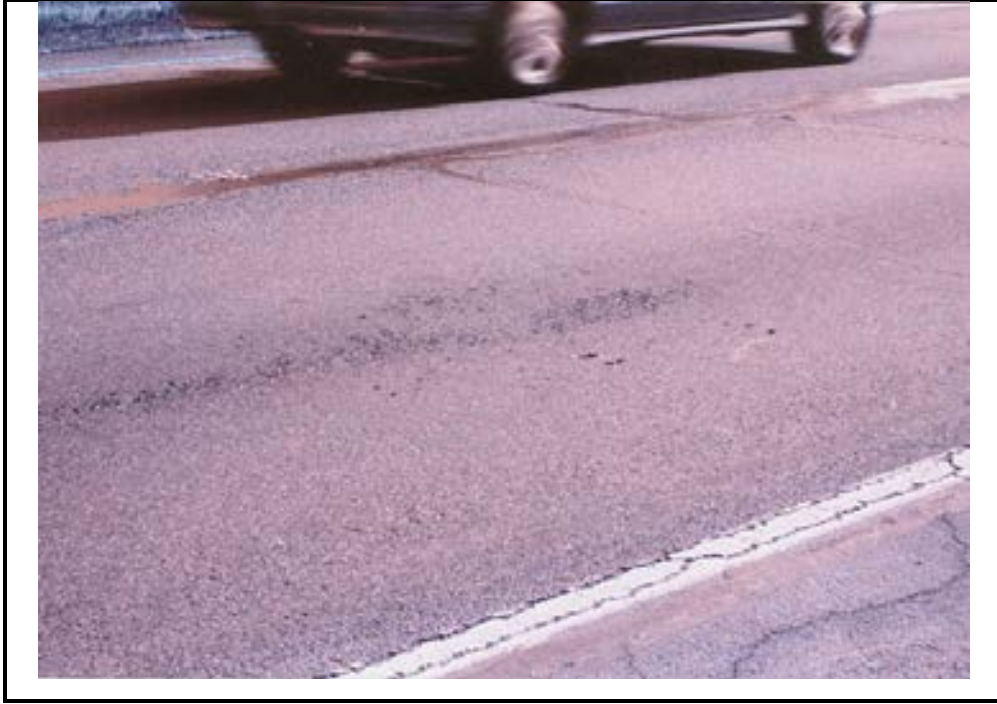
Severity Level:	Low--	Very little coarse aggregate has worn away. Loss of fine aggregate. Coarse aggregate exposed.
	Medium--	Surface has an open texture and is moderately rough with considerable loss of fine aggregate and some coarse aggregate removed.
	High--	Most of the surface aggregate has worn away or become dislodged. Surface is severely rough and pitted and may be completely removed in places.
Extent Level:	Occasional--	Less than 20 percent of the surface area is raveling.
	Frequent--	Between 20 and 50 percent of the surface area is raveling.
	Extensive--	More than 50 percent of the surface area is raveling.

Photo B-1. Raveling in Composite Pavement, Medium Severity

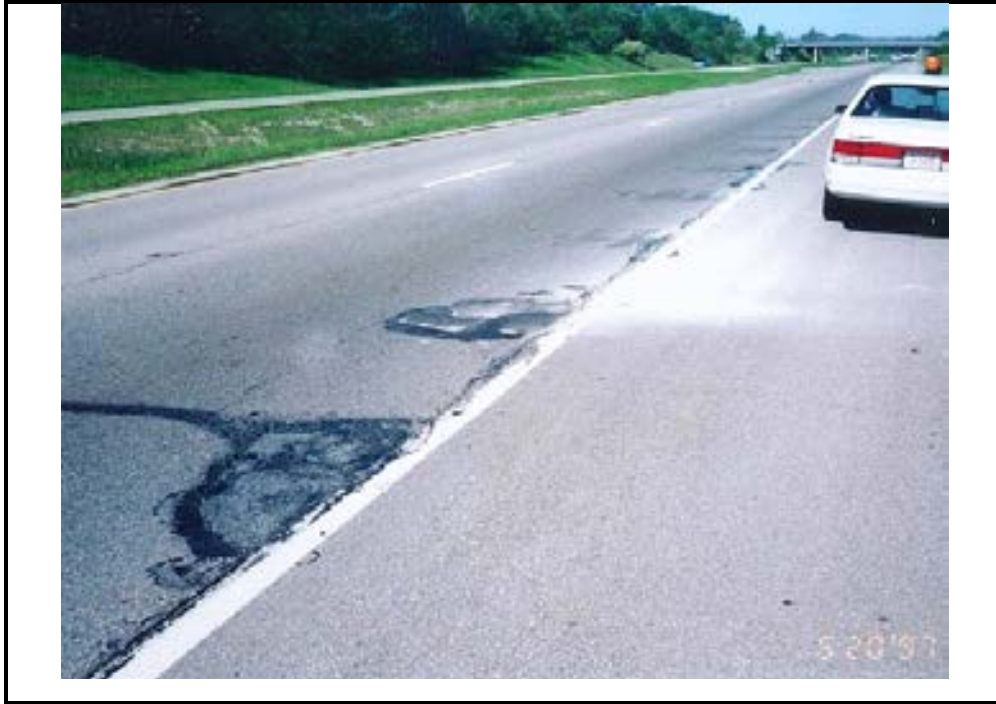
Distress Type:	Pumping
Description:	Pumping is the ejection of fine soil particles through pavement cracks, joints, or along pavement edges. Pumping can be identified by the presence of surface staining and base or subgrade material near joints or cracks. Shoulder disintegration at the pavement edge is often an indicator of pumping beneath the slab.
Severity Level:	Severity levels are not considered. Rater must be certain of pumping.
Extent Level:	Occasional-- Less than 10 percent of the joints and cracks exhibit pumping. Frequent-- 10 to 25 percent of the joints and cracks exhibit pumping. Extensive-- More than 25 percent of the joints and cracks exhibit pumping.

Photo B-11. Pumping in Composite Pavement

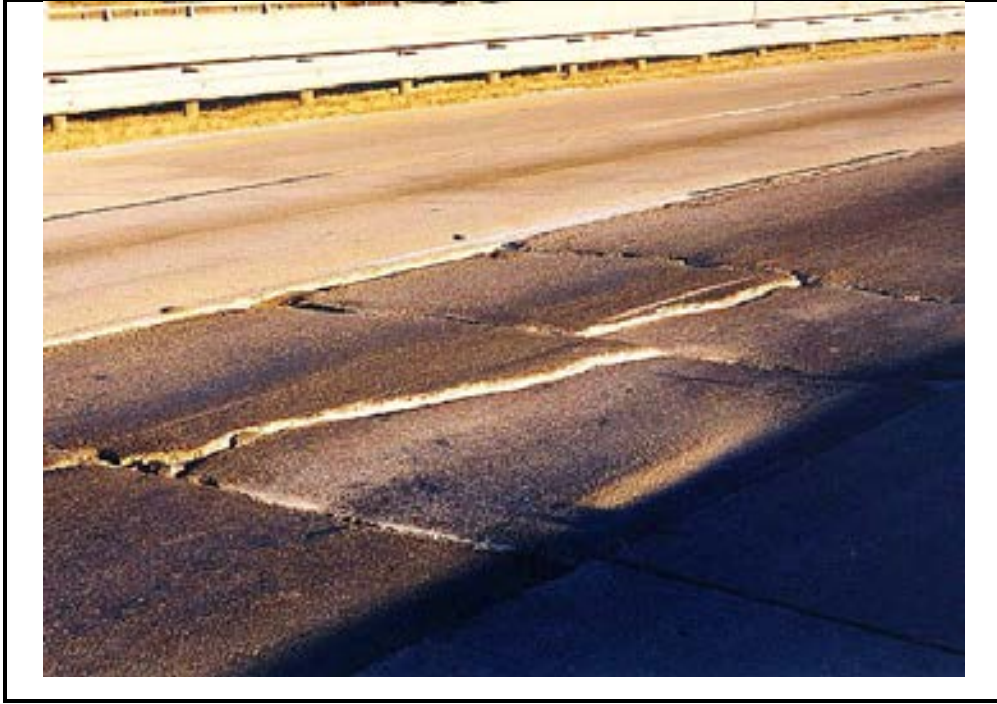
Severity Level:	Low--	Cracks defining the shattered area are tight [less than 1/8 inch (3mm) in width] with little or no spalling. There is no faulting of the shattered area.
	Medium--	Crack width greater than 1/8 inch (3 mm) with some spalling. Moderate distortion which does effect ride quality somewhat.
	High--	Severe distortion and poor ride quality over the shattered area.
Extent Level:	Occasional--	Less than 2 shattered slab areas/mile (per 1.6 km) of section length.
	Frequent--	Between 2 and 5 shattered slab areas/mile (per 1.6 km) of section length.
	Extensive--	More than 5 shattered slab areas/mile (per 1.6 km) of section length.

Photo B-13. Shattered Slab of Composite Pavement, High Severity

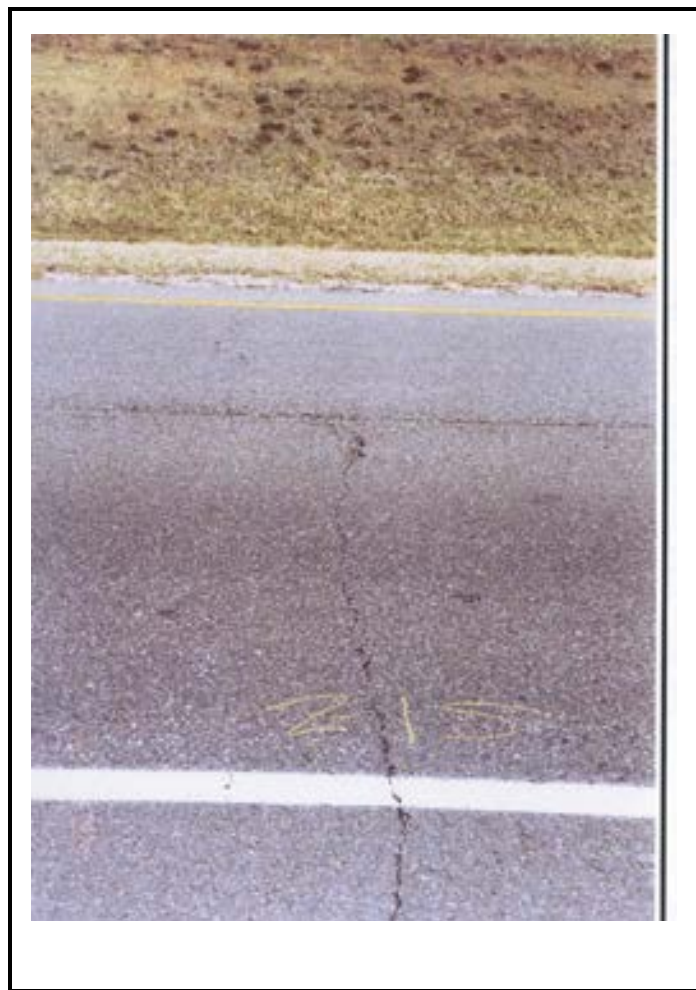
Photo B-15. Unjointed Base, Transverse Cracking in Composite Pavement, Low Severity

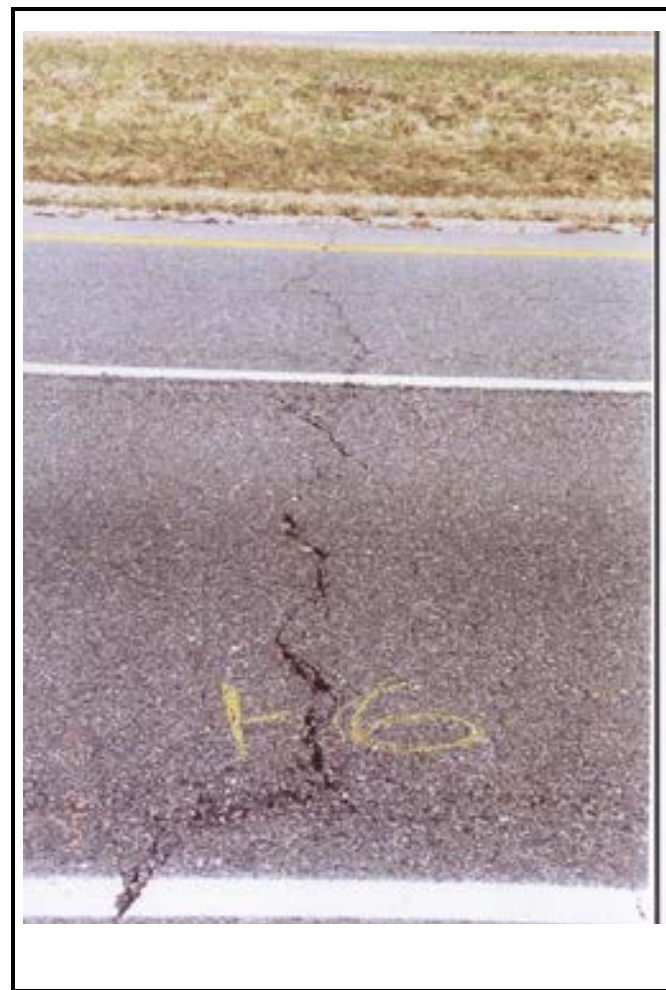
High-- Crack opened or spalled to a width greater than 1 inch (25 mm) over at least one half its length.

Photo B-16. Unjointed Base, Transverse Cracking in Composite Pavement, High Severity

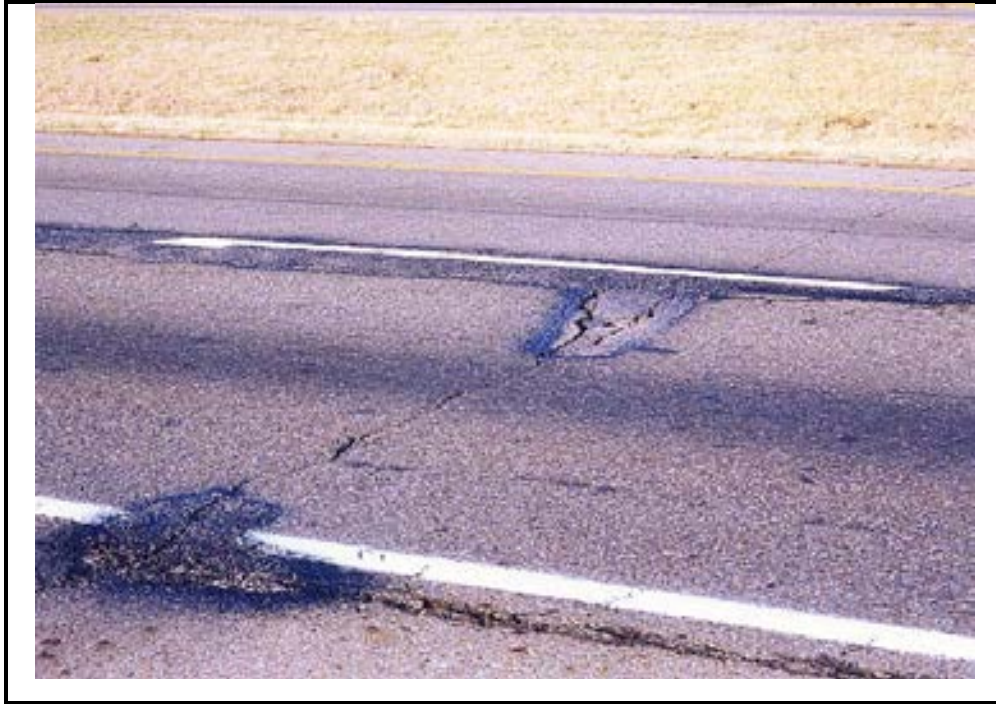
Photo B-17. Jointed Base, Reflection Cracking in Composite Pavement, Medium Severity

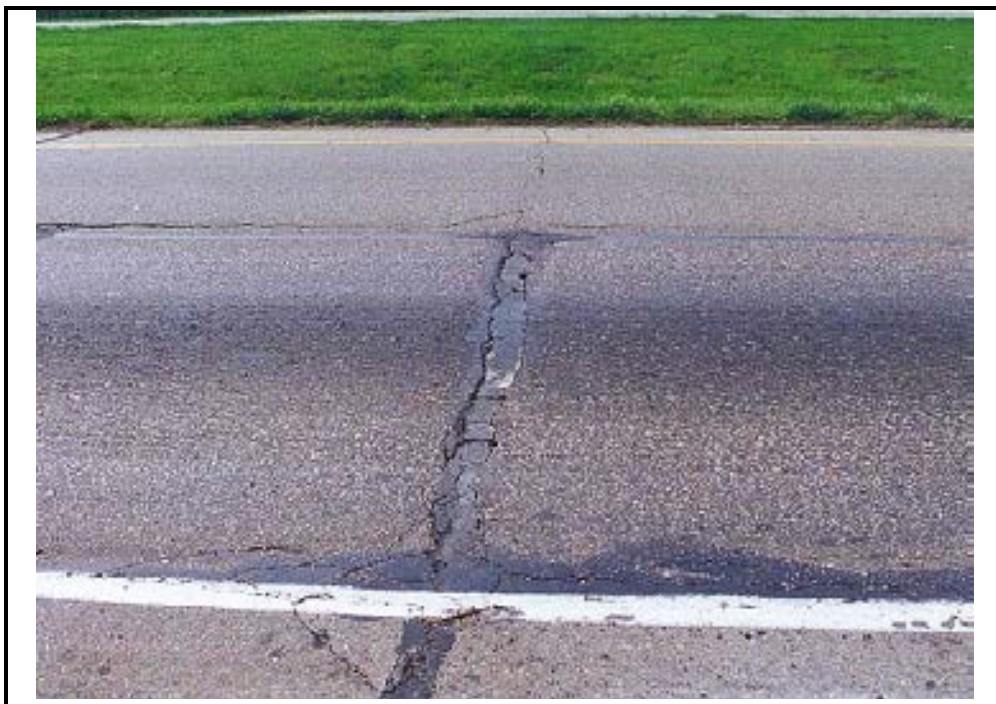
Photo B-18. Jointed Base, Reflection Cracking in Composite Pavement, High Severity

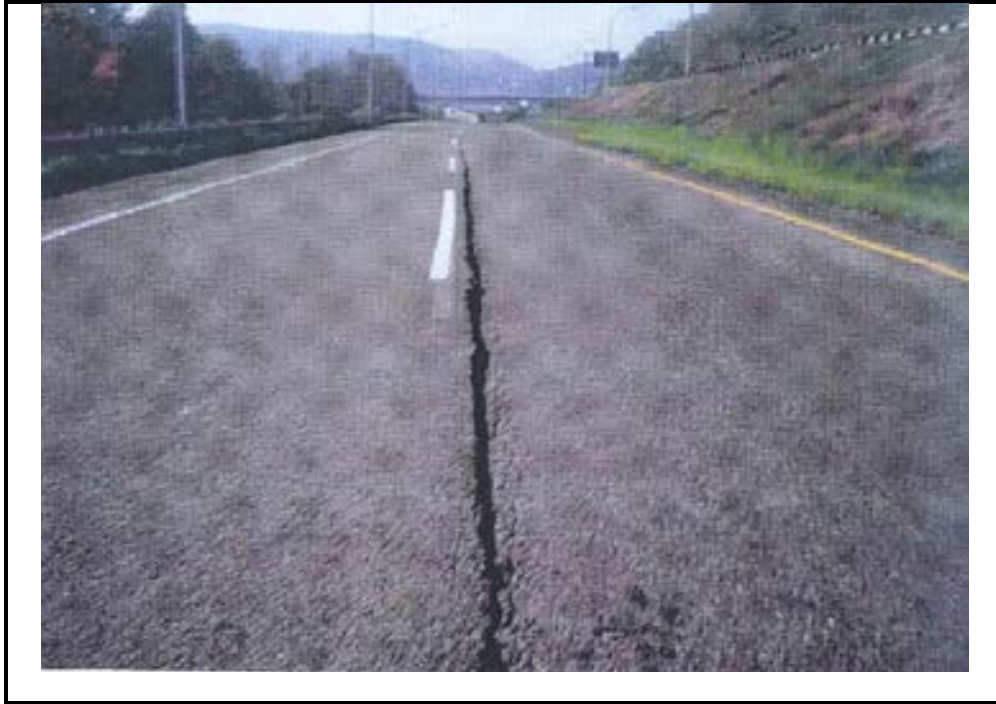
Extensive-- More than 150 feet per station (45 m/30 m). Complete reflective longitudinal cracking along the pavement centerline and edge [200 linear feet per station (60 linear m/ 30 m)] is termed extensive.

**Photo B-19. Longitudinal Cracking in Composite Pavement,
High Severity**

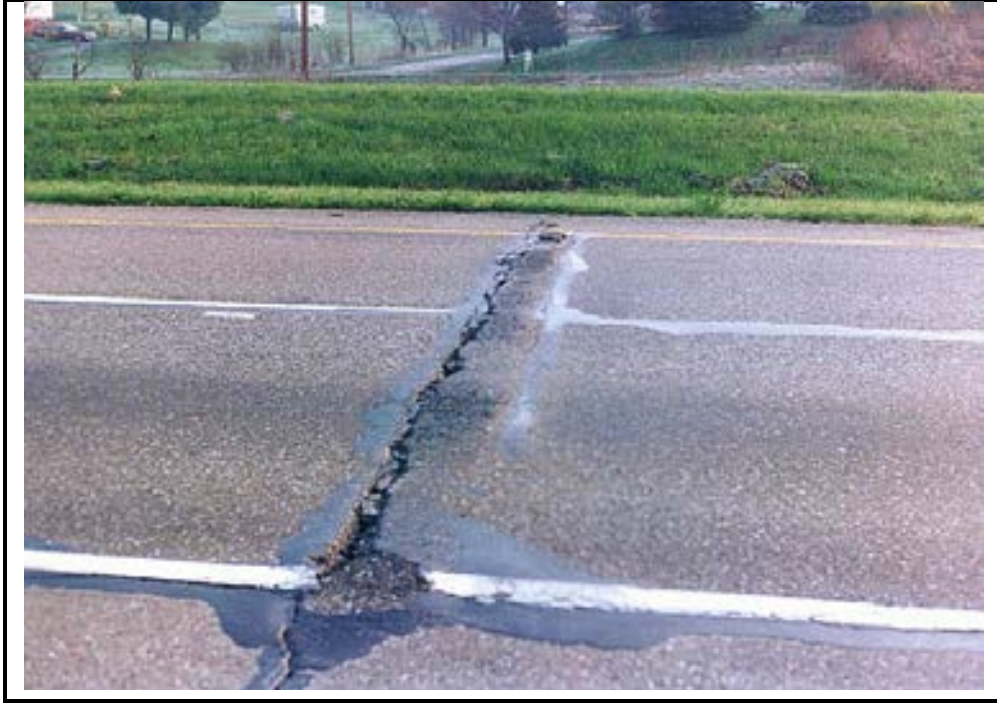
Distress Type:	Pressure Damage/Upheaval	
Description:	Upheaval is a bump or hump in the pavement surface at a transverse joint or crack. The upheaval is a result of thermal expansion in the underlying concrete base creating compressive forces.	
Severity Level:	Low--	Bump height less than ½ inch (13 mm), barely noticeable effect upon ride.
	Medium--	Bump height ½ to 1 inch (13 to 25 mm) with a readily noticeable effect upon ride quality.
	High--	Bump height greater than 1 inch (25 mm) severely reducing ride quality.
Extent Level:	Occasional--	Less than 5 upheavals/mile (per 1.6 km).
	Frequent--	Between 5 and 10 upheavals/mile (per 1.6 km).
	Extensive--	Greater than 10 upheavals/mile (per 1.6 km).

**Photo B-20. Pressure Damage/Upheaval in Composite Pavement,
Medium Severity**

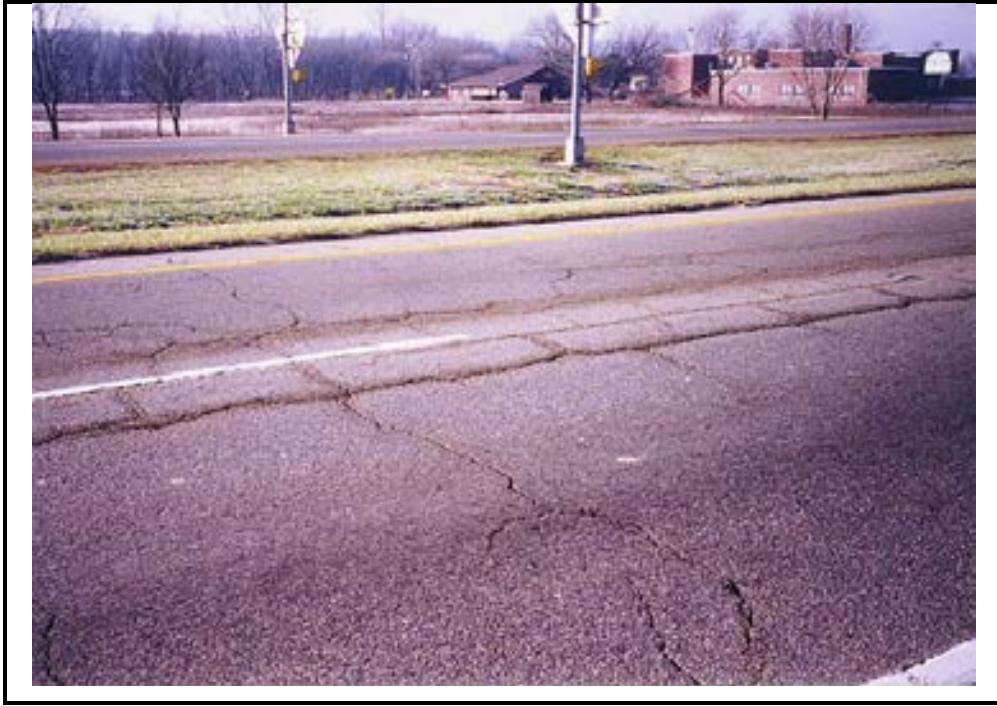
Occasional—	Less than 50% of existing cracks are no longer effectively sealed.
Frequent—	More than 50% of existing cracks are no longer effectively sealed.
Extensive—	None of the existing cracks have been sealed, there is no sealant on the roadway.

Photo B-21. Crack Sealing Deficiency in Composite Pavement, Unsealed Cracks

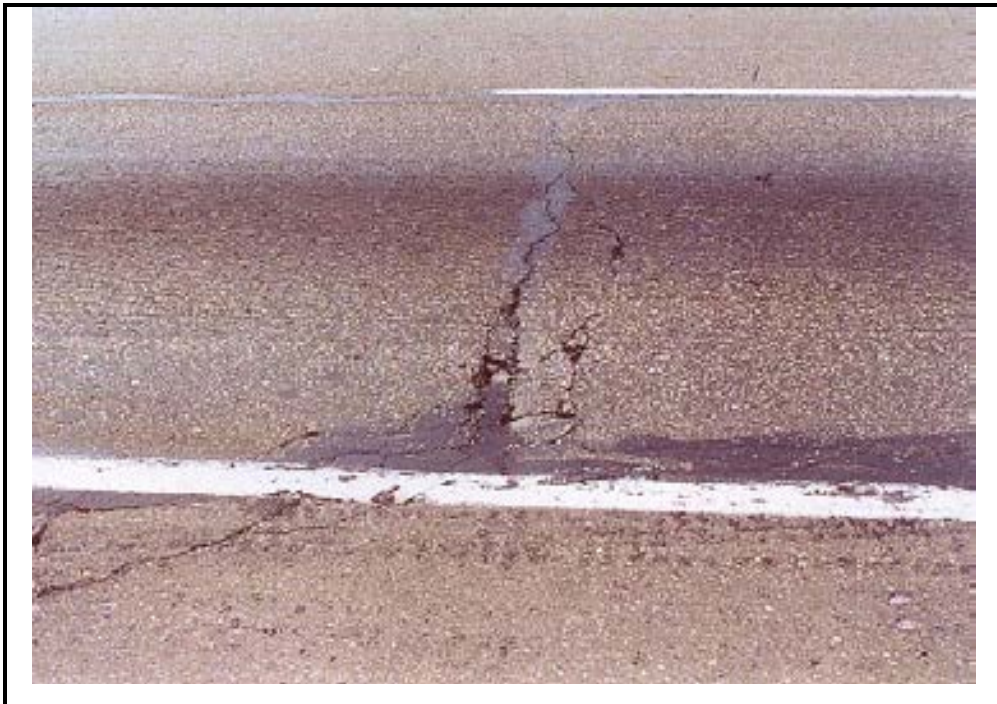
Photo B-22. Crack Sealing Deficiency in Composite Pavement, Cracks not sealed properly

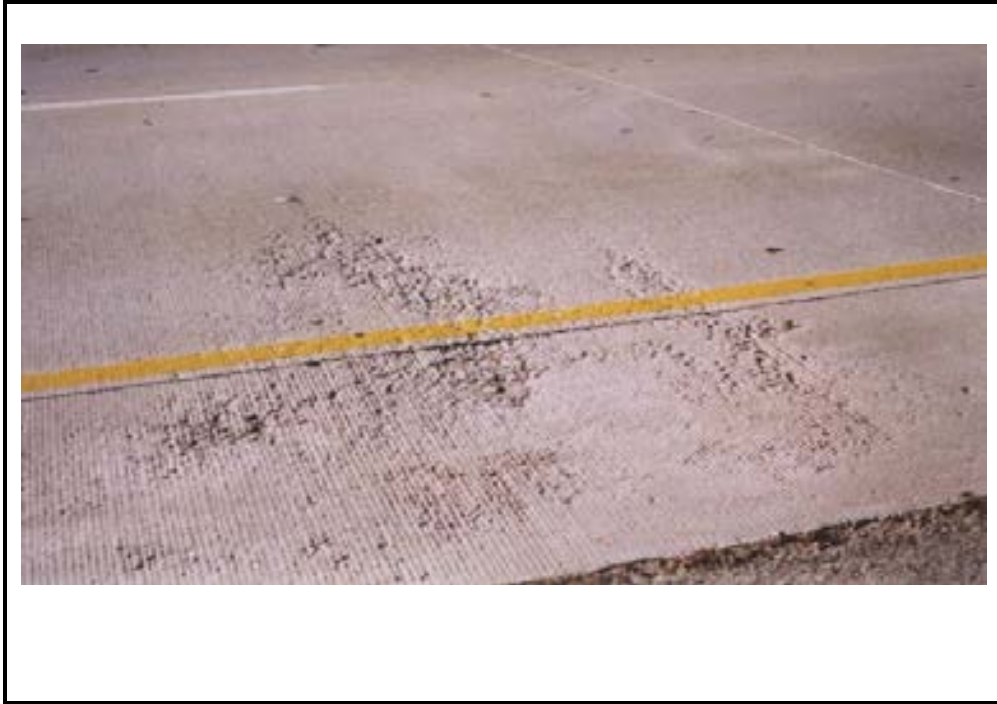
Severity Level:	Low--	Very little aggregate is visible, or some popouts, or high steel.
	Medium--	Surface has an open texture and is moderately rough with considerable loss of fine aggregate and some coarse aggregate removed.
	High--	Surface rough or pitted.
Extent Level:	Occasional--	Less than 20 percent of the surface area affected; less than 2 high steel/mile (per 1.6 km) if high steel is the only deterioration present.
	Frequent--	Between 20 to 50 percent of the surface area affected; between 2 and 4 high steel/mile (per 1.6km) if high steel is the only deterioration present.
	Extensive--	Equal to or greater than 50 percent of the surface area affected (this level includes continuous distress in both wheel tracks); greater than 4 high steel/mile (per 1.6km) if high steel is the only deterioration present.

Photo C-1. Surface Deterioration in Jointed Concrete Pavement, Medium Severity

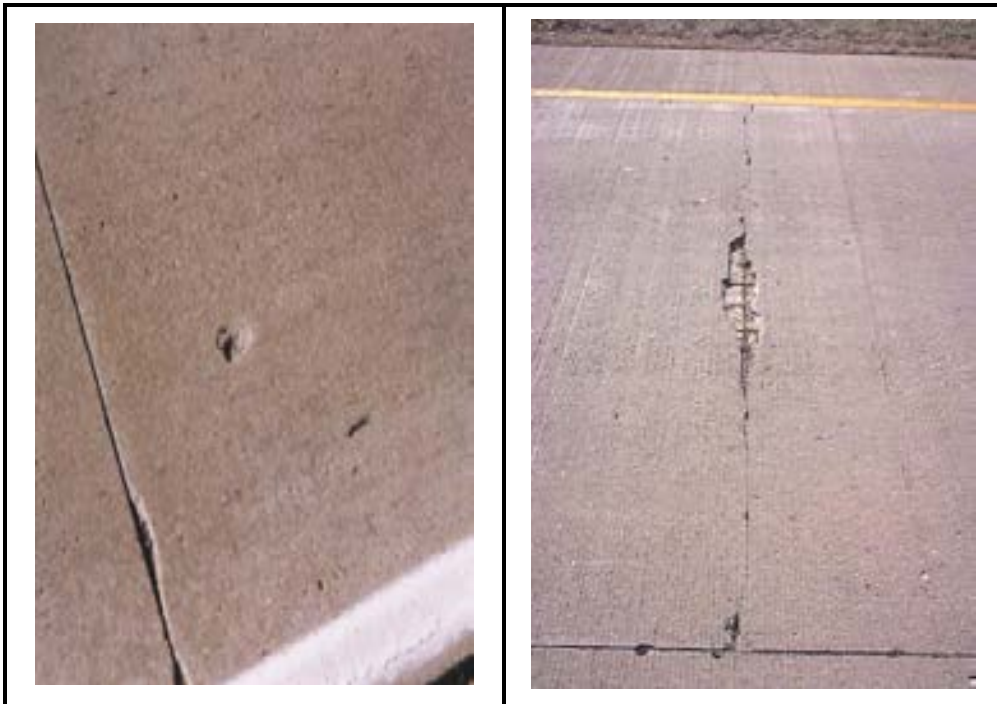
Photo C-2. Surface Deterioration in Jointed Concrete Pavement, Popouts and High Steel

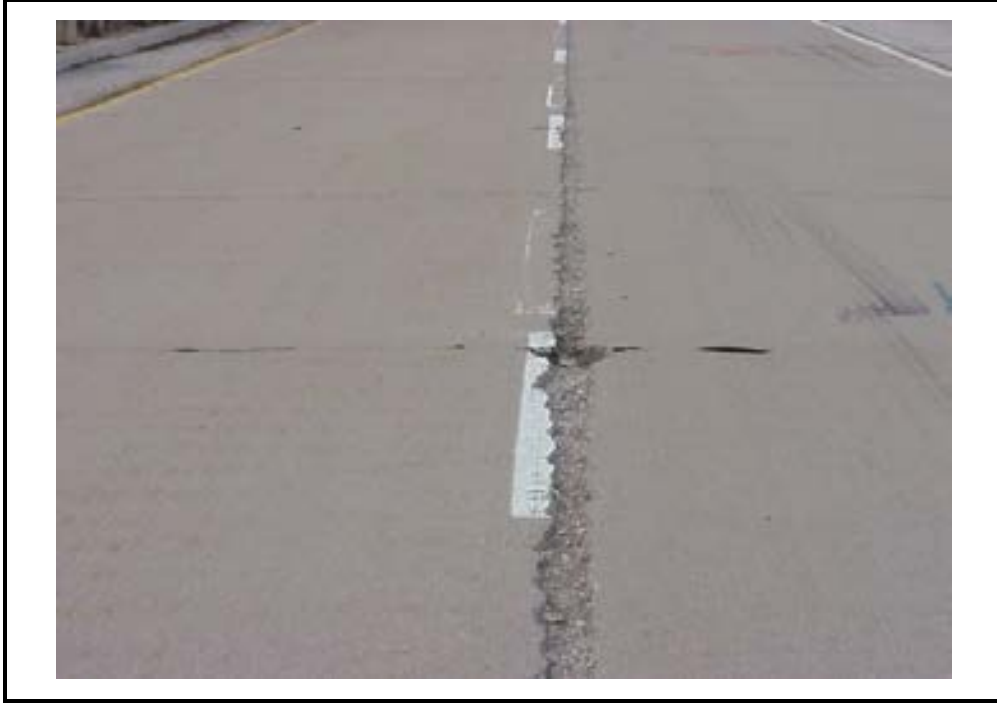
Photo C-3. Longitudinal Joint Spalling in Concrete Pavement, High Severity

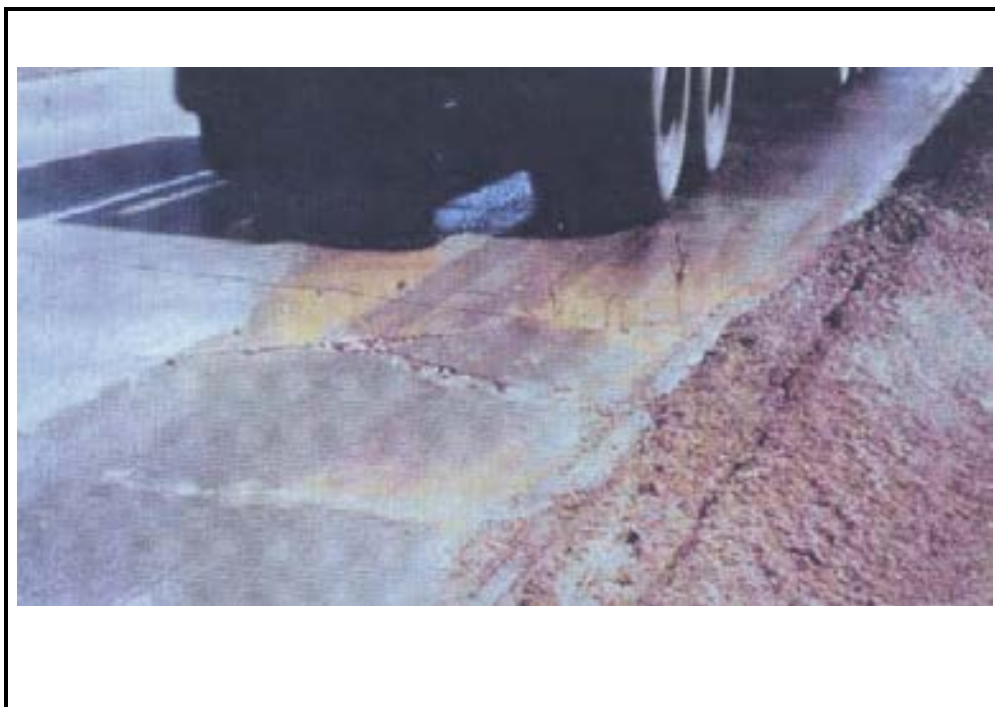
Photo C-6. Pumping in Jointed Concrete Pavement, High Severity

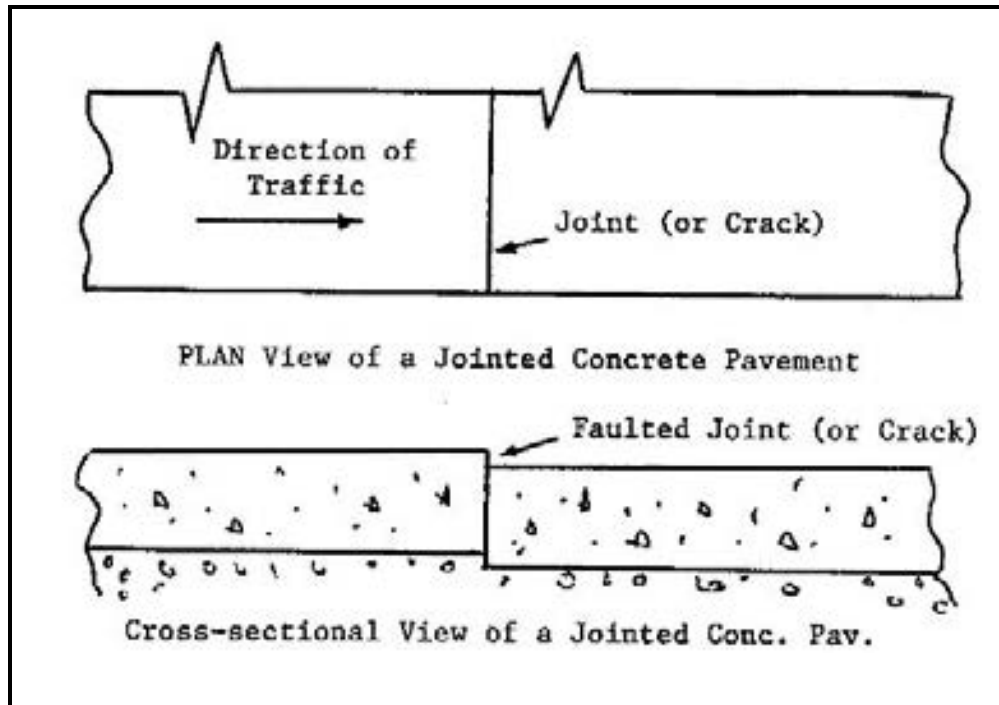
Photo C-8. Sketch showing Faulting in Jointed Concrete Pavement
