PAVEMENT CONDITION RATING SYSTEM

The Ohio Department of Transportation
Office of Pavement Engineering
1980 West Broad Street
Columbus, OH 43223

April 2006

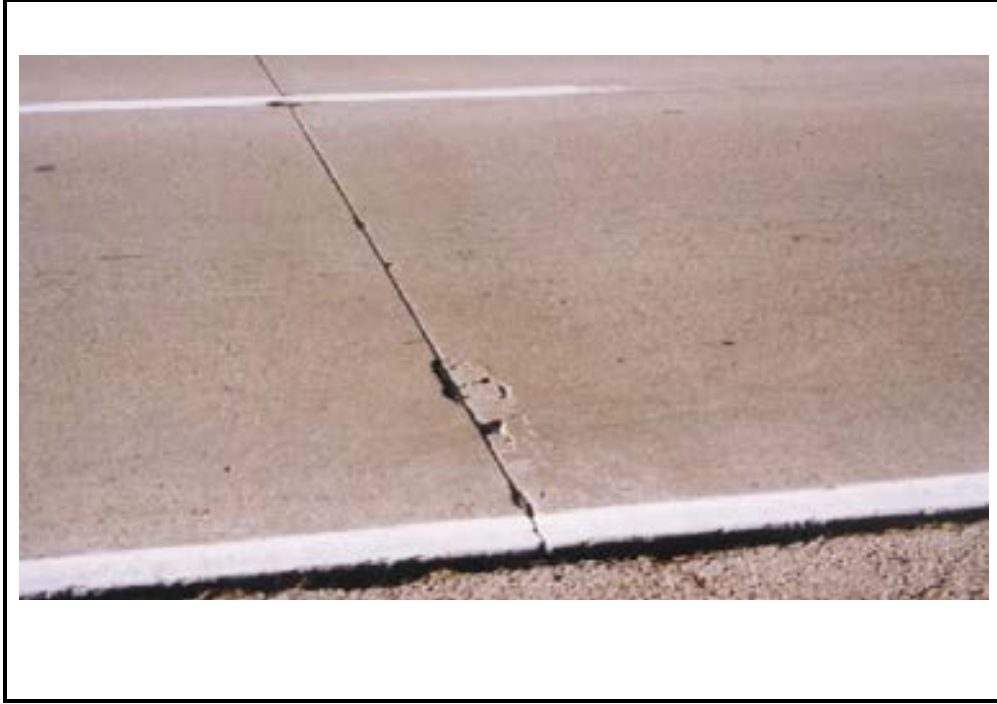
Severity Level:	Low--	Spalls less than 4 inches (100 mm) wide, measured to the center of the joint, with loss of material, or spalls with no loss of material and no patching.
	Medium--	Spalls 4 to 9 inches (100 mm to 225 mm) wide, measured to the center of the joint, with loss of material.
	High--	Spalls greater than 9 inches (225 mm) wide, measured to the center of the joint, with loss of material.
Extent Level:	Occasional--	Less than 25 percent of the transverse joints are spalled.
	Frequent--	Between 25 and 75 percent of the transverse joints are spalled.
	Extensive--	More than 75 percent of the transverse joints are spalled.

Photo C-11. Transverse Joint Spalling in Jointed Concrete Pavement, Low Severity

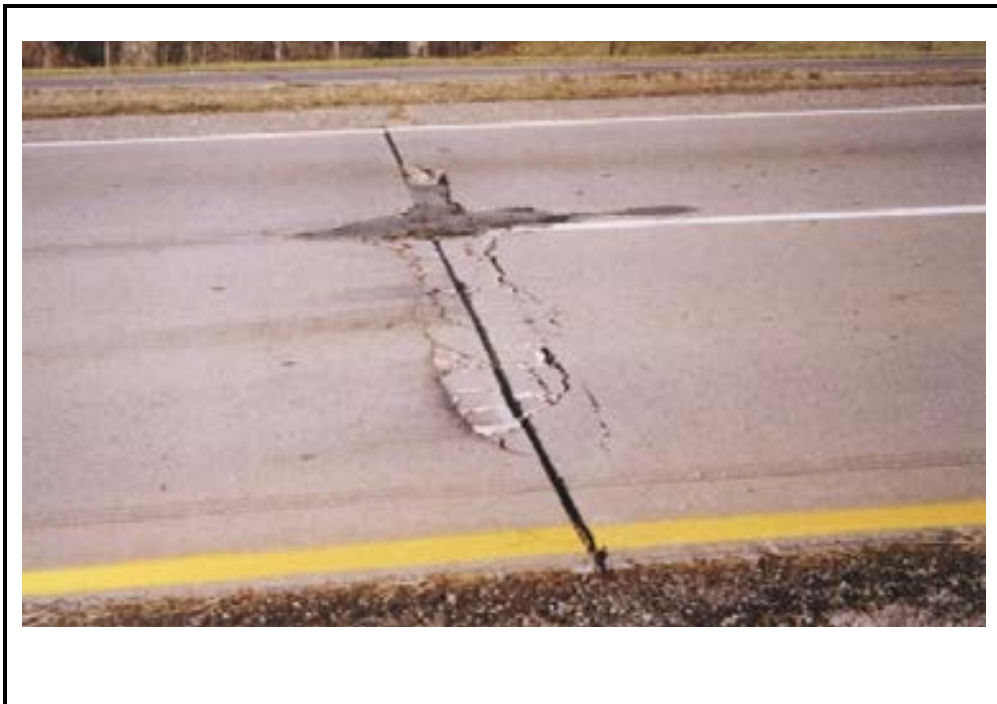
Photo C-12. Transverse Joint Spalling in Jointed Concrete Pavement, High Severity

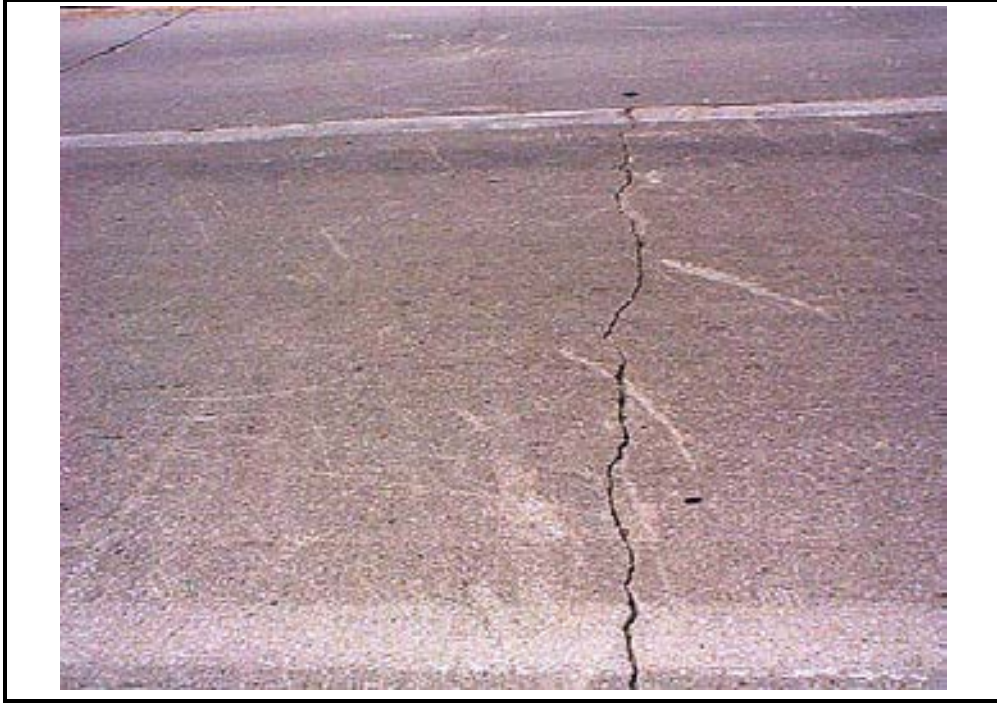
Severity Level:	Low--	Hairline crack.
	Medium--	Crack width is larger than hairline, but less than 3/16 inches.
	High--	Crack width is greater than 3/16 inch.
Extent Level:	Occasional--	Less than 10 percent of the slabs are cracked at any severity.
	Frequent--	Between 10 and 30 percent of the slabs are cracked at any severity.
	Extensive--	Greater than 30 percent of the slabs are cracked at any severity.

**Photo C-13. Transverse Cracking - Plain Concrete in Jointed Concrete Pavement,
Medium Severity**

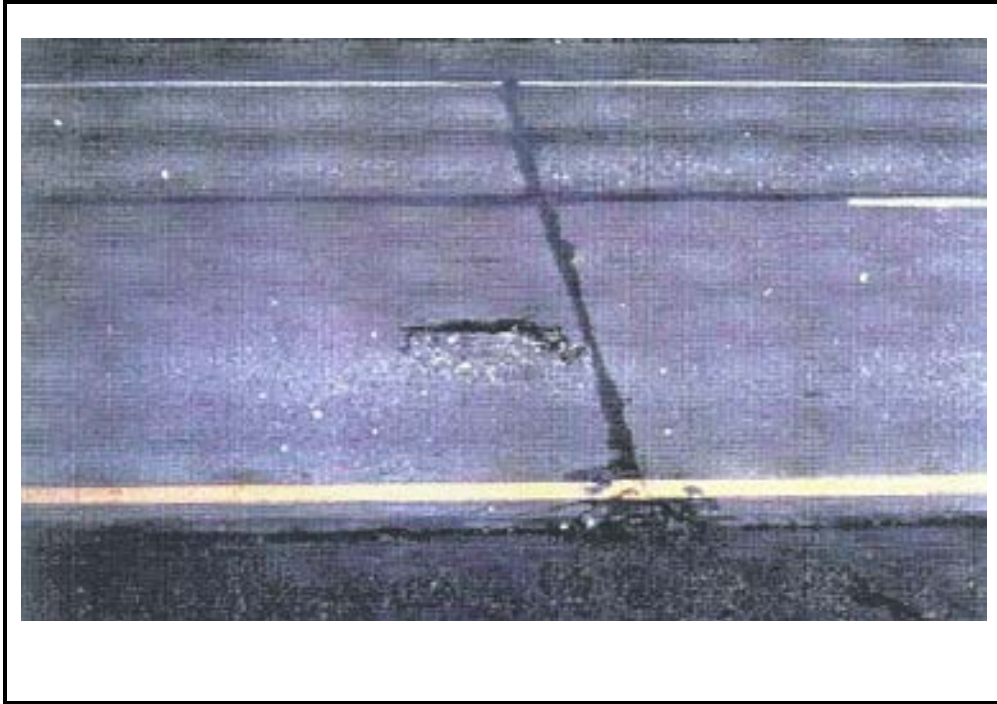
Photo C-14. Pressure Damage in Jointed Concrete Pavement

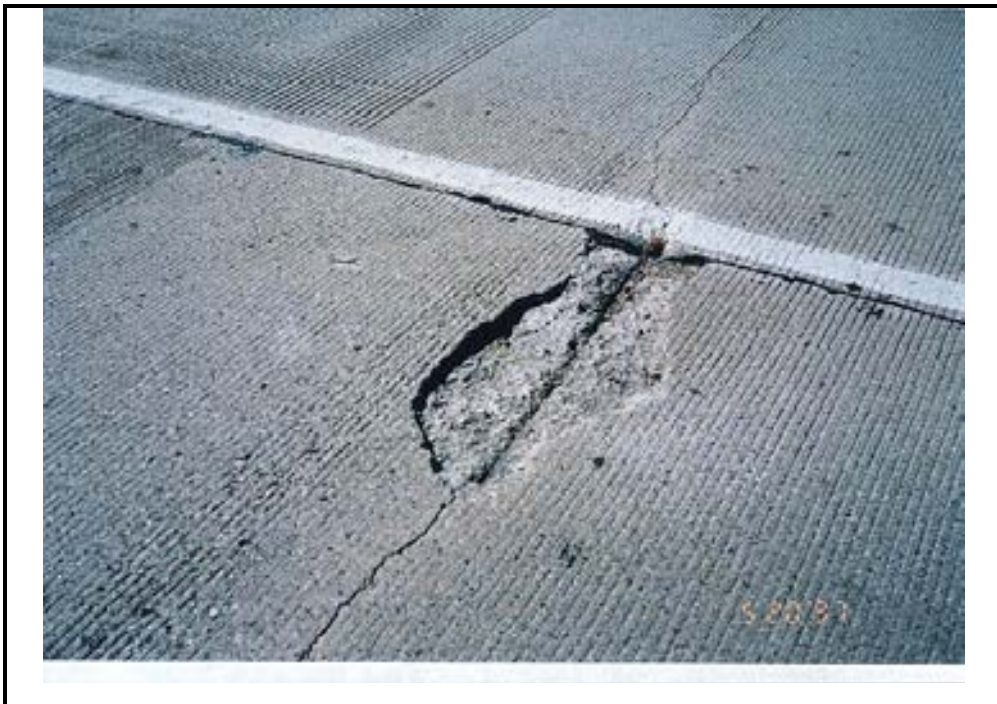
Photo C-15. Pressure Damage in Jointed Concrete Pavement

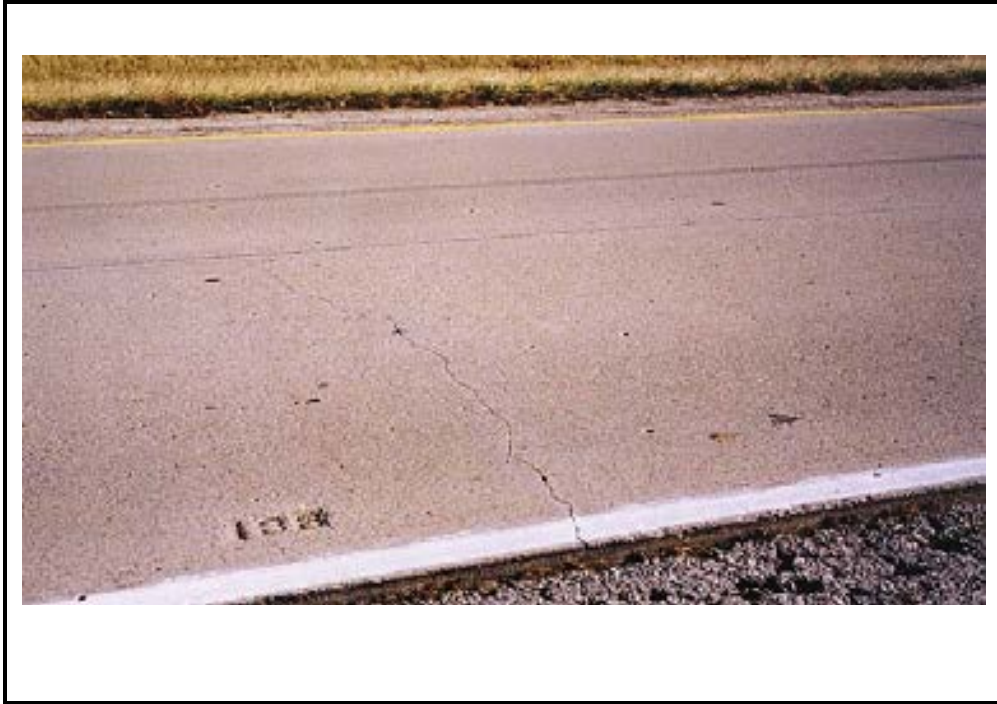
Photo C-16. Transverse Cracking in Jointed Concrete Pavement, Low Severity

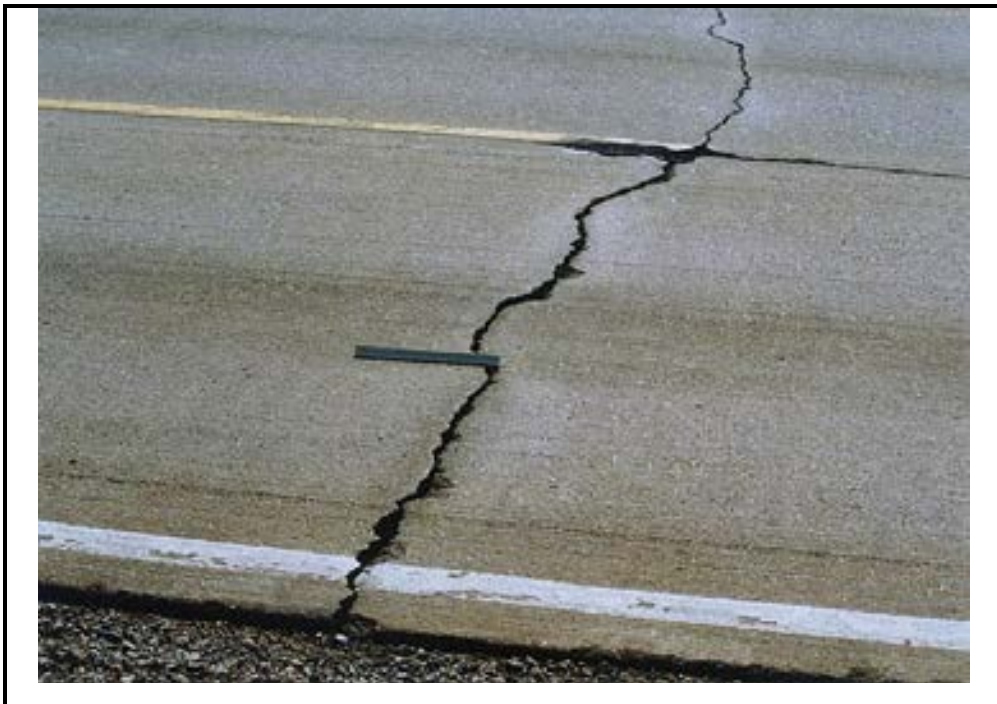
Photo C-17. Transverse Cracking in Jointed Concrete Pavement, High Severity

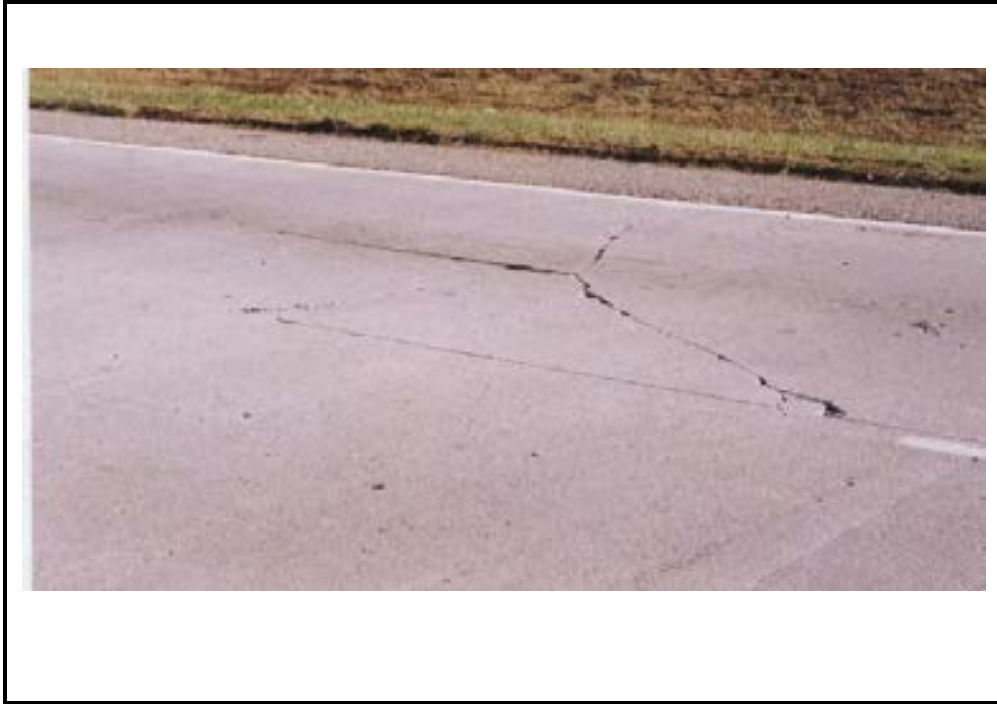
Photo C-18. Longitudinal Cracking in Jointed Concrete Pavement, Medium Severity

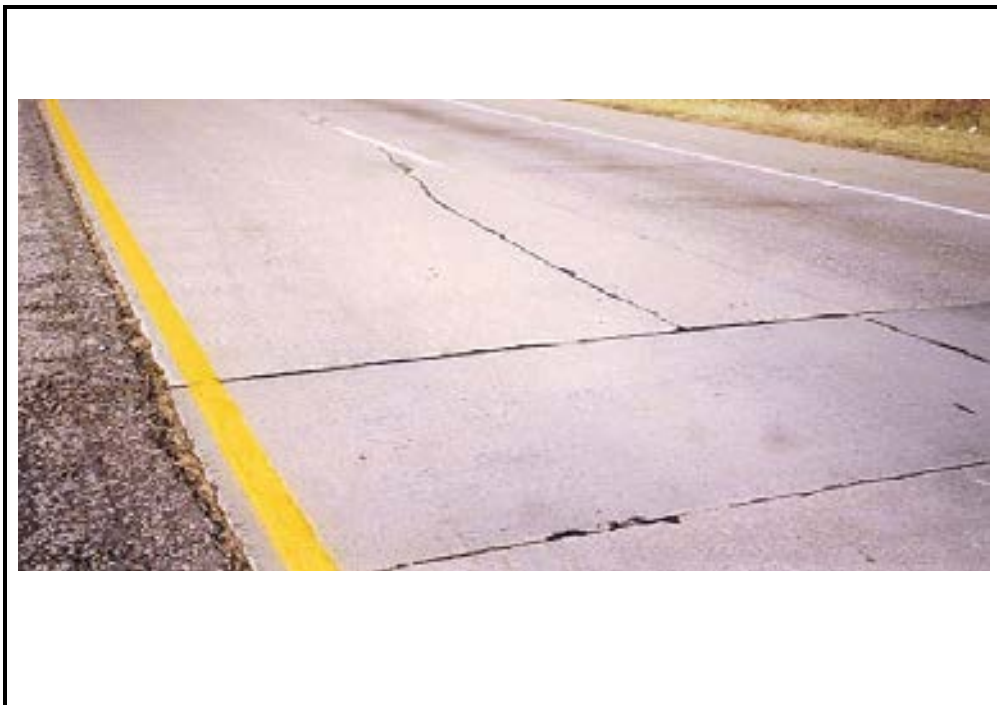
Photo C-19. Longitudinal Cracking in Jointed Concrete Pavement, Medium Severity

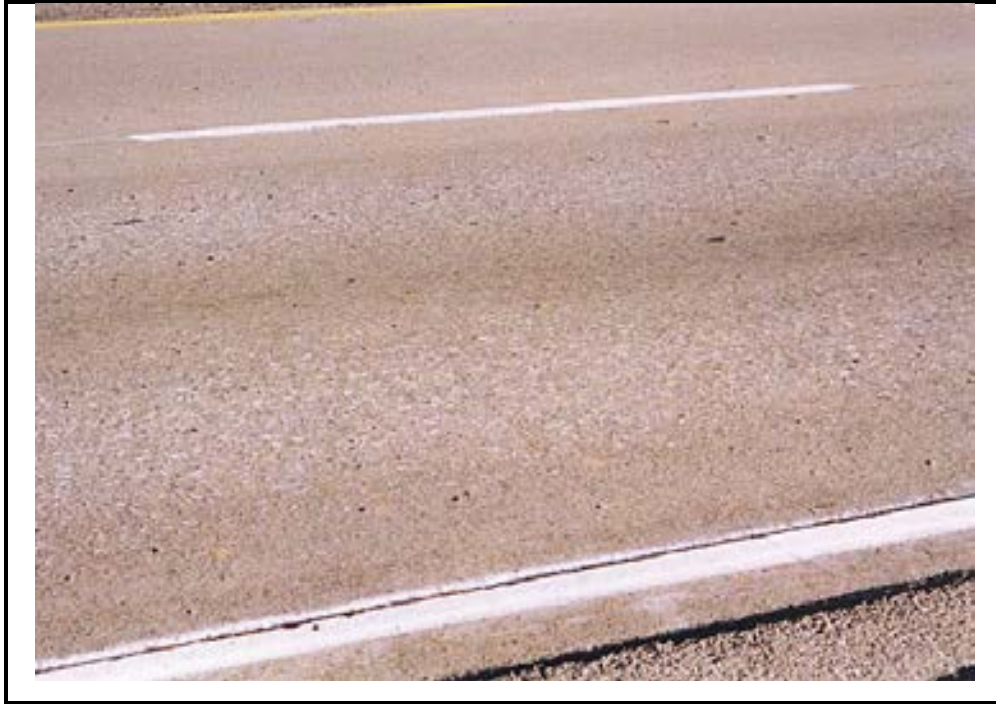
Photo D-1. Surface Deterioration in CRC Pavement, Medium Severity

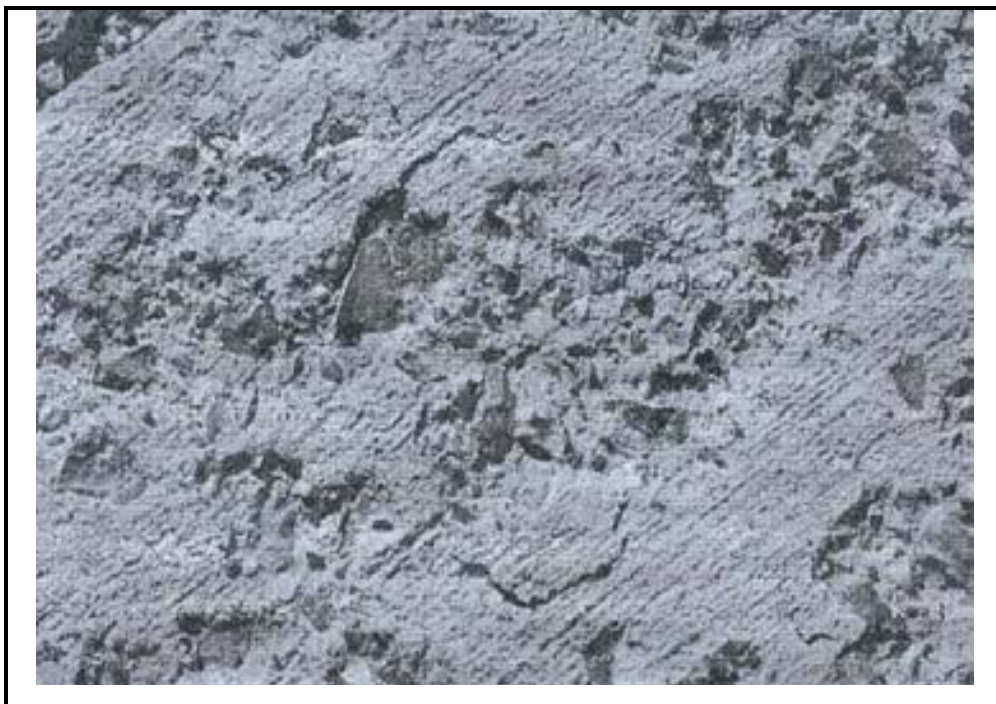
Photo D-2. Surface Deterioration in CRC Pavement, High Severity

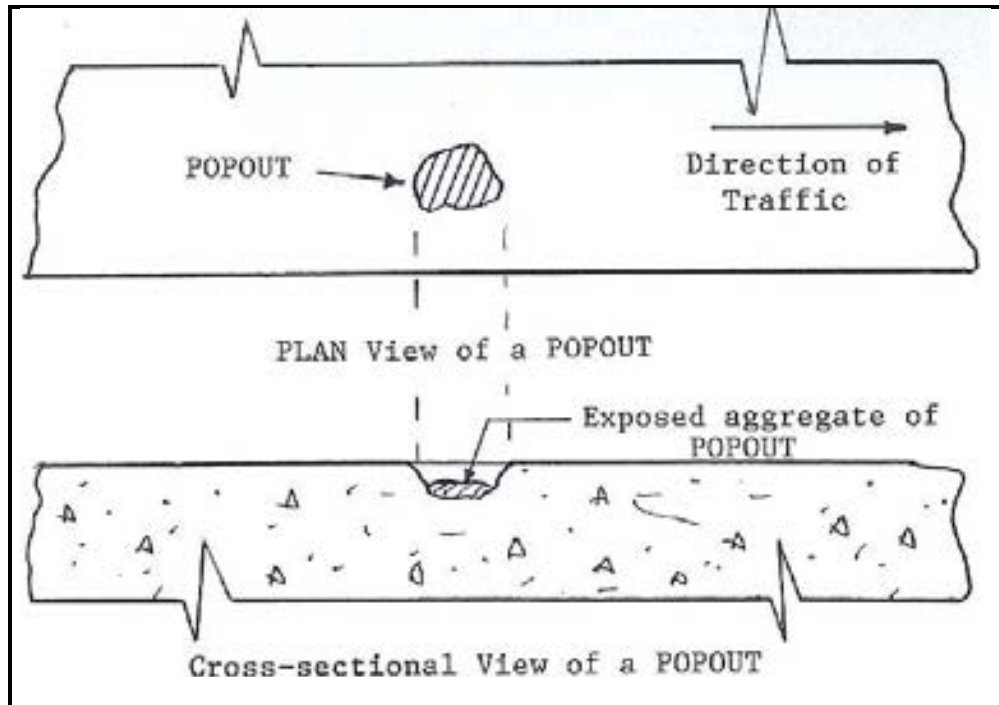
Distress Type:	Popouts
Description:	Cone shaped holes in the pavement surface with aggregates at the bottom and unrelated to joint or crack spalling. Aggregate quality is related to this type of distress. Popouts usually range from 1 to 4 inches (25 to 100 mm) in diameter and from ½ to 2 inches (13 to 50 mm) in depth.
Severity Level:	Severity levels are not considered.
Extent Level:	Occasional-- Less than 20 percent of the area is affected. Frequent-- Between 20 and 50 percent of the area is affected. Extensive-- More than 50 percent of the area is affected.

Photo D-3. Popout in CRC Pavement, Plan and Cross-section Views

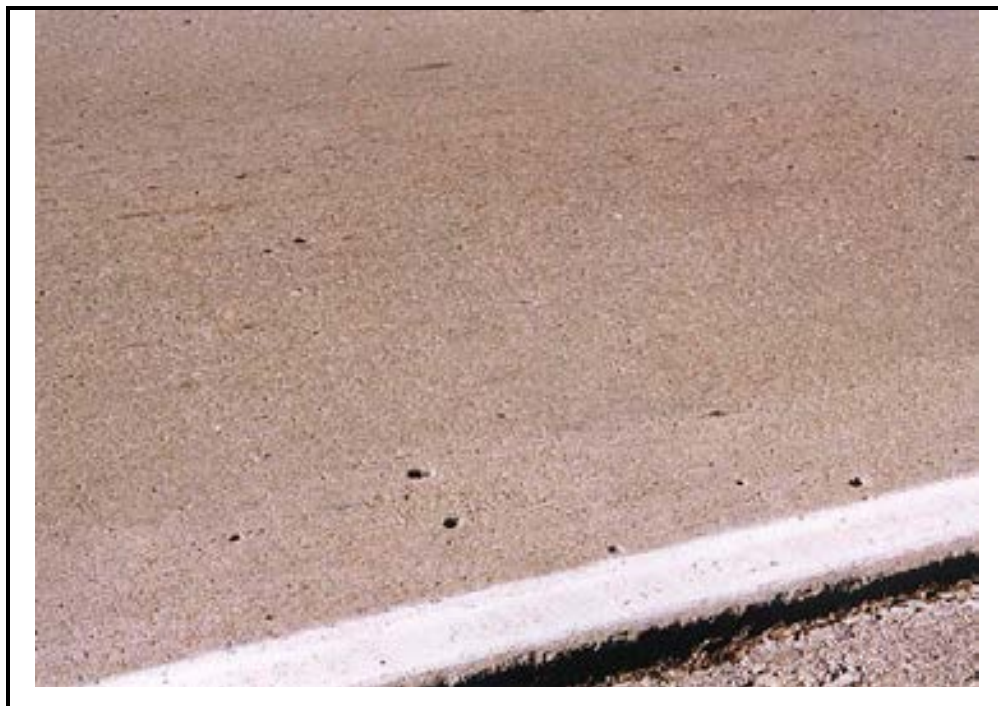
Photo D-4. Popouts in CRC Pavement

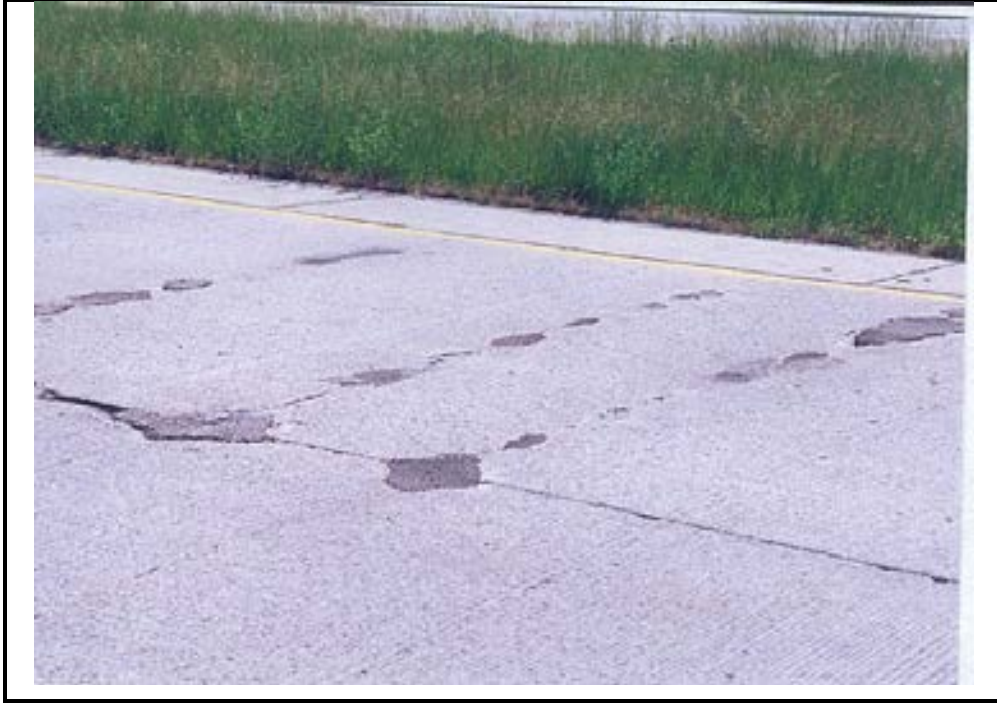
Severity Level:	Low--	Patch size <1 sq. ft. (0.1 m ²), and patches are not deteriorated.
	Medium--	Patch size <1 sq. ft. (0.1 m ²)., with deterioration present.
	High--	Patch size >1 sq. ft.(0.1 m ²), regardless of deterioration.
Extent Level:	Occasional--	<10 patches/mile (per 1.6 km).
	Frequent--	10 to 20 patches/mile (per 1.6 km).
	Extensive--	>20 patches/mile (per 1.6 km).

Photo D-5. Patching in CRC Pavement, Low Severity

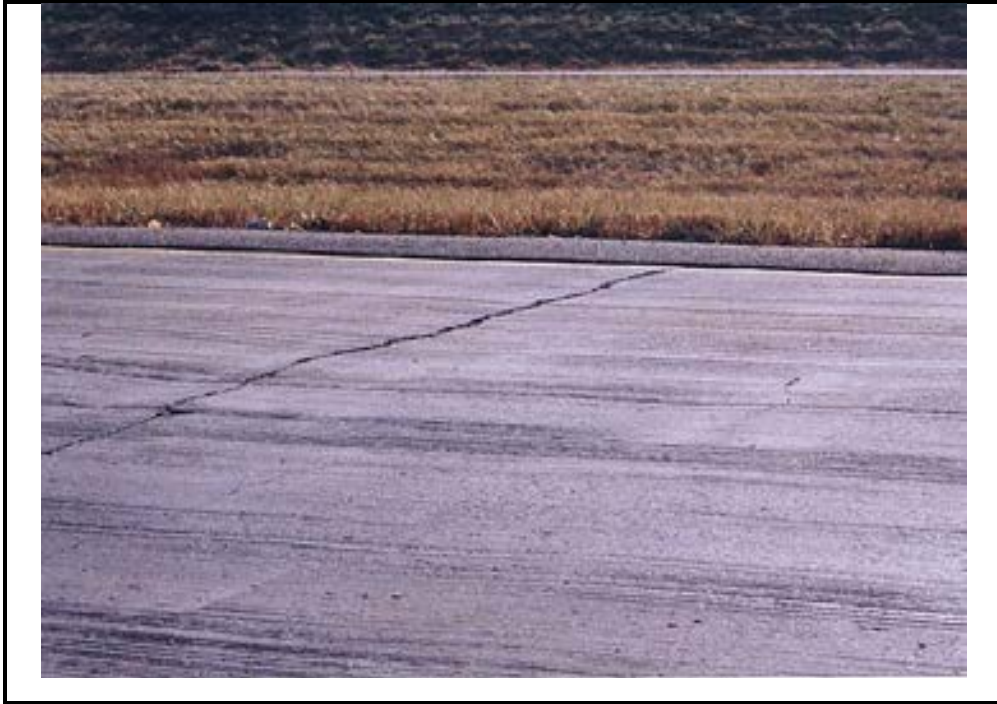
Photo D-10. Transverse Cracks in CRC Pavement, Low Severity

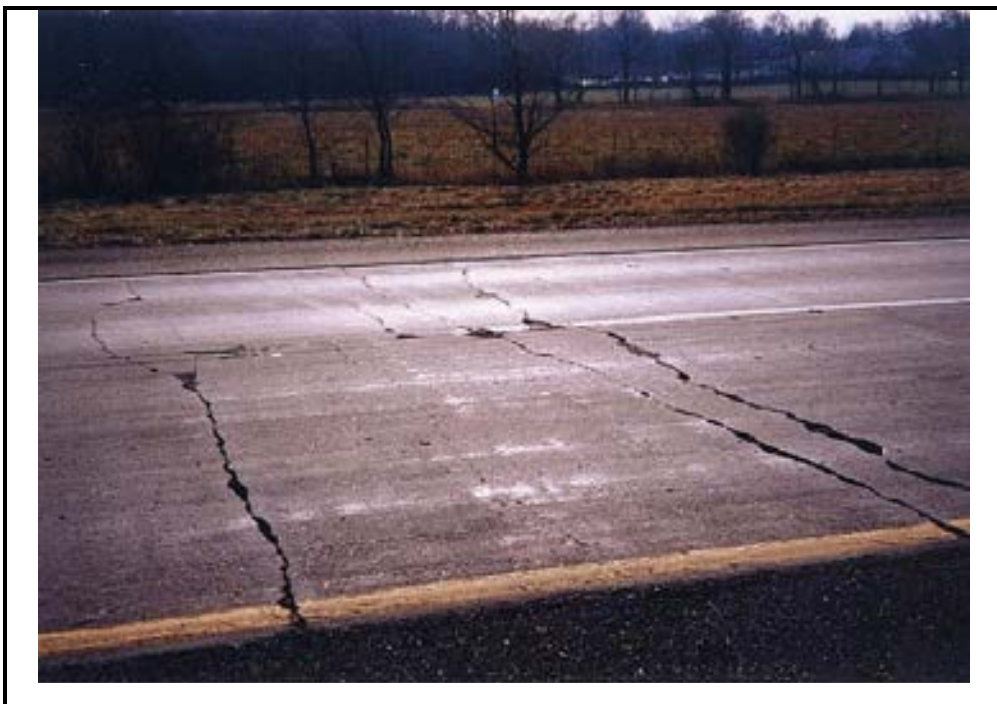
Photo D-11. Transverse Cracks in CRC Pavement, Medium Severity

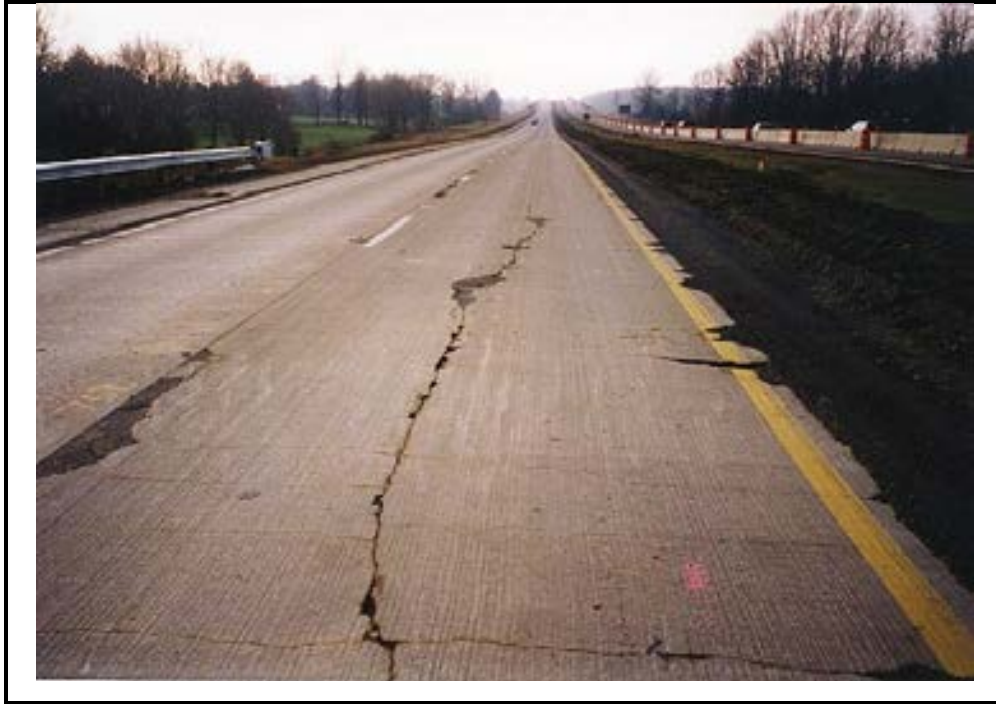
Severity Level:	Low--	Hairline or tight cracks with little crack spalling.
	Medium--	Crack opened or spall at the surface to a width of 1/4 inch to 1 inch (6 to 25 mm) over a distance equal to at least one-half the crack length.
	High--	Crack opened or spalled at the surface to a width greater than 1 inch (25 mm) over a distance equal to at least one-half the crack length.
Extent Level:	Occasional--	Longitudinal cracking occurs along less than 5 percent of the section length.
	Frequent--	Longitudinal cracking occurs along from 5 to 15 percent of the section length.
	Extensive--	Longitudinal cracking occurs along more than 15 percent of the section length.

Photo D-12. Longitudinal Cracking in CRC Pavement, Medium Severity

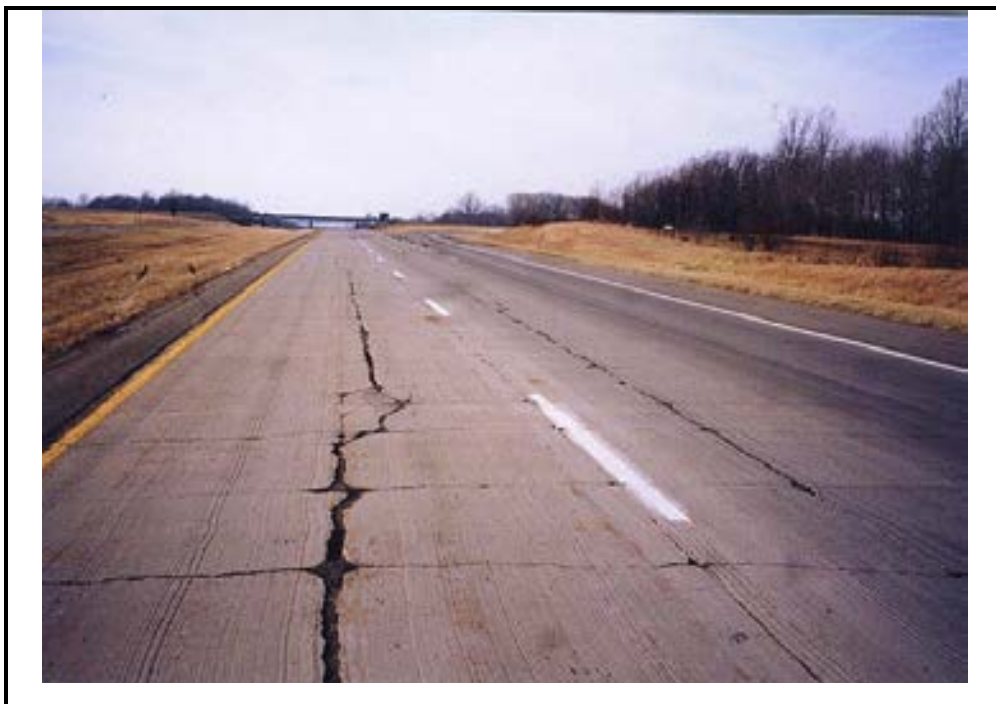
Photo D-13. Longitudinal Cracking in CRC Pavement, High Severity

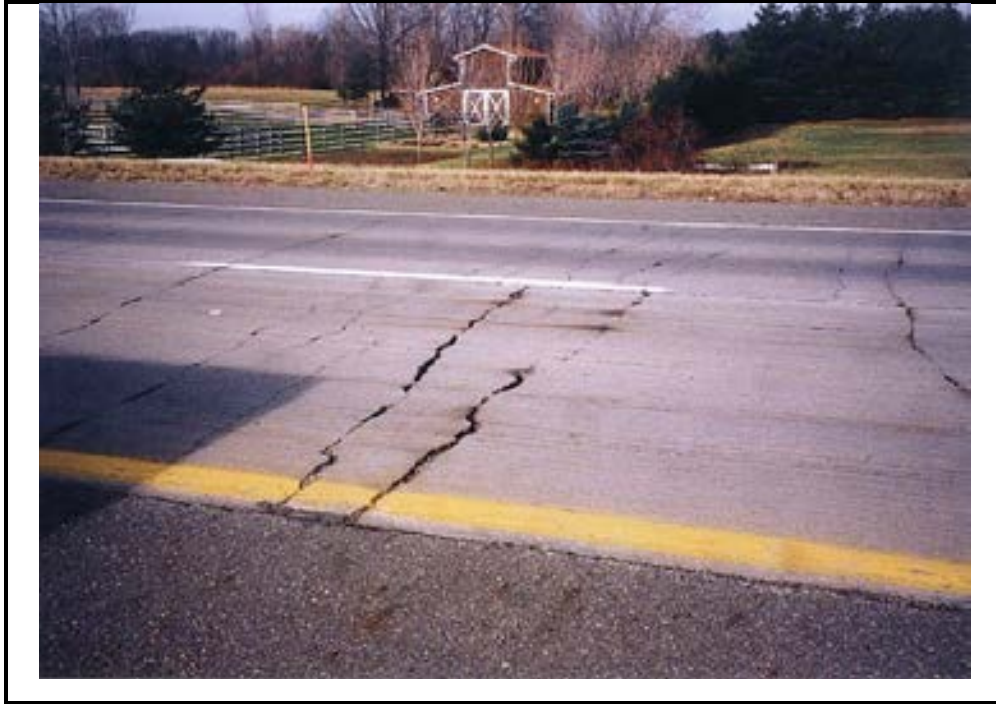
Photo D-16. Spalling in CRC Pavement, Medium Severity

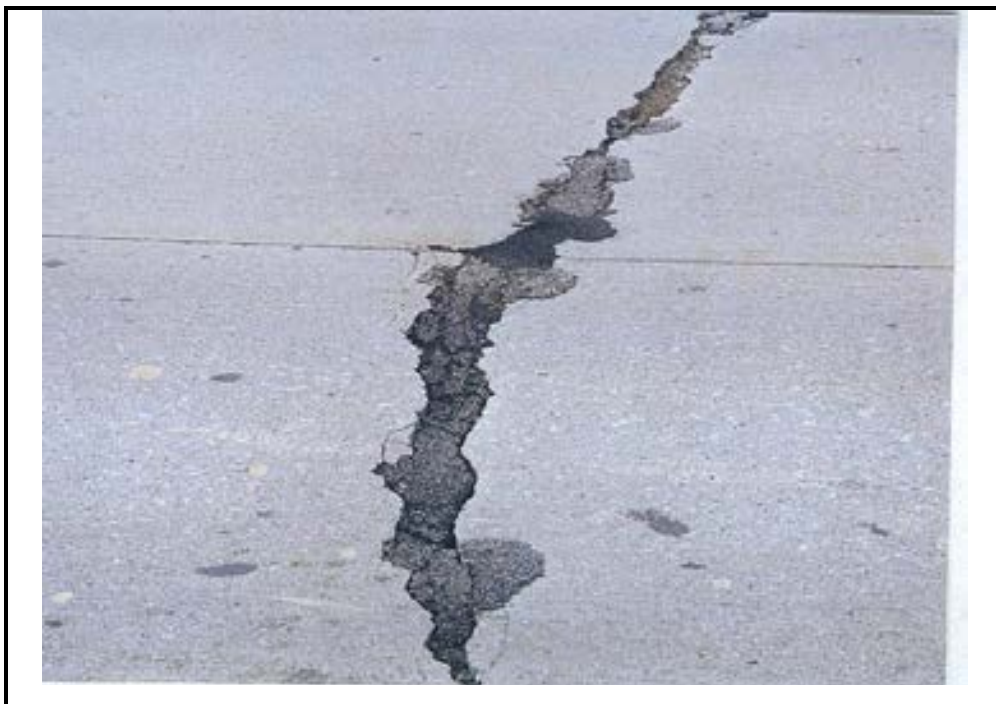
Photo D-17. Spalling in CRC Pavement, High Severity

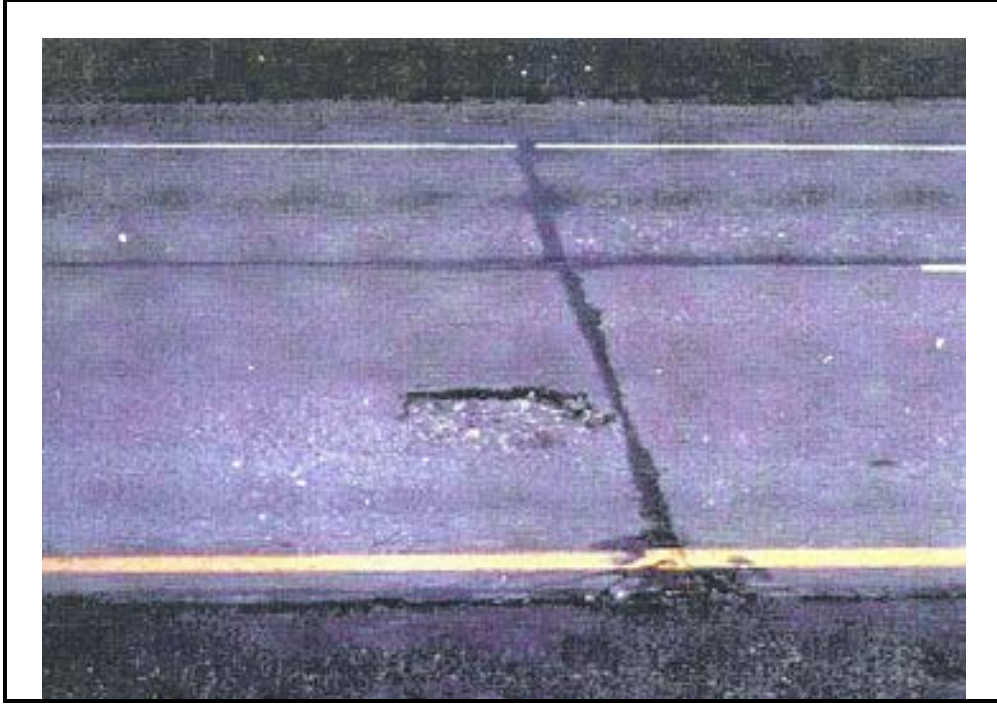
**Photo D-18. An Example of Pressure Damage in Jointed Concrete Pavement .
Pressure Damage in CRCP is similar to as shown above.**

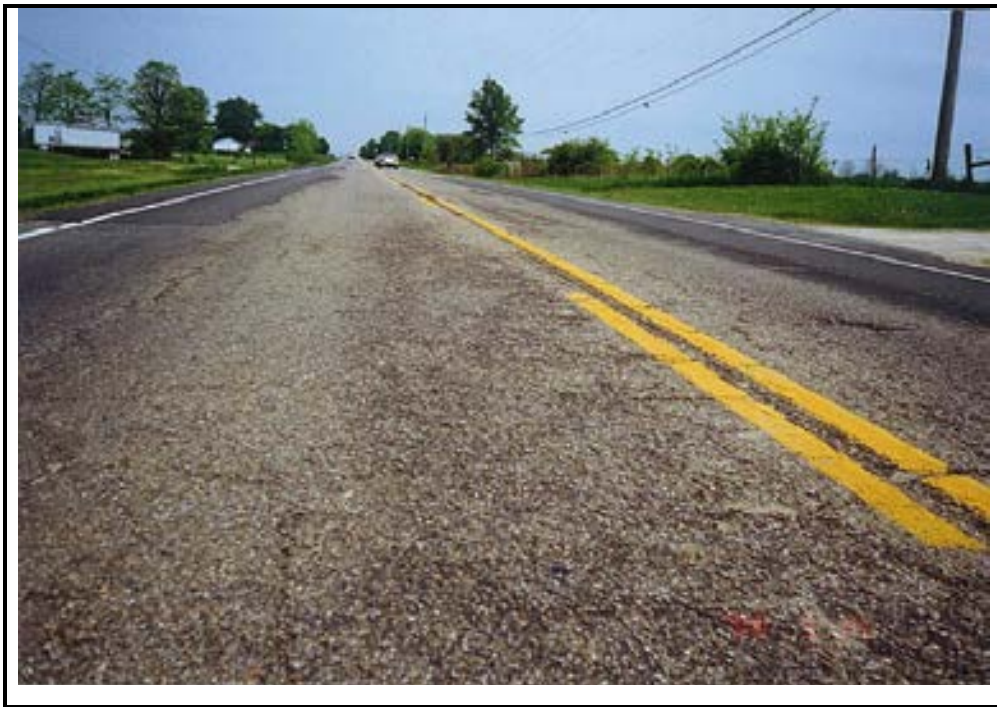
Photo E-2. Raveling in Local Pavement, High Severity

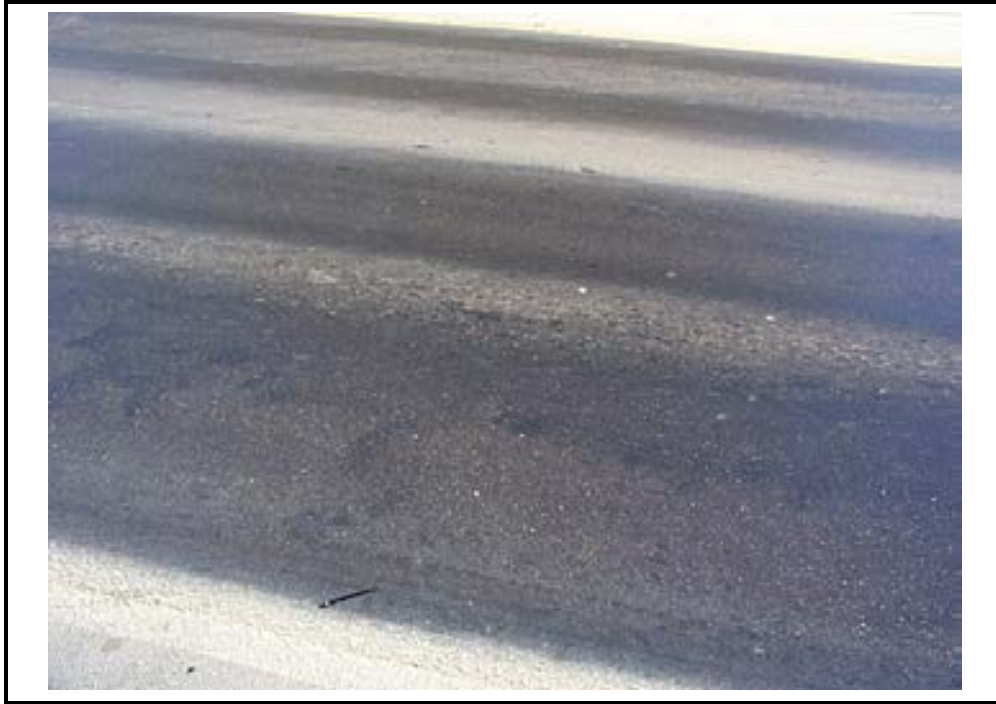
Distress Type:	Bleeding
Description:	Bleeding or flushing is the presence of free asphalt binder on the pavement surface. Bleeding is caused by an excess amount of bituminous binder in the mixture and/or low air void content.
Severity Level:	Only 2 severity levels are defined. Medium-- Both coarse aggregate and free bitumen are noticeable at the pavement surface. High-- Surface appears black with very little aggregate noticeable.
Extent Level:	Occasional-- Less than 10 percent of the length exhibits bleeding. Frequent-- Between 10 and 30 percent of the length is bleeding. Extensive-- Bleeding occurs in more than 30 percent of the length.

Photo E-3. Bleeding in Local Pavement, Medium Severity

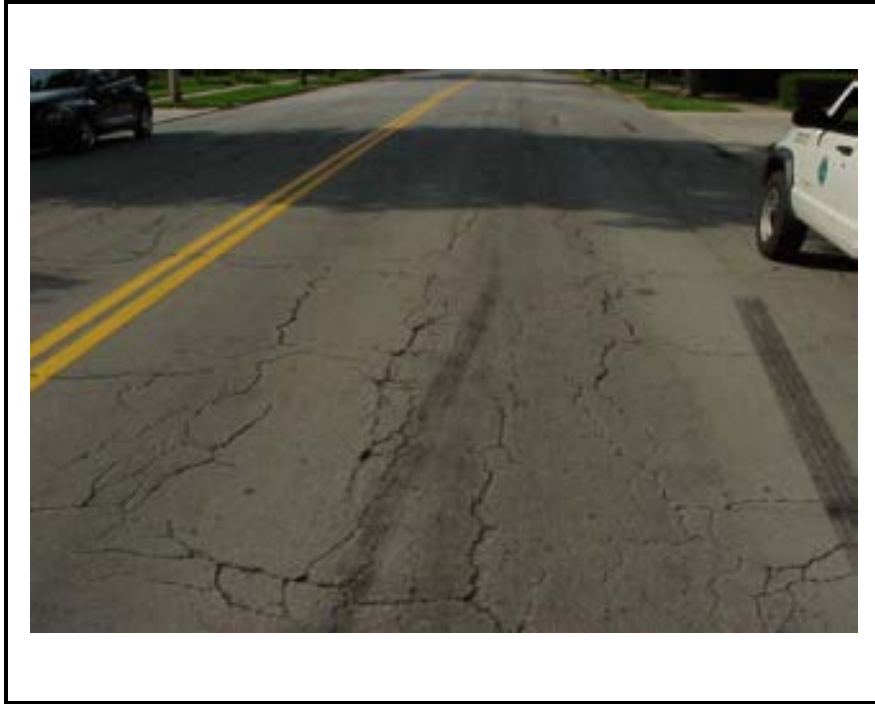
Severity Level:	Low--	Average size of block formed is greater than 5' x 5', but less than 9' x 9'.
	Medium--	Average size of block formed is greater than 1' x 1', but less than 5' x 5'.
	High--	Average size of block formed is less than 1' x 1'; Multiple cracking with extensive alligator cracking, and some alligator blocks are easily removed.
Extent Level:	Occasional--	Less than 20 percent of the section length is affected by this distress.
	Frequent--	Between 20 and 50 percent of this section length is affected by this distress.
	Extensive--	Greater than 50 percent of the section length is affected by this distress.

Photo E-11. Map Cracking in Local Pavement, Medium Severity

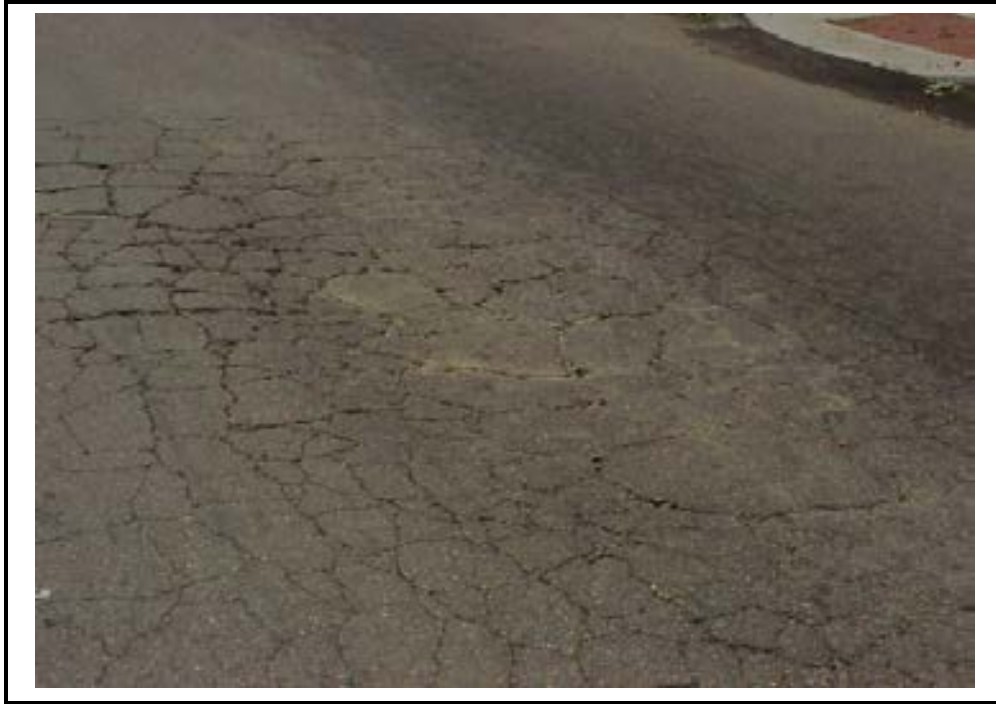
Severity Level:	Low--	Barely noticeable pitch and roll, and jarring bump or drop of vehicle while in motion.
	Medium--	Noticeable pitch and roll, and harsh jarring bump or drop of vehicle while in motion.
	High--	Continuous pitch and roll, and hard jarring bump or drop of vehicle while in motion; poor ride; Or pumping exists.
Extent Level:	Occasional--	Less than 2 isolated base failures/mile (per 1.6 km) of roadway, or less than 10% of the section length is continuous base failure.
	Frequent--	2 to 5 isolated base failures/mile (per 1.6 km) of roadway, or 10 - 30% of the section length is continuous base failure.
	Extensive--	More than 5 isolated base failures/mile (per 1.6 km) of roadway, or greater than 30% of the section length is continuous base failure.

Photo E-12. Base Failure in Local Pavement, High Severity

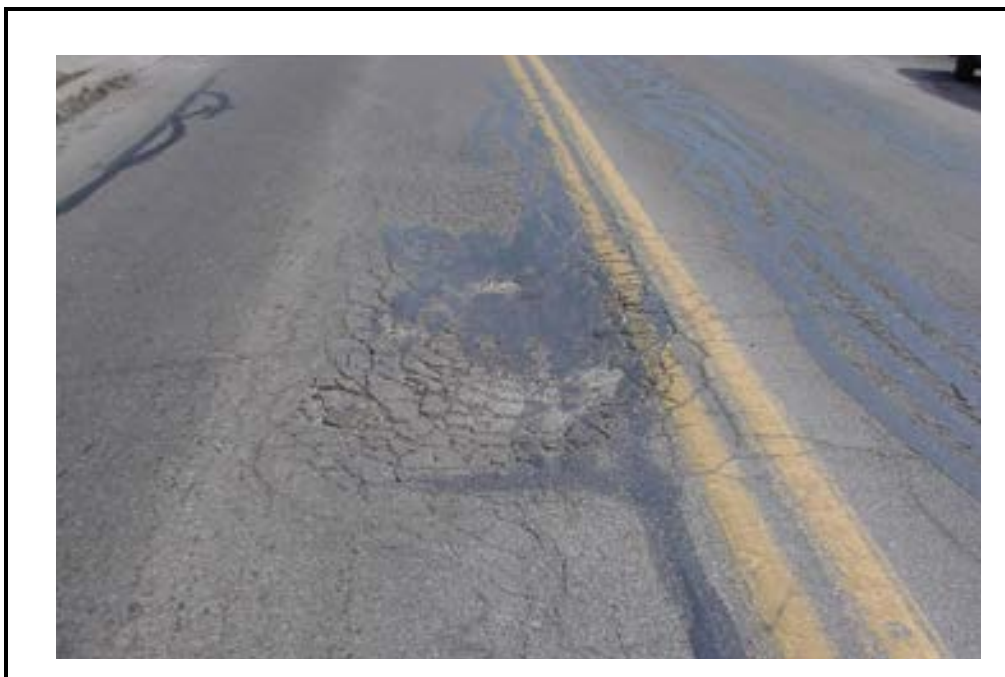
Photo E-13. Base Failure in Local Pavement, High Severity

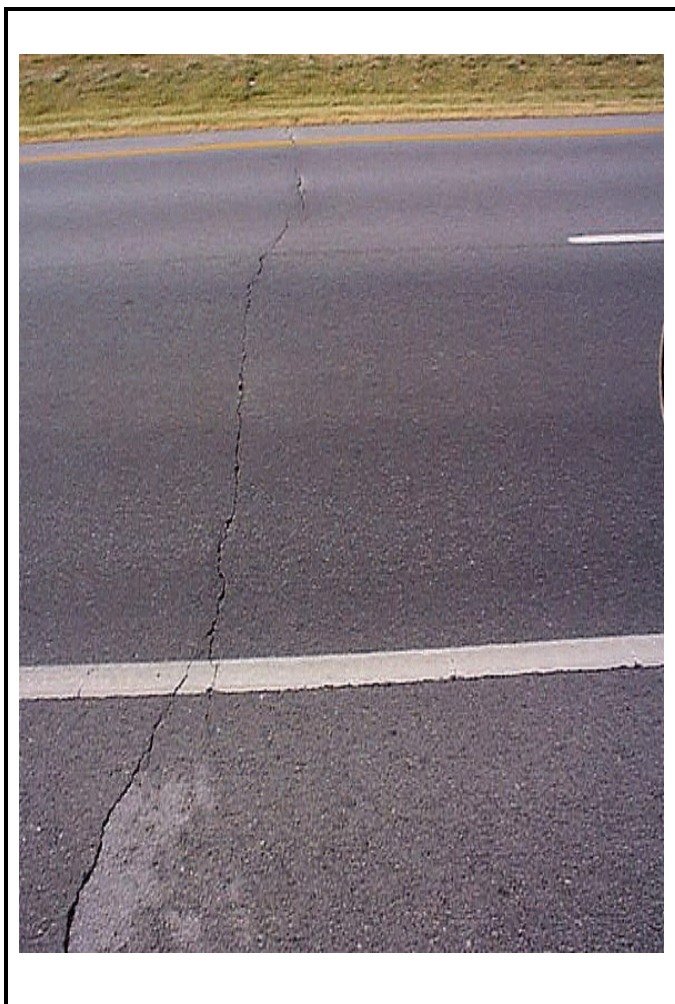
**Photo E-16. Transverse Cracking in Local
Pavement, Low Severity**

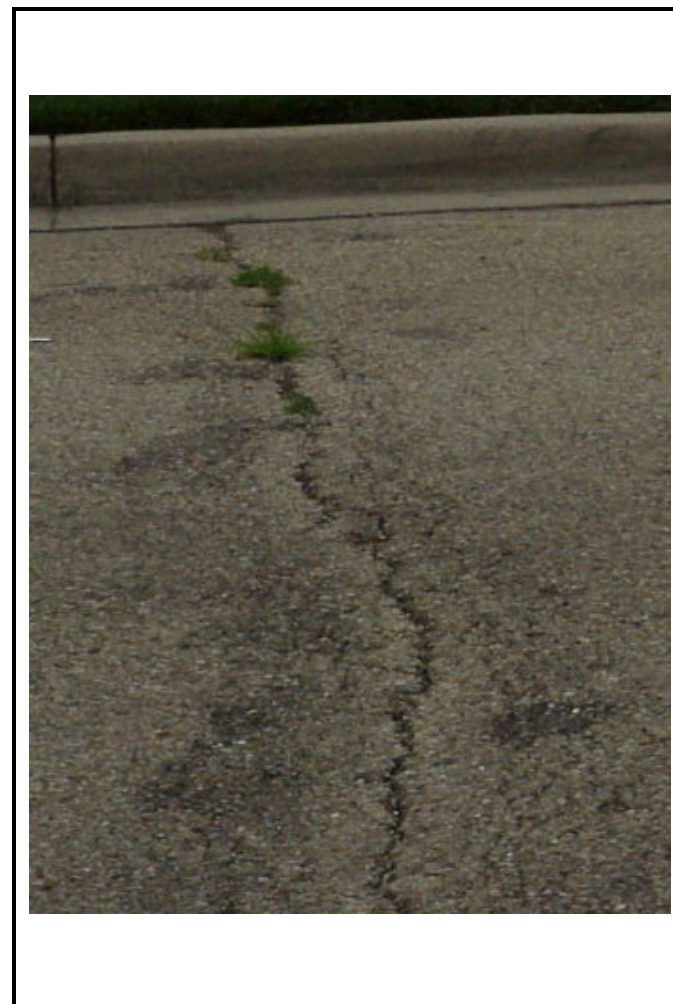
**Photo E-17. Transverse Cracking in Local
Pavement, High Severity**

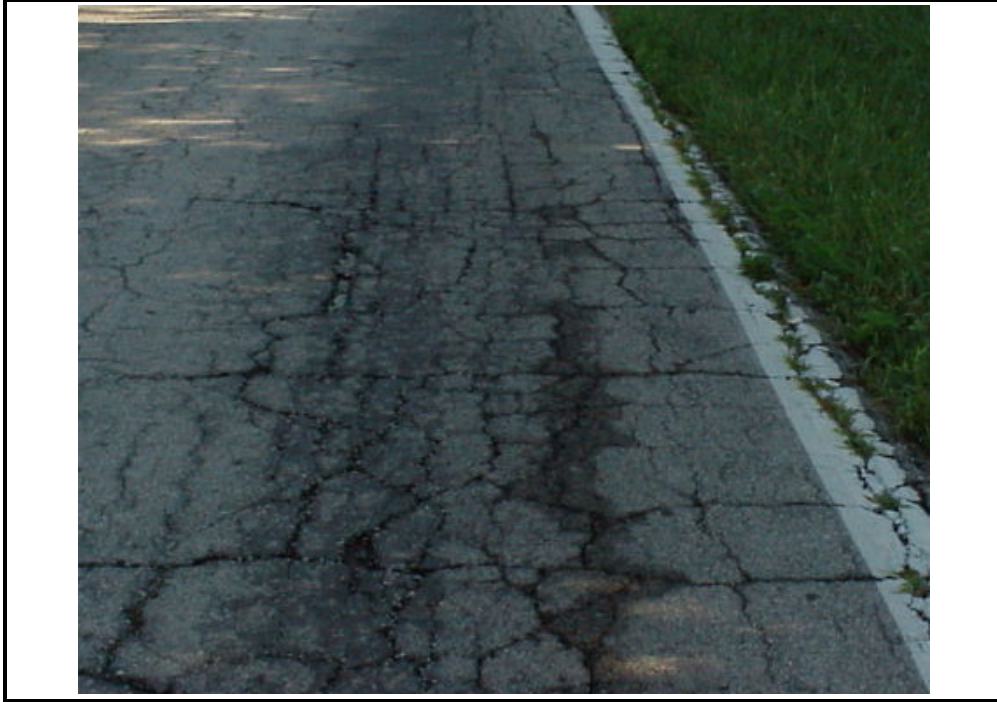
Photo E-18. Wheel Track Cracking in Local Pavement, High Severity

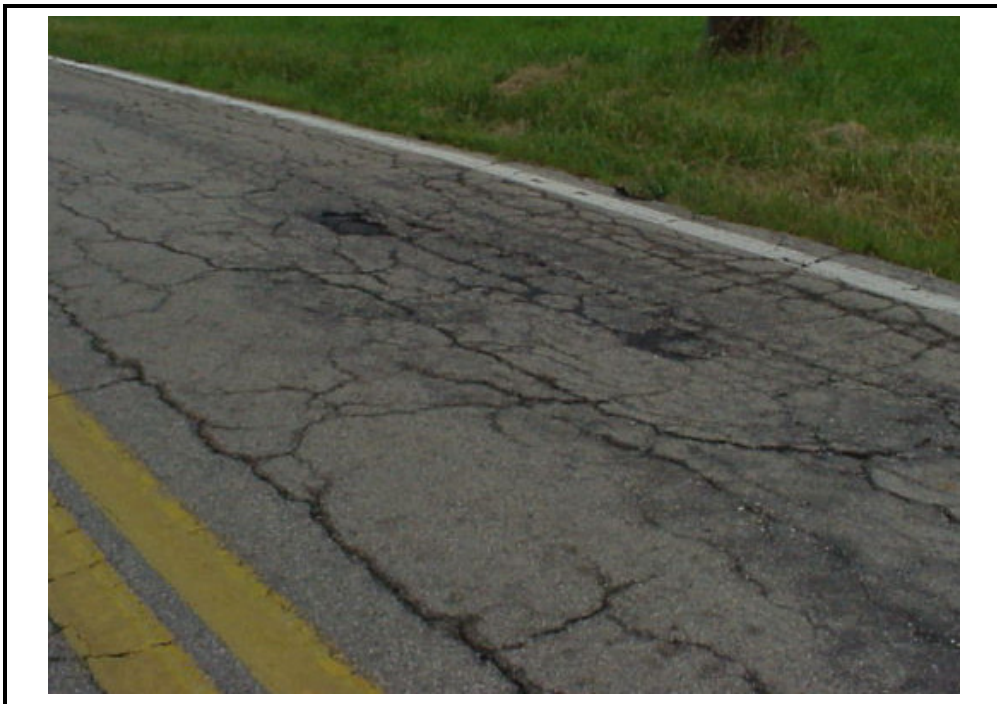
Photo E-19. Wheel Track Cracking in Local Pavement, High Severity
