PAVEMENT CONDITION RATING SYSTEM

The Ohio Department of Transportation
Office of Pavement Engineering
1980 West Broad Street
Columbus, OH 43223

April 2006

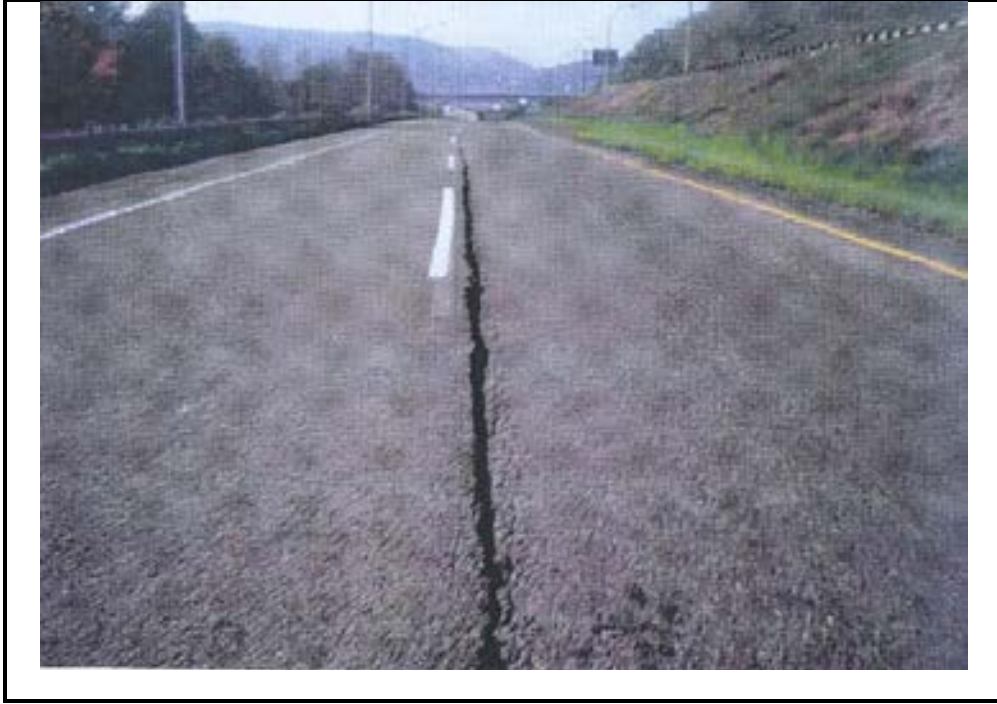
Photo E-20. Longitudinal Cracking in Local Pavement, High Severity

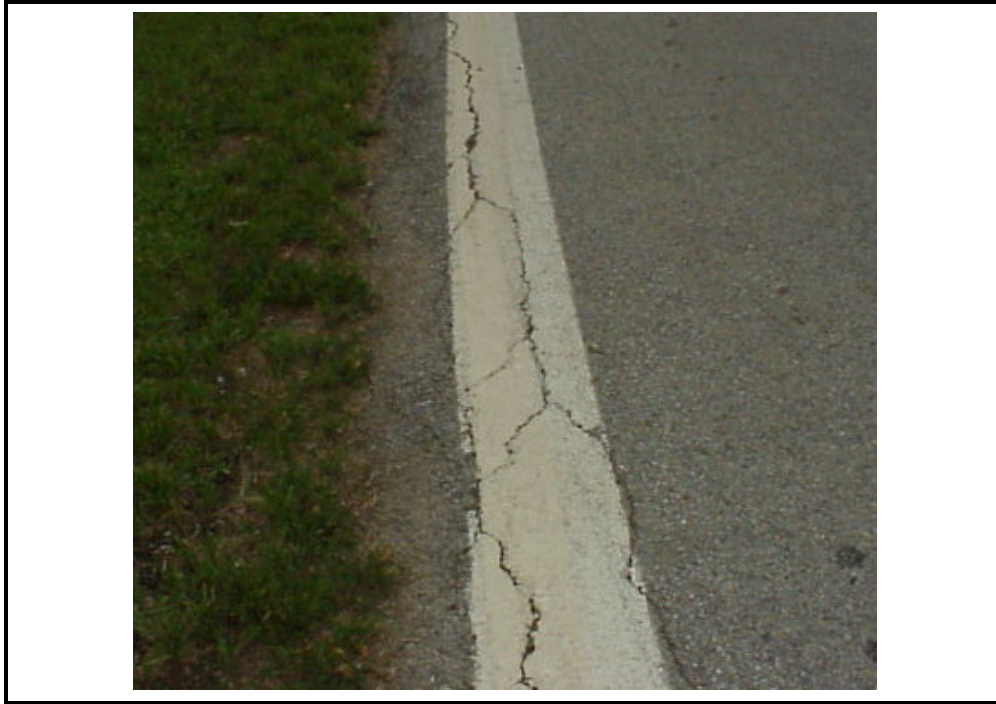
Photo E-21. Edge Cracking in Local Pavement, Medium Severity

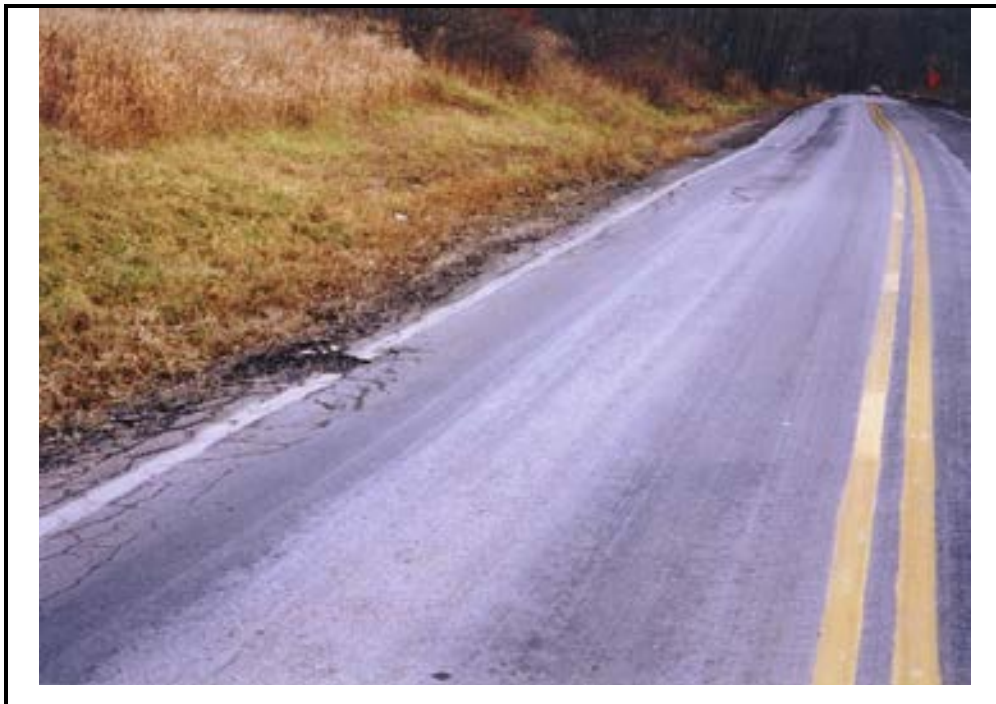
Photo E-22. Edge Cracking in Local Pavement, High Severity

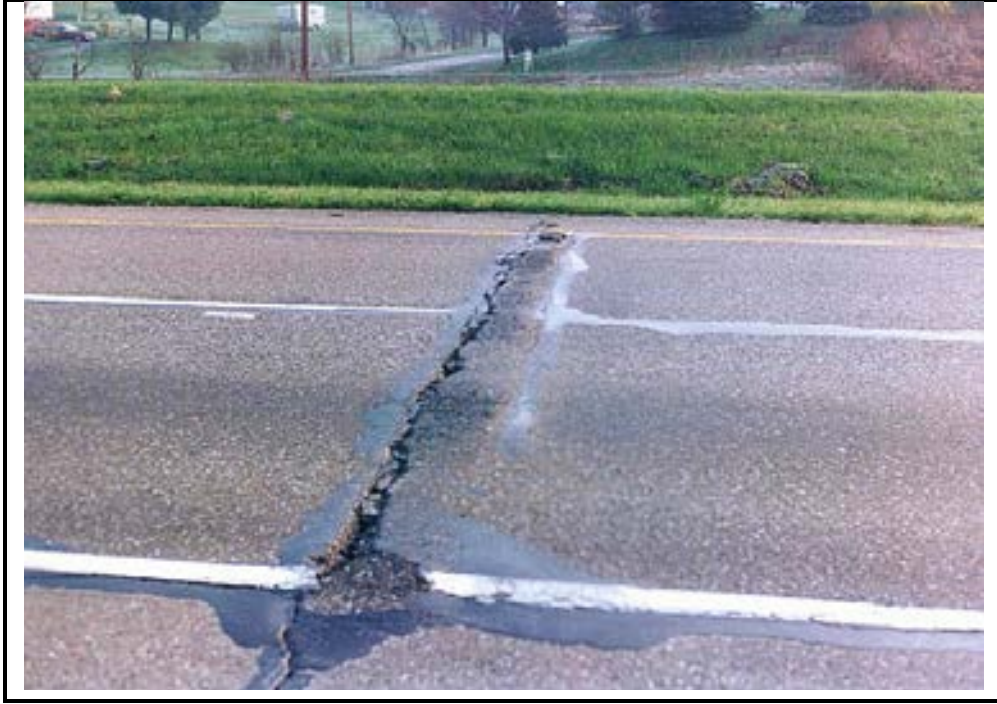
**Photo E-23. Pressure Damage/Upheaval in Local Pavement,
Medium Severity**

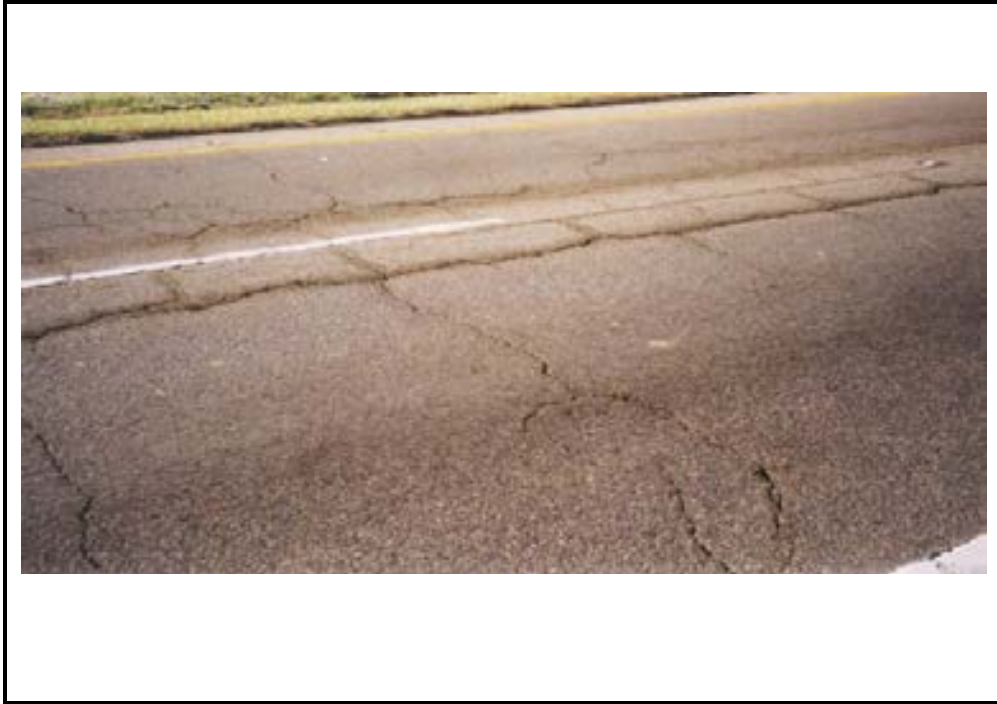
Photo E-24. Crack Sealing Deficiency in Local Pavement, Unsealed Cracks

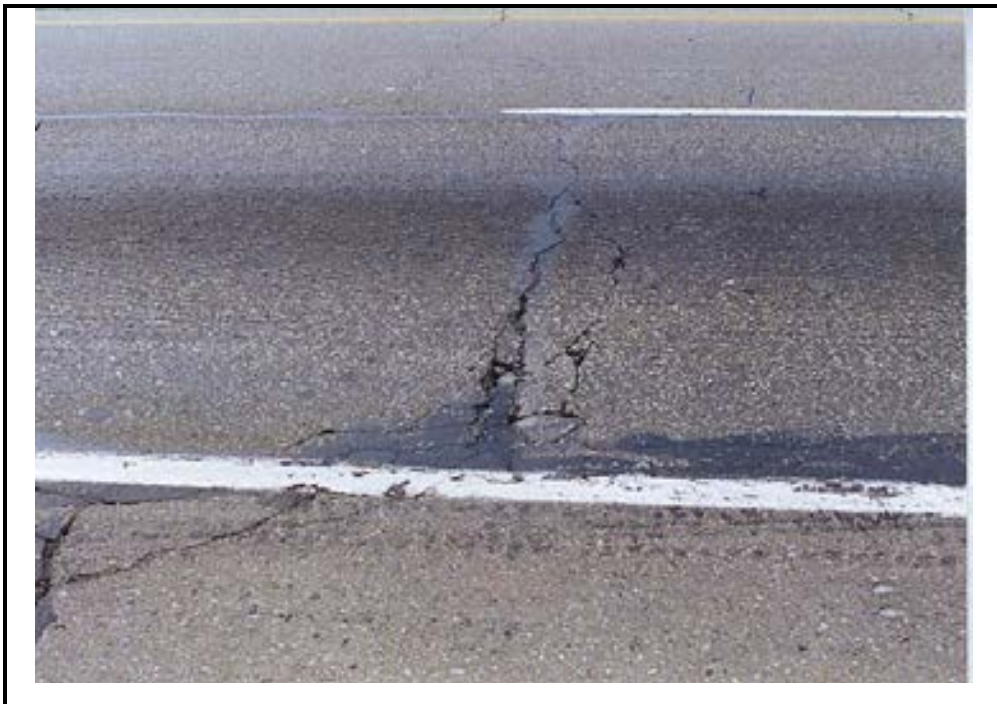
Photo E-25. Crack sealing Deficiency in Local Pavement, Cracks not sealed sufficiently

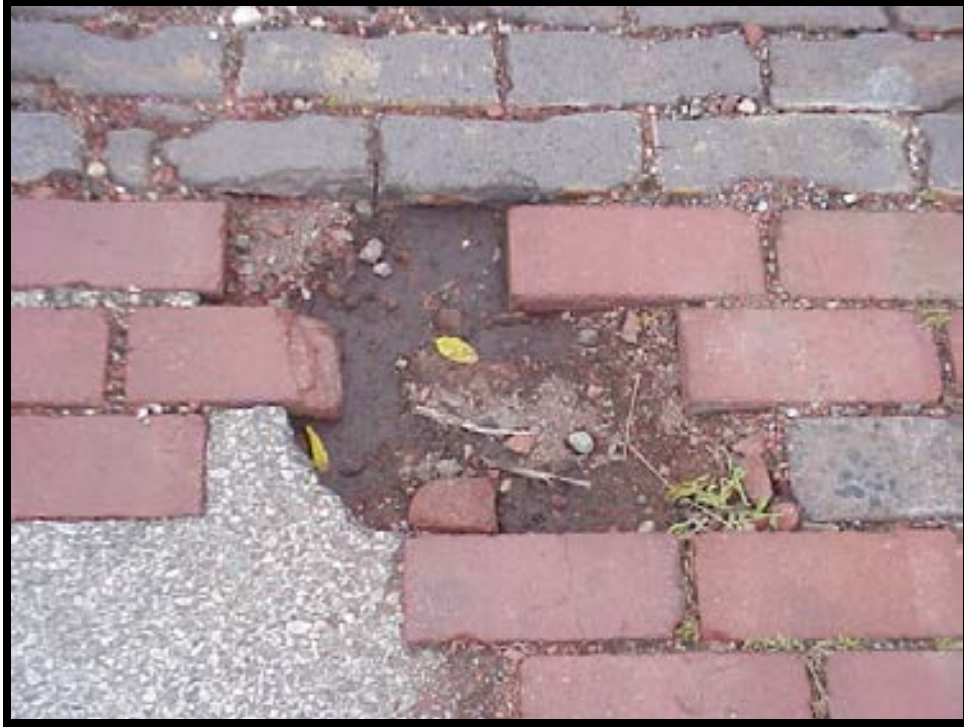
Photo F-1. Brick Deterioration in Brick Pavers, Medium Severity

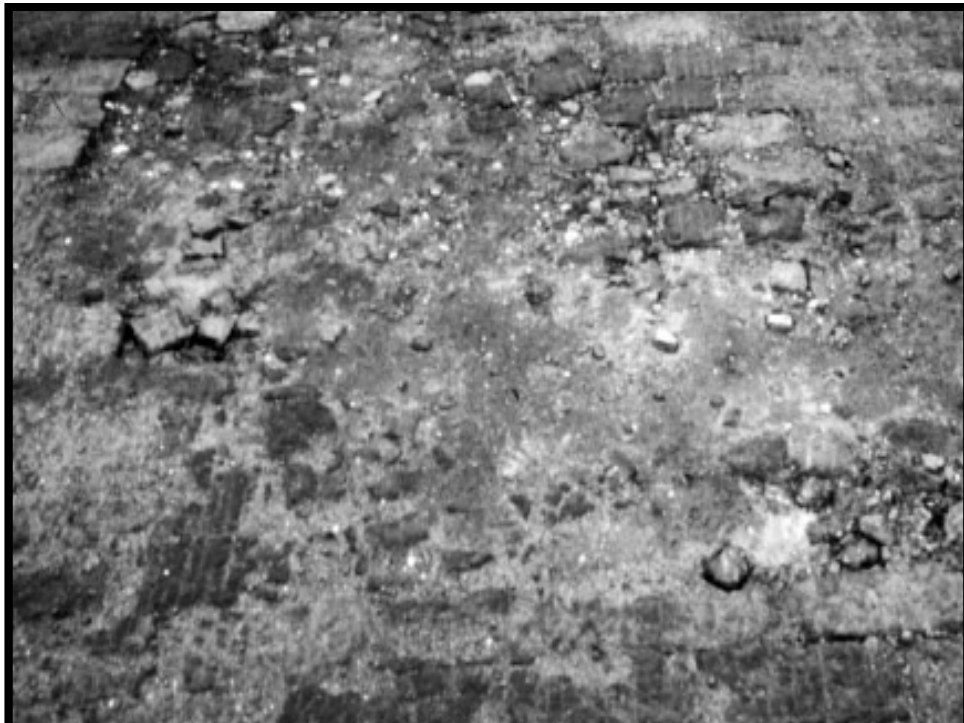
Photo F-2. Brick Deterioration in Brick Pavers, High Severity

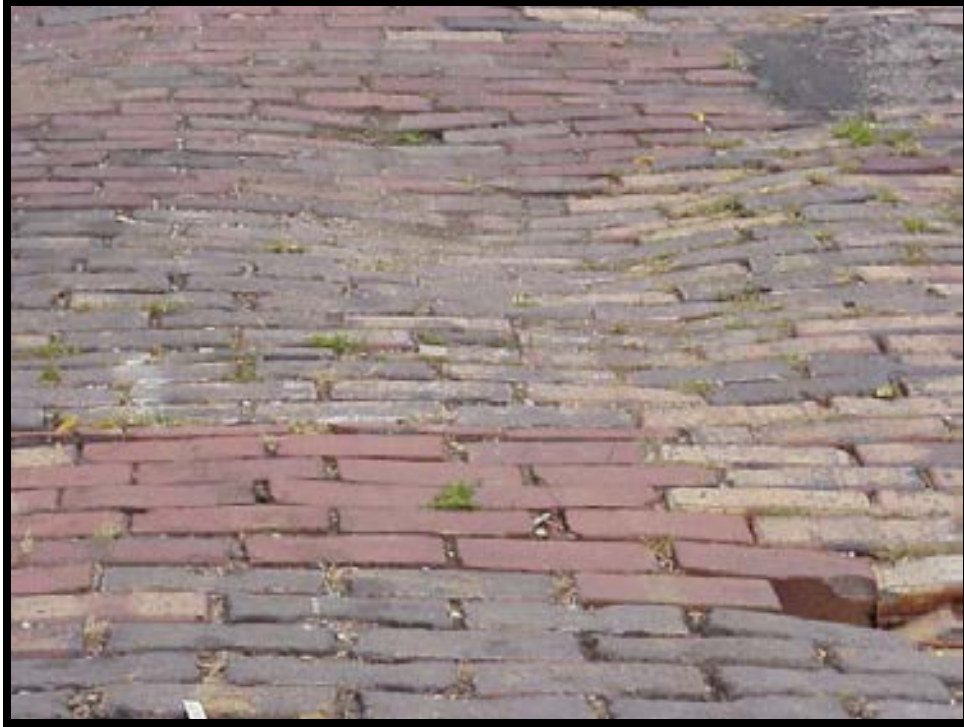
Photo F-7. Pumping in Brick Pavers
